HERITAGE SURVEY AND EVALUATION FORM

| Municipal Address | 14 Crescent Road | Building or Property Name | 042270055 | |

| Heritage Conservation District name | Rockcliffe Park |

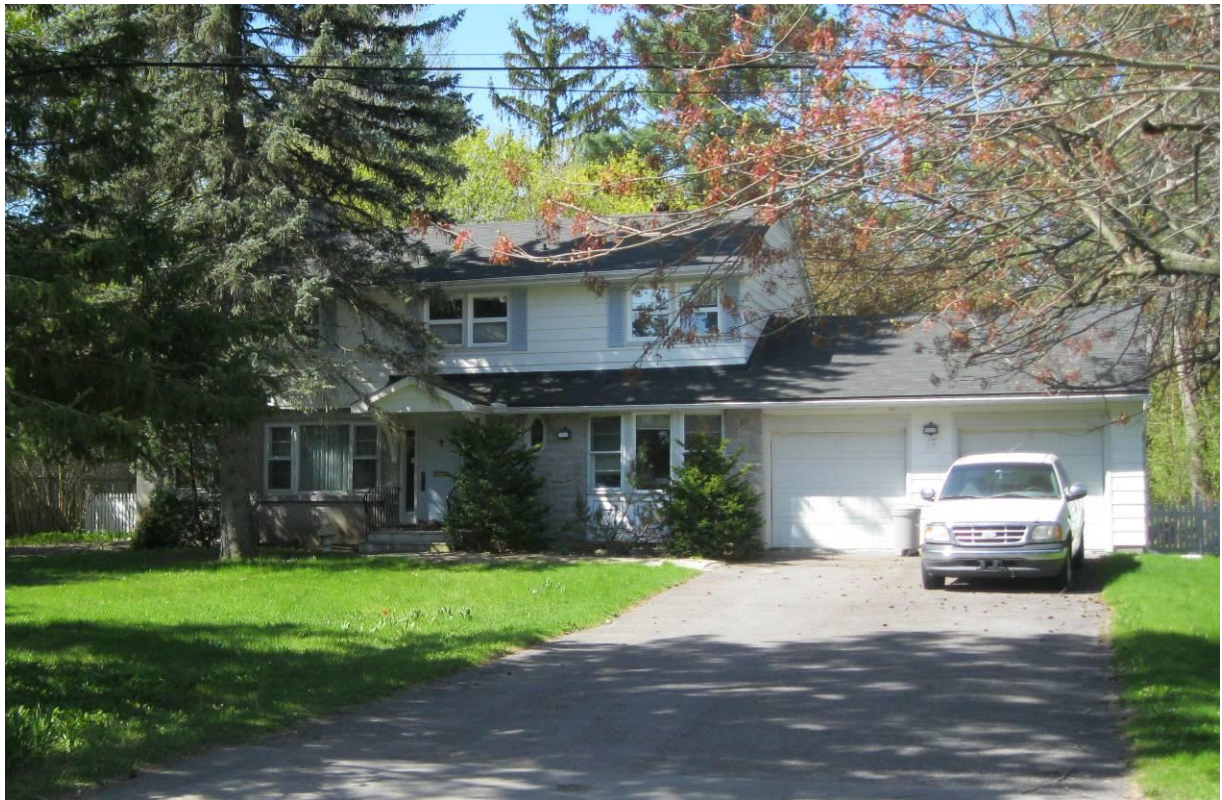
Main Building

| <p>14 Crescent is a two storey, rectangular, centre hall plan structure with a moderately pitched side gable roof. There is a single storey double car garage attached to the north side of the house, and the eave of the garage roof carries over across the front of the house, until it reaches the front door, where a small pediment awning has been constructed above the door. The single unglazed door is flanked by sidelights. South of the door there is a wide picture window with a fixed central pane flanked by two one over one single hung sash windows. A bay window with the same configuration is located on the north side of the entrance. There is a small, elongated hexagonal window just north of the door. The second storey contains three centered pairs of one over one single hung sash windows, each with decorative shutters. The house is clad in fabricated stone on the first storey and horizontal siding on the second.</p> | |
