## **Appendix C – Rideau Valley Conservation Authority's City Stream Watch Reports**

- City Stream Watch Becketts Creek 2011 Summary Report
- City Stream Watch Becketts Creek 2017 Catchment Report

# Becketts Creek 2011 Summary Report

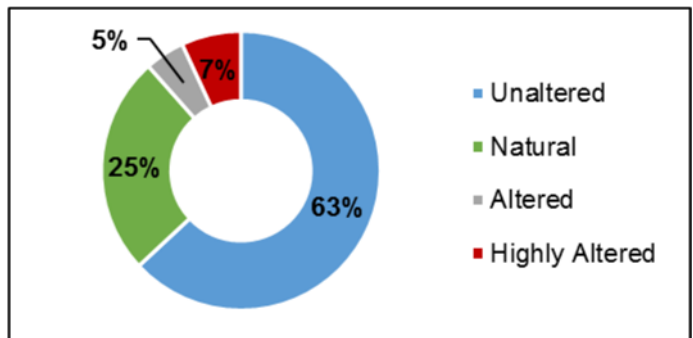
**Figure 5** Anthropogenic alterations along Becketts Creek

Highly altered sections (7% of sections) have the highest proportion of alterations. Including riparian buffers less than five meters, shoreline alterations are found on most of the section, and portions of the stream may flow through culverts.

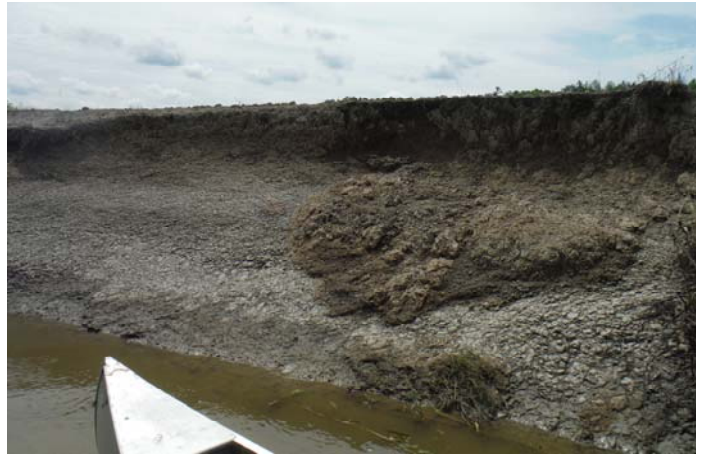
Near the mouth and in many other reaches of Becketts Creek, the system is dominated by steep forested slopes and leda clay that makes them unstable. In the upper reaches of the system, certain agricultural areas have unstable banks with exposed soils, lack of vegetation and undercutting.

Stream bank erosion with visible soils and lack of vegetation

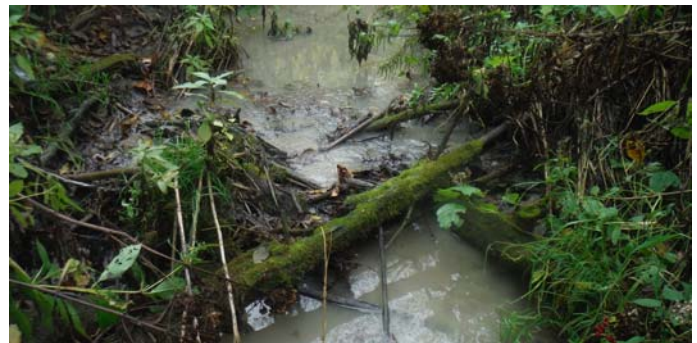
Figure 16 Instream wood structures along Becketts Creek

Figure 16 shows that the majority of Becketts Creek had low levels of instream woody material in the form of branches and trees. Instream wood material is important for fish and wildlife habitat, by providing refuge and feeding areas. Excessive amounts can create barriers.

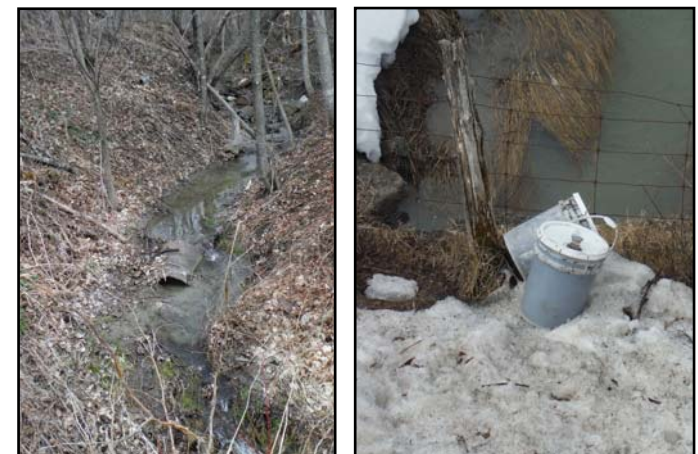
In the headwater portions of the catchment garbage and dumping was also observed. The images below show examples of dumping and oil spills near roads.

Pollution observed along headwater areas of Becketts Creek: metal drums and pails of unknown fluids

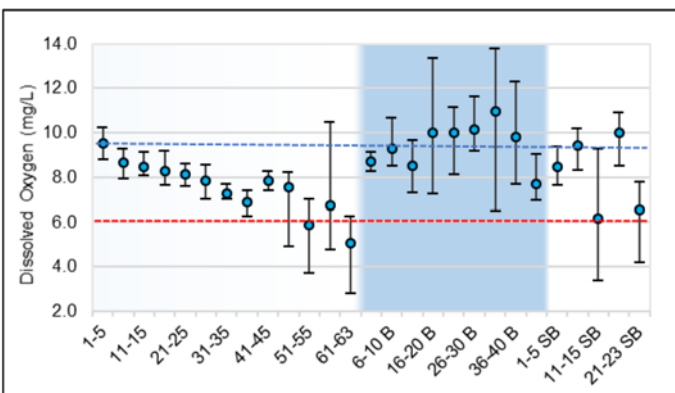
**Figure 22** Dissolved oxygen ranges in surveyed sections of Becketts Creek: 1-63 main stem, 1-44 branch (B) in blue, 1-23 south branch (SB)

Figure 22 shows the concentration levels found in the surveyed portions of Becketts Creek. The two dashed lines depicted represent the Canadian water quality guidelines. Most of the surveyed portions had adequate oxygen levels to support warm-water aquatic life. Levels below the Canadian water quality guideline were found in agricultural areas and at road crossings (sec. 51-63; 11-23 SB). Average levels across the system were 8.4 milligrams per liter.

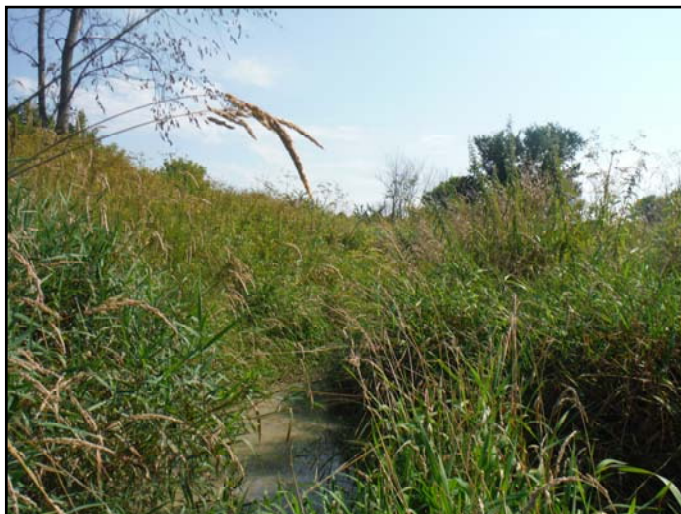
Section of Becketts Creek upstream of Sarsfield Road with highly elevated conductivity levels

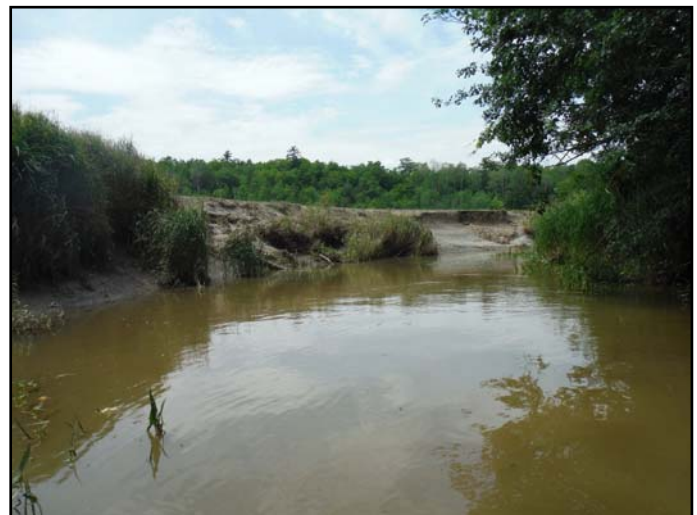
Section of Becketts Creek upstream of Birchgrove Road that would benefit from buffer enhancement to improve shoreline conditions and water quality.

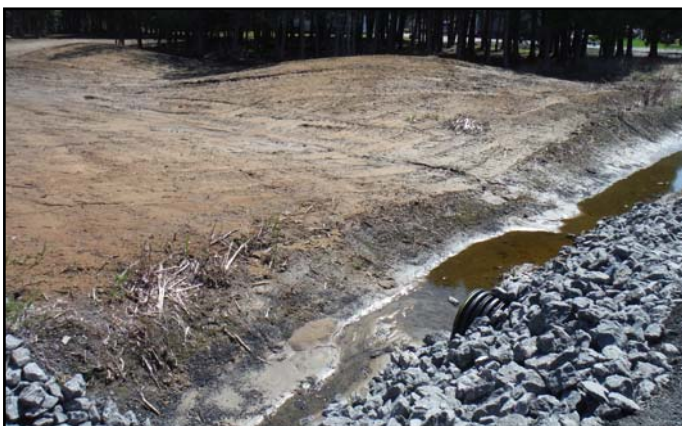
Extensive sediment deposition observed on Joannise Road
