## HERITAGE SURVEY AND EVALUATION FORM Building or 514 Manor Avenue Municipal Address Property Name 042220142 Legal Description PLAN M22 BLK A7 Plan Lot Block Date of Original Lot Development Date of current 1940 structure Additions Original owner

Heritage	Conservation	District	name
1 ICHILAGE			Hallic

Rockcliffe Park

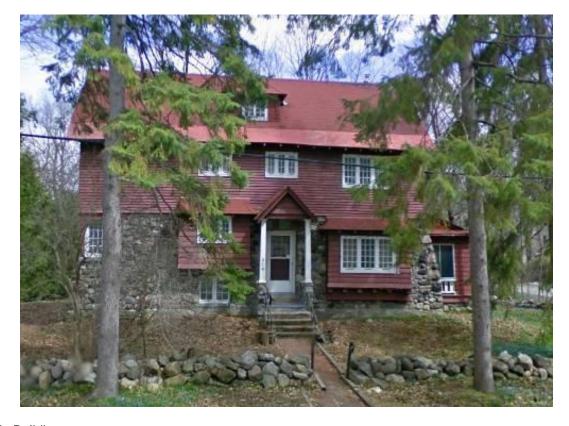
Main Building

This two storey building is rectangular in plan and capped by a steeply pitched side gabled roof. The exterior is siding except for elements of the front facade which are uncut rubble stone. There are overhanging eaves with rafter tails on all facades. The upper storey of the front facade features three differently sized and unevenly spaced multi paned rectangular windows all grouped in threes. The north portion of the lower storey contains a single multi paned rectangular window. The doorway is relatively centrally placed on the front facade and covered by a front gabled rooflet supported by posts. Adjacent to the door is a rectangular projection with overhanging eaves and rafter tails and a single multi paned window. There is a window in the basement storey directly below. On the south side of the lower storey there is another rectangular projection with eaves and rafter tails containing a multi paned rectangular window. Attached on the south facade is a one storey shed roof sunroom with large vertical windows on all facades. There is an exterior stone chimney centered on the south facade of the main building behind this extension.
