Tree Information Report

Submitted as part of Committee of Adjustment Application to the City of Ottawa

Address: 304 Olmstead/206 Levis

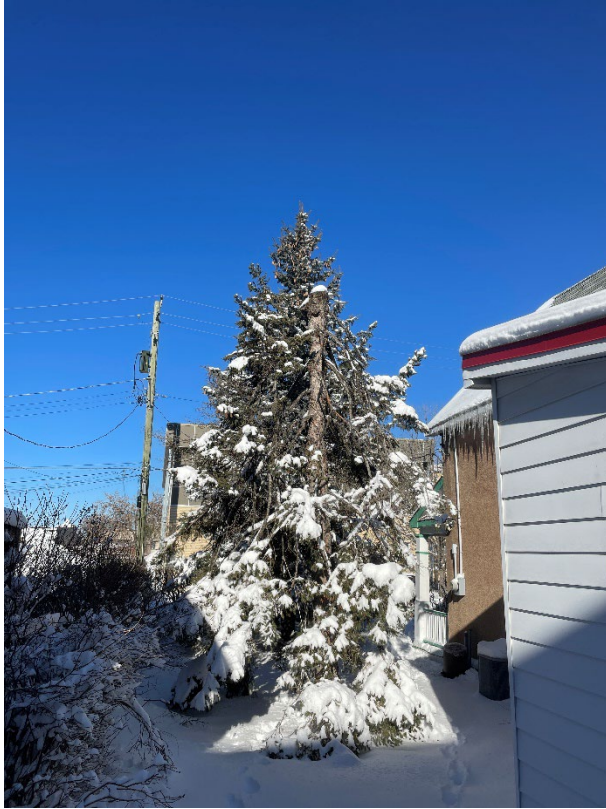
Figure 1; tree 1 (behind) and tree 1 (front), Colorado spruce to be removed

The existing two homes on these properties will be replaced with 3 buildings, of which two are semidetached dwellings. The footprint for the new home at 206 Levis will be shifted further west, which will conflict with the locations of trees 1 and 2 which are in the footprint of the new home. The new building on the south side of 304 Olmstead will be in conflict with trees 3 and 4. Tree 4 is directly in the footprint of the new home, and tree 3 is located where the future driveway is proposed. Shifting the driveways to accommodate this tree is not recommended as the tree in a poor location directly underneath the hydro lines which will undoubtedly cause problems in the future as significant limbs are be pruned back. It is recommended that this tree be removed, and new trees be planted in more suitable locations once construction is complete.

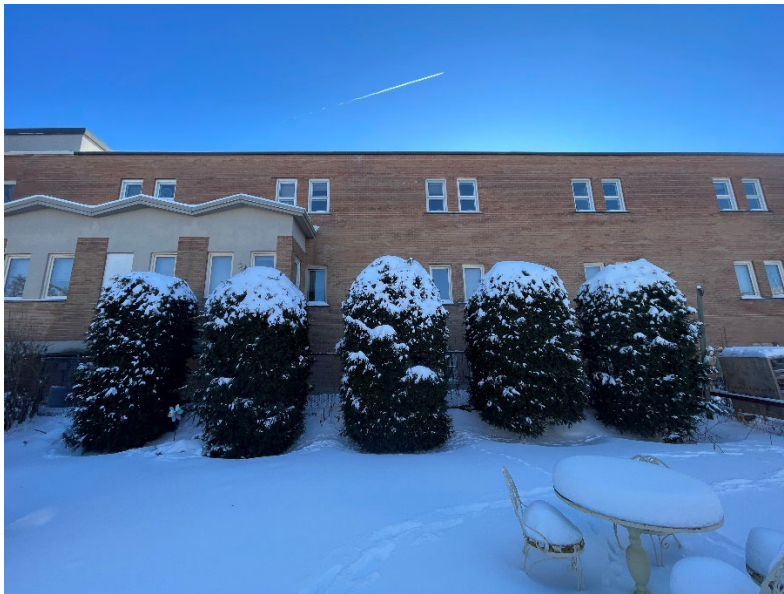
Figure 2: Line of cedar bushes that are well maintained and retainable.

There is a line of 7 cedar bushes along the south side of 206 Levis that would be ideal candidates for preservation. These trees are healthy and have been well maintained and are far enough away from any proposed construction. Although these trees are less than 30 cm in diameter, it is suggested that they be retained, and the standard tree protection guidelines be applied as follows:

Prior to any site works, protective fencing should be installed around the trees as indicated in the attached Tree Information Map and maintained until all construction on site has been completed as per the **City of Ottawa Tree Protection Specifications (March 2021)**. Within the fenced area, the following tree protection guidelines should be applied:

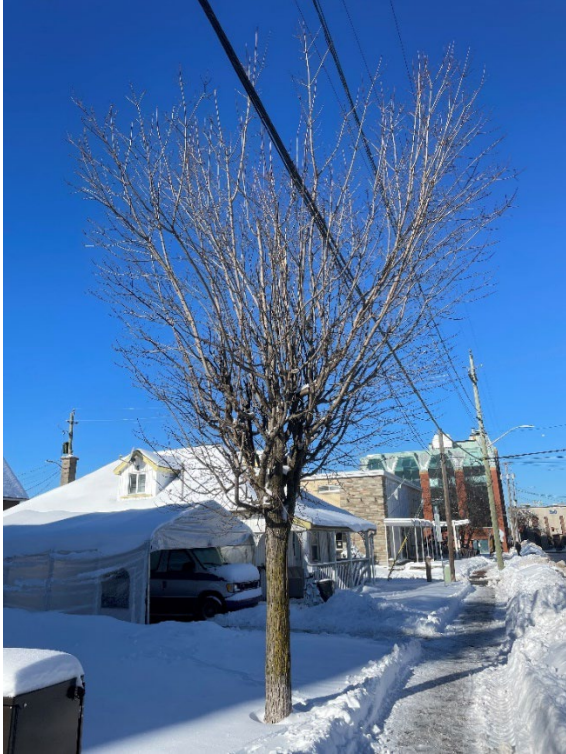
Figure 3: City owned sugar maple to be removed

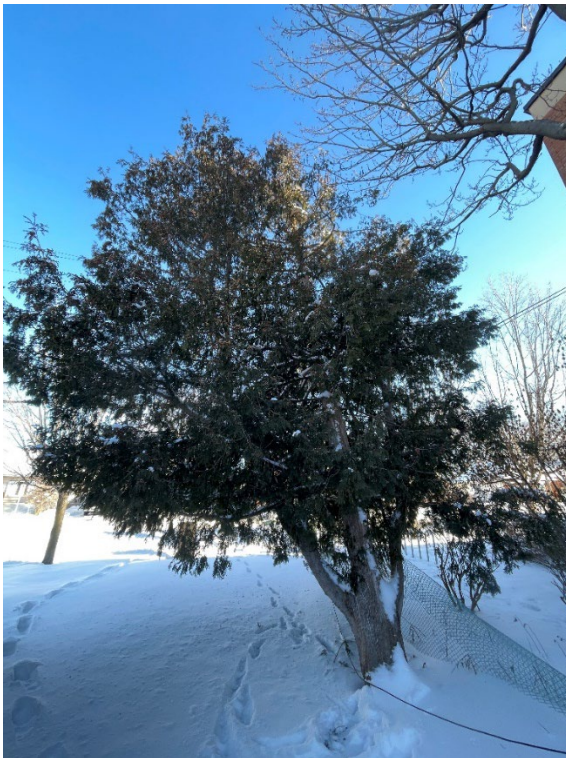
Figure 4: Tree 4, eastern white cedar to be removed.
