248 & 250 BAYSWATER TREE INFORMATION REPORT

DATE: MAY 10, 2023

OTTAWA TREE REPORTS

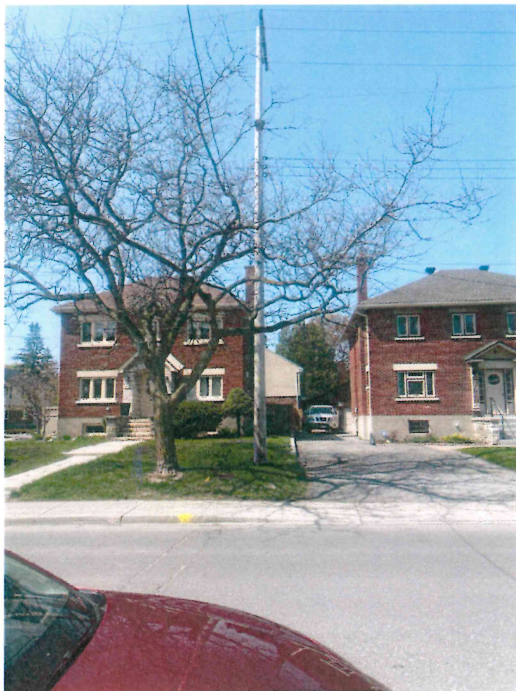
Figure 1 – Tree 1 south of 250 Bayswater Avenue

Tree 1 is a 46 cm Honey locust *Gleditsia triacanthos* that is completely located on City of Ottawa property approximately 3.4m south of the private approach in front of 250 Bayswater Avenue (see Figure 1). This tree has a critical root zone (CRZ) of 4.6 m and the CRZ of this tree extends under the existing private approach by approximately 1.2 m. Due to the condition of the existing private approach, and the noticeable presence of ridges (bulges), more than likely roots have grown underneath the existing surface. Excavation will be required to remove the existing surface, and for the installation of the new surface; the roots (less than 10% overall) that have protruded under the private approach will be damaged, during this excavation. To limit the root damage (eg tearing) a preconstruction root grinding operation is recommended.

Considering Tree 1 is a City of Ottawa owned tree, it is recommended that the owner contact City of Ottawa Forestry Operations to perform a root pruning (grinding) operation on a line 3.3m from the base

of the tree, parallel to the private approach surface, from the back of sidewalk to the property line of 252 Bayswater. This will cleanly sever all roots according to arboricultural best practices, and at this distance from the trunk flare will not impact the static relevant zone or stability of Tree 1. In discussion with the owner, the proposed private approach works are scheduled to occur in the Fall of 2024, therefore a Spring 2024 root pruning operation is recommended; if the City's Forestry Operations cannot meet this timeline, it is recommended the owner receive written authorization to perform the root grinding as prescribed, under the supervision of Ottawa Tree Reports.

Tree 1 is a 46 cm Honey locust *Gleditsia triacanthos*, located on City property in front of 252 Bayswater. It is recommended that snowfence (in accordance to the City’s specification) be installed perpendicular from the back (means towards home) of sidewalk along grass at the driveway edge, towards the property line for 6.7 m. The tree will protection will act as a barrier to ensure construction related material are not stored on CRZ, nor are the roots subject to compaction. The Contractor should also ensure that exhaust fumes from all equipment must NOT be directed towards this trees canopy.

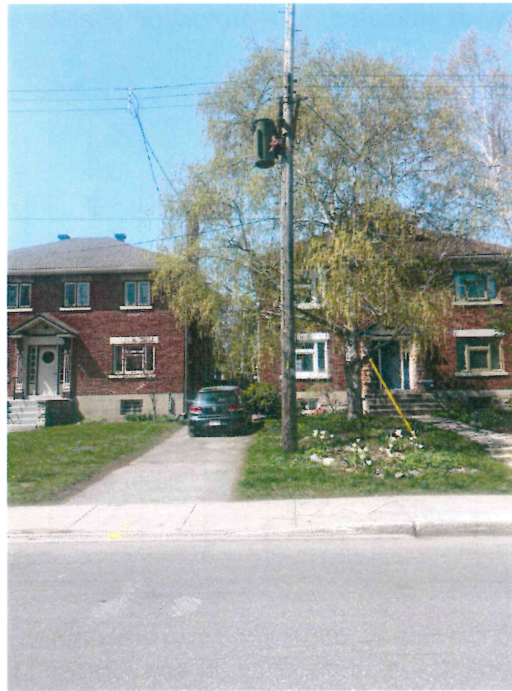
Figure 2 – Tree 2 north of 248 Bayswater Avenue

Tree 2 is a 37 cm White Birch *Betula papyrifera* that is completely located on City of Ottawa property at approximately 3.4m north of the property line of 248 Bayswater Avenue (no private approach). As seen in Figure 2 the property line is approximately located at the southern edge of the private approach of 246 Bayswater Ave, this is not a shared access. This tree has a critical root zone (CRZ) of 3.7 m. The CRZ of this tree potentially extends under the existing private approach by approximately 1.2 m. Considering there is a grade change down from the trunk flare of this tree to the private approach, the absence of any bulges or ridges (indicating settlement around roots), the likelihood of roots being present on the south side of the driveway (the owners' property) is extremely low. However, if roots are encountered during excavation for the new private approach (for 248 Bayswater Avenue), it is recommended that any, and all roots that are exposed or damaged during excavation, shall be pruned in accordance with good arboricultural practices.

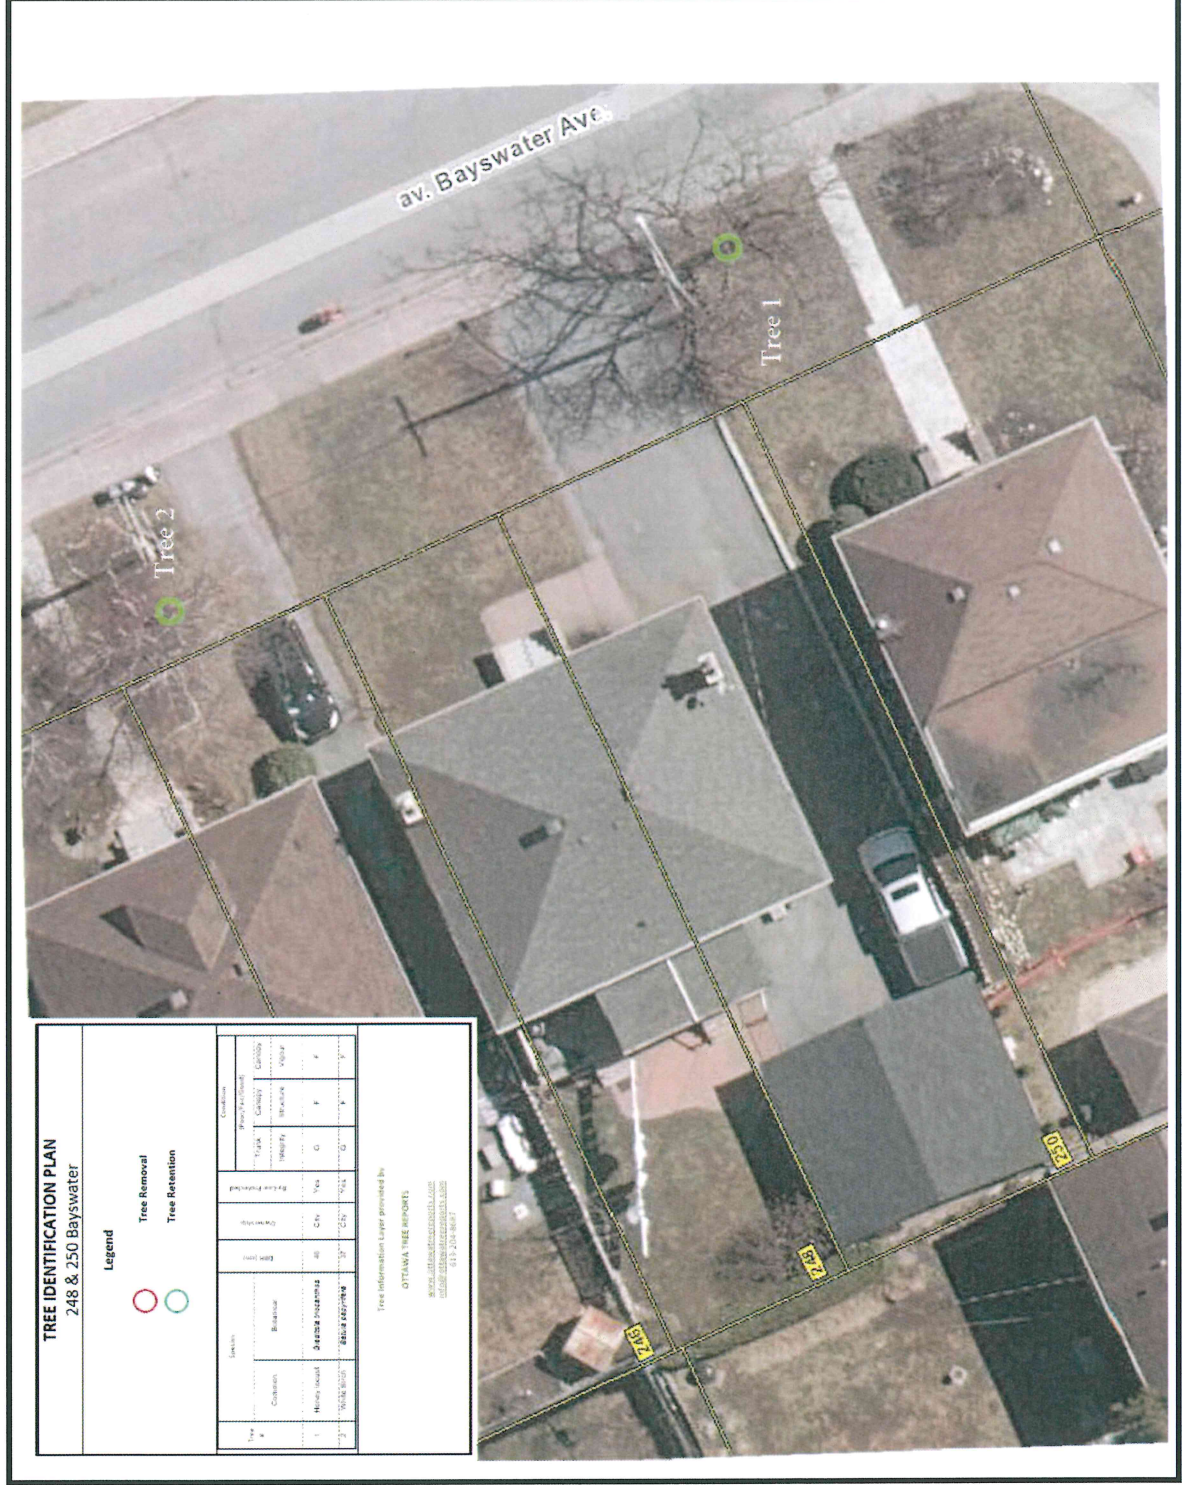
Tree Identification Plan

TREE IDENTIFICATION PLAN 248 & 250 Bayswater									
Legend									
		Tree Removal		Tree Retention					
		○		○					
Tree #	Species		Tree Condition	Tree Health	Tree Location	Tree Protection		Tree Removal	
	Common Name	Botanical Name				Yes	No	Yes	No
1	Maple	Acer sp.	Good	Healthy	Yes	No	Yes	No	
2	Oak	Quercus sp.	Good	Healthy	Yes	No	Yes	No
