RE: 598 Kirkwood - Minor Variance Application

OGC Ltd. is pleased to submit a Minor Variance application on behalf of the owner, for the subject site known as 598 Kirkwood to permit a reduced rear yard setback for the construction of a low-rise apartment addition to an existing building.

RE: TREE INFORMATION REPORT (FULL) FOR 598 KIRKWOOD AVENUE

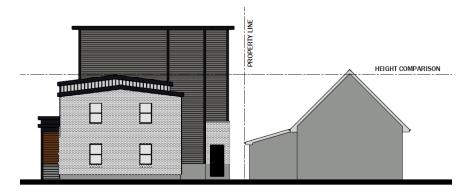
Figure 4 – Site Context along Kirkwood

The streetscape appearance along Kirkwood remains the same when considering the depth of lot and location of the proposed addition in relation to the existing dwellings.

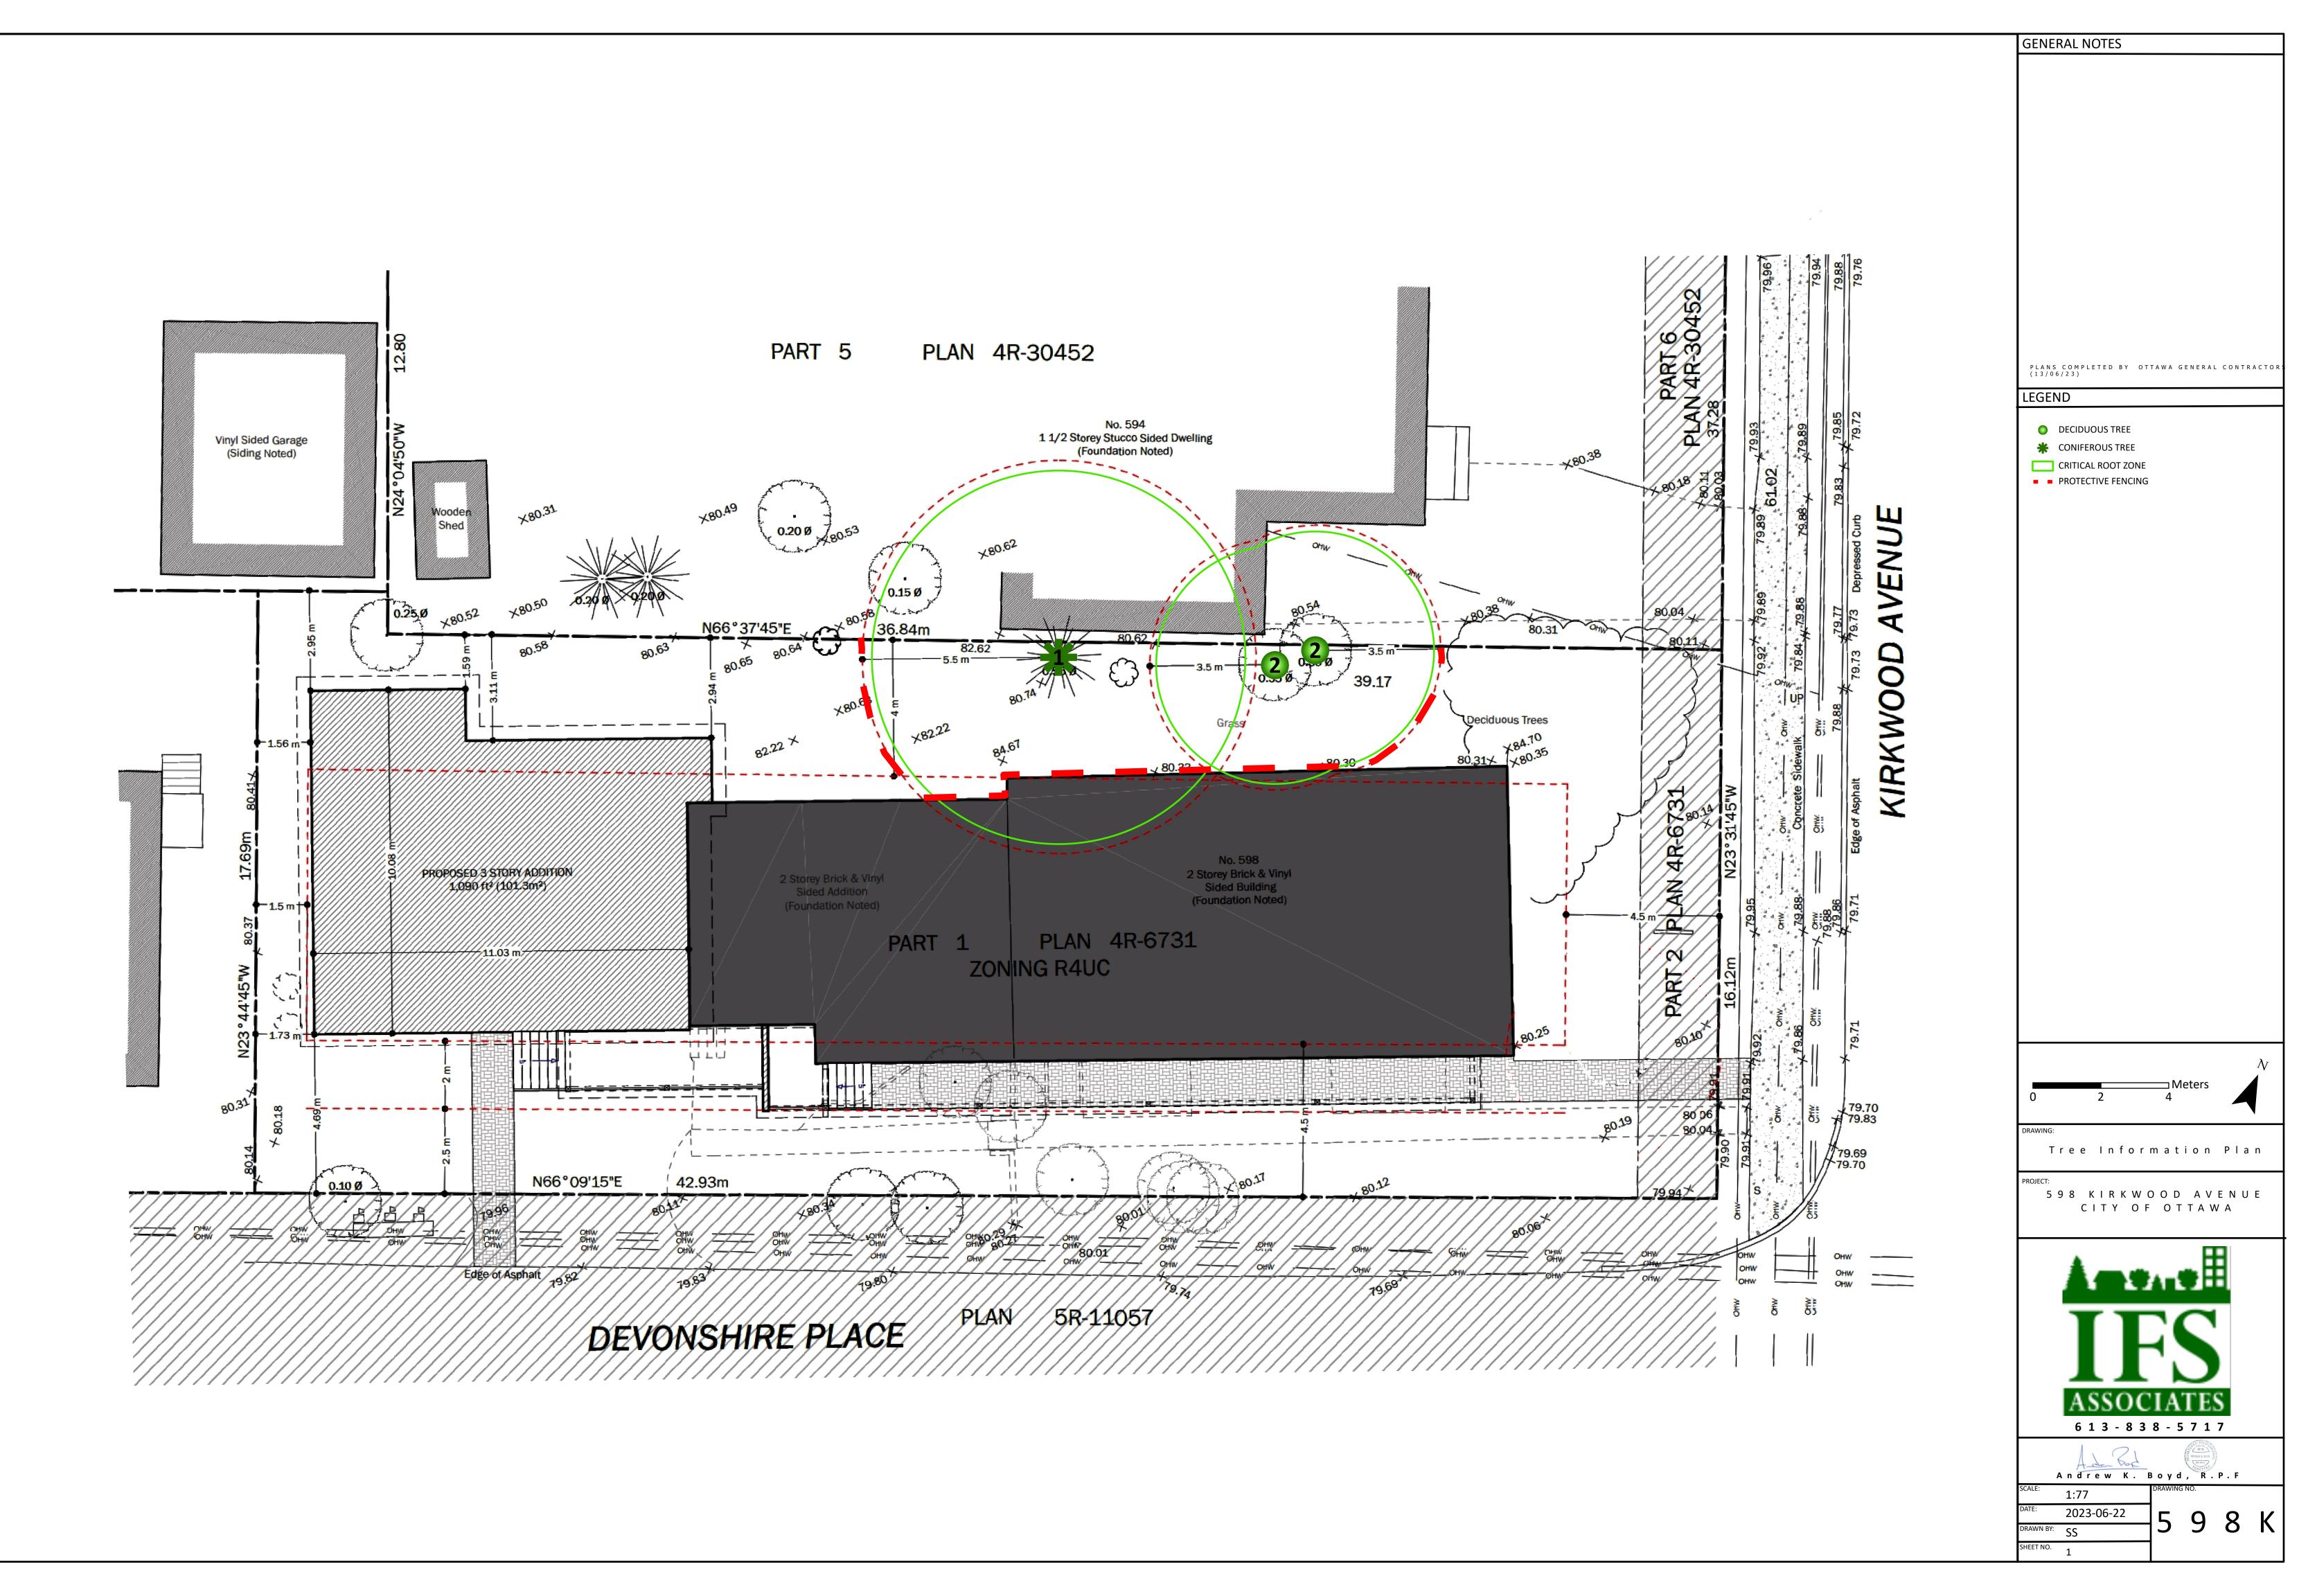
Table 1 on page 2 details the two individual distinctive trees on the subject property. Both trees are referenced by the numbers plotted on the tree information plan included on page 3 of this report.

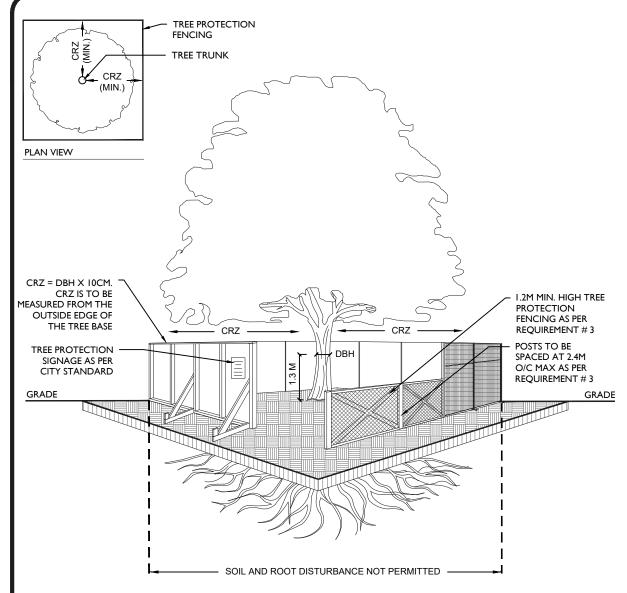
SCALE:	NTS		
DATE:	MARCH 2021		
DRAWING NO.:	1 of 1

- 1. PRIOR TO ANY WORK ACTIVITY WITHIN THE CRITICAL ROOT ZONE (CRZ = 10 X DIAMETER) OF A TREE, TREE PROTECTION FENCING MUST BE INSTALLED SURROUNDING THE CRITICAL ROOT ZONE, AND REMAIN IN PLACE UNTIL THE WORK IS COMPLETE.

- DO NOT EXTEND HARD SURFACE OR SIGNIFICANTLY CHANGE LANDSCAPING
- 3. TREE PROTECTION FENCING MUST BE AT LEAST 1.2M IN HEIGHT, AND CONSTRUCTED OF RIGID OR FRAMED MATERIALS (E.G. MODULOC - STEEL, PLYWOOD HOARDING, OR SNOW FENCE ON A 2"X4" WOOD FRAME) WITH POSTS 2.4M APART, SUCH THAT THE FENCE LOCATION CANNOT BE ALTERED. ALL SUPPORTS AND BRACING MUST BE PLACED OUTSIDE OF THE CRZ, AND INSTALLATION MUST MINIMISE DAMAGE TO EXISTING ROOTS. (SEE DETAIL)

TO BE IMPLEMENTED FOR RETAINED TREES, BOTH ON SITE AND ON ADJACENT SITES, PRIOR TO ANY TREE REMOVAL OR SITE WORKS AND MAINTAINED FOR THE DURATION OF WORK ACTIVITIES ON SITE.

- 1. Erect a fence as close as possible to the critical root zone (CRZ) of trees (City of Ottawa tree protection barrier detail included on page 5).
- 2. Do not place any material or equipment within the CRZ of the tree.
- 3. Do not attach any signs, notices or posters to any tree.
- 4. Do not raise or lower the existing grade within the CRZ without approval.
- 5. Tunnel or bore when digging within the CRZ of a tree.
- 6. Do not damage the root system, trunk or branches of any tree.
- 7. Ensure that exhaust fumes from all equipment are NOT directed towards any tree's crown.

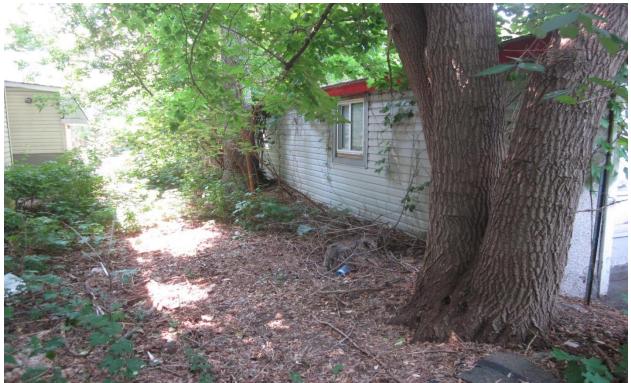
Picture 1. Trees #1 and 2 (left to right), lower boles of private spruce and maple trees at 598 Kirkwood Avenue

Pictures 1 and 2 on page 6 of this report show the two distinctive trees on the subject property.

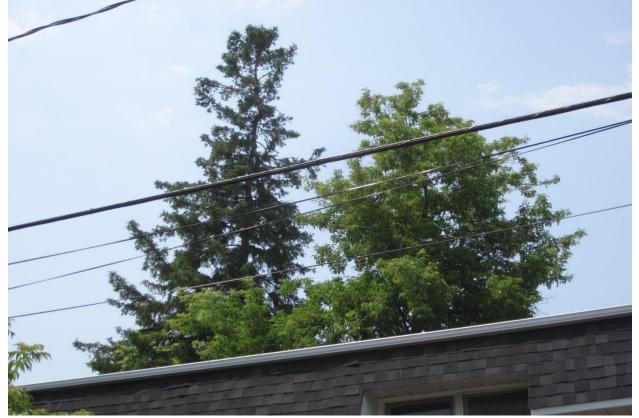
Picture 2. Trees #1 and 2 (left to right), upper crowns of private spruce and maple trees at 598 Kirkwood Avenue
