Tree Information Report

Submitted as part of Committee of Adjustment Application to the City of Ottawa

Address: 567 McLeod Street
Date of Site Visit: April 24, 2023
Date of Report: April 26, 2023
Prepared by: Kevin Myers, ISA Certified Arborist®
info@dendronforestry.ca

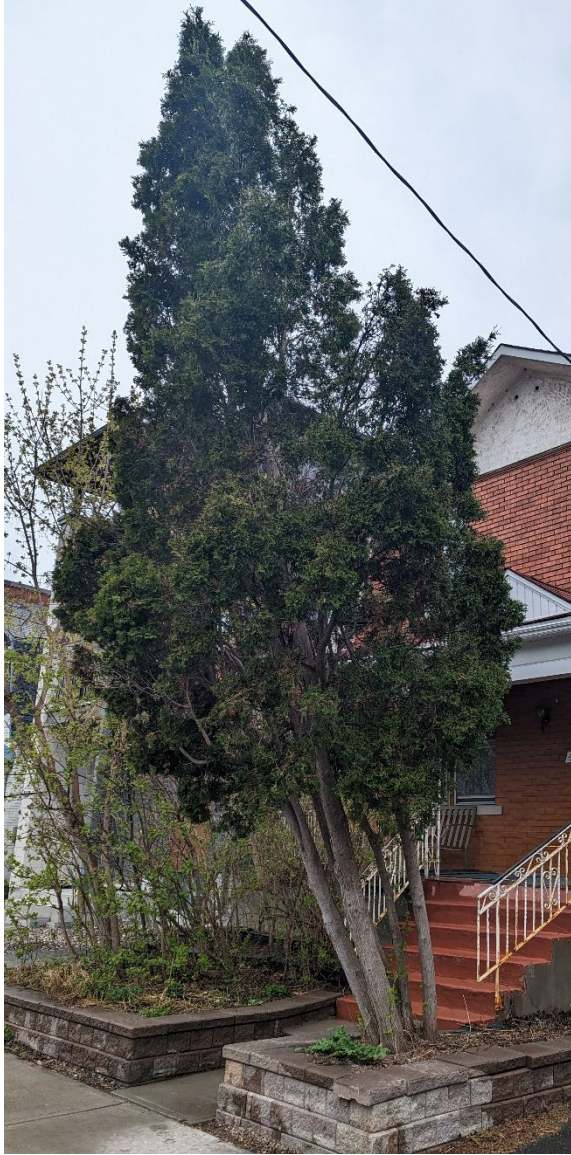
Above: Tree 1 - City cedar to be removed.

Trees 1 and 2 are small in stature and do not contribute greatly to the streetscape or canopy cover. They are contained within a front garden area that appears to have not been maintained in several years; it is overrun with Manitoba maple (*Acer negundo*) and Rose of Sharon (*Hibiscus syriacus*) sprouts. The provided site plan implies this area will be cleared and re-landscaped post construction.

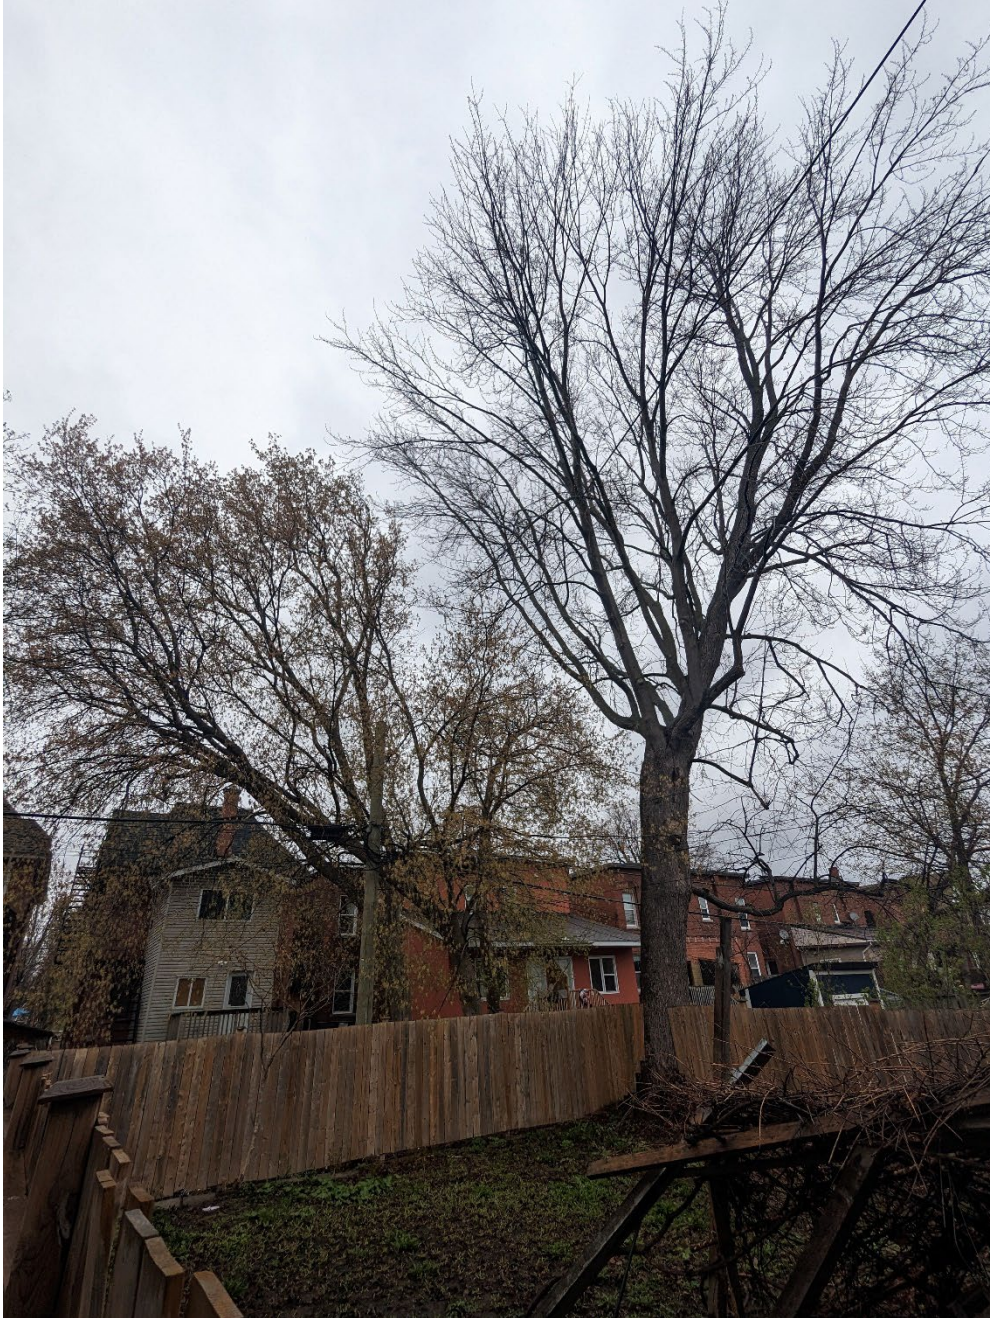
(Left): Tree 3 - Adjacent Manitoba maple to be retained. (Right) Tree 4: Boundary red maple to be retained.

Tree 4 is a very large red maple in good condition. The impacts to its CRZ from the proposed construction are expected to be minor and the tree will likely be able to withstand this stress well, especially given the softscaping in the rear yard of 563 McLeod. The crown of the tree is quite high and it is unlikely to require pruning given the distance from proposed construction. For future protection of this tree, hardscaping in the rear yard should be kept outside the CRZ.
