Somerset Apartments - General Scope of Work Description

Somerset Street and Bank Street | 2023-07-10 | 21-1962

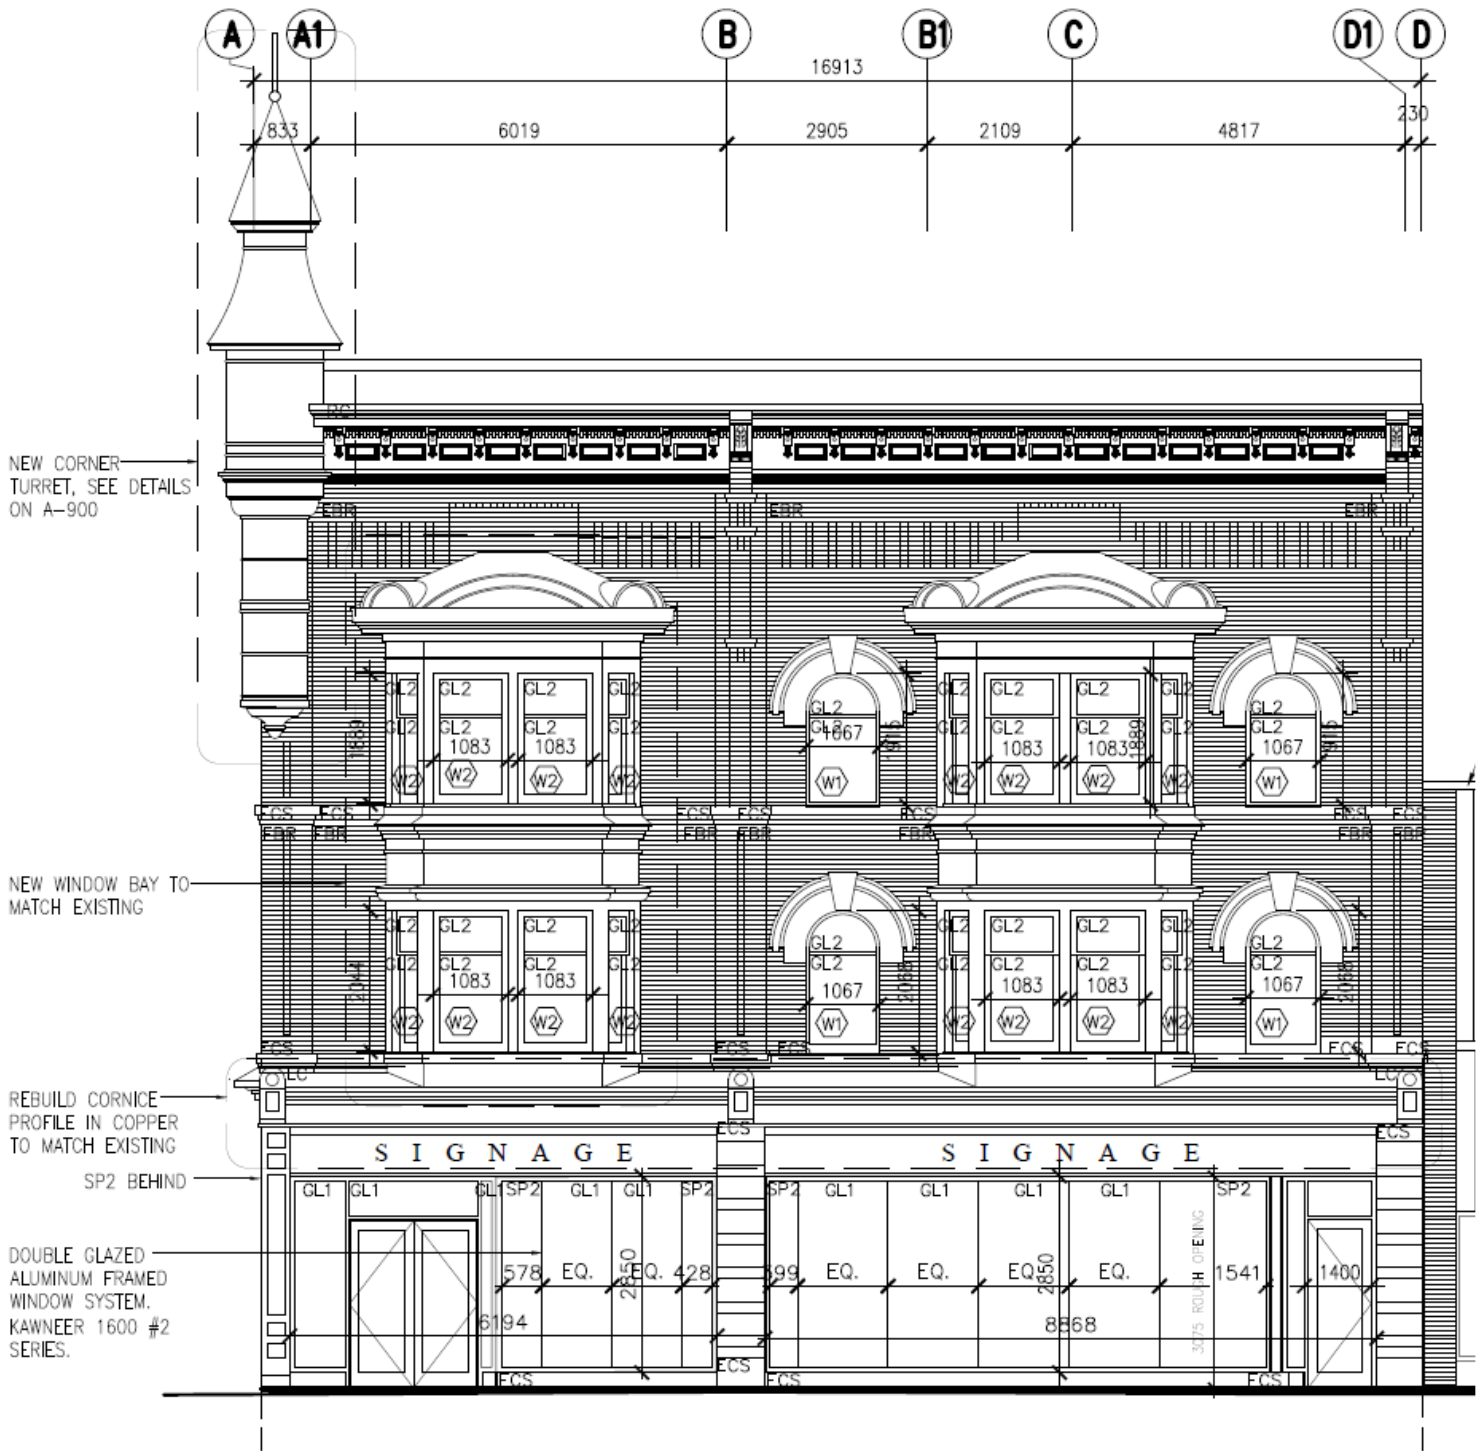
BANK STREET ELEVATION DETAILING THE CORNER TURRET, THE TWO BAY WINDOWS AND THE GROUND FLOOR COMMERCIAL SHOPFRONT. Source; CHMIEL Architecture. 2023.

Existing top metal cornice (modillions, dentils, dentil band... Etc.) to be restored and repainted as per original record colours or white. Blue metal side to be repainted as shown in picture below and 3d view.

All existing windows at Level 2 and Level 3 to be replaced as per original window frame colour or white in aluminum. Existing window colours are not original. Window sill flashing to be added to avoid water infiltration. All existing decorative terracotta lintels to be restored and repainted as per historical record intent or white. Refer to HIA by John Stewart.

Existing arched window on ground level to be replaced with new window. Frames to be painted as per original window frame colour or white in aluminum. Masonry brick to be restored.

Low level metal cornice and brackets to be restored/reconstructed with new material and repainted as per historical records intent or white. Blue metal side to be repainted as shown in picture below and 3d view.

New metal panel for sign board for the mercantile area at ground level. Refer to A-200 Architectural Elevations.
