SOMERSET HOUSE - 352 Somerset Street, Ottawa ON
Heritage Approval Resubmission

Project No. 21-1962
Revised: 16 February 2023

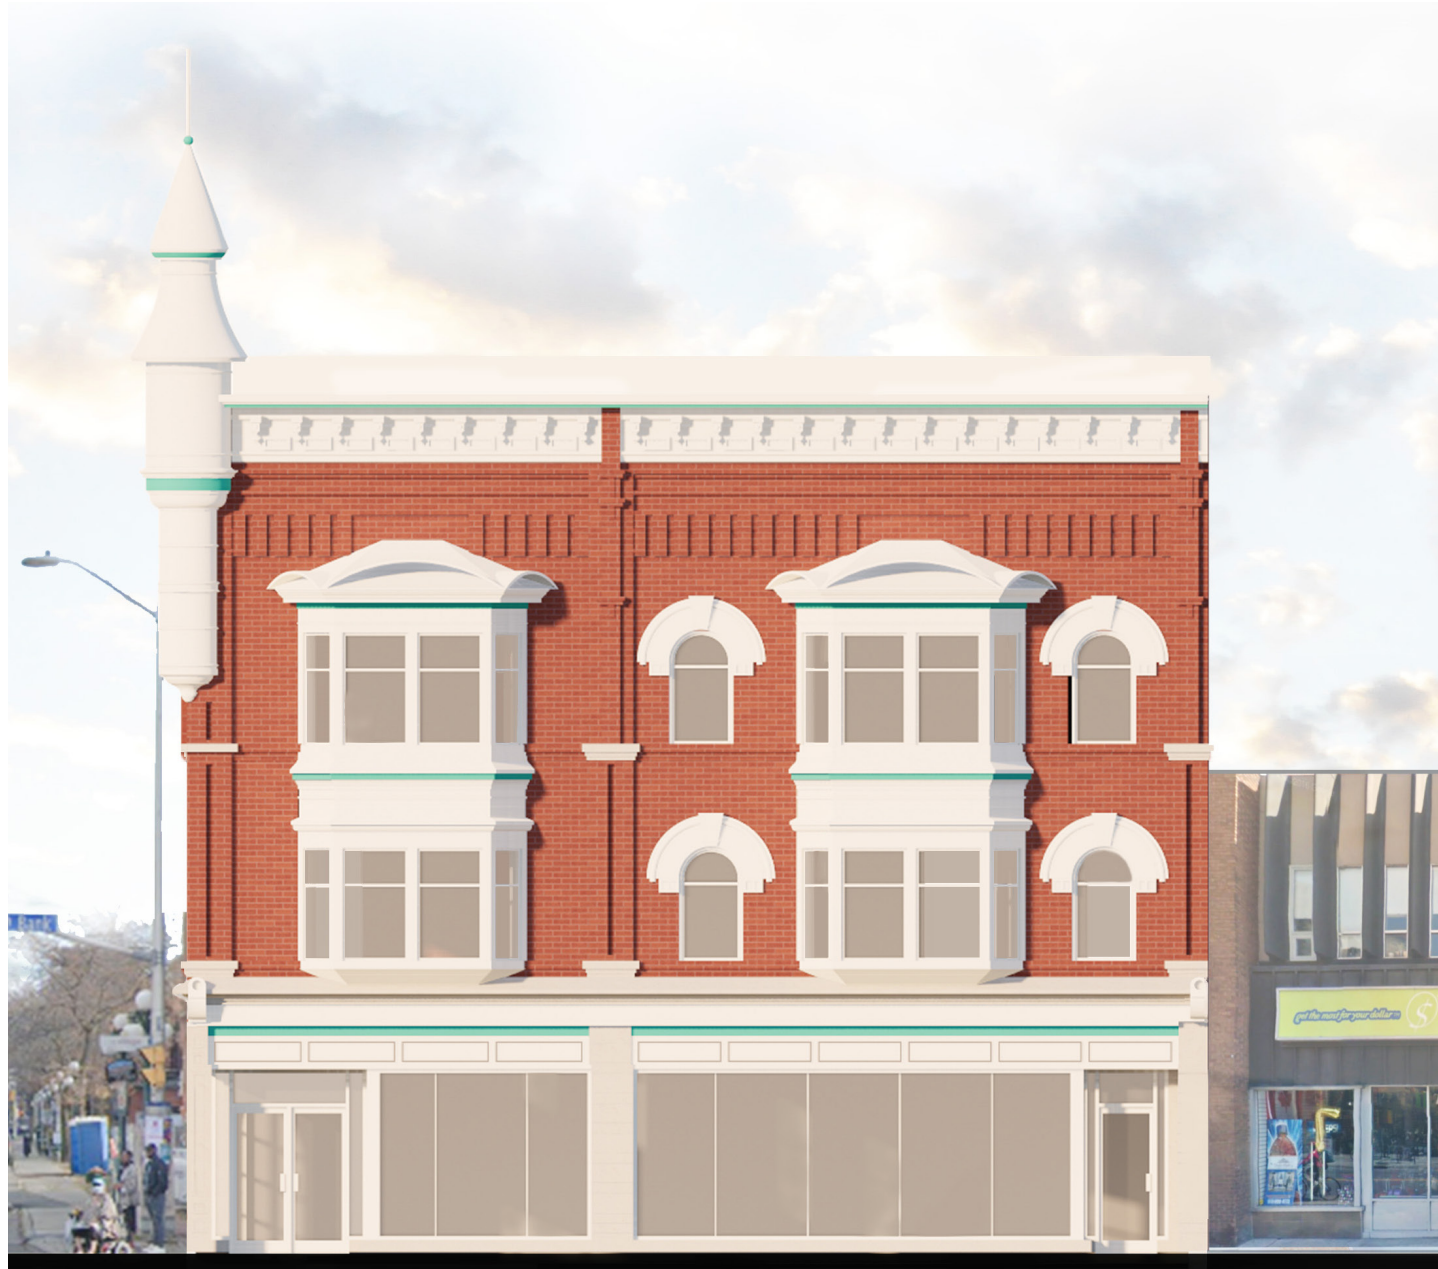
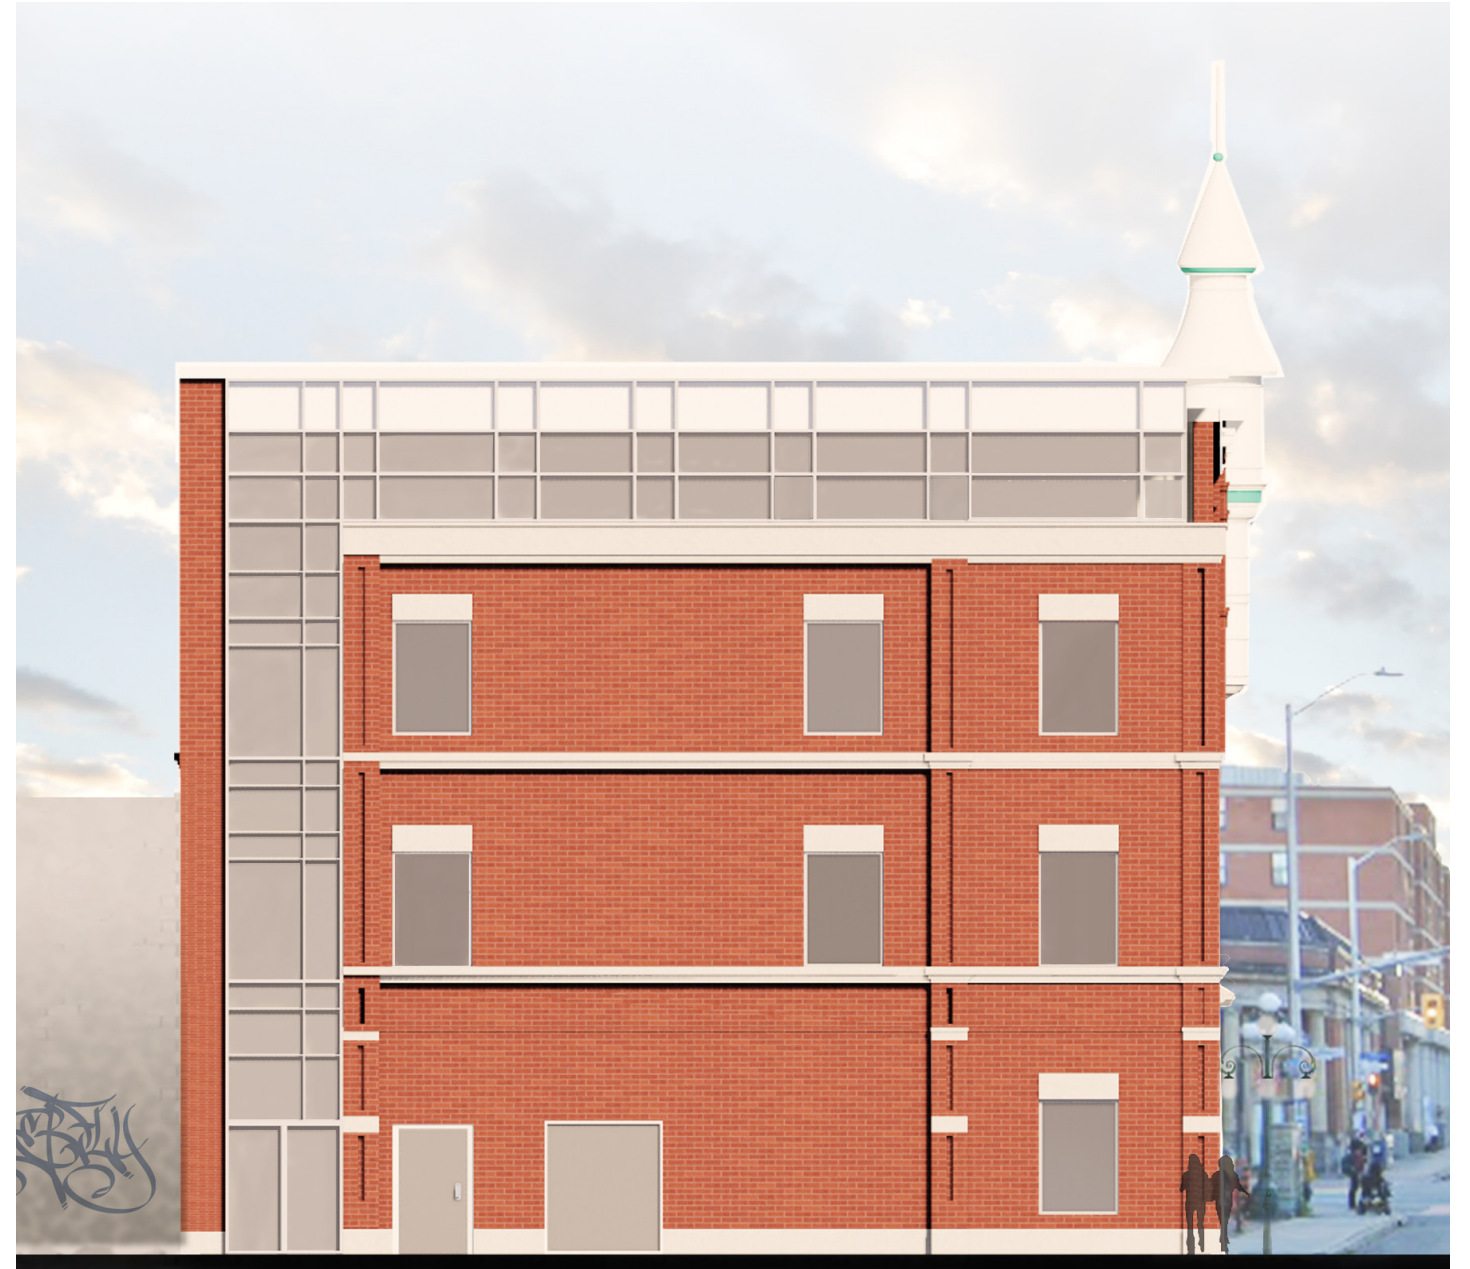
Somerset House - West & East Elevation Views

Existing windows to be replaced. Stone window heads to be restored.

New masonry to match existing

New windows with rectangular stone heads.

Low level cornice and brackets to be restored/reconstructed.

Existing corner turret to be restored and extended similar to original detailing and finishing.

Restoration of existing roof cornice features - modillions, dentils, dentil band, etc. (remove, restore, replace and repaint).

New windows to be installed and arch details to be restored.

Existing bay window to be removed and replaced with new to match historical record.

Original bay window to be constructed to match historical record.

New storefront glazing and signband to be installed.

Existing column to be restored and refinished.

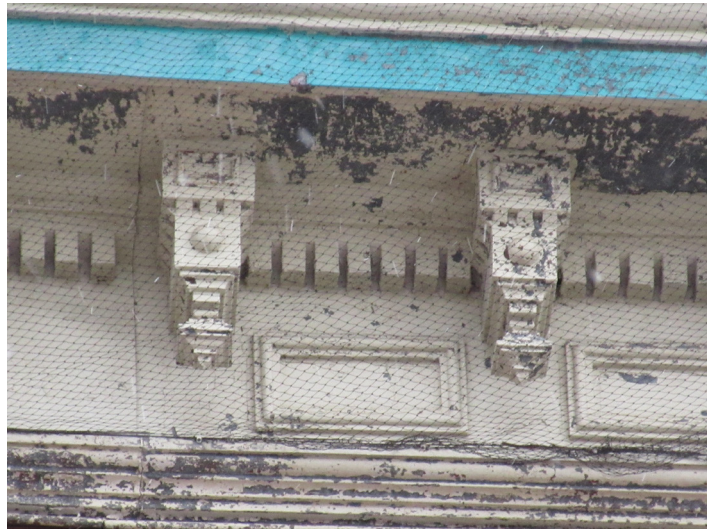
Cornice Dentils & Modillions to be Removed, Restored & Reinstated

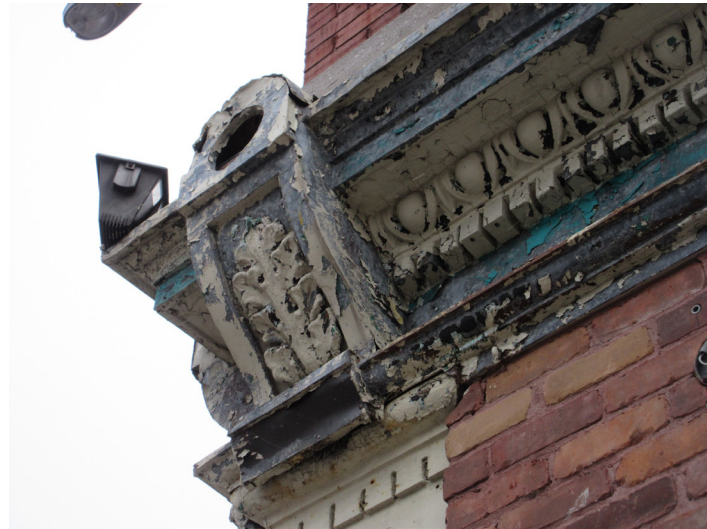
Cornice Brackets to be restored

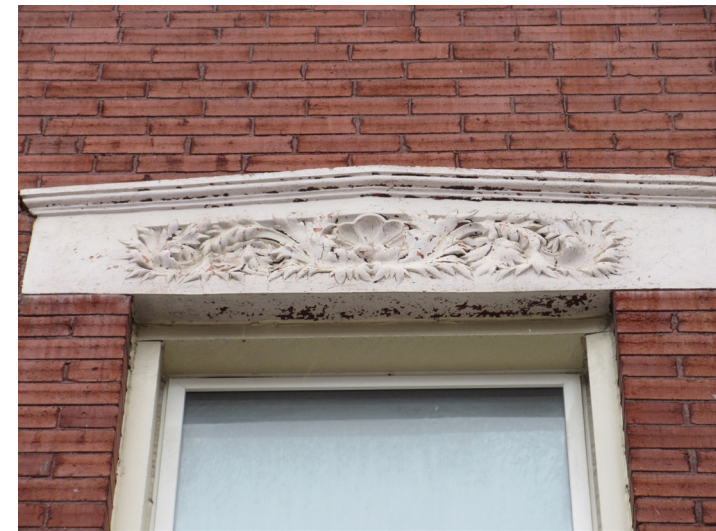
Precast Stone Window Headers to be Restored

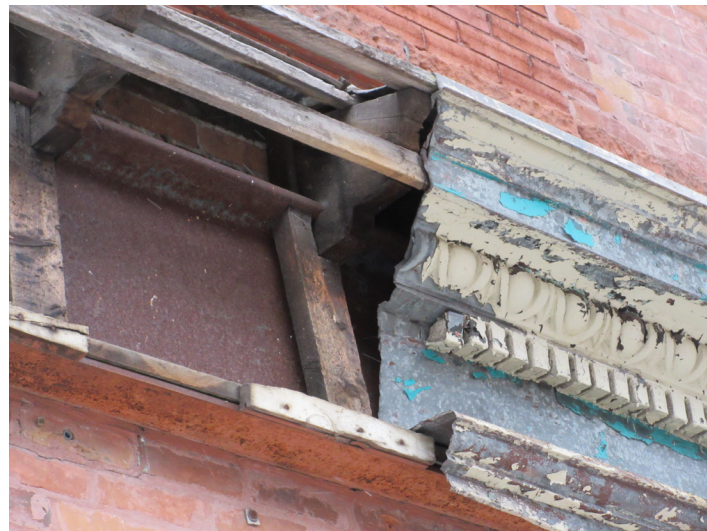
Low Level Cornice to be Replicated

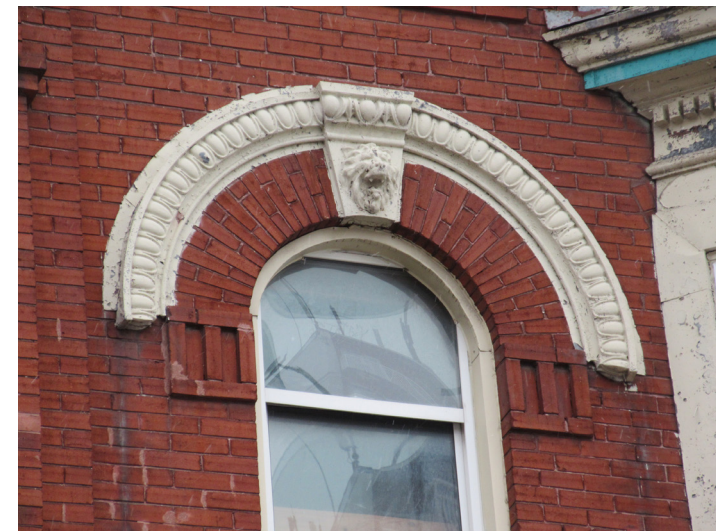
Arched Window Metal Work Details to be Restored

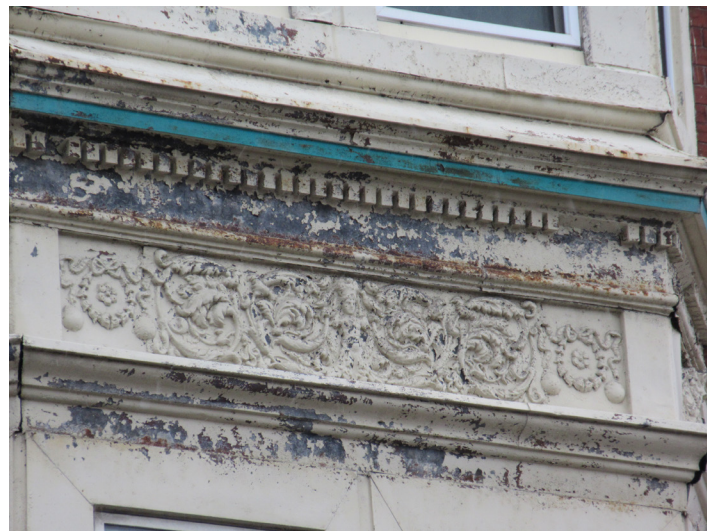
Bay Window Metal Work Relief Details to be Restored

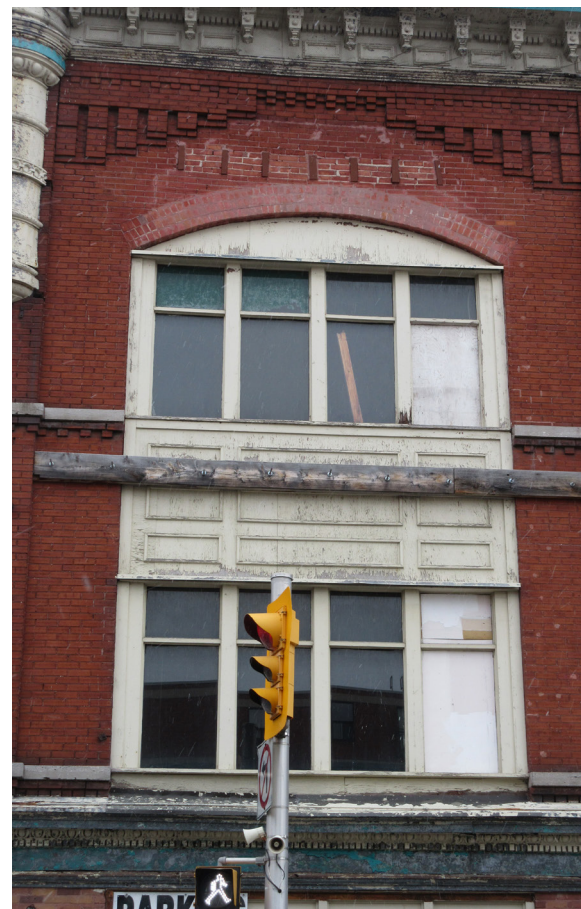
New Bay Window to be Constructed to Match Adjacent Existing Bay Window

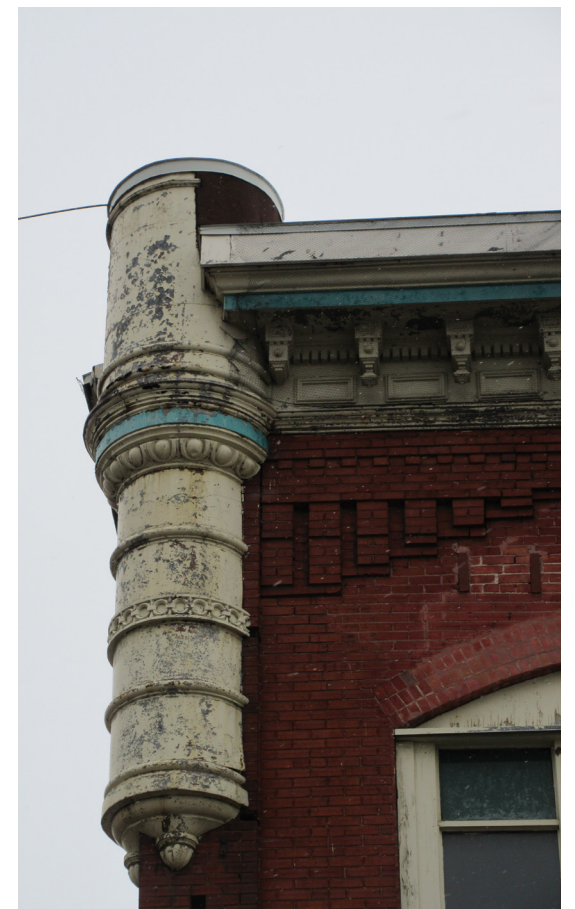
Existing Turret to be Restored and extended Similar to Original Detailing

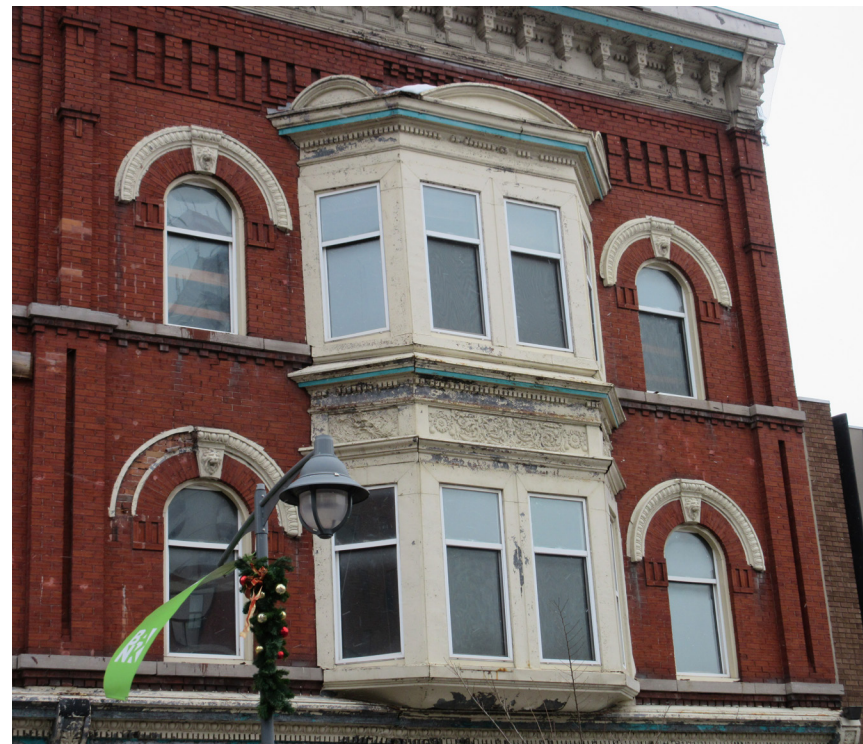
Existing Bay Window Structure to be Reconstructed

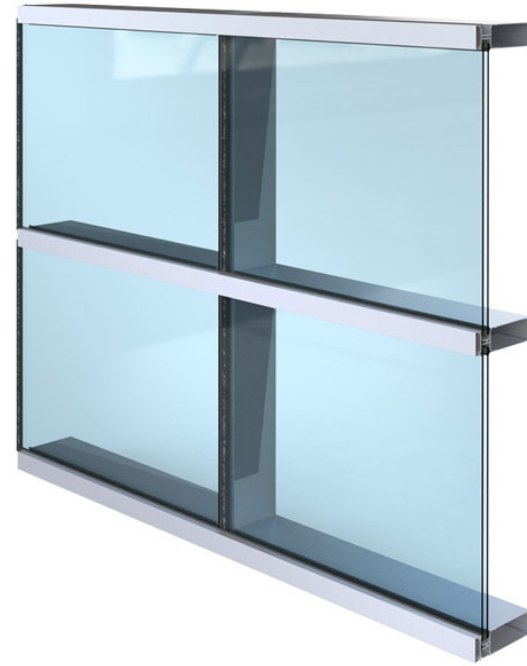
Aluminum Curtain Wall Framing with Vertical Structural Silicone Joints - Existing Building Storefronts (off white frame) & New Construction (off white frame)

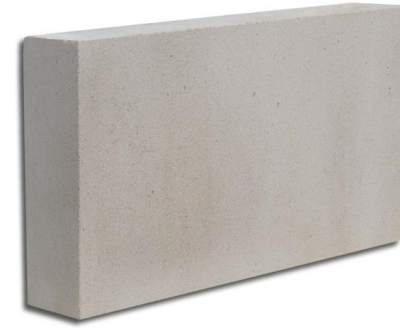
Precast Stone (window heads, sills, wall bands) - New Construction

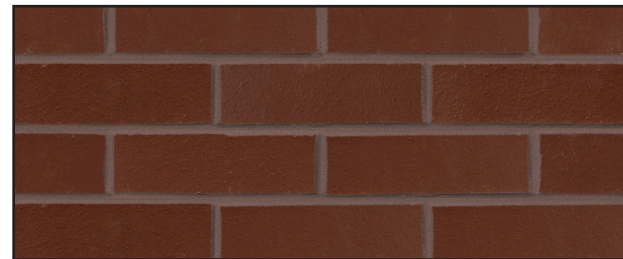
Existing Brick - New Construction Brick to match Existing Material.

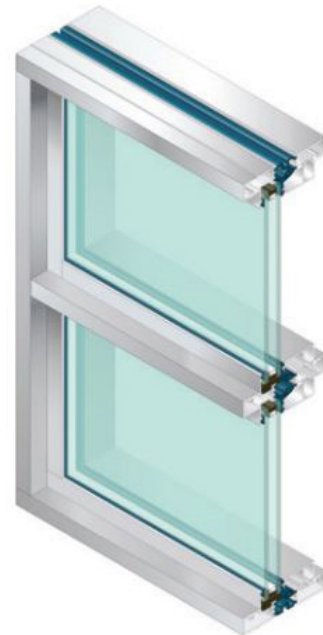
The AA™6500 Thermal Window with "top hat" accent feature provides added strength and interest to the sightline.

Prefinished Aluminum Fixed Windows - New Construction
