Tree Information Report

Submitted as part of Committee of Adjustment Application to the City of Ottawa

Address: 540 Golden Ave

540 Golden Avenue - Garage and Rear Entrance Alterations

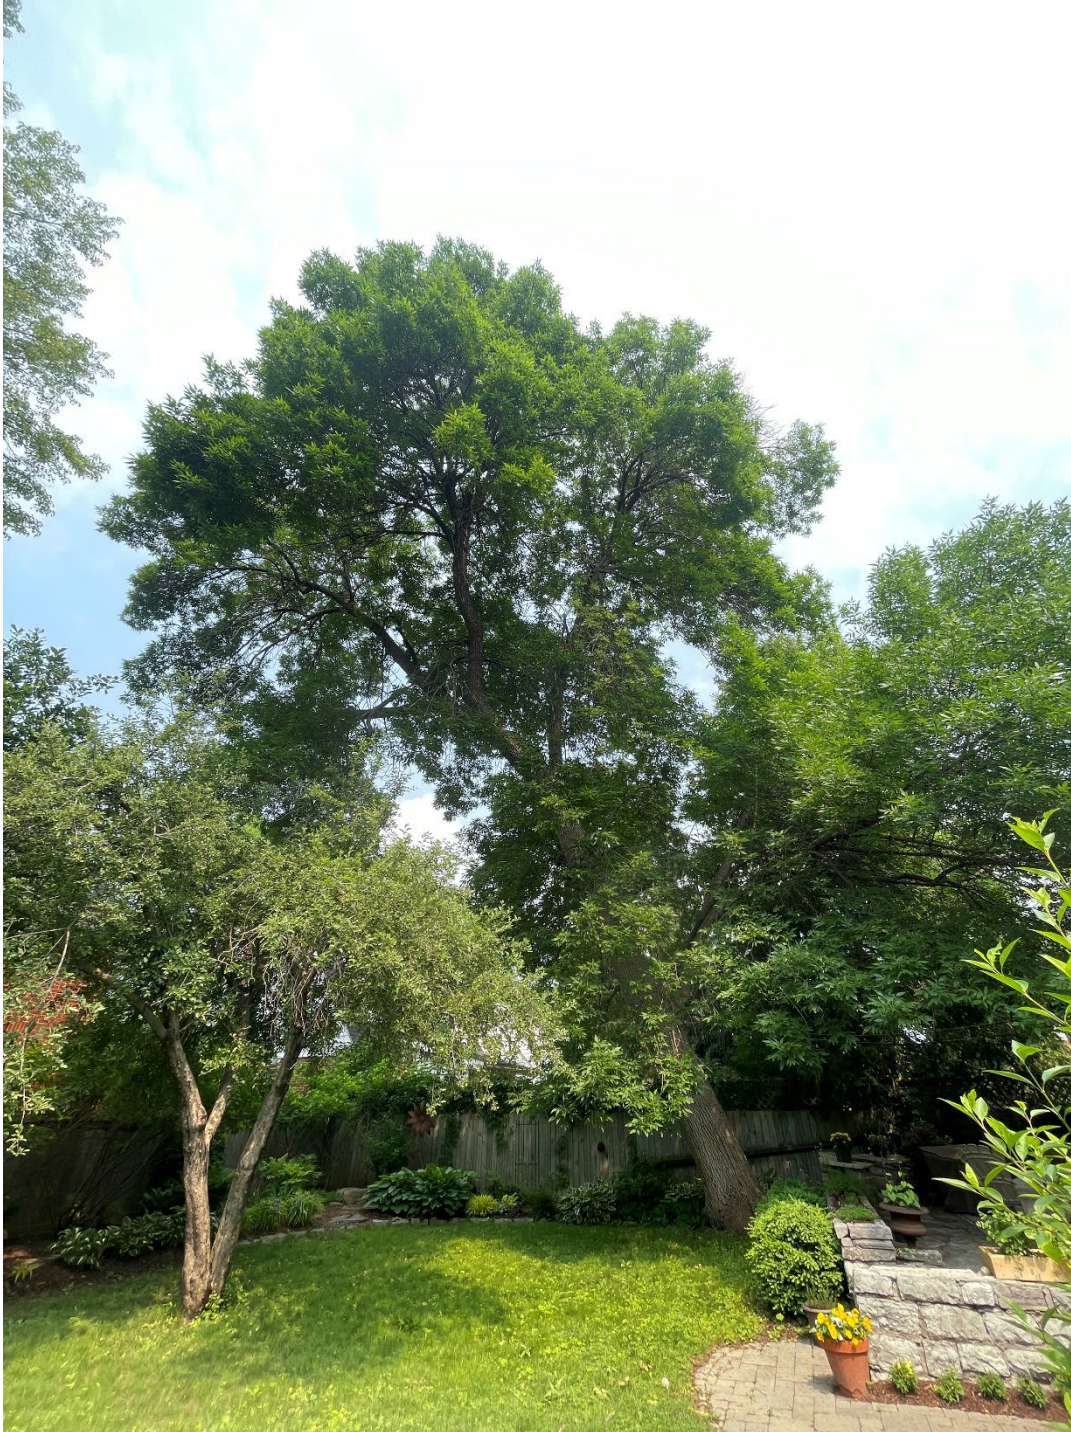
Figure 1: Tree 2, large ash tree in the rear yard

Tree ¹	Species	Diameter at breast height (cm)	Ownership ^{2,3}	Condition	Action	Recommendations
1	Eastern white cedar (<i>Thuja occidentalis</i>)	41 cm	Private	Fair; some hydro pruning	Retain and protect	No action required as far enough away from construction
2	Green ash (<i>Fraxinus pennsylvanica</i>)	85 cm	Private	Good/fair; has been injected almost yearly, some crown dieback	Retain and protect	Avoid critical root zone during construction as per City of Ottawa Tree Protection Specifications (March 2021); no protective fencing required
3 ³	Silver birch (<i>Betula pendula</i>)	14, 13 cm	Jointly owned with City	Fair; lean over sidewalk and road	Retain and protect	Avoid critical root zone during construction as per City of Ottawa Tree Protection Specifications (March 2021); no protective fencing required

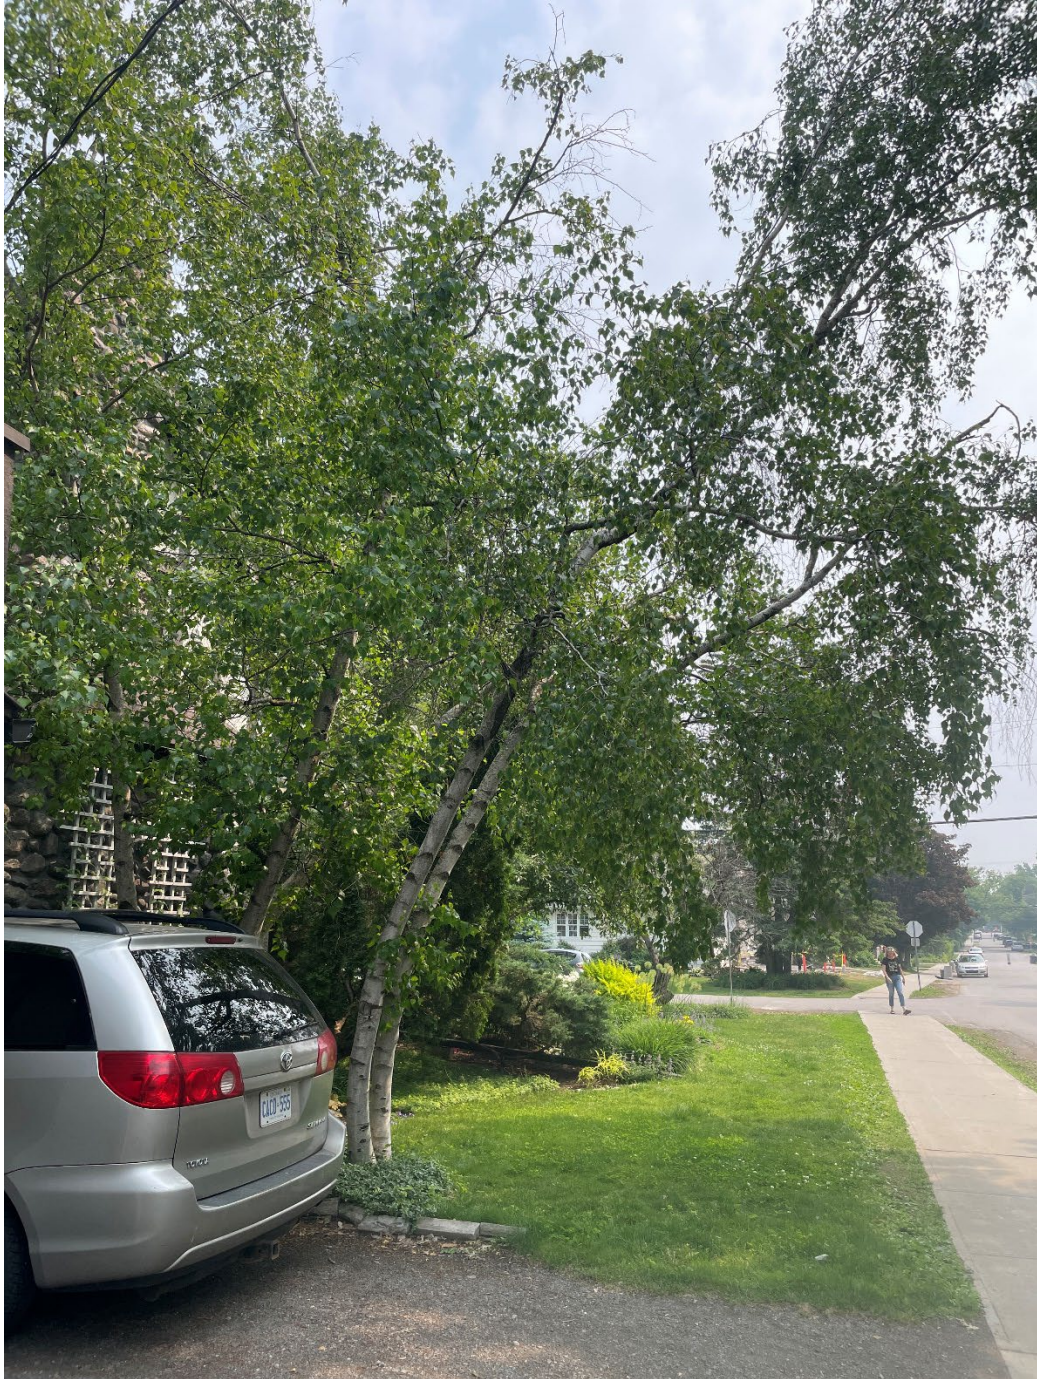
Figure 2: Tree 3, jointly owned birch tree to be retained
