CONSERVATION PLAN

359 KENT STREET, 436 & 444 MACLAREN STREET, OTTAWA

July 2023 Revision 3

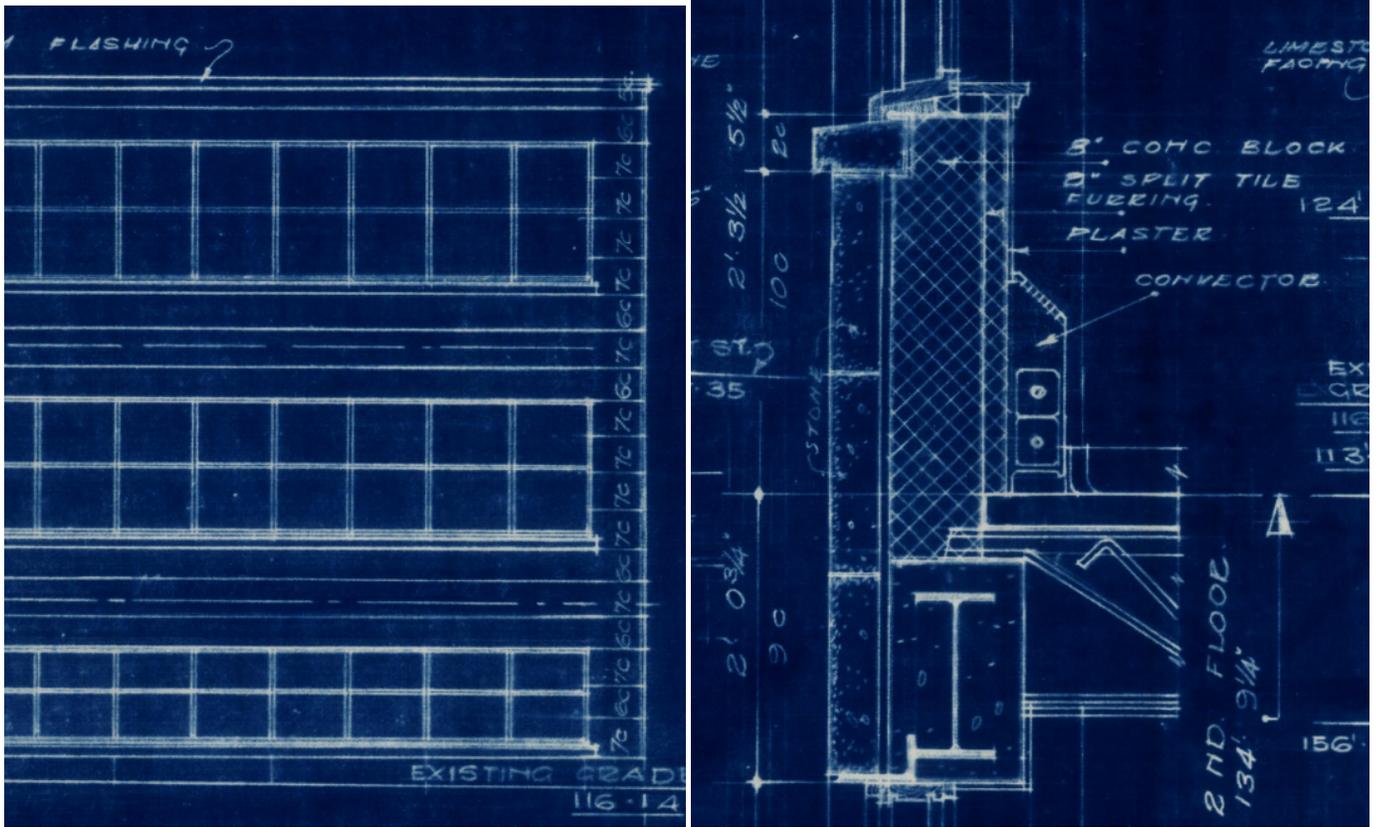
Figure 11 (left): Detail section through the walls clad in limestone illustrating the structural frame and materials and their relationships. Note the windowsill that is supported on the masonry back-up wall as well as the relationship of the aluminium windowsill to the limestone sub-sill. Source: 1955 Architectural Drawing Set A4.

Figure 5 (right): Detail of the Gilmour Street façade where the coursing height pattern is noted that vary consistently between two heights (6C and 7C). Source: 1955 Architectural Drawing Set A4.

The limestone cladding is supported vertically by steel shelf angles that are in turn attached to the steel frame that is embedded in concrete for fire-rating purposes (see Figure 5). A block back-up wall is constructed between floor slabs and supports the exterior cladding. The stones are secured laterally to the back-up wall with wire ties. There is a 25mm air gap between the inside face of the stone and the back-up wall. The foundation walls are poured concrete construction and there may be instances where the cladding is adhered to the concrete.

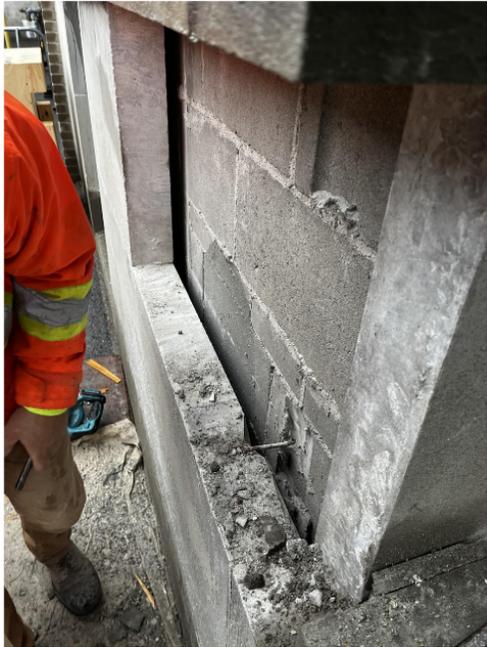
Figure 12: View of a test removal panel from a building at 100 Argyle constructed circa 1955 using a similar limestone cladding material as 359 Kent. The limestone cladding units are secured to the concrete block back-up wall with a single metal anchor centred on the width of the panel. Source: Heritage Grade Test Removal Report, 100 Argyle.

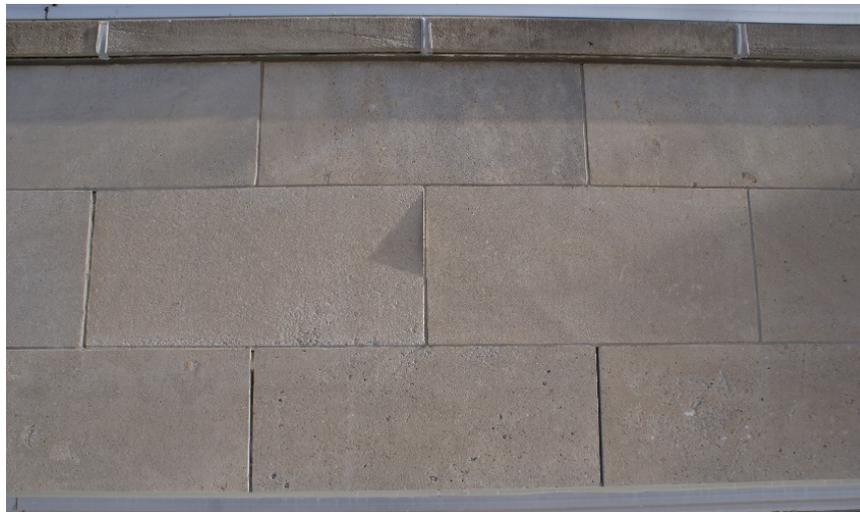
Condition: The limestone cladding is in good condition generally with a few stones at grade level that have been adversely affected by de-icing salts. A number of stones have surface defects or concretions that have not weathered well; however, they are limited in number. A detailed condition assessment of each stone panel will be completed as part of the dismantling process. There are a number of stone panels where the mortar is missing from the joints particularly in the area of the introduced Kent Street entrance providing a general sense of how difficult the removal of the mortar from the units may be during the salvage process.

Figures 13: View of the Niagara limestone cladding above the Kent Street entrance. Note the variations in the material, coursing, and the windowsill course band the length of units corresponding with the cladding coursing. Mortar is missing from a number of joints. Source: Commonwealth 2023.

Risks: The removal of any adhered Portland based pointing from the stones may be problematic, and a method should be developed to minimize damage that may result. Exposing the stones outdoors for a period of six-months including a winter is one option. (It will be important to follow up with Masonry Contractor, who carried out the test removal of a limestone panel from the façade of the building at 100 Argyle. This will give a sense of how the adhered Portland from the stone was removed. In the summary description it states that the Portland mortar was well adhered to the end grain of the stone.)

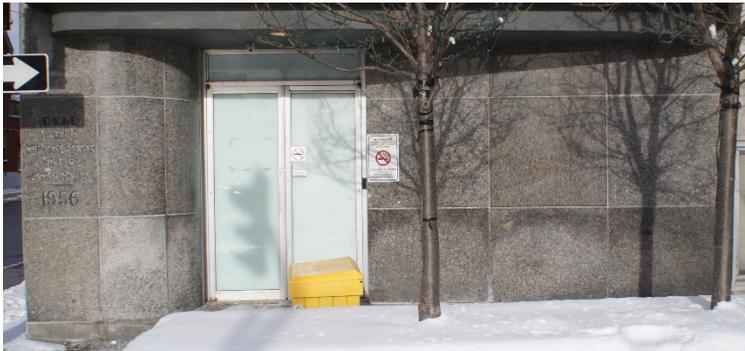
Figure 14: View of granite inset entrance with canopy

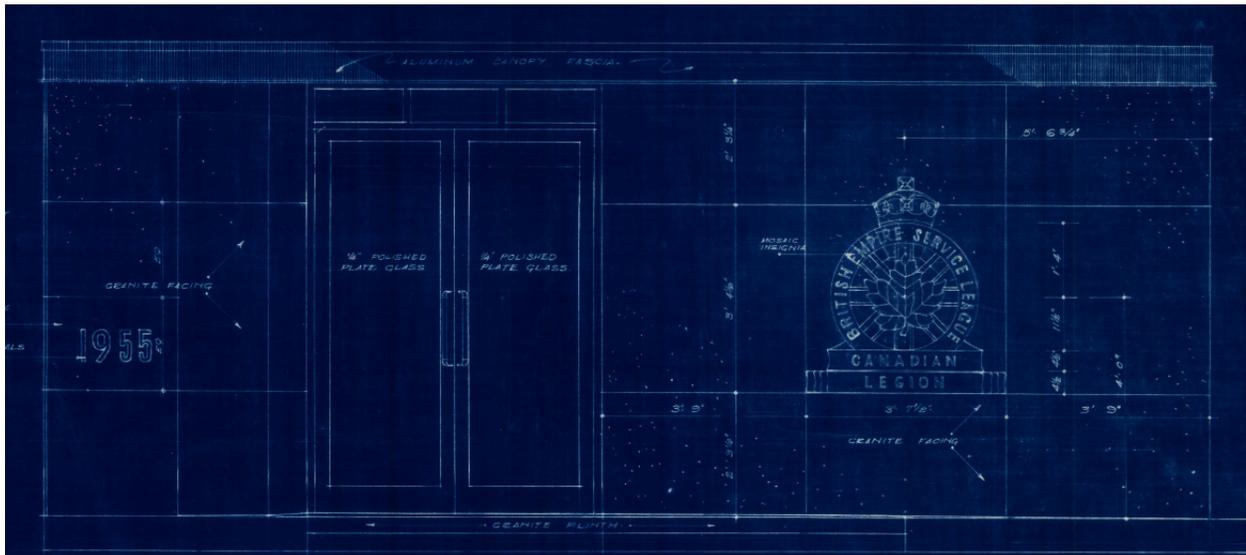
Figures 15: Elevation of the Gilmour Street entrance illustrating the arrangement of the granite cladding. The Royal Canadian Legion crest was removed in 2009 and the original granite panels removed, and new material inserted possibly due to the poor condition of the material. Note the two radius cut granite panels to the left of the door and the panel arrangement to the right of the door. Source: 1955 Drawing Set A5. City of Ottawa.

Condition: De-icing slats have had a major impact on the lower three stones set at floor level. The surfaces are disaggregated and crumble to the touch. The memorial stone with an incised date and inscription is in better condition although it is not clear when the inscription was incised.

Rehabilitation – The original granite cladding panels to the east of the entrance door were removed in 2009 when the coat of arms was removed. The entrance door width will be increased to meet the OBC. Remove the existing granite panels and insert a glazed curtain wall to the east of the new entrance door maintaining the existing entrance plan configuration and canopy.

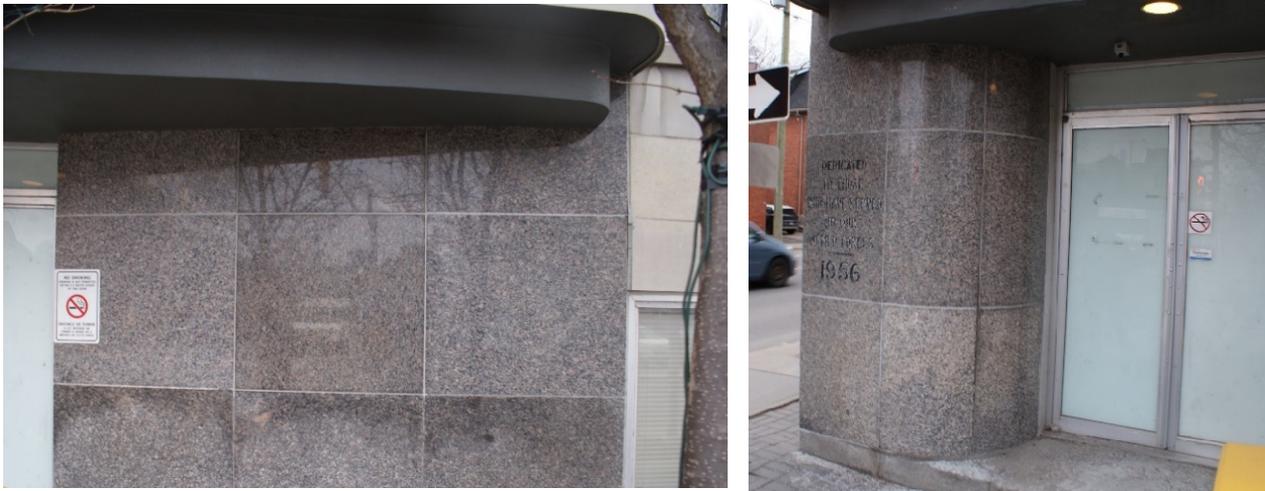
Figures 16 & 17: (6-left) View of the introduced polished granite panels to the right of the Gilmour Street entrance. (7-right) View of the original polished granite panels. Source: Commonwealth 2023

Restoration: Reinstall new polished granite cladding to match the original material and panel configuration modified in width to accommodate an increased exit width to the right of the door where the original material was removed in 2009.

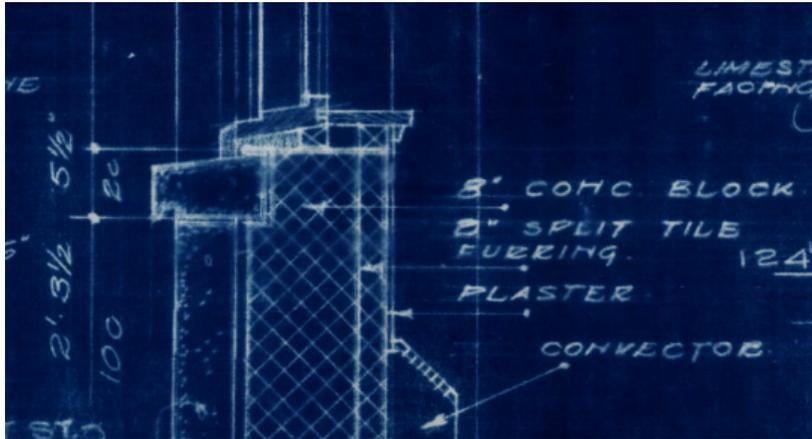
Figure 18; Detail section through the Kent and Gilmour facades illustrating the arrangement of the limestone sill course and limestone cladding. The sills are bonded to the limestone cladding and the concrete back-up wall making it difficult to salvage the windowsill course material. The drip edge only adds to the difficulty of successfully salvaging the material for reuse. Source: 1955 Drawing Set A4

Condition: The limestone windowsills are relatively porous along cleavage planes, susceptible to de-icing salts, and freeze-thaw cycling to varying degrees dependent upon material defects within individual stones. Stones vary in quality as is evident on all elevations where sound stones are interspersed with poorer quality material that has failed. Typical failure patterns include delamination along cleavage planes after the surface has weathered and at the exposed surfaces where the material pops during freeze thaw cycling. Approximately 30% of the sill stones will need to be replaced, and further loss is expected during the dismantling, storage, and reinstallation processes; however, between the four façades there should be enough good quality sill stones to complete the Gilmour and Kent street windowsill courses.

Conservation Approach: Rehabilitation – The limestone sills will continue to weather and deteriorate over time. The limestone is not the highest quality material. Install new pre-cast concrete sills that are tinted to match the dimension, form, and colour of the existing material.

Material Testing: The successful salvaging of the material will depend upon the bond strength of the mortar to the limestone sills being less than the bond strength between layers of deposition at cleavage planes. Given the varying quality and failure rate of the limestone windowsills the material should be tested in a lab for porosity, density, etc.

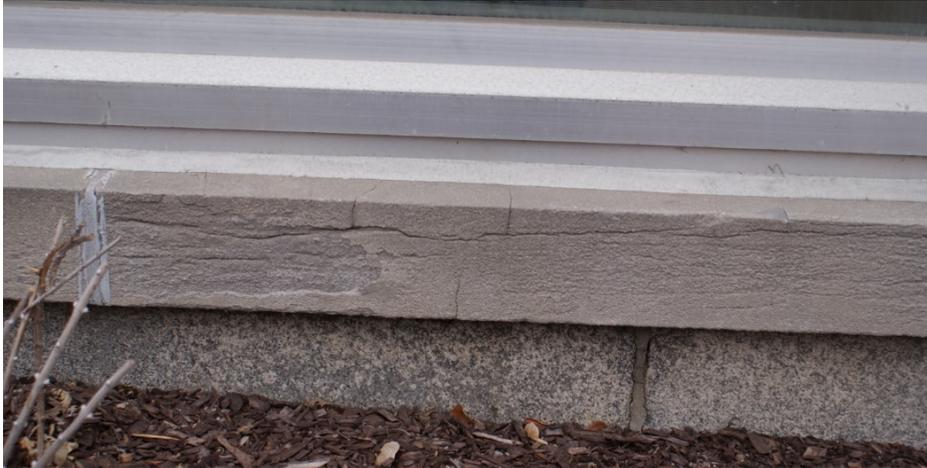
Figure 20: View of a deteriorated limestone windowsill and the granite plinth course below. The cleavage planes within the limestone sills are evident where the sawn surface has weathered. The cleavages planes follow the layers of deposition of the sedimentary rock. Source: Commonwealth 2022.

Rehabilitation – The limestone sills will continue to weather and deteriorate over time. The limestone is not the highest quality material. Install new pre-cast concrete sills that are tinted to match the dimension, form, and colour of the existing material. Replacing them all is the client's preference.

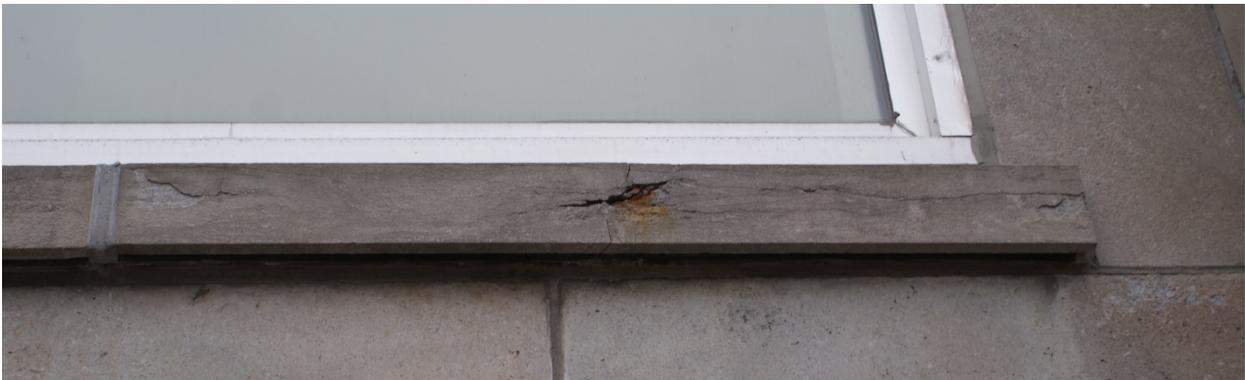
Figure 21: View of a deteriorated limestone windowsill. The cleavage planes within the limestone sills are evident where the sawn surface. The cleavages planes follow the layers of deposition of the sedimentary rock. Source: Commonwealth 2022.

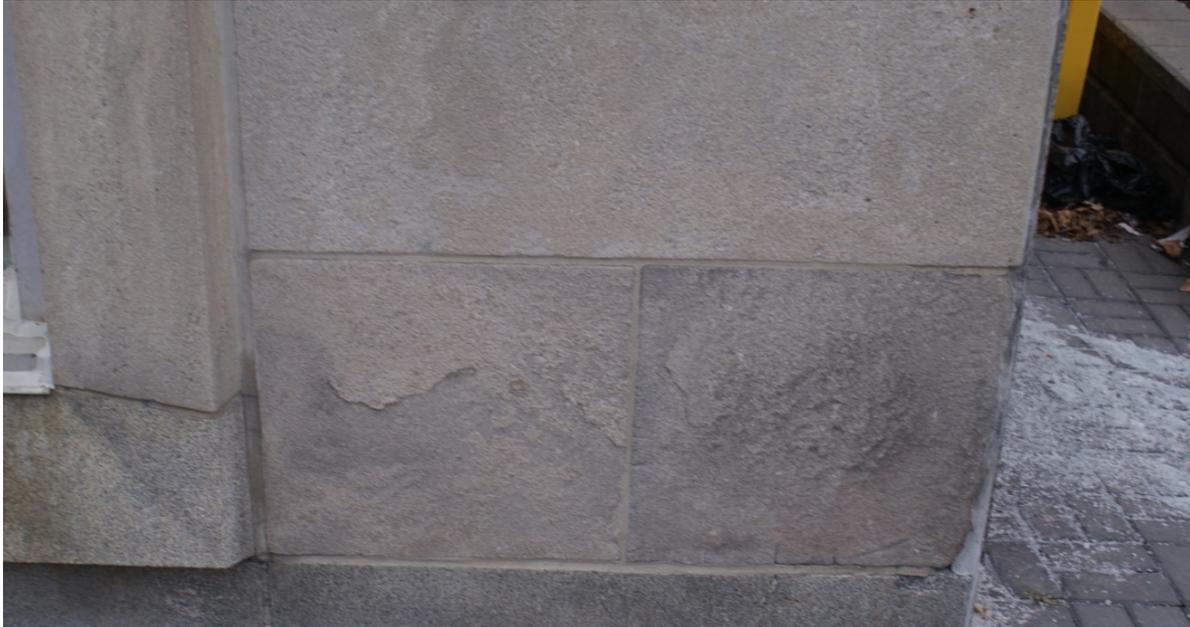
Condition: The limestone window surrounds on the multi-storey windows on Kent and Gilmour are generally in good condition. There is some deterioration of the surface due to de-icing salts where the units are in proximity to grade, some material defects, and rust staining of the material. The condition of the individual units will be assessed and noted during the dismantling phase.

Figure 22: Detail view at the base of the wall at the south-west corner. The surface of the two Niagara limestone panels at the base of the wall are scaling due to de-icing salts. The granite plinth course is evident at the bottom of the photo. The Niagara limestone window surround is the vertical element to the left and a granite windowsill/surround below. Source: Commonwealth 2022.

Preservation of the limestone window surrounds and reinstallation in the Kent and Gilmour Street façades.

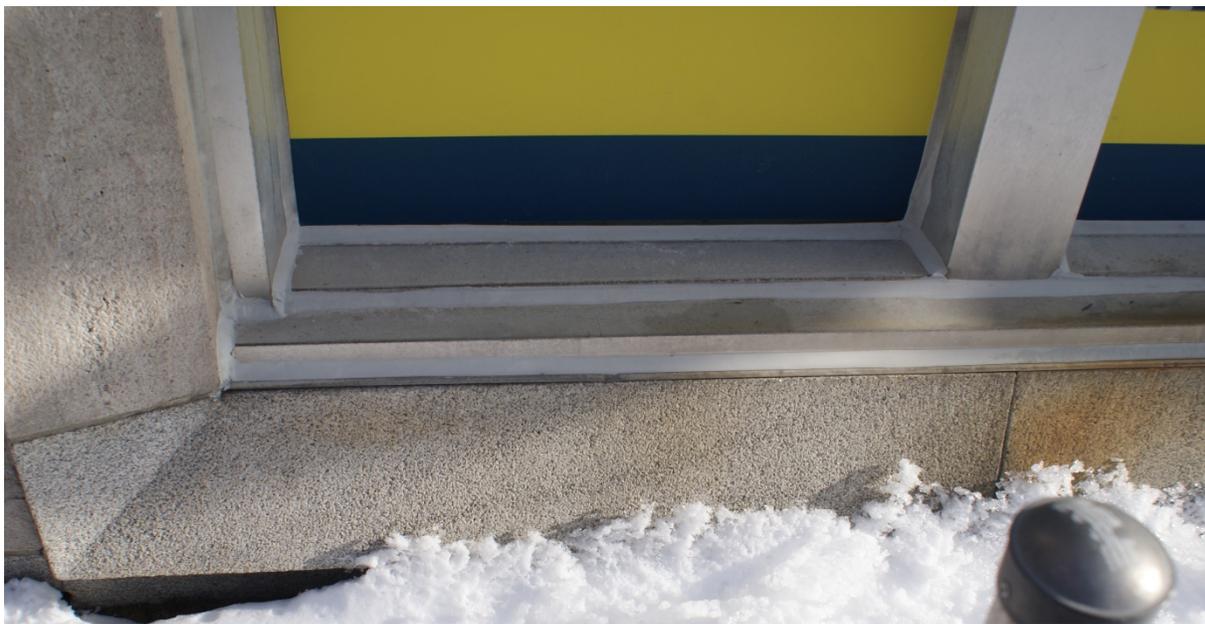
Figure 23: Detail view of the base of the Kent Street window. The horizontal units at the base of the window are formed of the same material as the granite plinth course. The vertical stone to the left is a limestone unit. Note the close match in colour and surface texture. Source: Commonwealth 2023

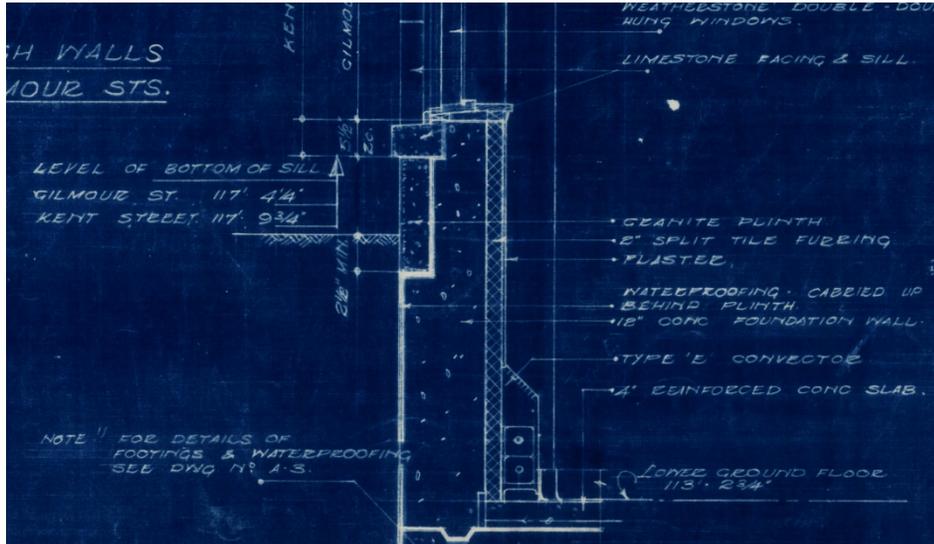
Description: A granite plinth course is located at the base of the Kent and Gilmour Street walls. The material is 100mm in thickness and is bonded to the cast concrete foundation walls. The granite forms a

Figure 24: Detail section through the Kent and Gilmour Street façades. A 100mm thick granite plinth is detailed in the drawing. Source: Original 1955 Drawing Set A4.

Preservation of the intact granite sill and plinth course panels and reinstallation in the Kent and Gilmour Street façades forming an upstand wall supporting curtain wall glazing. The condition of the material buried below grade has not been determined.

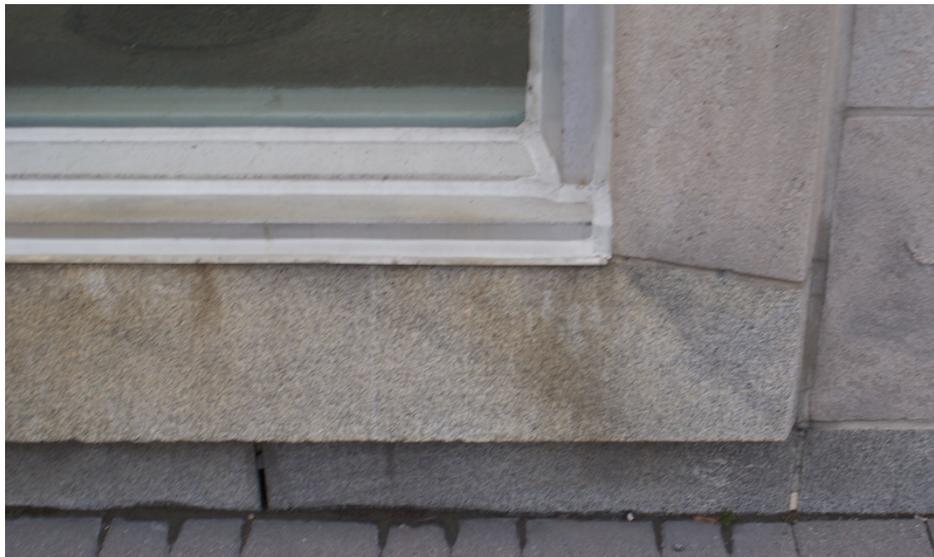
Condition: The granite sill on the Kent Street window is in good condition. The condition of the granite plinth course buried below grade has not been determined.

Figure 25: Detail of the granite plinth course and granite windowsill surround at the base of the three-storey Kent Street window. The colour of the granite sill is very close to the limestone cladding and window surrounds. Source: Commonwealth 2022.

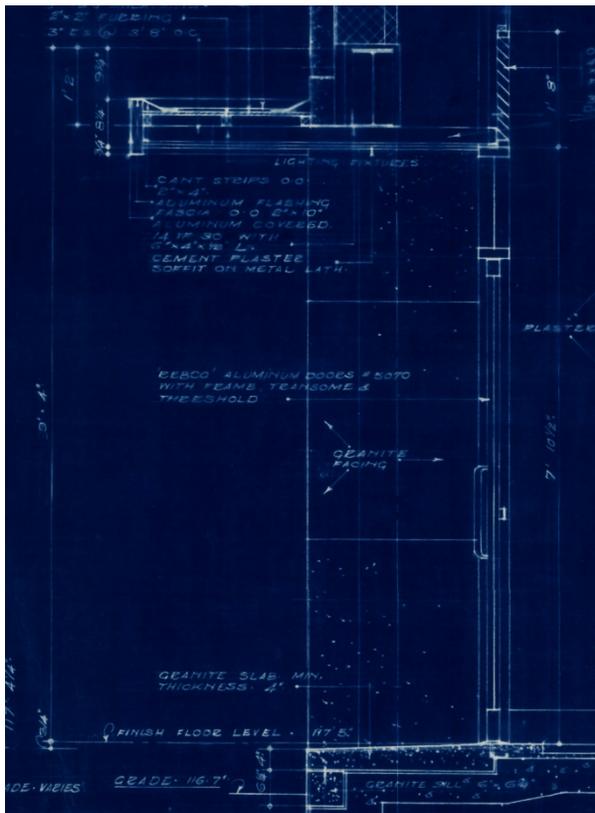
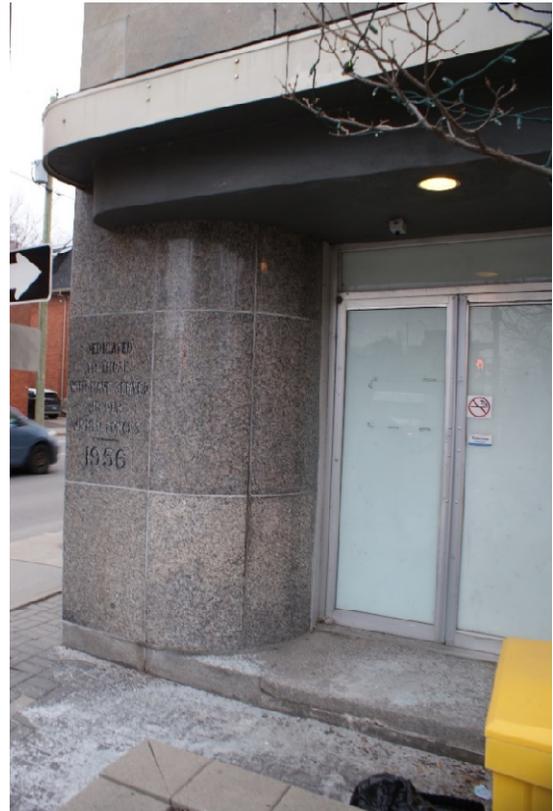
Condition: The canopy has been modified with a dropped modern enclosure with recessed lighting.

Figures 26 & 27: Detail section of the Gilmour Street Entrance illustrating the form and materials and the relationship to the entrance doors. Existing view of the canopy illustrating alterations to the canopy and entrance doors. Source: Original 1955 Drawing Set A5 & Commonwealth 2022.

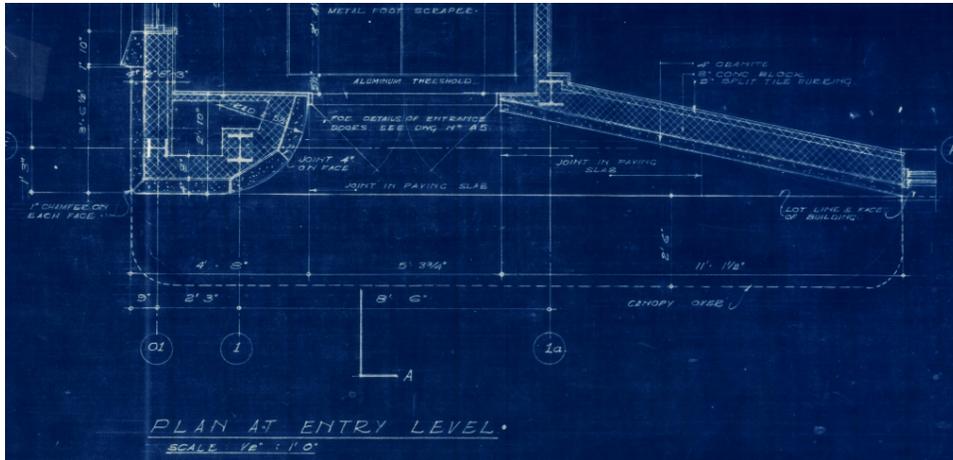
Figure 28: Plan view of entrance canopy.
Source: 1955 Drawing Set A6

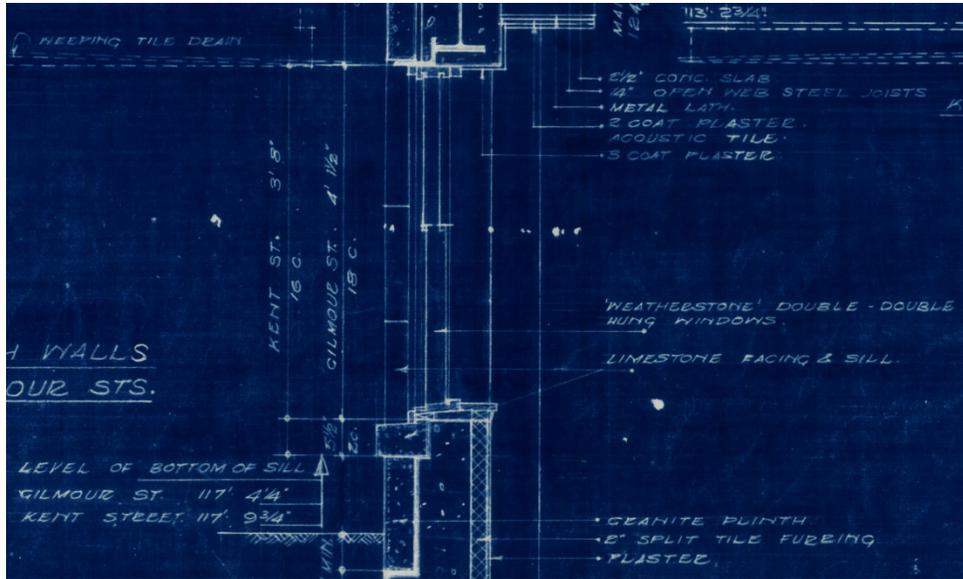
Figure 29: Detail section through the Kent and Gilmour Street façades illustrating the horizontal placement of the window assemblies within the exterior walls. The varying window heights between the Kent and Gilmour façades are related to the differing grades. Source: Original 1955 Drawing Set A4.

Rehabilitation – The windows are being replaced with a modern aluminum thermal unit. The horizontal and vertical arrangement of the original sash should be maintained in the new units. The horizontal division at the midpoint of the height of the units is an important feature adding to the horizontal sweep of the façades a character defining feature of the International Style.

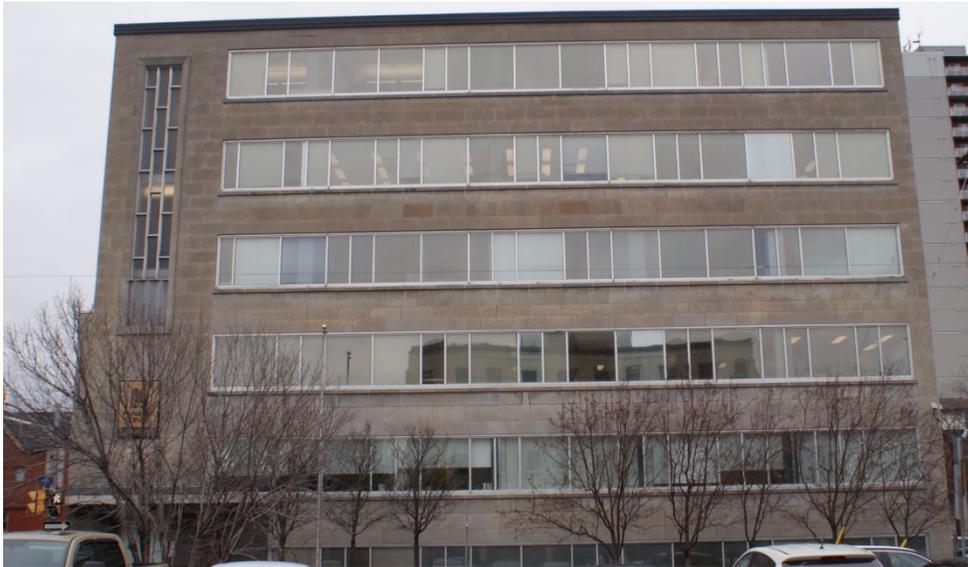
Condition: The existing windows are being replaced with new aluminium thermal units. The original vertical and horizontal division of the lights will be replicated in the three-storey windows on the Kent and Gilmour façades.

Figure 30: View of the windows on the Gilmour Street façade. All of the original windows have been replaced with the exception of the three-storey window above the Gilmour Street entrance. Source: Commonwealth 2022.

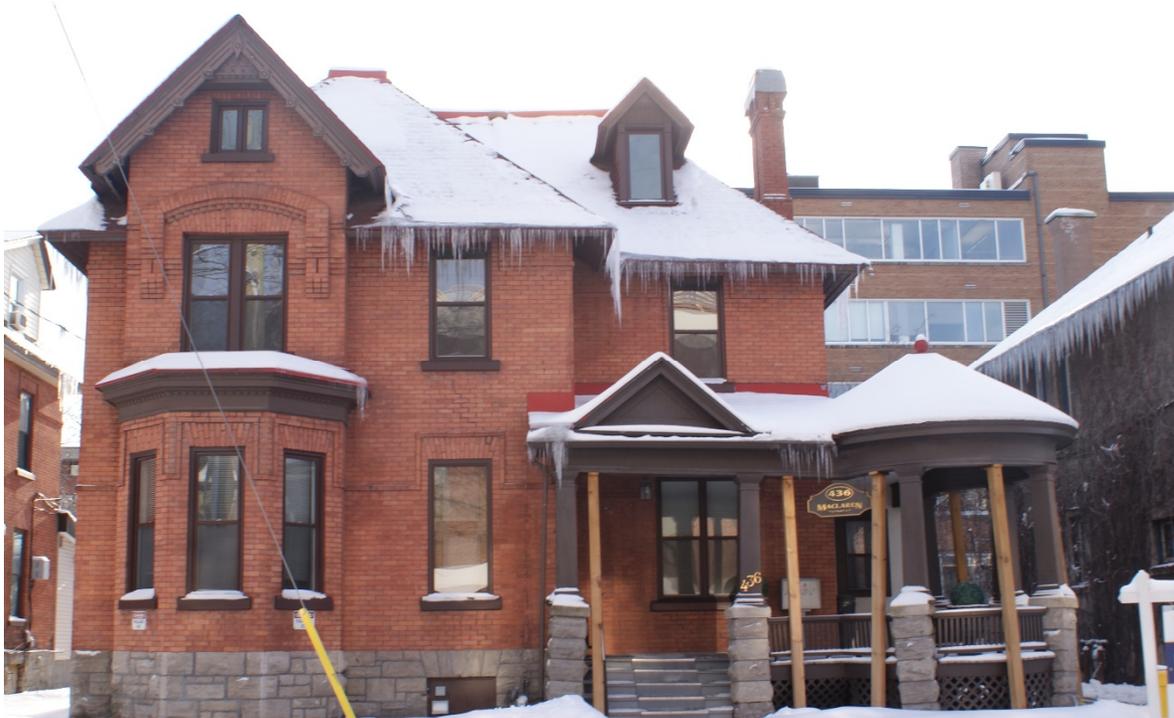
Figure 35: View of 436 MaClaren Street. The masonry piers supporting the porch have settled due to inadequate foundation depth. A detailed assessment of the condition of the porch is required. Guidelines from the CHCDP provide guidance for the conservation approach to the materials and assemblies. Source: Commonwealth 2023.

Response: Following the CMPHCP policies and guidelines for **front porches** a restoration plan is being prepared. The coursed limestone pillars supporting the deck structure will be dismantled and rebuilt with a new foundation as part of the 2024 work plan. The work will include the masonry piers, deck structure, railings, and columns.

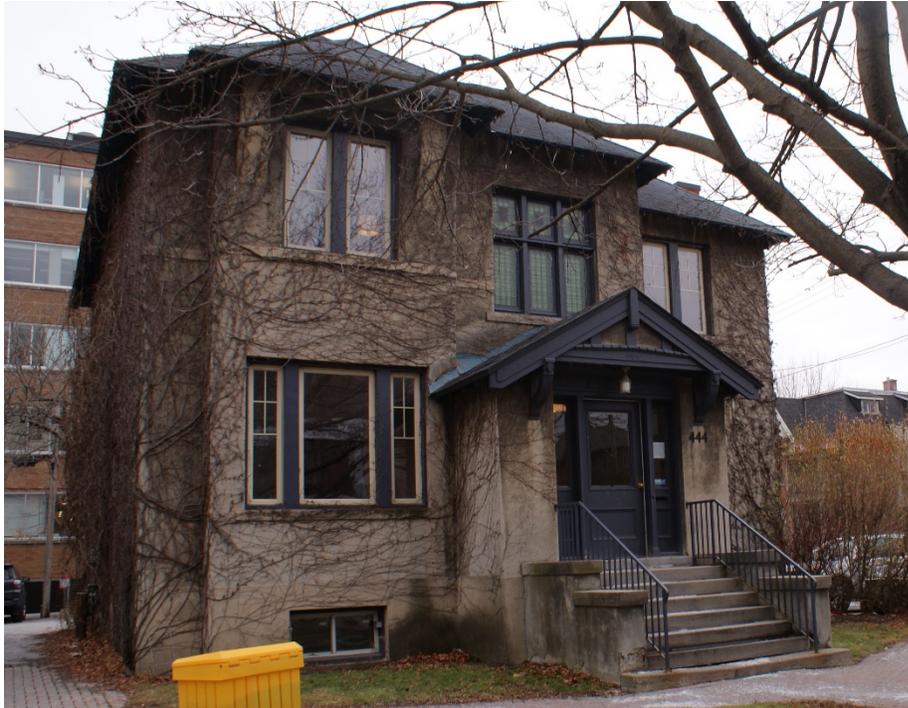
444 MaClaren was designed by W.E. Noffke and built for Chas Ogilvy in 1914 and will be retained in the proposed development. The condition of the building is good, however there are vines growing on all faces of the stucco façade which will be removed in Winter 2024. The building is fully leased to commercial tenants and will be maintained in good repair. The building will eventually be integrated into the development through complementary landscape design, and its interior uses will continue to serve local residents.

Figure 36: View of 444 MacLaren Street. The stuccoed exterior wall is covered in vines that should be removed before they have an adverse impact on the stucco finishes. Source: Commonwealth 2022

The building at 444 MacLaren is covered in vines that should be removed. The guidelines contained in the 2022 Centretown Heritage Conservation District Plan (CHCDP) are provided to guide the conservation work.
