321 Dalhousie Street,  
110 York Street,  
137-141 George Street,  
Ottawa, ON

CULTURAL HERITAGE IMPACT STATEMENT

PREPARED FOR:  
Claridge Properties

PREPARED BY:  
BRAY Heritage

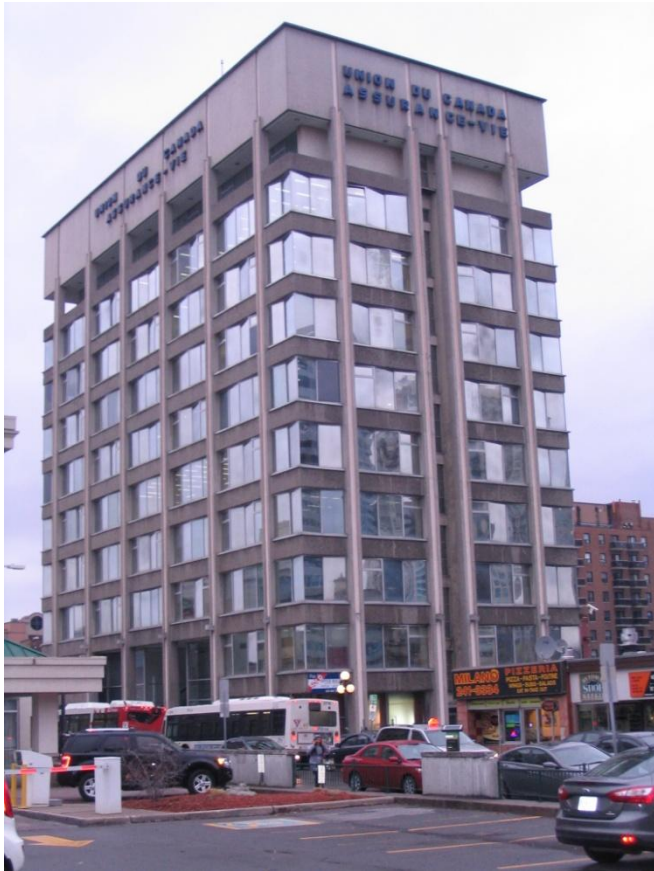
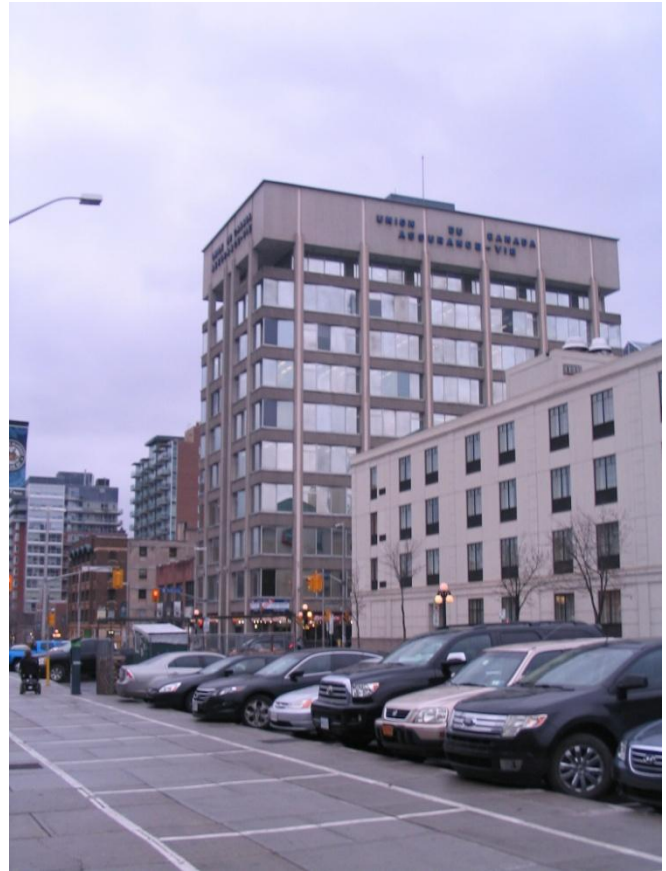
The current structure is a 11 storey commercial building with a full basement (used for storage and office/maintenance/services), retail (restaurant) at grade on the York Street corner, and office floors above, with a double height mechanical services floor at the top. It is a reinforced concrete and steel structure with large glazed openings within the exterior structural grid. Cladding is rusticated precast concrete panels. The windows are designed as trios of large panels, alternatively arranged at a slight angle so that they are diagonally oriented within the window frames, and at a sharp angle at the building corners. This design and the rusticated cladding are the only exterior decorative elements.

321 DALHOUSIE, VIEW TO NE ACROSS DALHOUSIE (LEFT); 321 DALHOUSIE, VIEW TO SE, DOWN YORK (RIGHT)

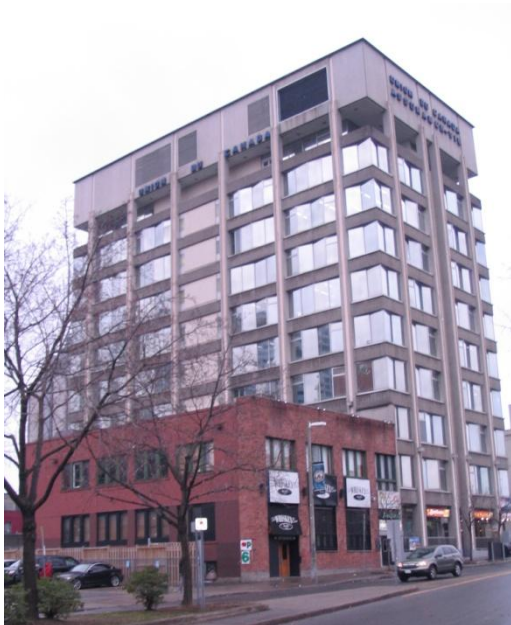
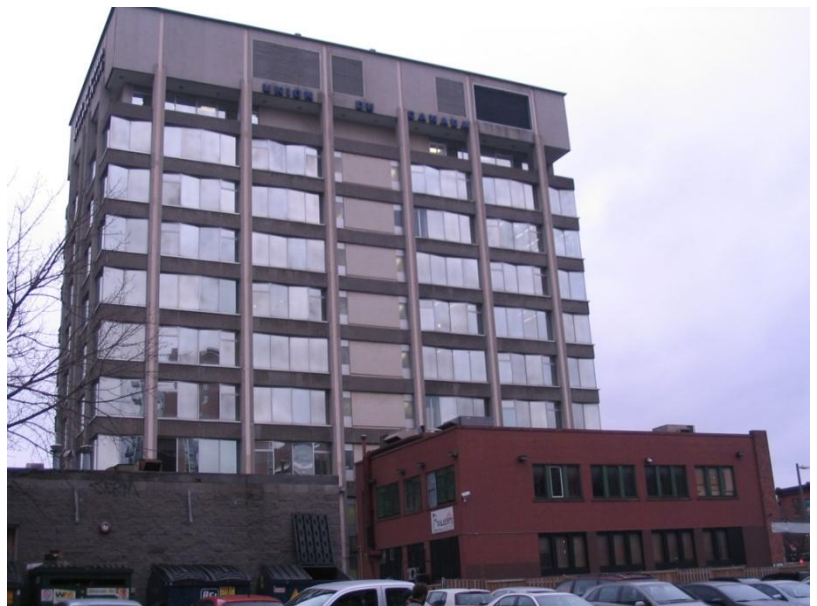
321 DALHOUSIE, VIEW TO SW, UP YORK (LEFT); 321 DALHOUSIE, VIEW TO NW, FROM PARKING LOT AT 137 GEORGE (RIGHT)

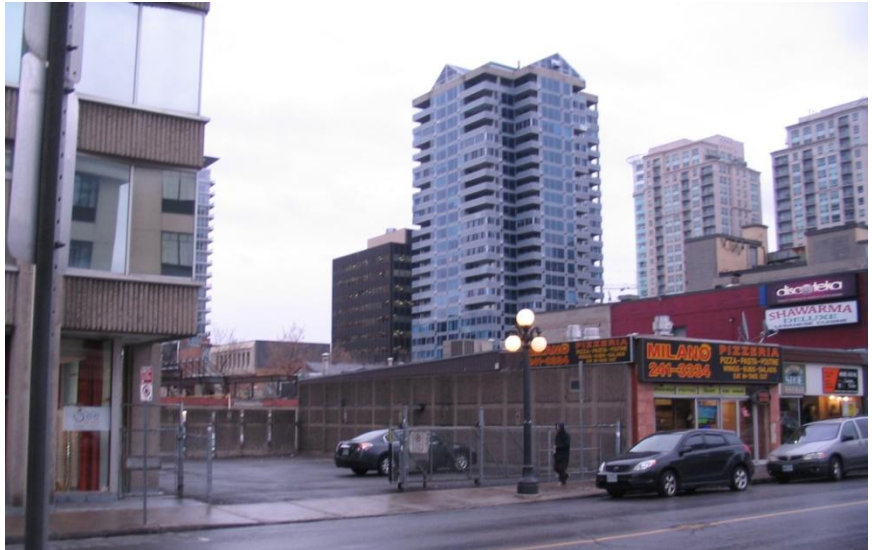
Next to the building, on the south side, is a small surface parking lot with a chain link fence and remote-controlled horizontal gate on the Dalhousie Street frontage and a wall on the east side constructed of rusticated precast concrete panels of the same type used on the office tower's cladding. A similar treatment is used along the southern wall of the parking lot, abutting the adjacent single storey commercial building at No. 339.

321 DALHOUSIE, VIEW TO SE OF SURFACE PARKING LOT ON DALHOUSIE

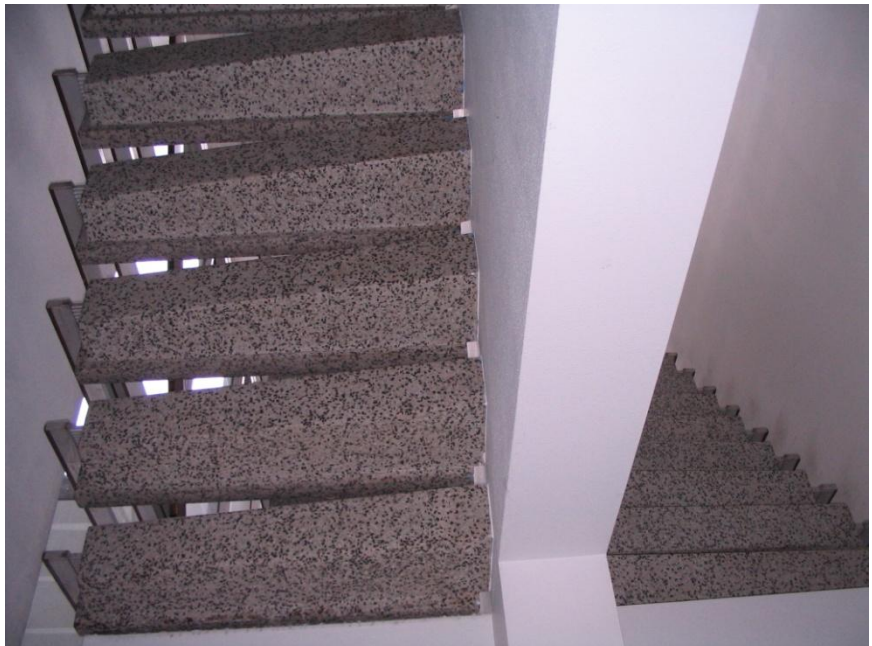
CANTILEVERED STAIRS ON S SIDE OF ENTRANCE LOBBY, FROM BELOW

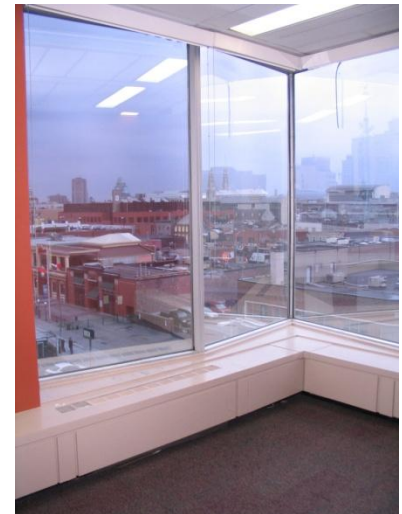
ANGLED WINDOW UNITS, NW CORNER OF BUILDING

- Removal of a representative angled window unit (s), for relocation elsewhere in the building (e.g. as a decorative feature within the entrance lobby, or as a divider within a commercial/hotel space)
- Retention (in situ or by relocation within the building) of one or both of the cantilevered stairs currently flanking the entrance lobby
- Retention of the working drawings for the former and existing 321 Dalhousie Street building, found in situ, and deposition of copies in the City archives

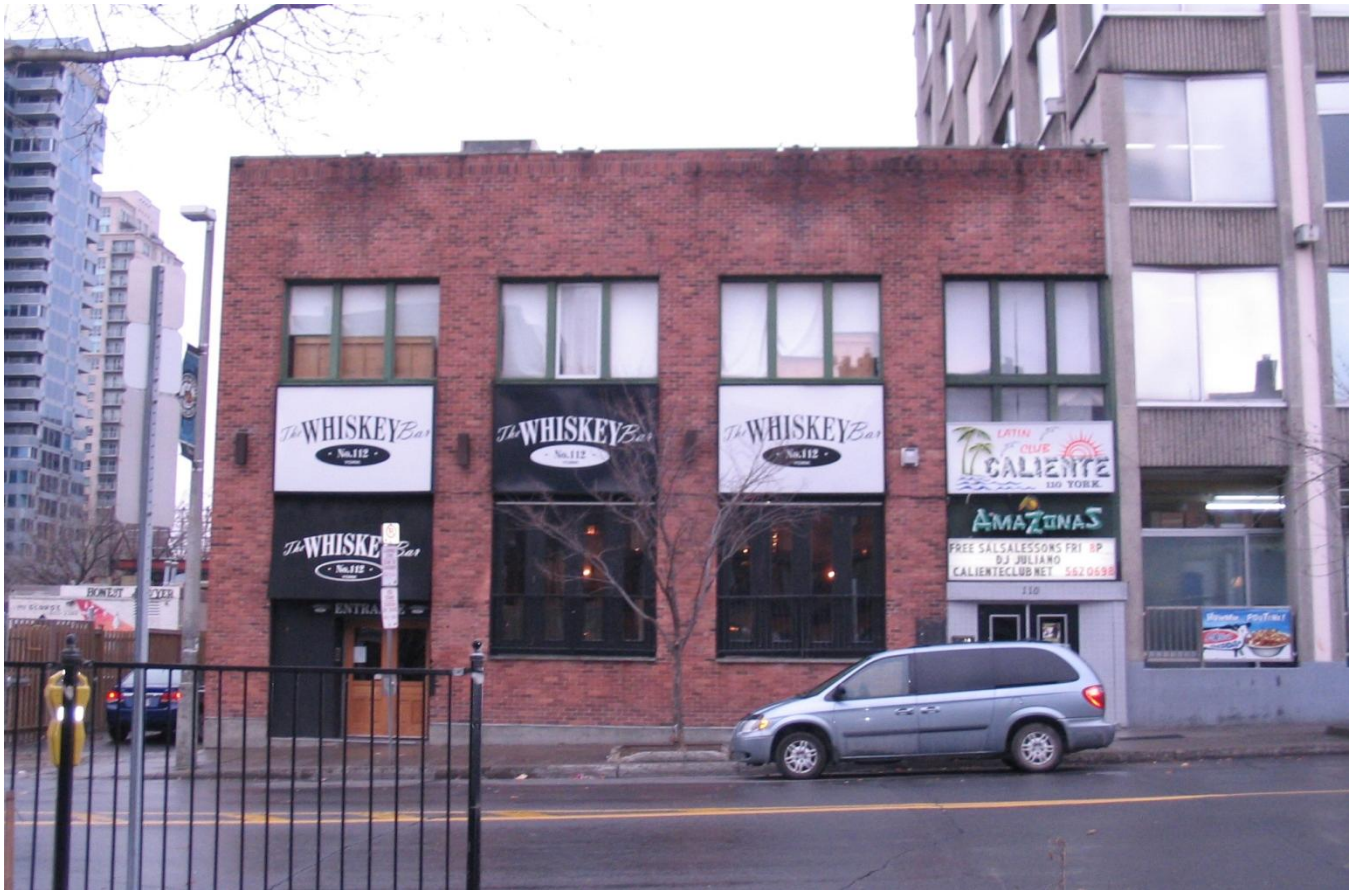
The existing building is a flat-roofed commercial building with four bays on the York Street facade, and an entrance in the first and fourth bays. It has a full basement. The brick facade has windows inset in each bay and a poured concrete foundation. The cornice has small decorative indentations in the flashing and a vertical brick string course. Fenestration on that side is a three panel steel frame window in each bay, on each floor, with a concrete sill. Signage covers part of the window openings but it appears that window openings were originally continuous from the second floor to the first floor. The east side wall has four of the same triple windows in each floor, with concrete sills. The south rear wall has two of the same triple windows flanking a smaller triple window on each floor, as well as offset windows over the west rear stairwell that run the full height of the second storey and a portion of the first. These windows are glazed in glass block. There are no interior features of note, although the glass block rear windows animate the interior stairs. The remaining, southern portion of the property is a surface parking lot. East of the building is a large surface parking lot.

110 YORK, VIEW TO S (FACADE)

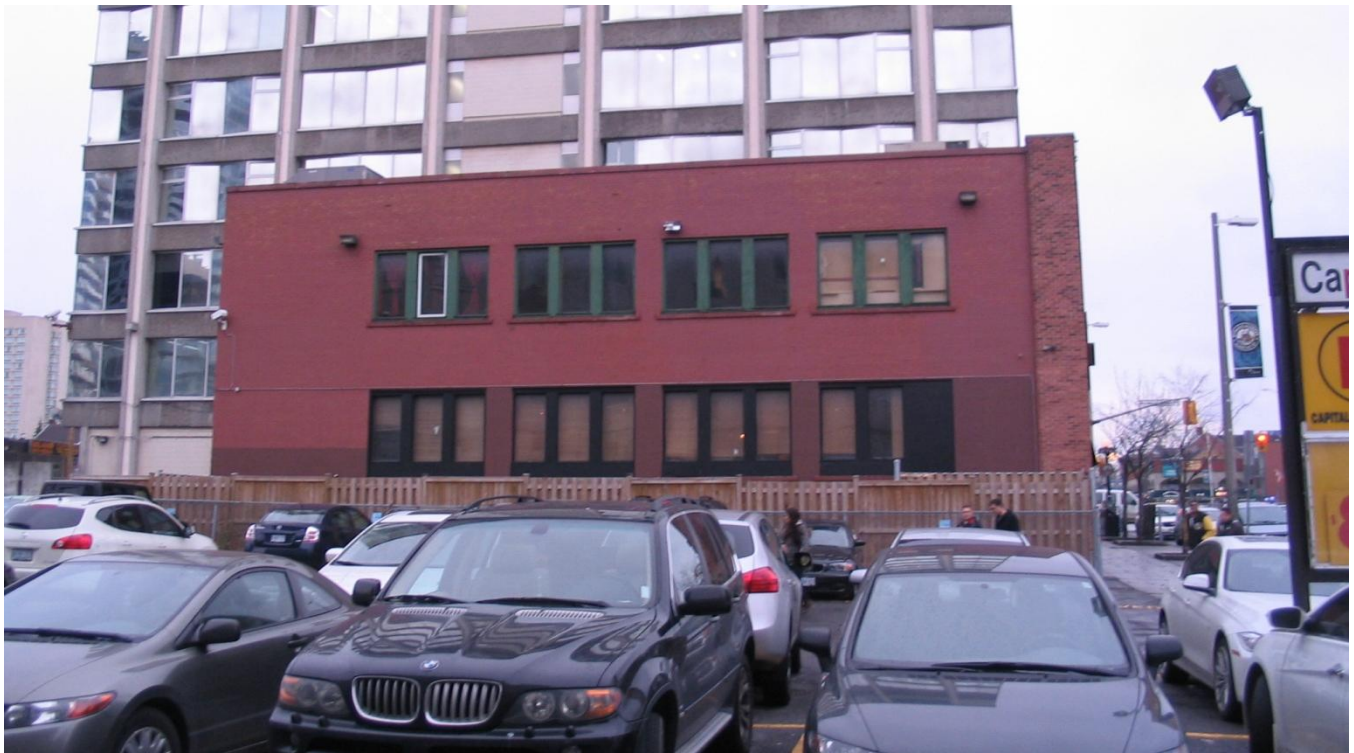
110 YORK, VIEW TO W (SIDE WALL)

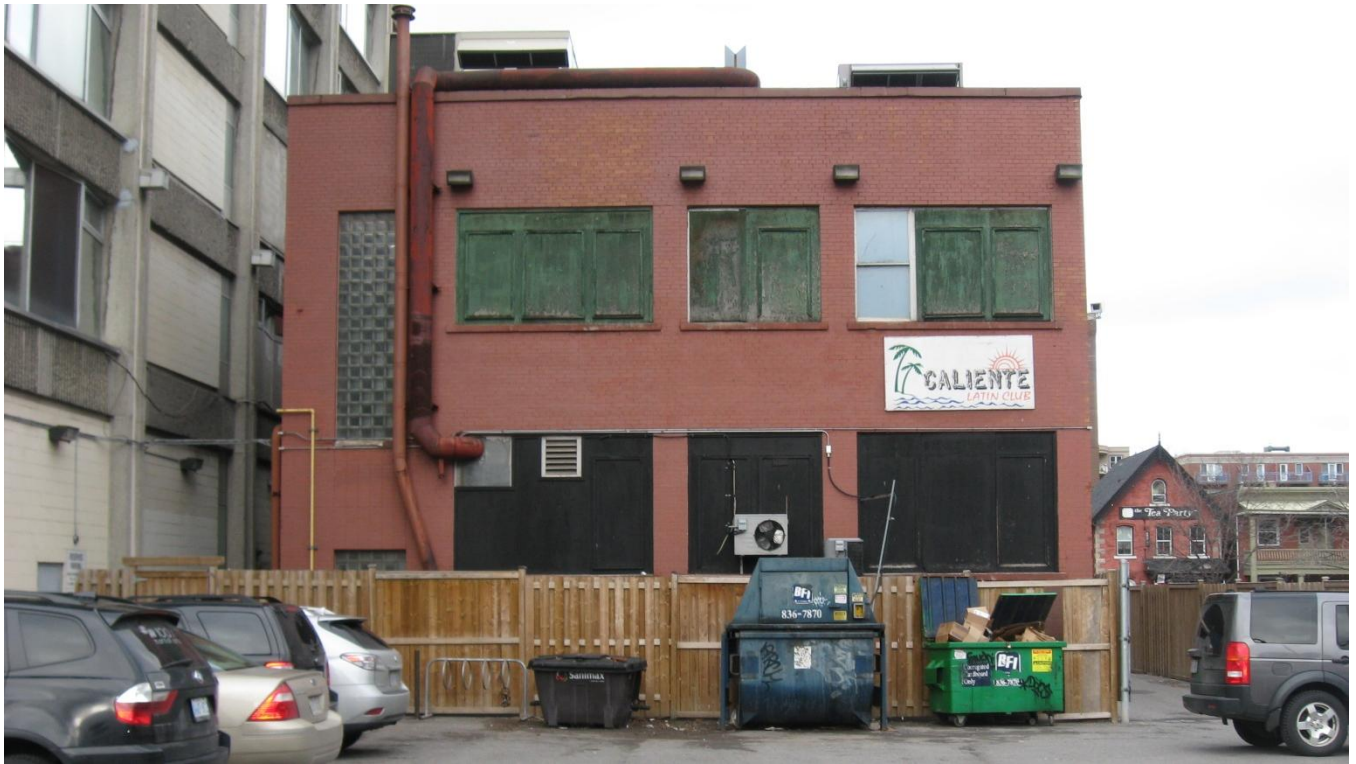
110 YORK, VIEW TO N (REAR WALL)

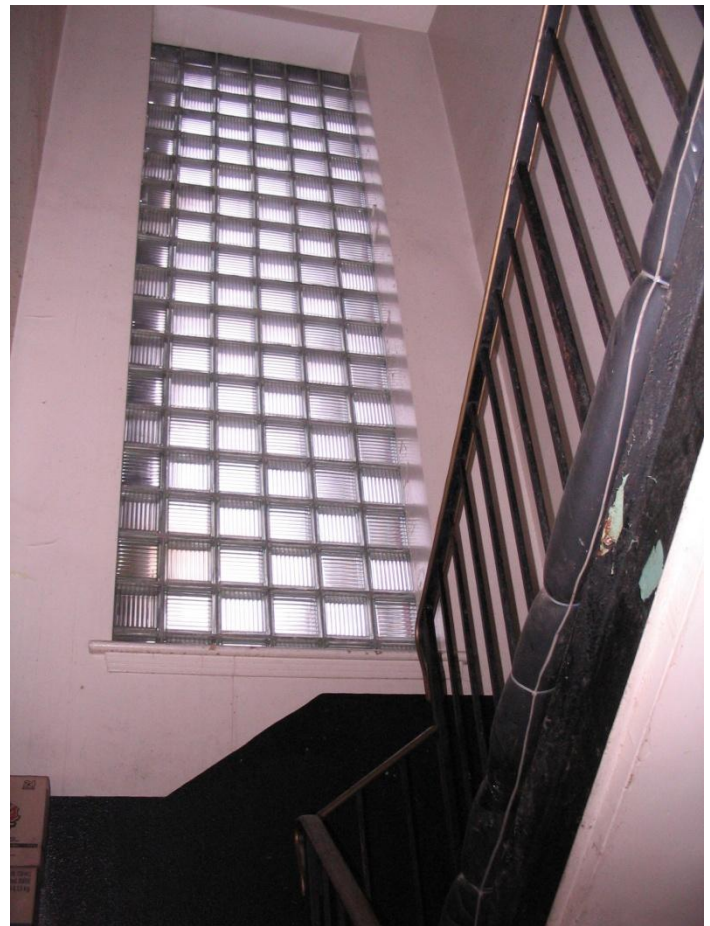
INTERIOR STAIRWELL WITH GLASS BLOCK WINDOW

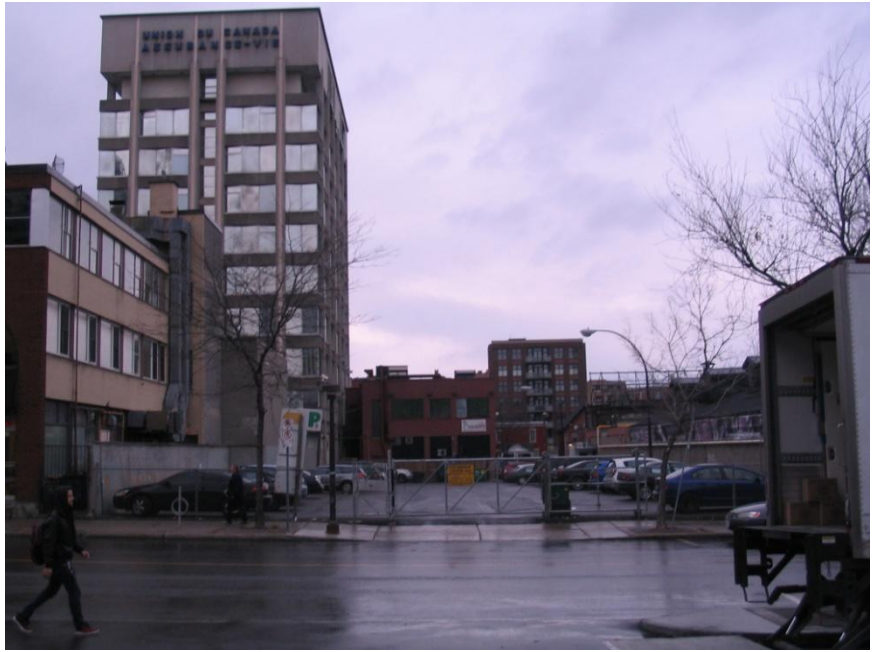
No. 137 is a vacant lot now used for surface parking. The lot is bordered on George Street by a chain link fence with a pedestrian gate and an automatically controlled horizontal gate controlled as part of the private parking operation. The only structure on the property is a small frame hut for the lot operator.

137 GEORGE, VIEW TO N

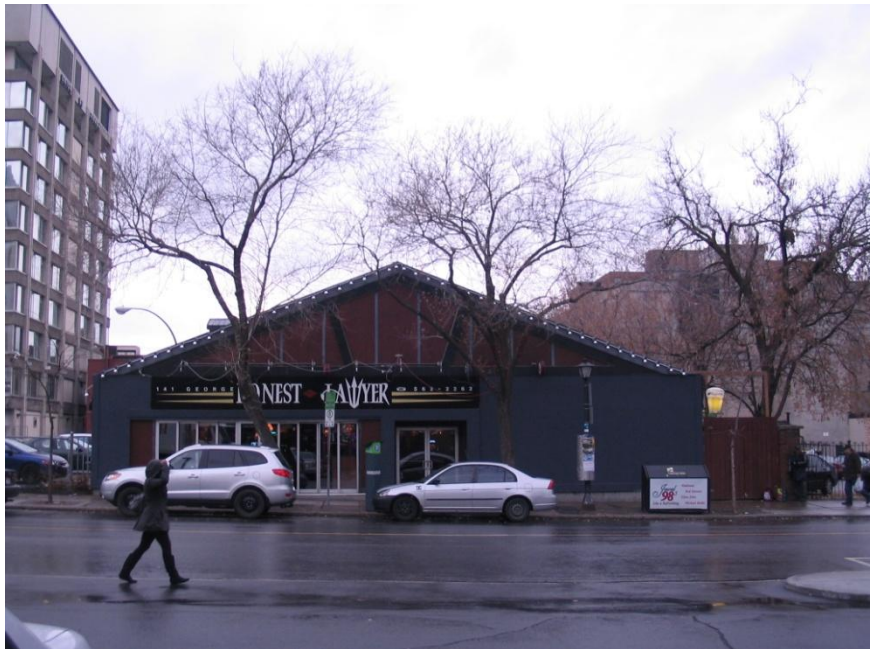
No. 141 is a 1 1/2 storey frame structure on a poured concrete slab. It currently houses the Honest Lawyer sports bar. The roof is a shallow gable, clad in standing seam metal roofing, and oriented gable end to the street. The George Street facade has glazing along the western half and a glazed double entrance door in the eastern half. It is clad in wood in the first storey and has a glazed gable end above. There is a glazed door to an outside fenced area on the east side. The remaining exterior walls are blank. The remaining, northern, portion of the site is a surface parking lot. East of the building is a large surface parking lot.

141 GEORGE, VIEW TO N

Demolition of the existing structure at 141 George Street is a suitable response to the goal of rehabilitating this streetscape and adding new commercial and residential uses. It is also recommended that the City update the 1990 Byward Market HCD Study to not only comply with the requirements of the 2005 Provincial Policy Statement and 2005 *Ontario Heritage Act*, but also to address the new and emerging planning and development policies now becoming City's preferred approach for portions of Lowertown, and which are described more fully in the planning justification that accompanies this development application.

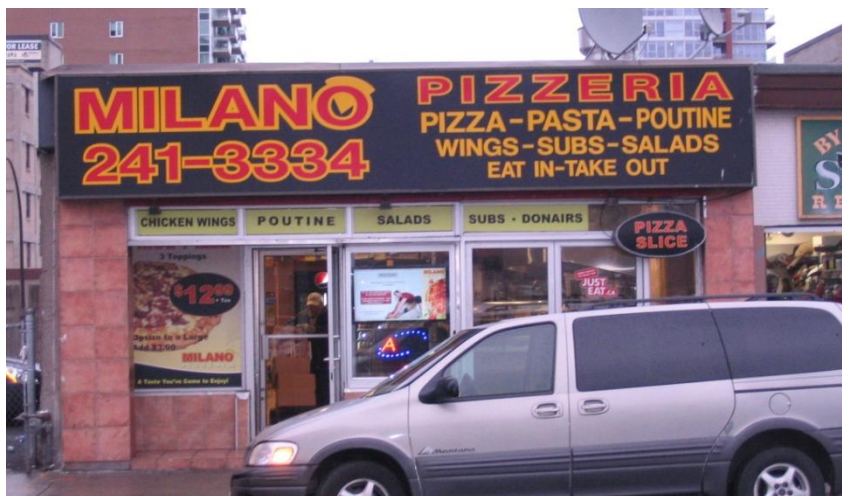
No. 339 is a single storey commercial structure, possibly of concrete block and on a poured concrete slab foundation, clad in brick and tile (facade), with glazing across most of the street facade, over which is a full-width sign board. The building appears to be a replacement for a 2 storey frame structure (residential? with frame outbuildings behind) shown on the 1878 fire insurance plan and on the 1888 and 1902 fire insurance plans. The 1948 and 1956 fire insurance plans show this building as a commercial frontage, either with a streetfront addition or replaced by a 2 storey concrete block structure on the north half of the lot and a 1 storey frame structure on the rest. The current structure may be an evolution of this structure, or a replacement. The 1990 HCD Study evaluation gave it no heritage significance, rating it as 4, the lowest rating.

339 DALHOUSIE, VIEW TO E

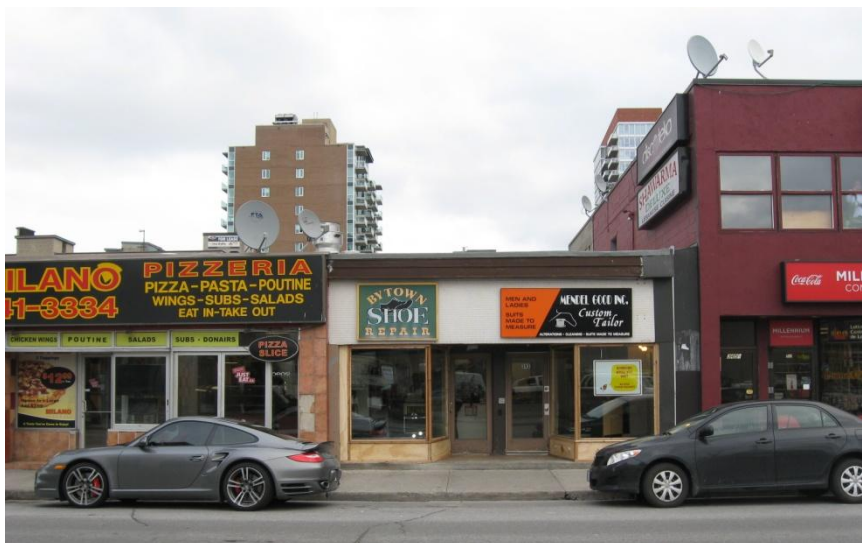
No. 341-343 is a single storey commercial structure, possibly of concrete block on a poured concrete slab foundation, or possibly frame. It has a central, inset entranceway with doors to a pair of small shops, each with glazing along the street frontage and angling into the entranceway. Both doors have large glazed panels. Above the glazing and entrance is a full-width signboard atop which is what appears to be a thick metal cornice. According to the 1990 HCD Study evaluation, the building may be part of a 2 1/2 storey double house that was built between 1851 and 1872, or it post-dates the structure shown on the 1956 fire insurance plan. A building on this site was part of an industrial complex from at least 1878, later the Low machine shop (1888 fire insurance plan, 1899 City Directory, replaced by a vacuum cleaner outlet (1902 fire insurance plan), subdivided into two shops by the time of the 1948 fire insurance plan (but shown as a 2 1/2 storey frame structure with a 1 storey street frontage and 1 1/2 storey rear addition). It appears that the 1948 building is a slight enlargement of the 1902 structure, with the single storey extension to the street, and the division of the building into two matching shops. As well, it appears that the existing structure is a single storey throughout, implying that the former 2 1/2 storey structure has either been reduced in height or replaced. The 1990 HCD Study evaluation rated this property at 3, which indicates some heritage value, due to its potential for containing portions of a very early building, and for demonstrating the “pattern of adaptation and re-use” identified as an historical trend in the Byward Market HCD.

341-343 DALHOUSIE, VIEW TO E

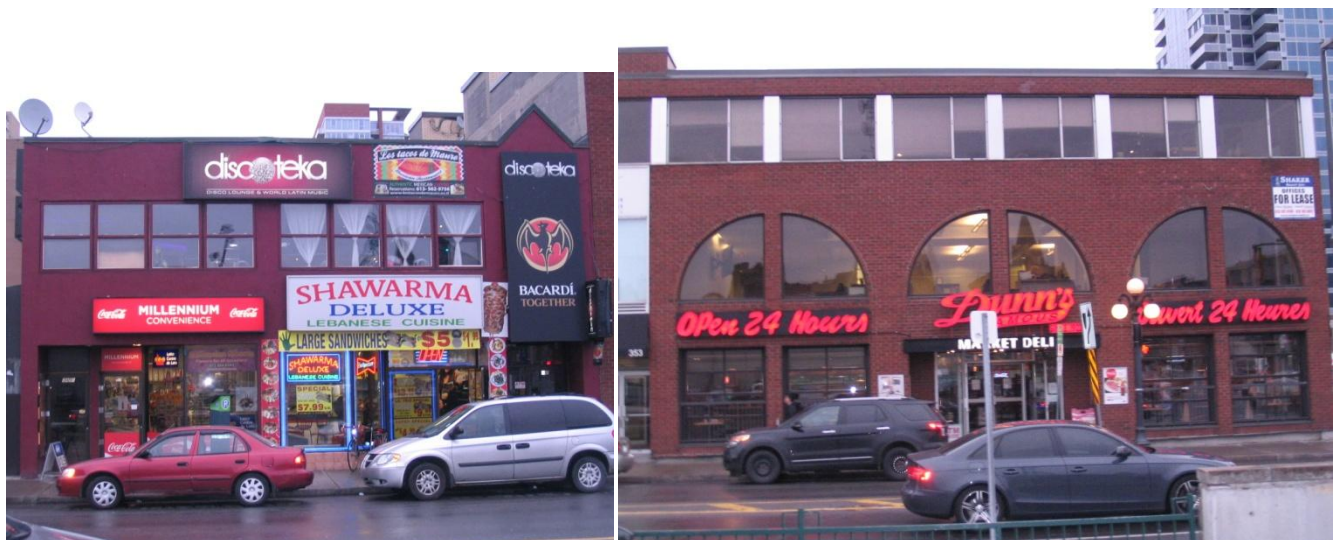
By the 1888 fire insurance plan, a 2 1/2 storey brick machine shop has been added to the street frontage, with 1 storey wings behind, and both the cooperage and blacksmith operations are now rebuilt and abut the street, an arrangement continued on the 1902 fire insurance plan. By the time of the 1948 fire insurance plan, No. 345 is a small, 1 storey frame shop with an open courtyard behind, while Nos. 347-349 are 2 1/2 storey brick shops with 1 storey frame additions behind. No. 347 may be the same building shown on the 1902 fire insurance plan, then housing a machine shop. The rest of the block, collectively shown as No. 351, is by this time occupied by a large 1 storey concrete block (north half) and brick (south half) service station, with fuel pumps and parking, set well back from the Dalhousie Street frontage, an arrangement confirmed on the 1956 fire insurance plan. It is not clear whether the current 2 storey commercial building at Nos. 347-349 incorporates elements of the earlier structures. The current 2 storey commercial building at Nos. 353-355 replaces the service station shown on the 1956 fire insurance plan.

345-349 DALHOUSIE, VIEW TO E

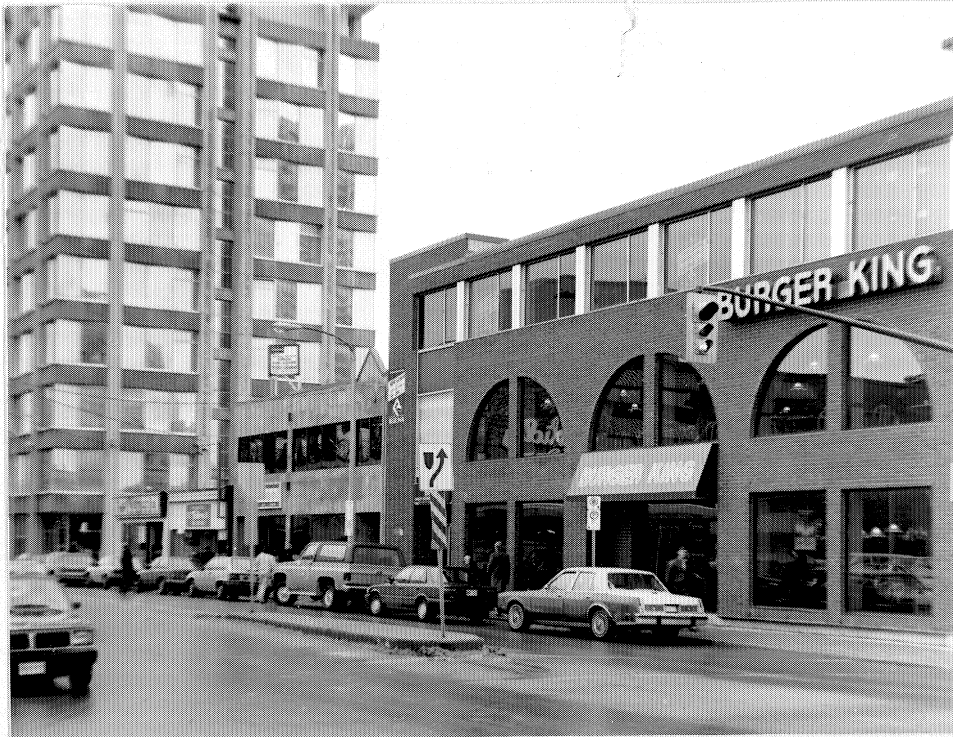
PHOTO DATE: Jan. 1990  
VIEW:  
SOURCE: H. Schade  
NEGATIVE NUMBER: 67- H

Compatibility With Heritage Environs: Compatible in scale and use. Incompatible materials and detailing
