# AN OPINION LETTER & SCOPED HIA 290 City Centre Avenue, Ottawa

**Revised, February 2024**

**Prepared for: District Realty Management Limited  
Prepared By: John Stewart Commonwealth Historic Resource Management**

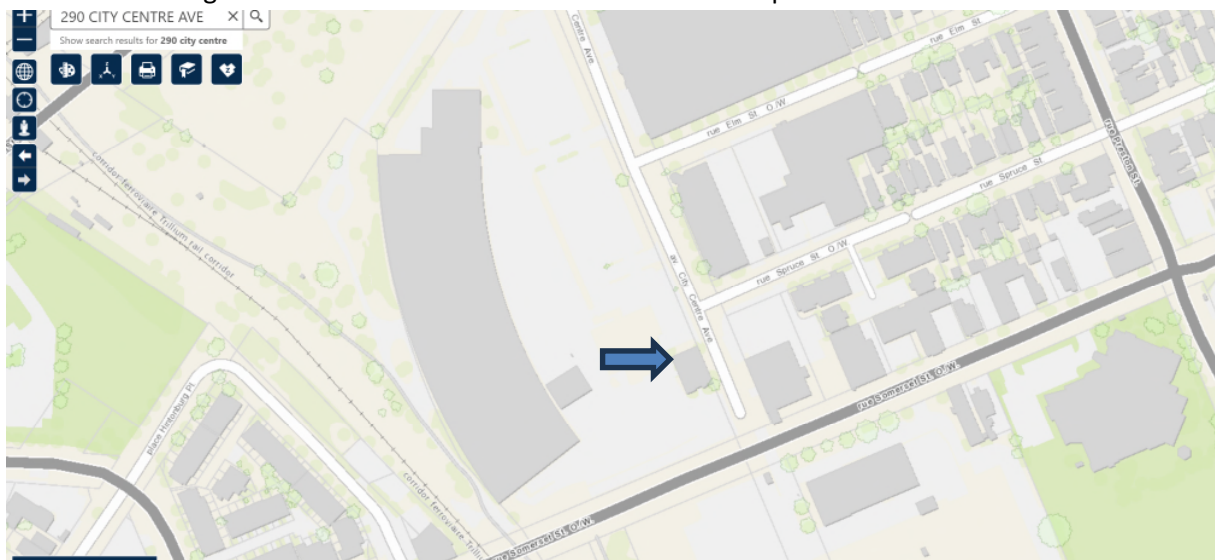
Figure 1: Block diagram of the City Centre site, with the building at 290 City Centre Avenue located at the southeast corner of the larger site identified as 250 City Centre Avenue (Arrowed). Source: Geoottawa.

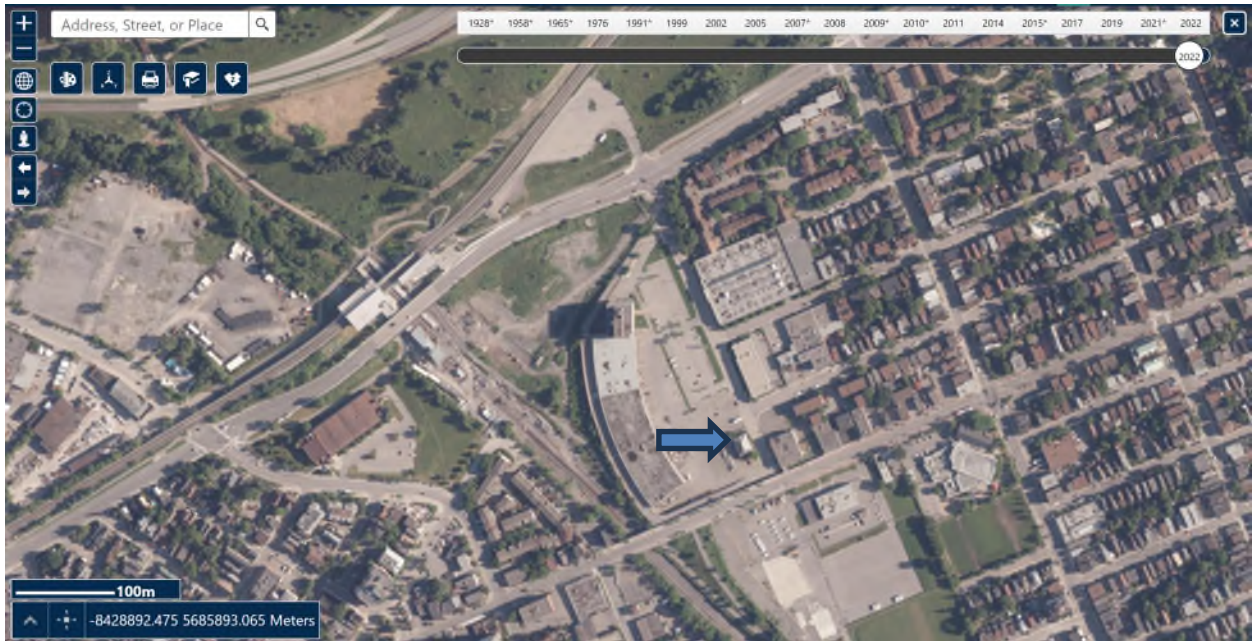
Figure 2: Aerial view of the City Centre site and surrounding context. 290 City Centre Avenue arrowed. Source: Geotowna 2022

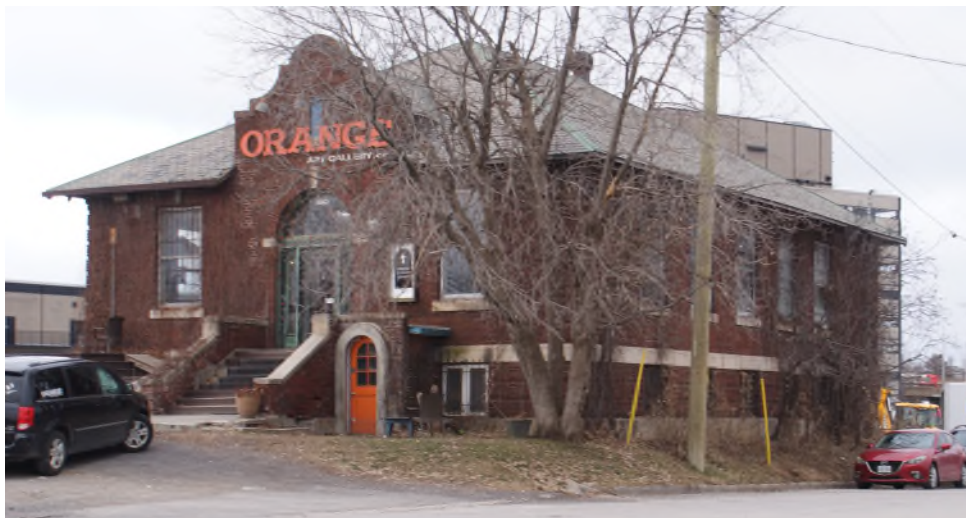
Figure 3: View looking north-west of the principal façades - south and east elevations illustrating the landscape character surrounding the building. Source: Commonwealth, December 2023.

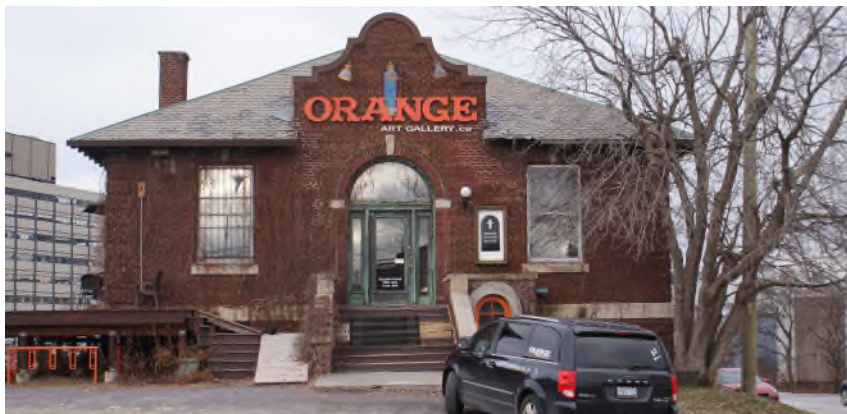
Figure 4: View of the principal façade / south elevation. The set of steps and wood deck to the left of the entrance steps were introduced within the last 10 years as part of an art gallery and event space. Source: Commonwealth; December 2023

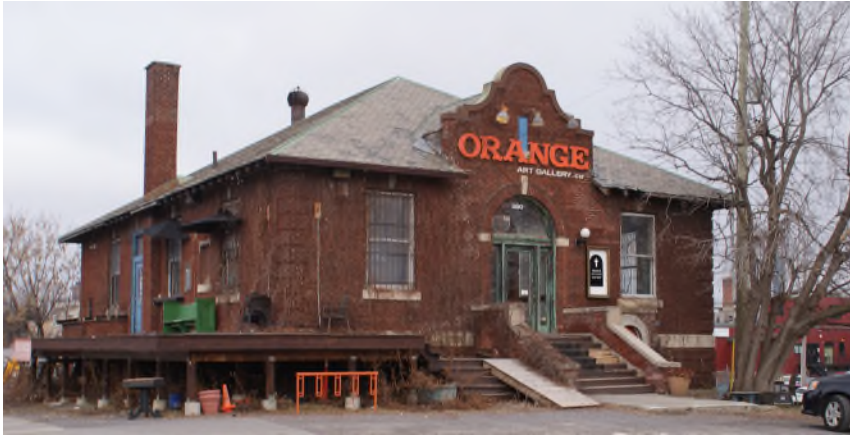
Figure 5: View looking north-east to the south and west elevations. Source: Commonwealth, December 2023.

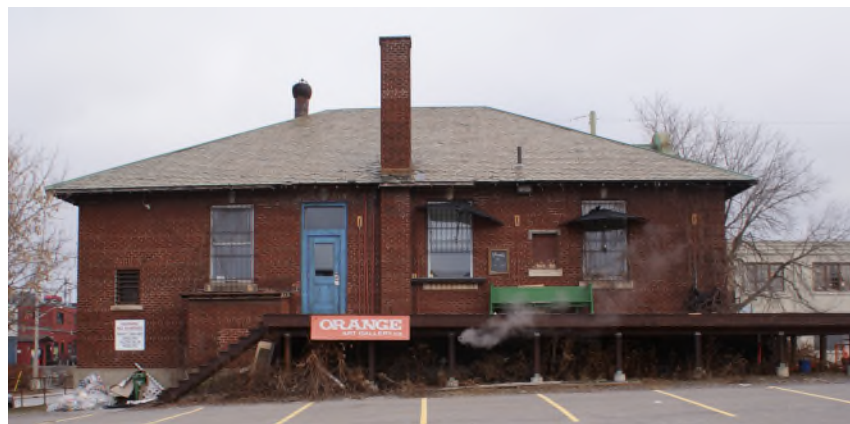
Figure 6: View of the west elevation. The architectural pre-cast stone string course and rusticated brick finish below extends to the small brick basement bump out. Source: Commonwealth, December 2023.

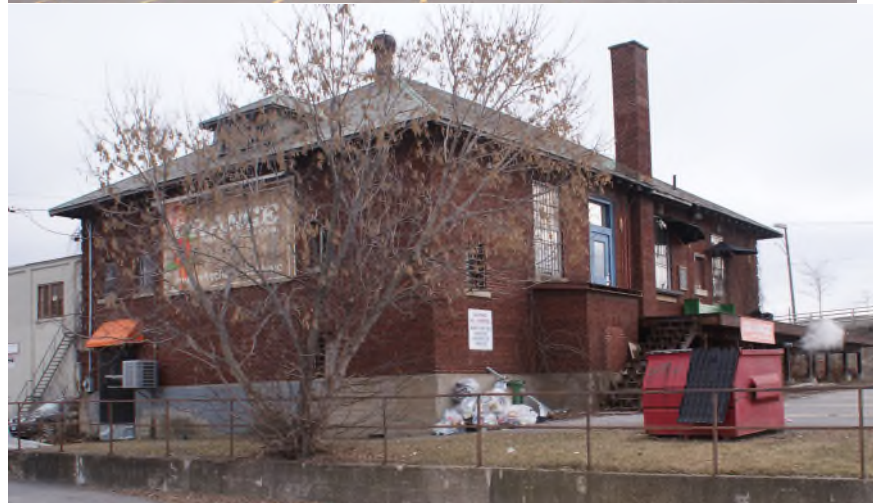
Figure 7: View looking southeast to the west and north façades. The retaining wall and tubular metal railing would appear to date to the early 1960s site development. Note the grassed area. Source: Commonwealth, December 2023.

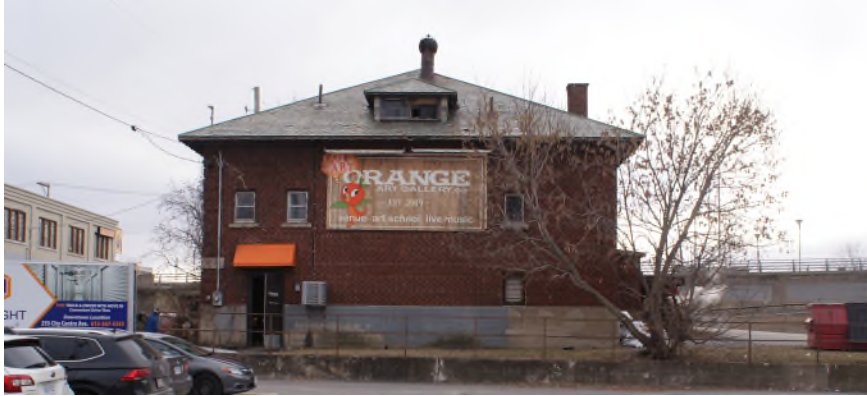
Figure 8: View of the north façade. Note the step cracking in the brickwork above the window at the north-east corner above the basement entrance. Note the grassed edge and tree. Source: Commonwealth, December 2023.

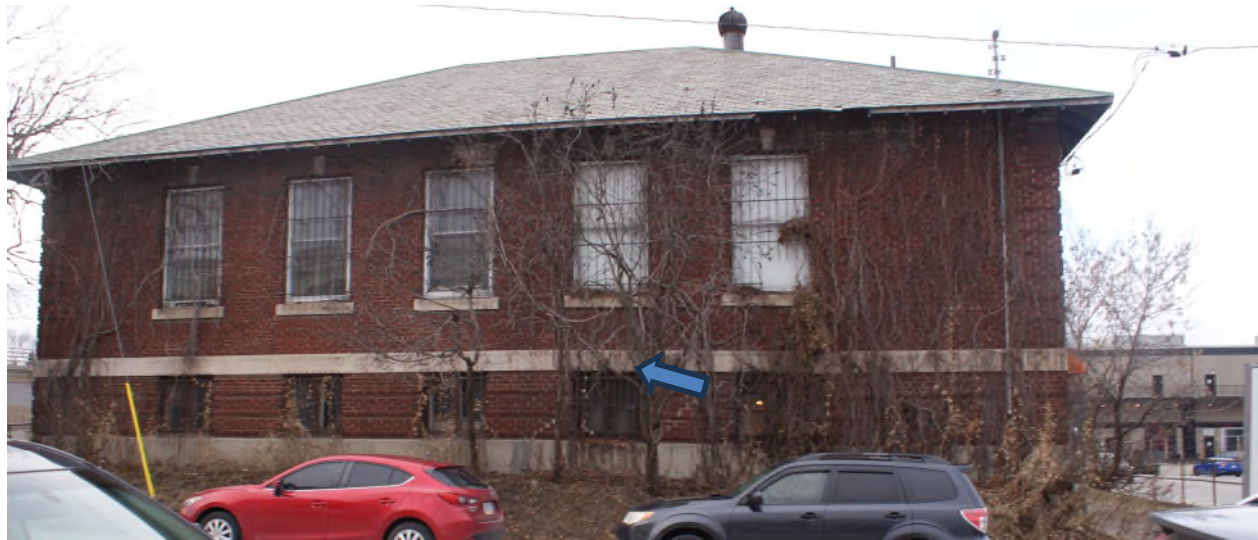
Figure 9: View of the east elevation. Note: The deflection/settlement in the string course extending from the second window from the right to the north-east corner (right corner). Stepped cracking is evident in the foundation, extending up to the windowsills through to the roof. The gauged brick forming the header above one window is missing, and brickwork at the north-east corner is displaced below the roof. Source: Commonwealth, December 2023.

The structure consists of two wythes of brick forming the exterior walls laid up in an American Common Bond set on a concrete foundation. The foundations have settled on portions of the east elevation, as is evident in the step cracking that extends through the concrete foundation walls up through to the roof level in the northern portion of the east foundation wall from approximately the midpoint of the east wall through to the north-east corner of the building. Gauged brick in the window head above one window has been displaced and is missing, exposing the inner brick wythe, and brick is displaced at the north-east corner at the roof level.

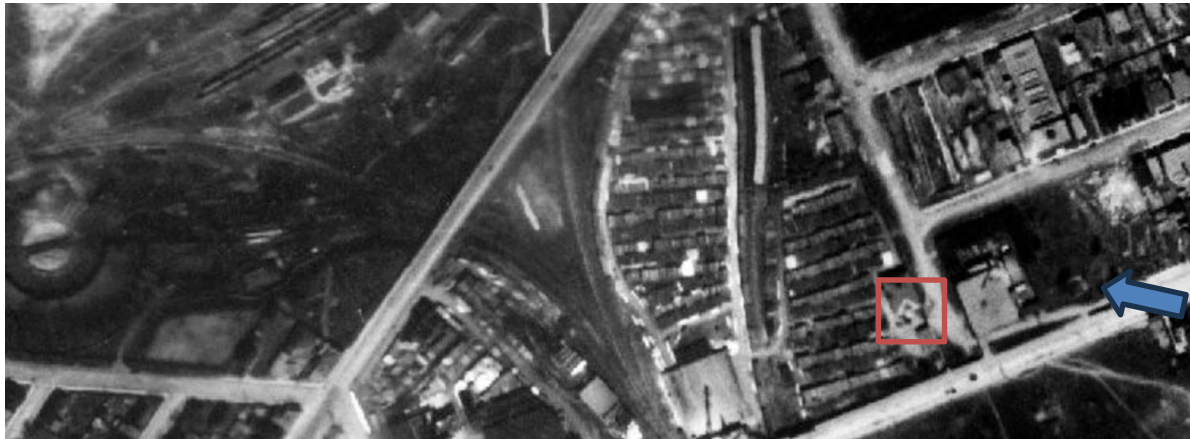
Figure 10: 1928 aerial view of the W. C. Edwards Co. lumberyard. The building fronted on to Somerset Street, with

the original address of 991 Somerset Avenue. By 1928, the Somerset bridge blocked direct access from Somerset, with the entrance coming off a laneway that connected with City Centre Avenue. (arrowed). Note the piled lumber surrounding the building at 290 City Centre Avenue, formally 128 Champagne Avenue (Arrowed). The planing mill is to the west, Source: Geottawa

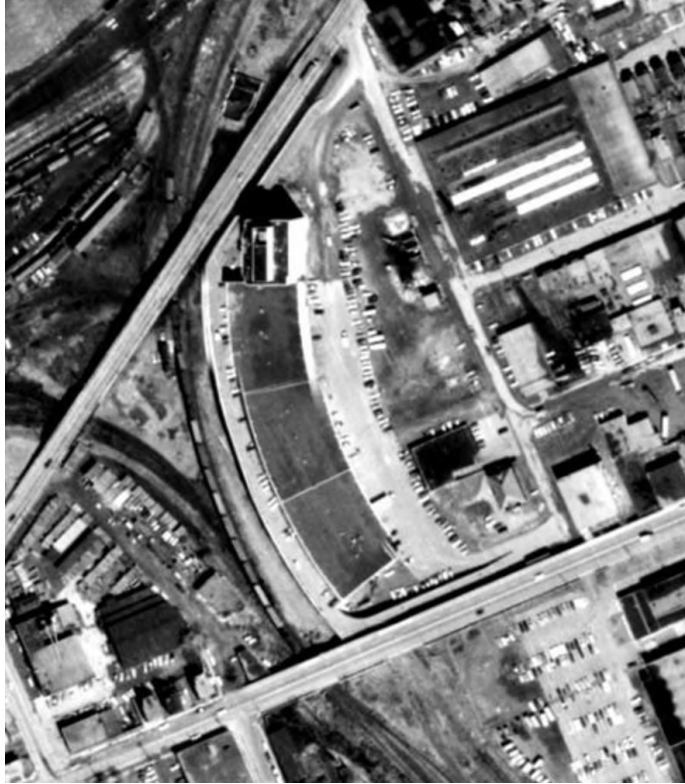
Figure 12: 1965 aerial view of the City Centre site after the site was redeveloped in 1963-64. The Somerset Bridge was completed in 1959. Source: Geottawa.

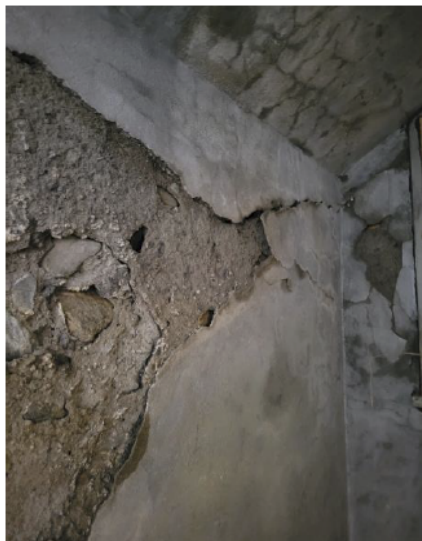
**Foundation Wall Deterioration**

- The majority of the main floor wood frame structure was concealed by interior finishes and could not be examined.
- The perimeter foundation walls were visually reviewed where accessible. The concrete was found to be in fair to poor condition, particularly at the front (south) walls.
- The brick bears directly on the foundation walls and was also found to be extensively deteriorated beneath the front entrance area. Due to elevation changes of the exterior grade, the brick cladding on the front and side walls is partially below grade.

As noted, it is our understanding that a major site remediation is planned to address environmental contamination. While the extent and depth of excavation will not be known until the project commences, the work will require that the entire structure be either temporarily supported or relocated. Based on our site observations, it is our opinion that extensive repairs and/or replacement of the foundation walls and lower sections of brick cladding will be necessary in order to accommodate any temporary shoring or relocation plan. It is anticipated that the value of this work will be cost prohibitive and it is our opinion that demolition of the structure will therefore likely be required to accommodate any major site remediation. The preliminary order of magnitude estimate for temporary relocation and reinstatement of the building is between \$900,000 plus HST and professional fees

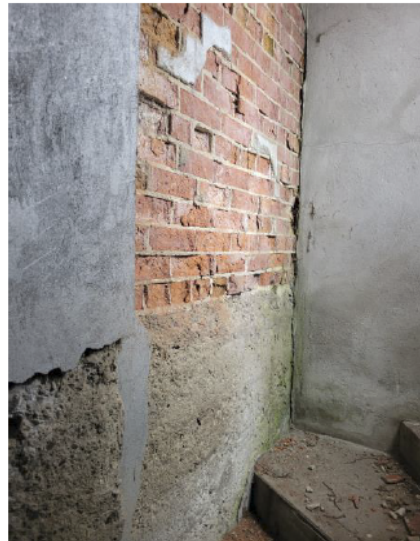
**Brick Deterioration**

- Settlement of the footings was noted at the north-east corner of the building where grades are at the basement floor level. The settlement is evident at the eaves.

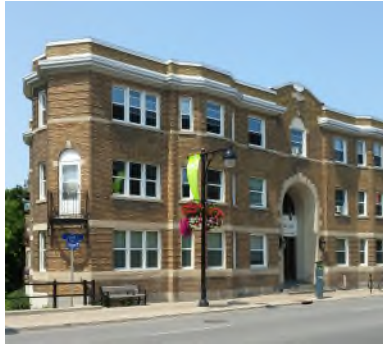
*The Noffke designed Ambassador Court apartment on Bank Street is a reference for many of the defining features found at 290 City Centre, including the concrete basement, the limestone banding set above the brick apron and rusticated brick above, the elaborate over scaled entrance and flush pedimented front.*
