RE: TREE INFORMATION REPORT (FULL) FOR 432 BLAKE BOULEVARD

This Tree Information Report (TIR) was prepared by IFS Associates Inc. (IFS) in support of an application for a building permit for 432 Blake Boulevard. The need for this report is related to trees protected under the City of Ottawa’s Tree Protection By-law (By-law No. 2020-340). The proposed construction includes the demolition of an existing single-family dwelling and construction of a low-rise apartment building.

PROJECT: 432 BLAKE BOULEVARD
CITY OF OTTAWA

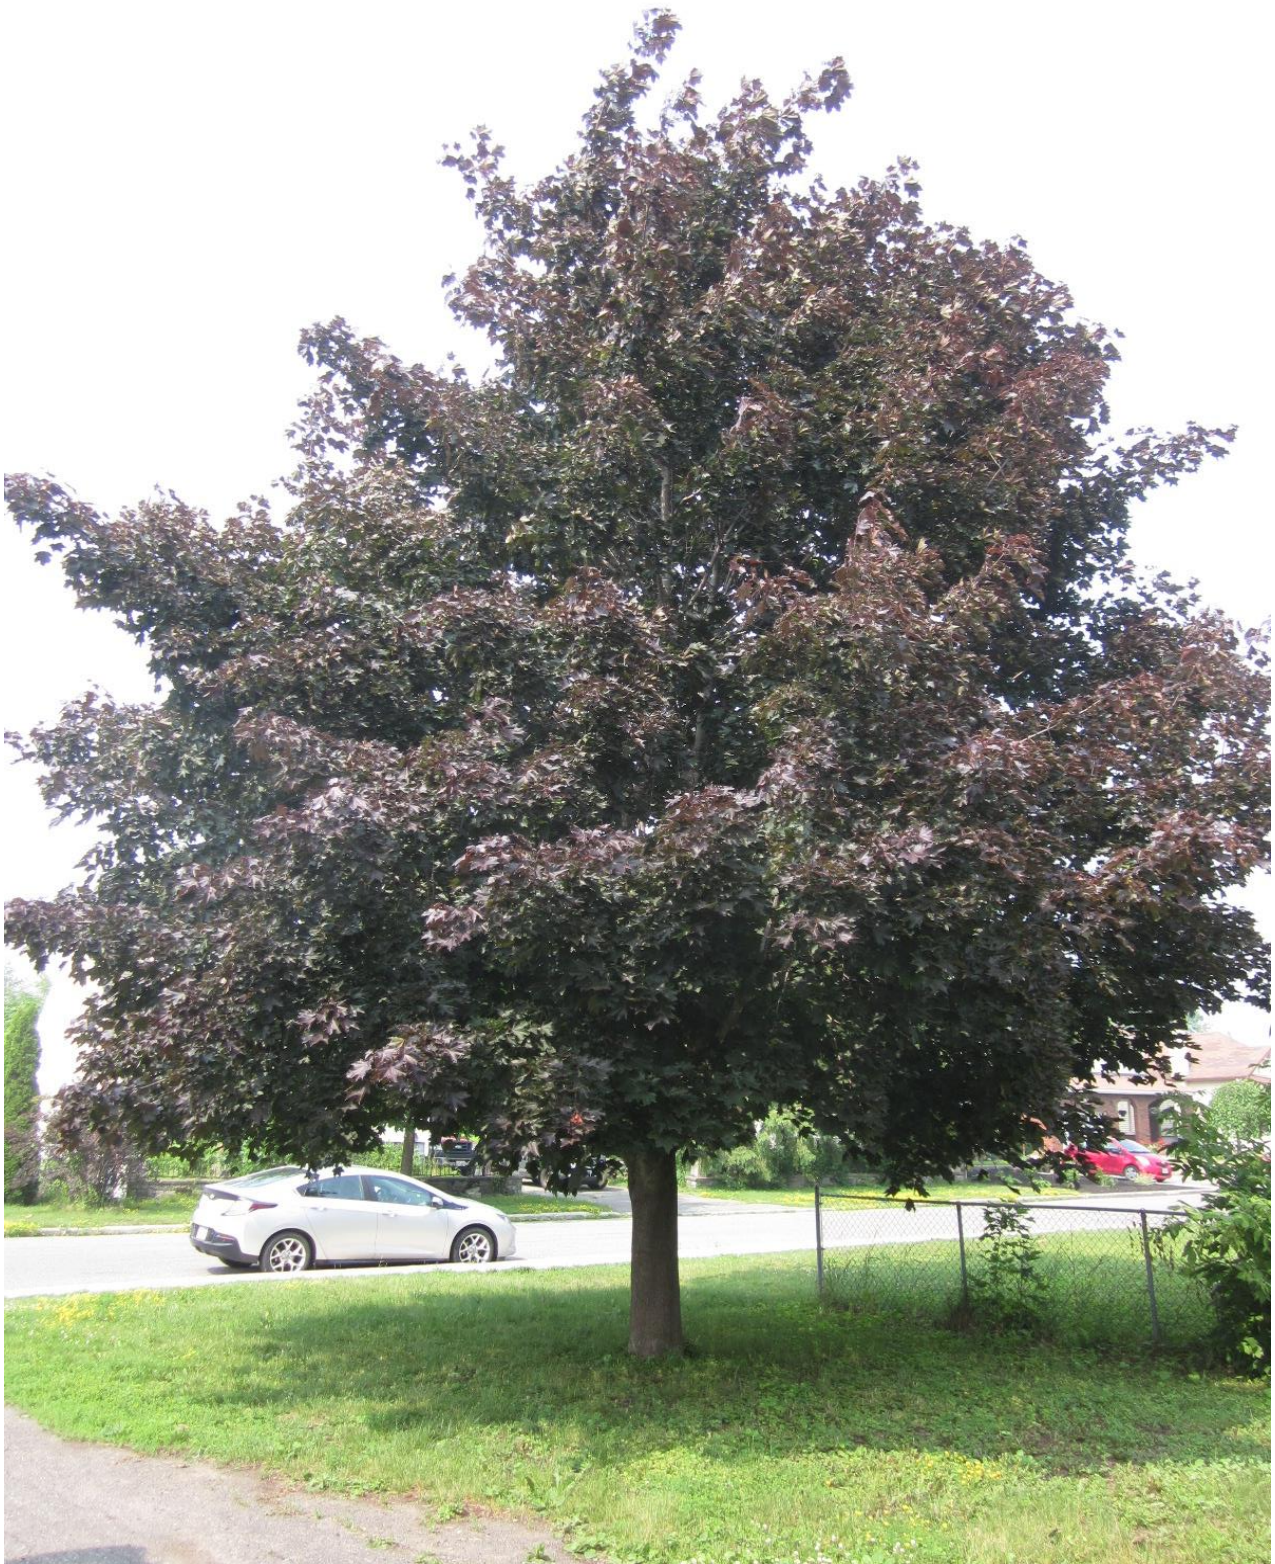
Tree No.	Tree species /Tolerance to Construction ¹	Ownership	DBH ² (cm)	CRZ ³ (m)	Distance to excavation (m) ⁴	Tree Condition, Age Class, Condition Notes, Species Origin and Status (to be removed or preserved and protected)	Reason for removal	Forester's Opinion re. Removal
1	Norway maple (<i>Acer platanoides</i>) / Moderate-Good	Private	36.2	-	-	Good; mature; 'Crimson King' variety; central stem with offset leader at 4m from grade; competing lateral at 1.75m on northeast; suppressed laterals starting at 1.5m – broad, dense, and generally symmetric crown; introduced invasive species; to be removed	Conflicts with front walkway	Tree and stump be removed
2	Manitoba maple (<i>Acer negundo</i>) / Good	Neighbour	+/-25	+/-2.5	+/-3	Fair; mature; single dominant main stem; divergent towards west due to influence of tree #3 and past clearance pruning; naturalized species; to be preserved and protected	Not applicable – to be preserved	Not applicable

Picture 1. Tree #1, private Norway maple to be removed from 432 Blake Boulevard

As the property is within the inner urban area, the following ratios are used in terms of replacement tree planting: 2:1 for each removed distinctive tree measuring 30-49 cm in diameter and 3:1 for each distinctive tree measuring 50 cm or greater in diameter. As one tree in the range of 30-49cm is to be removed, compensation of two new trees is required. Replacement trees must be at least 50mm in caliper if deciduous and 2m in height if coniferous. Suggested replanting locations are shown on the plan on page 3.

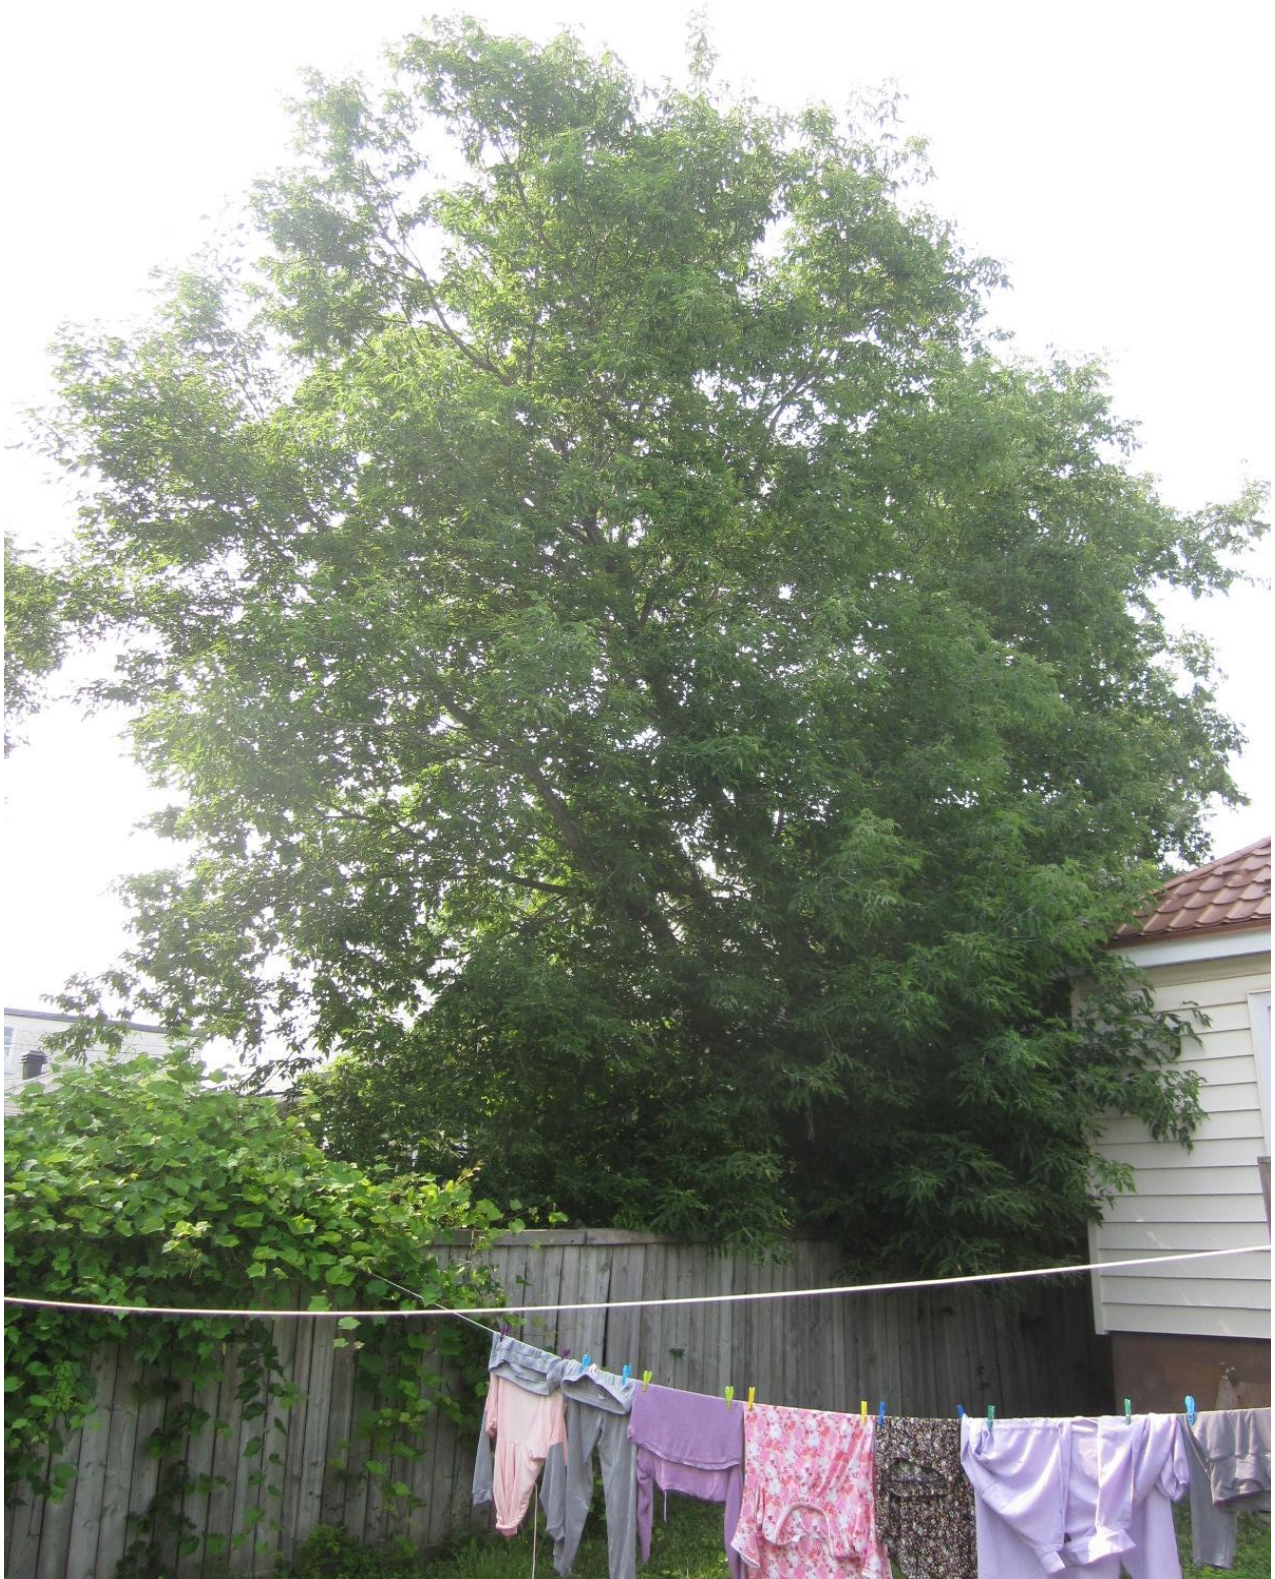
3	Manitoba maple (<i>Acer negundo</i>) / Good	Neighbour	+/-35	+/-3.5	+/-3	Fair; mature; main stem with competing lateral at 1.5m on southeast; divergent towards south due to influence of tree #2; naturalized species; to be preserved and protected	Not applicable – to be preserved	Not applicable

Picture 2. Tree #3, neighboring Manitoba maple to be preserved adjacent to 432 Blake Boulevard

1. Erect a fence as close as possible to the critical root zone (CRZ) of trees (City of Ottawa tree protection barrier detail included on page 6).
2. Do not place any material or equipment within the CRZ of the tree.
3. Do not attach any signs, notices or posters to any tree.
4. Do not raise or lower the existing grade within the CRZ without approval.
5. Tunnel or bore when digging within the CRZ of a tree.
6. Do not damage the root system, trunk or branches of any tree.
7. Ensure that exhaust fumes from all equipment are NOT directed towards any tree's crown.
