## Tree Information Report v2.0

Submitted as part of Committee of Adjustment Application to the City of Ottawa

**Date of Report:** April 29, 2024  
**Property Address:** 1302 Aurele Street  
**Prepared for:** Planning P2 Concepts Inc c/o Jasmine Paoloni; [planning@p2concepts.ca](mailto:planning@p2concepts.ca)  
**Prepared by:** Kevin Myers, ISA Certified Arborist®; [kevin.myers@dendronforestry.ca](mailto:kevin.myers@dendronforestry.ca)  
**Date of Site Visit:** March 11, 2024

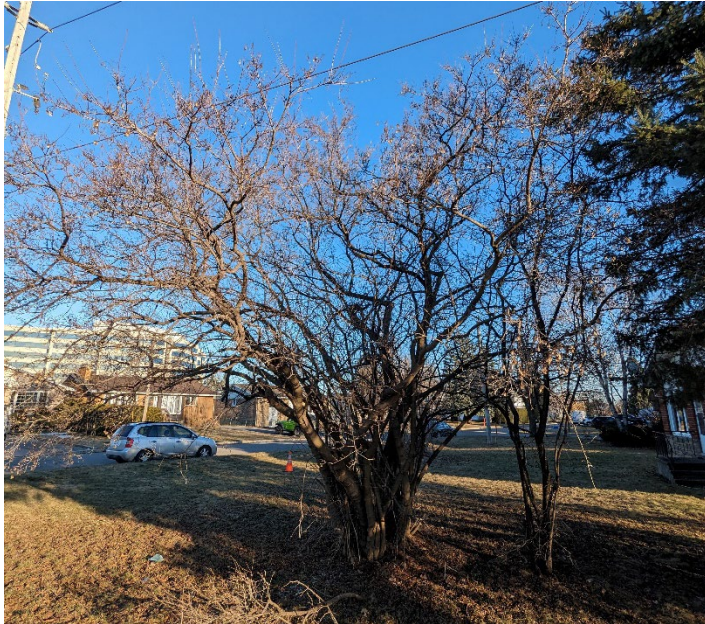
*Above: Tree 1 - city Amur maple to be retained.*

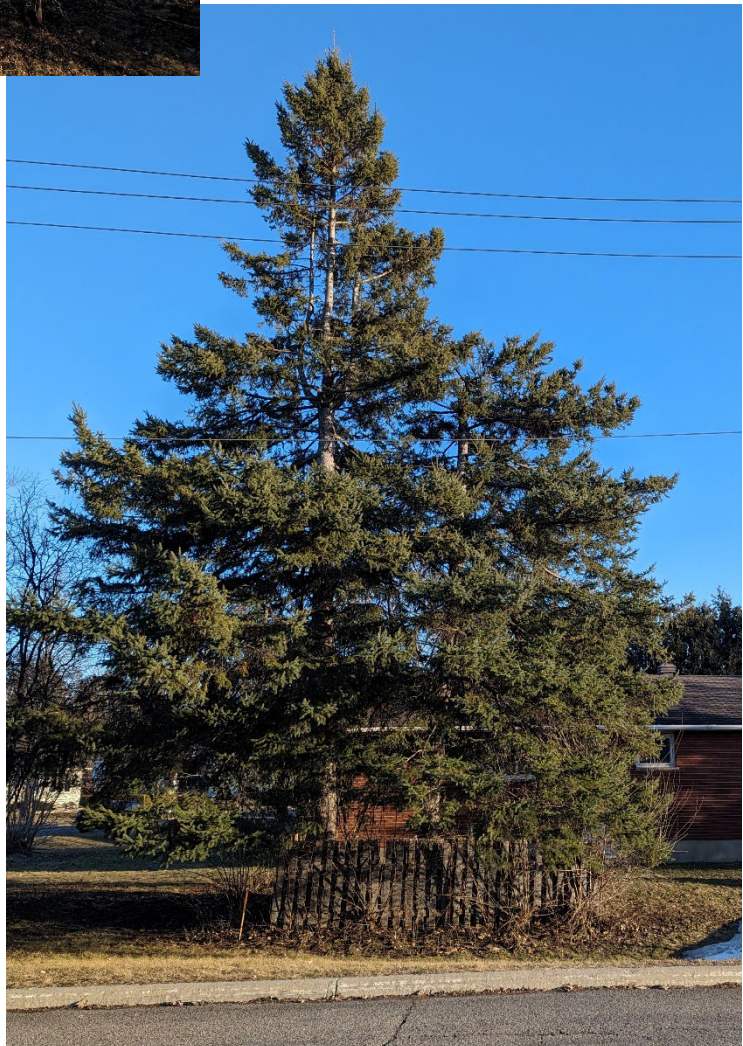
*Right: Tree 2 and 3 - private spruces to be retained.*

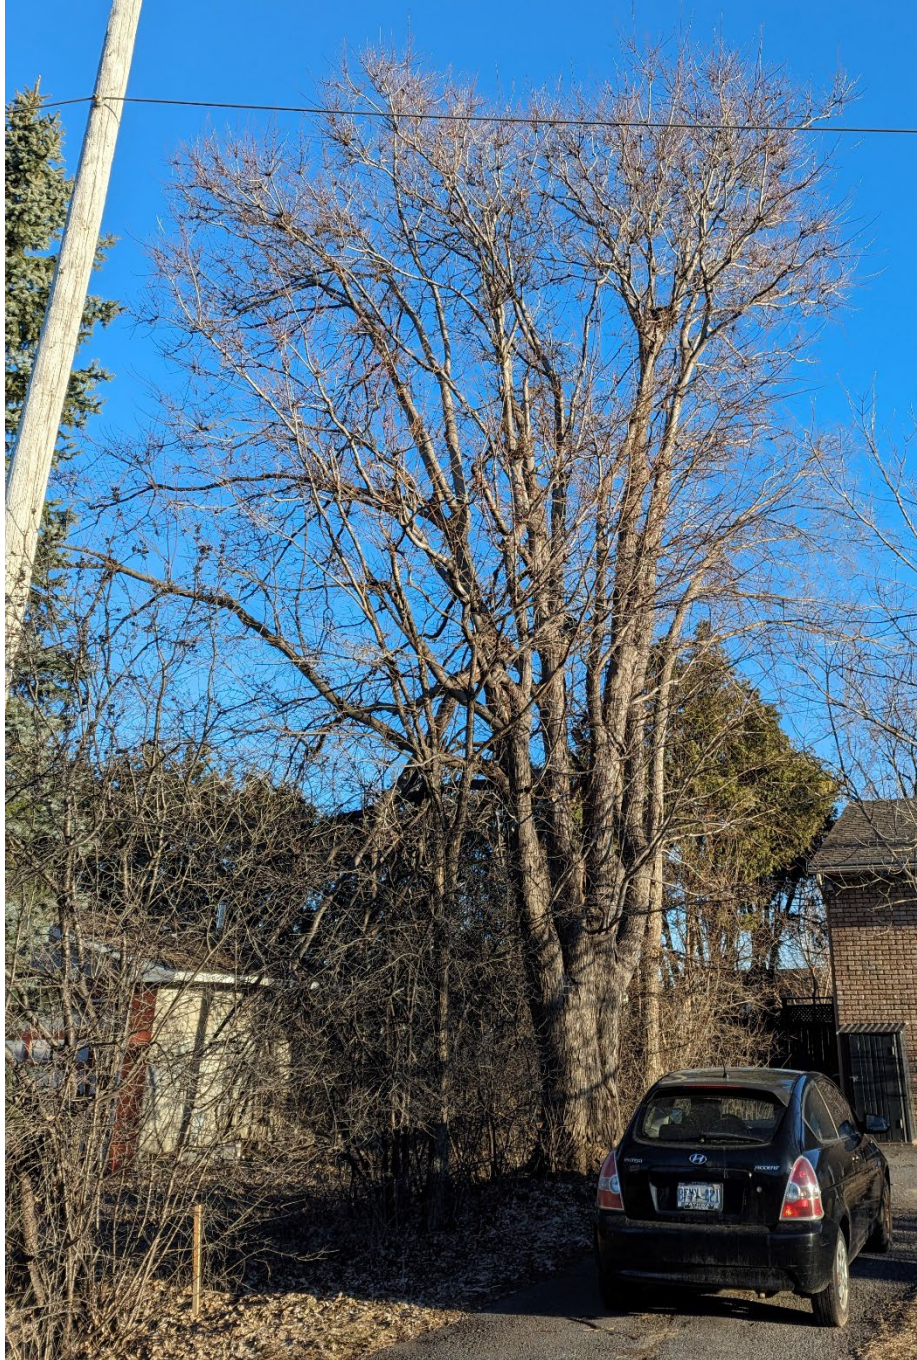
**Tree 4** is a large adjacent Freeman maple nearing the pinnacle of its expected growth. Some branches have broken (likely due to ice or wind) and it is recommended these be removed prior to site works for safety reasons. After consultation with the client, the northern parking spaces have been moved further north to avoid cutting directly across the trunk of the tree – by removing only a corner portion from the CRZ, the concerns around loss of stability are lessened. To avoid excessive root loss, excavation for the parking spaces is not to exceed a depth of 15cm. It is recommended that topsoil be removed and roots revealed using compressed air, so that roots are not torn or damaged by machinery and precision removal can occur.

*Tree 4 - adjacent maple to be retained (view from the west on Eugene street).*

Covering the parking spaces with permeable surface could lead to greater water availability and faster recovery of the root system after construction.

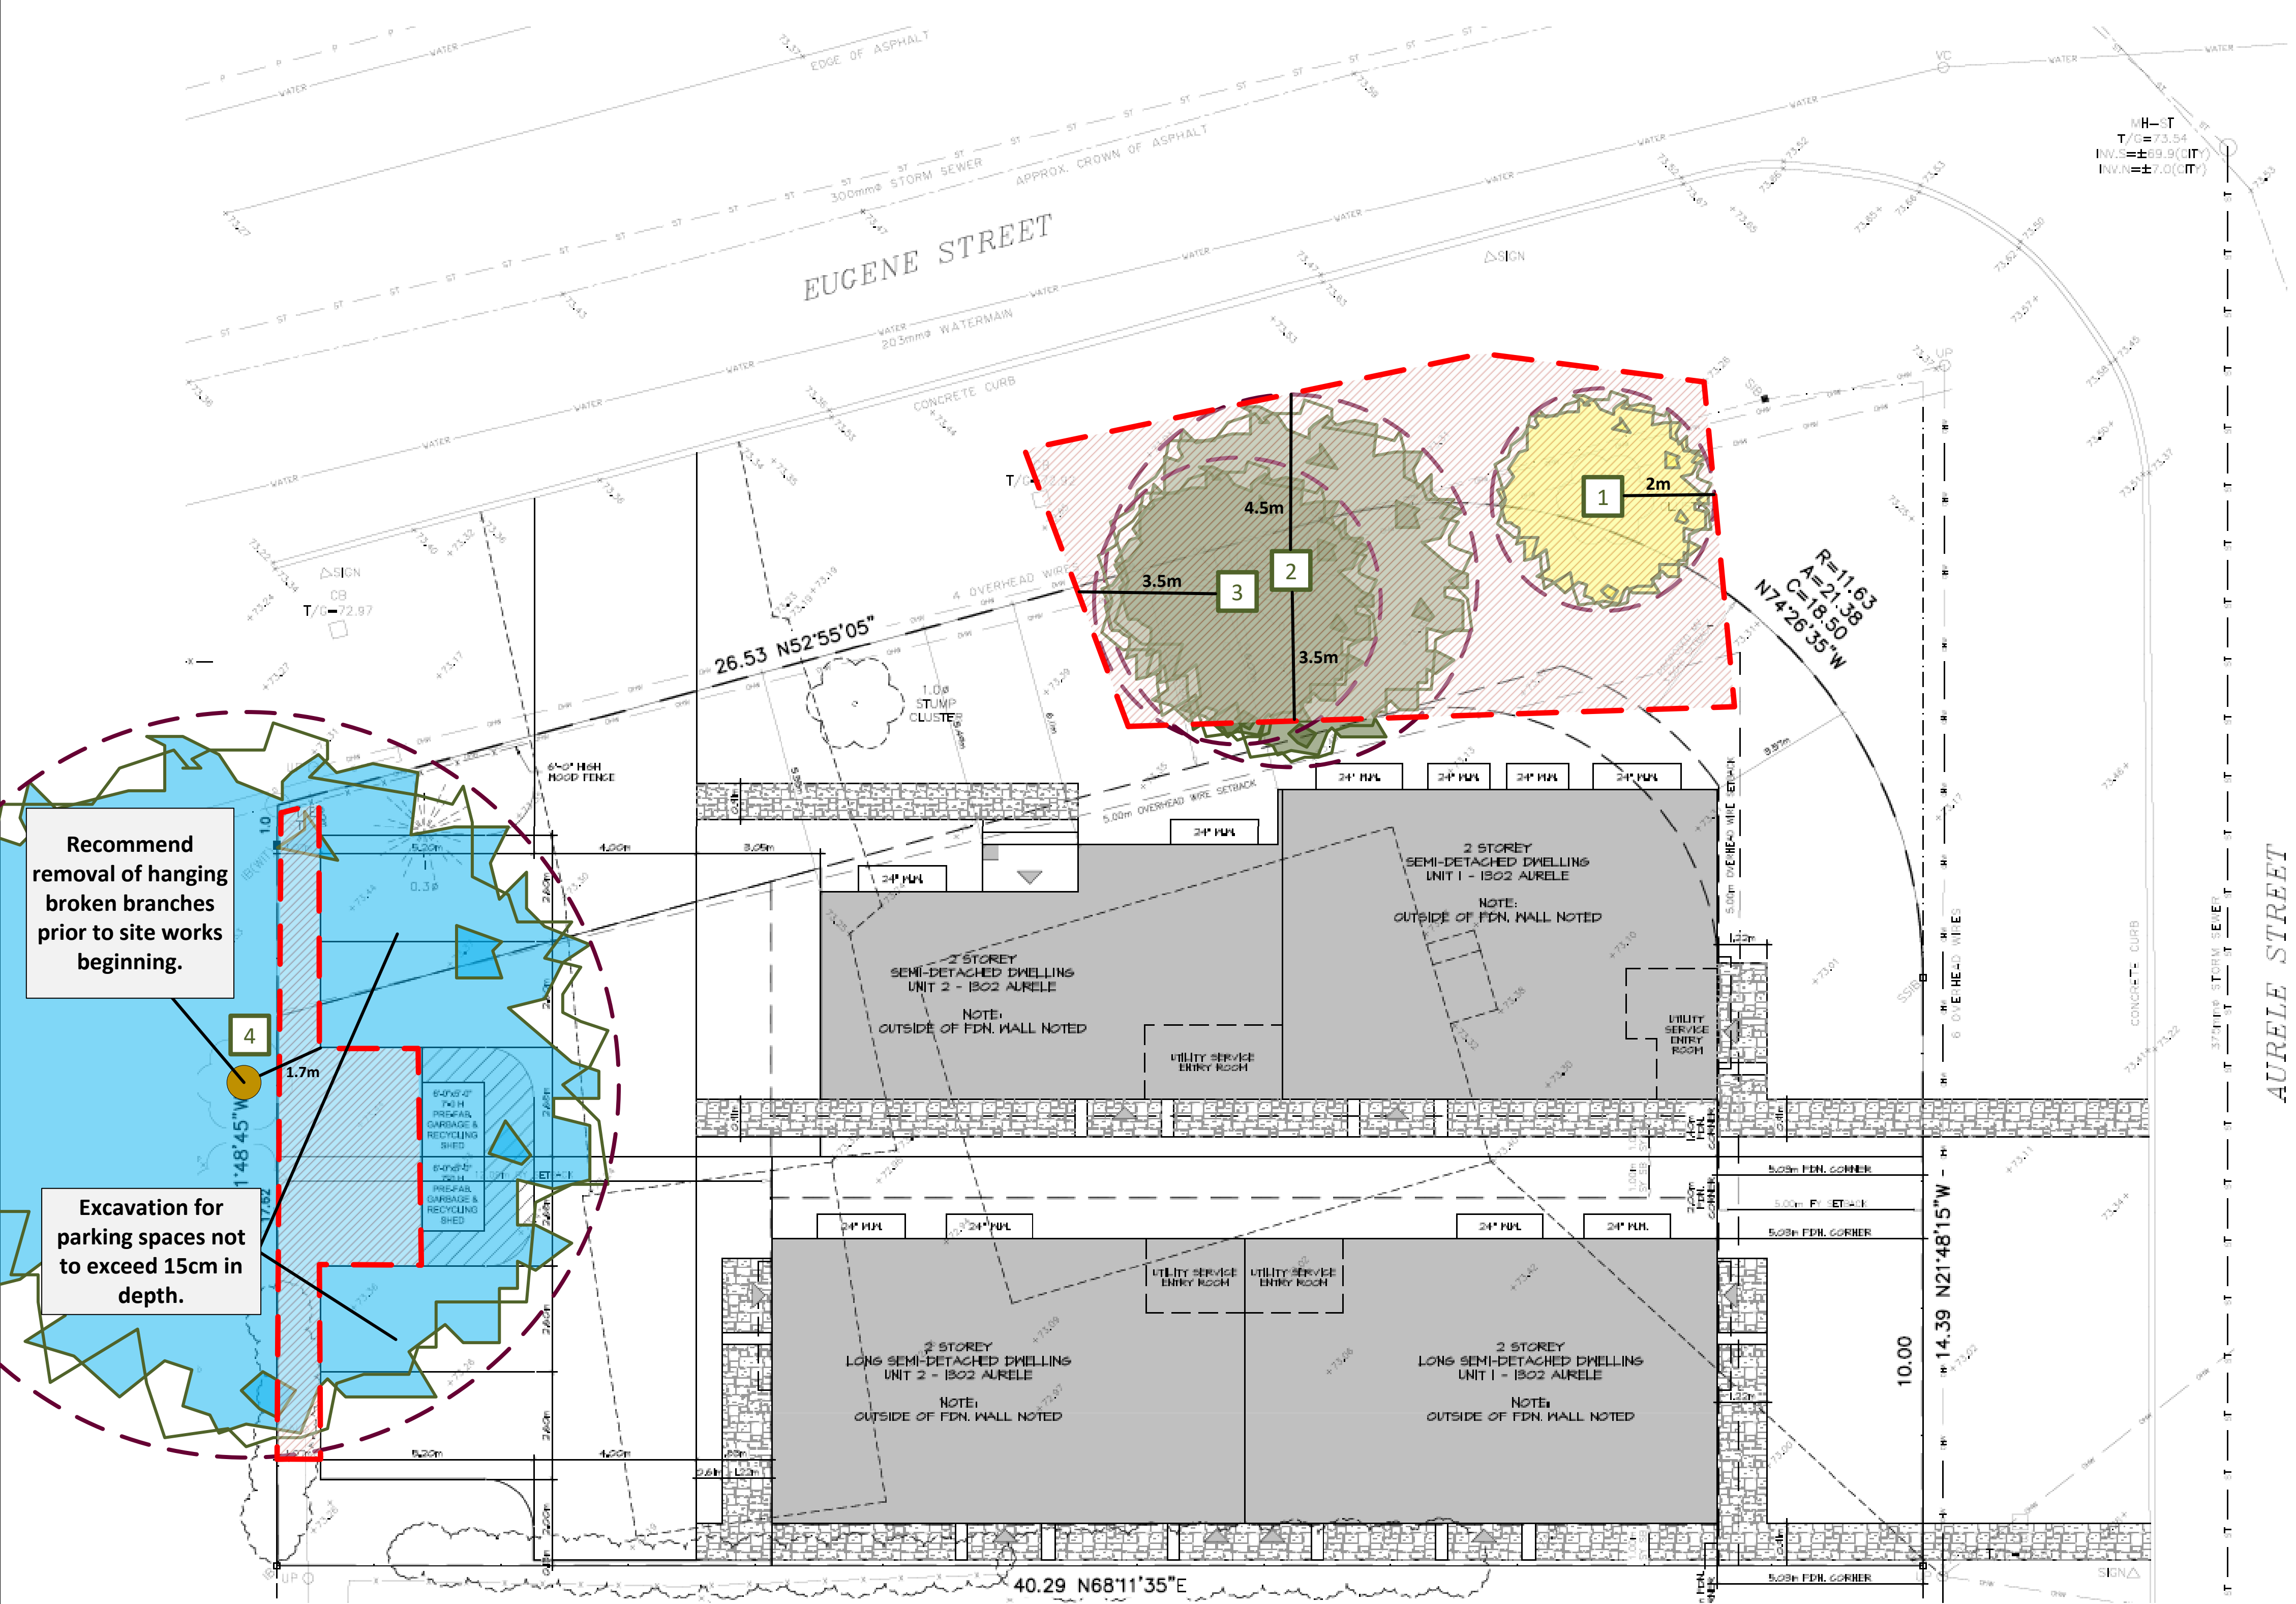
TIR Map – 1302 Aurele Street  
 Tree layer prepared by  
 Dendron Forestry Services  
 Version 2.0, April 29, 2024  
 For more information, please contact: info@dendronforestry.ca

The three protected trees along Eugene avenue are expected to be minimally impacted by construction. They are to be protected with fencing as described below and shown in the map.

**Prior to any site works**, protective fencing should be installed around the Tree Protection Area as indicated in the attached Tree Information Map and maintained until all construction on site has been completed as per the City of Ottawa Tree Protection Specifications (March 2021).
