Tree Information Report

Submitted as part of Committee of Adjustment Application to the City of Ottawa

Address: 9 Mayo
Date: June 8, 2022
Prepared by: Astrid Nielsen, RPF, ISA Certified Arborist ®
131 Smirle Ave, Ottawa, K1Y 0S4
Astrid.nielsen@dendronforestry.ca
Prepared for: Kim Scapillati, marcokim555@gmail.com
Site Visit: June 6, 2022

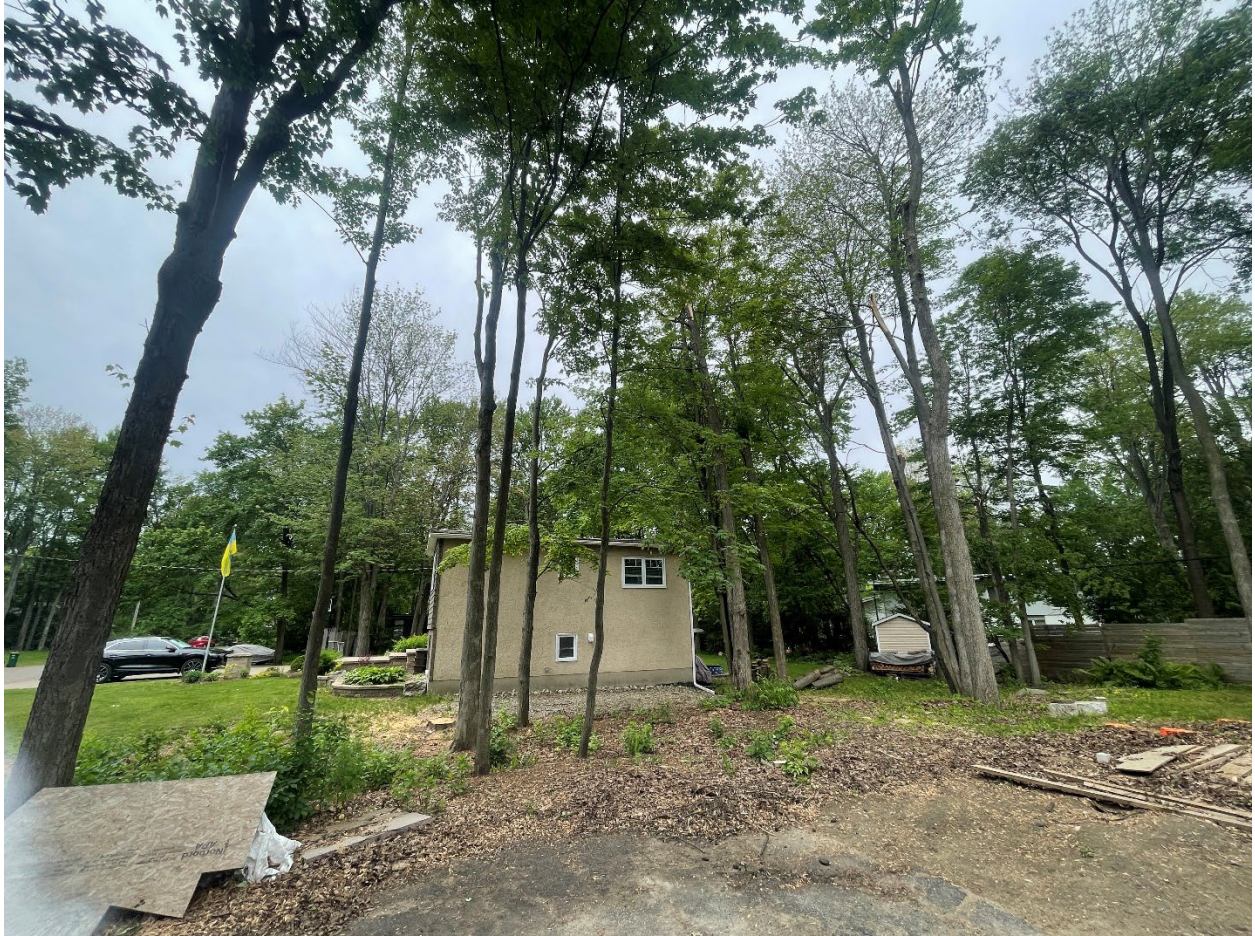
Figure 1: Picture showing area of asphalt where the new addition will be going, and the trees in the background. Picture taken from the centre of the property facing west

Prior to any site works, tree protection should be discussed with the contractors completing the work. Construction activity should be restricted to the area covered by asphalt only, and any soft surface should be avoided, especially for access. Within the soft surface area, the following guidelines should be applied:

- Do not change the grade
- Do not store construction material
- Do not operate machinery
- Do not convert to hard surface or change the landscaping
- Do not excavate unless it is a method that has been pre-approved by the City
- Do not place signs, notices or posters to any tree
- Do not damage the root system, trunk, or branches of any tree
- Direct the exhaust away from the tree
