Subject: Application to demolish 227-229, 231-233 and 235-237 St. Patrick Street, properties designated under Part V of the *Ontario Heritage Act*

File Number: ACS2024-PDB-RHU-0069

Report to Built Heritage Committee on 10 September 2024

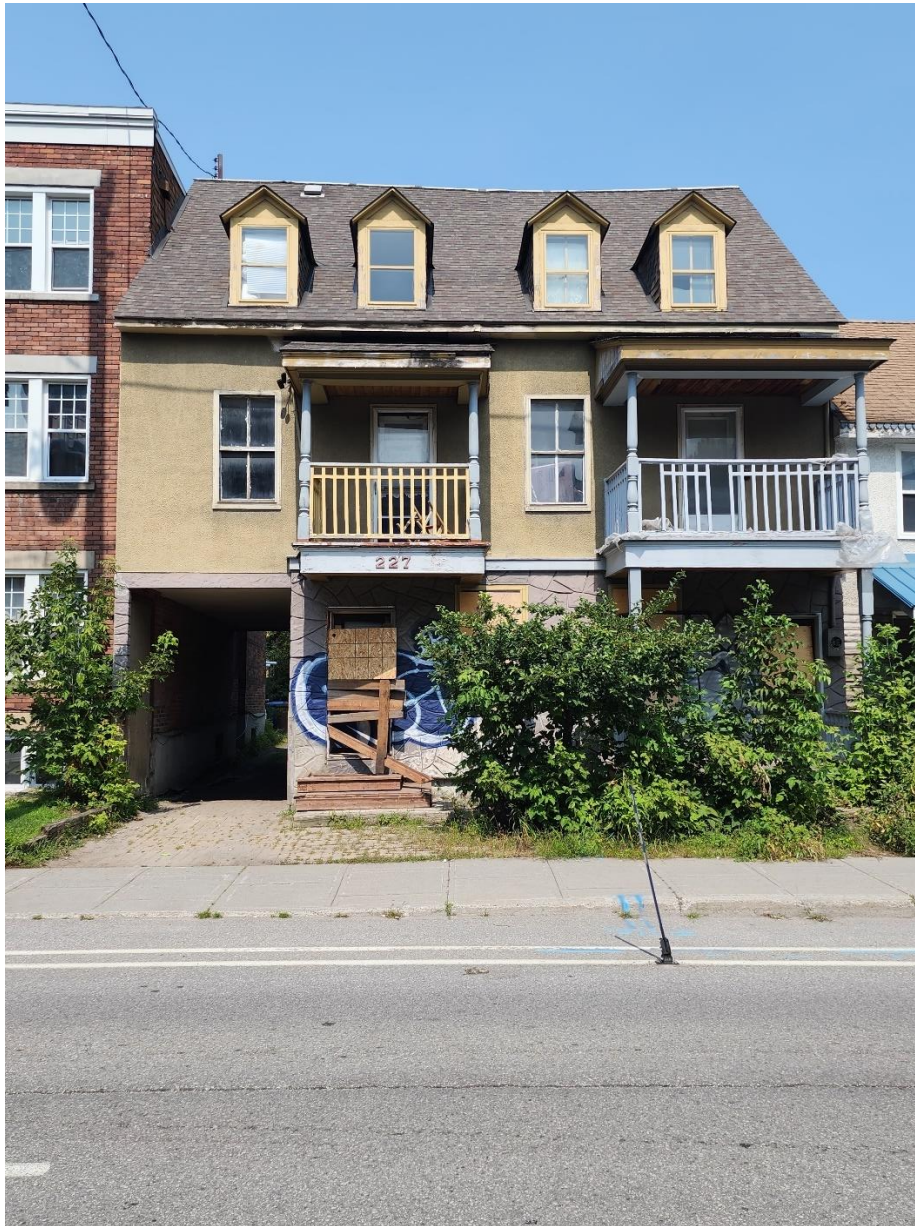
227-229 St. Patrick Street (south façade), City of Ottawa August 2024

- The overall condition of the building is poor
- A majority of the exterior wall structure is not repairable and requires removal or replacement
- Stone foundation is in poor condition that the best repair possible would be a completed dismantling and rebuild of the wall
- Sloping of the upper floors likely a result of the previous attempts at replacing significantly deteriorated ground floor supporting members... and would also need significant remediation to be rectified
- Buckling of exterior walls indicate early onset structural collapse

“We are concerned that the advanced state of deterioration, significant damage to the interior linings, and the evidence of buckling of the exterior walls are all indications of early onset structural collapse. This structure is now past saving, and in fact may pose a danger to the unsuspecting public if permitted to weather another winter season. Note that the nature and extent of damage gives less concerns to lateral events (wind, seismic) than to winter loadings (ice, snow), however the need for immediate shoring cannot be ruled out if planning for immediate interventions proves impossible.

We recommend the structure be demolished without delay.”

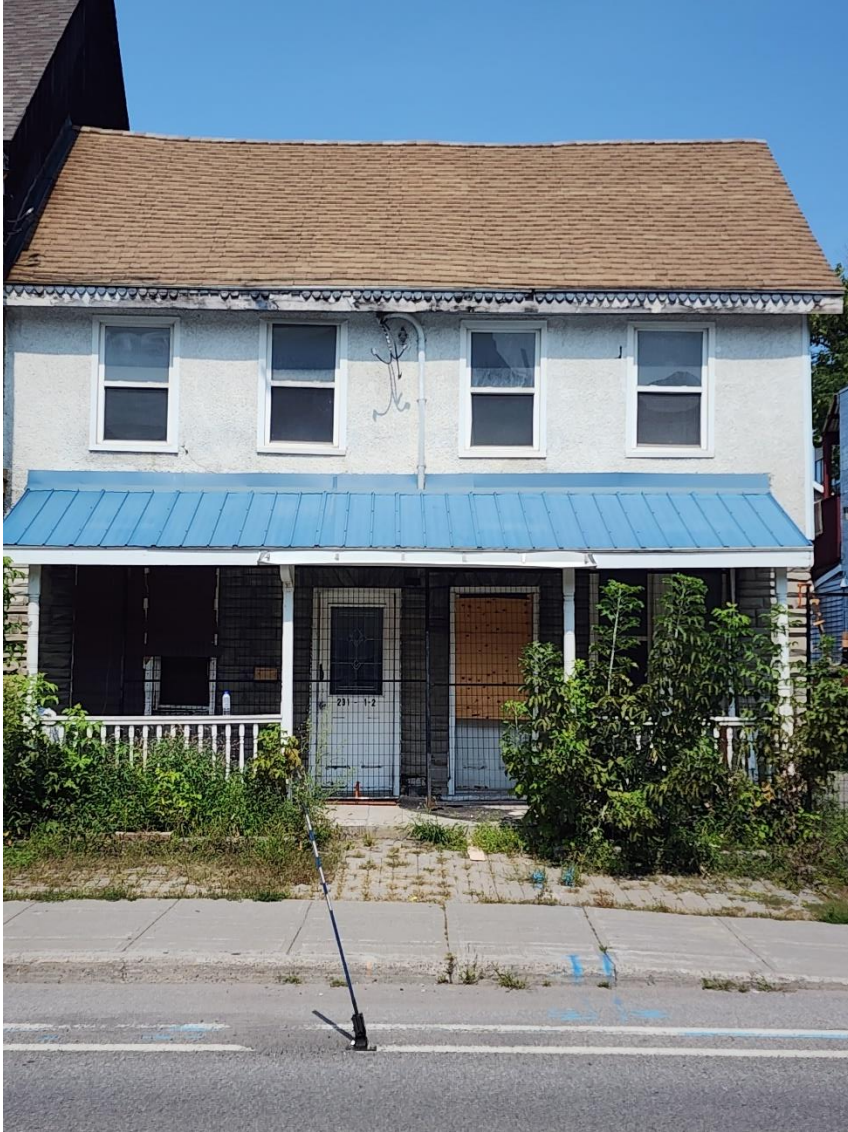
229-231 St. Patrick Street (south façade), City of Ottawa, August 2024

- The overall condition of the structure is poor
- The south wall stucco and water damage sustained by the faux-stone concrete likely indicate that the front façade cannot be salvaged
- The foundation is poor, bricks are missing and the concrete appears to be decaying
- The ground floor framing is in poor condition, with many members in a state of decay with water damage present

“The building requires immediate intervention to prevent further deterioration and loss. The current extent of rot may, if further exploration reveals a more limited total infection, be treatable. The structure does not currently appear to be at risk of collapse and may be a candidate for rehabilitation if plans and detailed execution of extensive interventions are made without delay. Unfortunately, the past changes to the structure make restoration likely impossible, and the current condition precludes preservation. It is our recommendation that, owing to the changes to the fabric and materials of the structure, and given the deterioration is extensive, as well as the difficulty in preserving the structure with adjacent demolition works to take place, demolition be approved.”

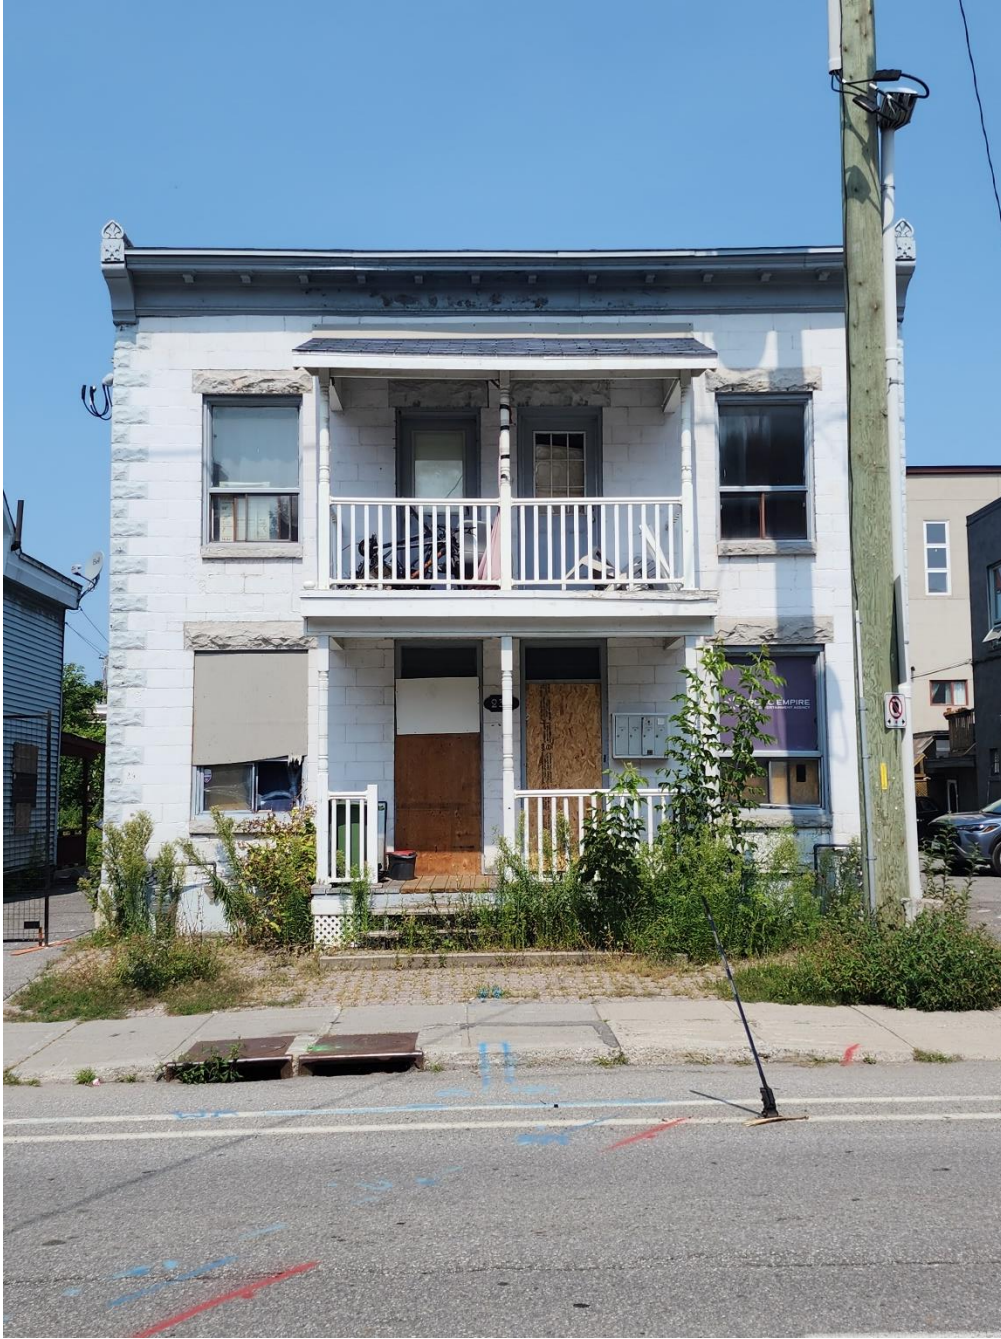
235-237 St. Patrick Street (south façade), City of Ottawa, August 2024

- The building is in very poor condition
- Peeling and bulging of the cladding on the east and west façades, and detachment, cracking and weathering of the cladding was noted on the south façade
- Advanced decay of the plank-on-edge structure was noted along with what appears to be dry rot
- The foundation wall of the structure is also believed to be in poor condition

“Considering the state of critical structural elements within the subject property, and more specifically the significant and advancing state of the plank-on-edge primary structure, preservation of the structure is not possible. Restoration of the building would be prohibitively difficult, with the sourcing of necessary timbers and other period materials being challenging at best. Rehabilitation of the structure is likely possible, however, it is our professional opinion that significant and necessary maintenance has been neglected in this structure. The rehabilitation of the property

Significant structural work is required to the ground floor framing, foundation, exterior wall, in addition to extensive cladding repairs. Front façade requires re-anchoring to the primary structure, and it is not clear if this element is entirely stable; in the event of a design level lateral load event, the façade could come away from what is clearly and evidently a rotting backing structure and pose a hazard to occupants or the unsuspecting public. This is a structure in a condition which may be explained as the ‘do nothing’ approach to maintenance, upkeep, occupancy, and use has been adopted continually for an extended period of time. Immediate planning for intervention, be it rehabilitation, selective demolition, or stabilization is urgently required and strongly recommended.”

The report for 235-237 St. Patrick Street suggests that elements of the front façade could be salvaged for reincorporation into a new development on the site. Staff encourage the owner to consider this option as part of the demolition process but do not recommend that Council require it through a condition of approval.

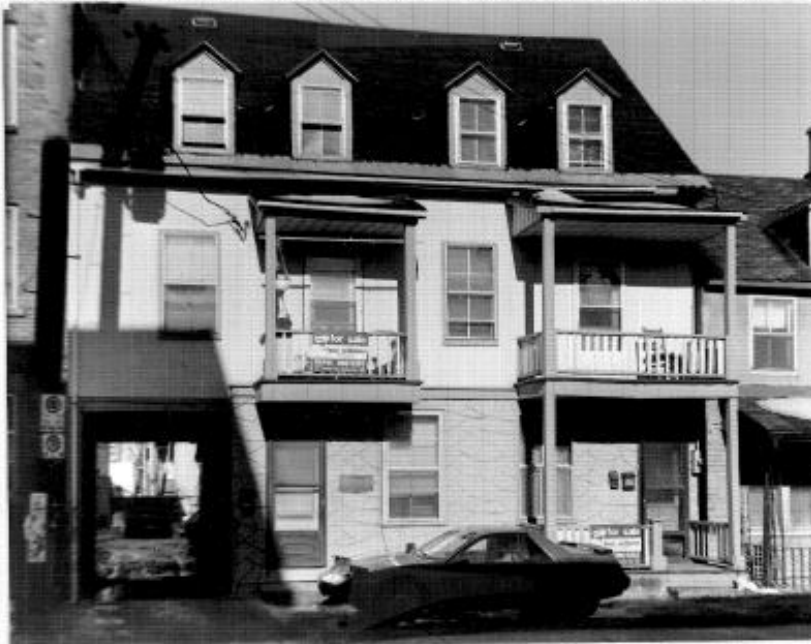
PHOTO DATE: Jan 1990
VIEW:
SOURCE: H Schade
NEGATIVE NUMBER: 86A-7

Architectural Design (Plan, Storeys, Roof, Windows, Materials, Details, Etc.): 2 1/2 storey double residence. Traditional side gable form with carriageway. Imitation stone and stucco siding, reworked wood porches, simple wood trim, asphalt shingle roof with dormers. Office use on side side.

Architectural Integrity (Alterations): Basic form intact. Changes to materials and detailing by 1901 - two 2 storey additions to E half, small one storey addition to W half

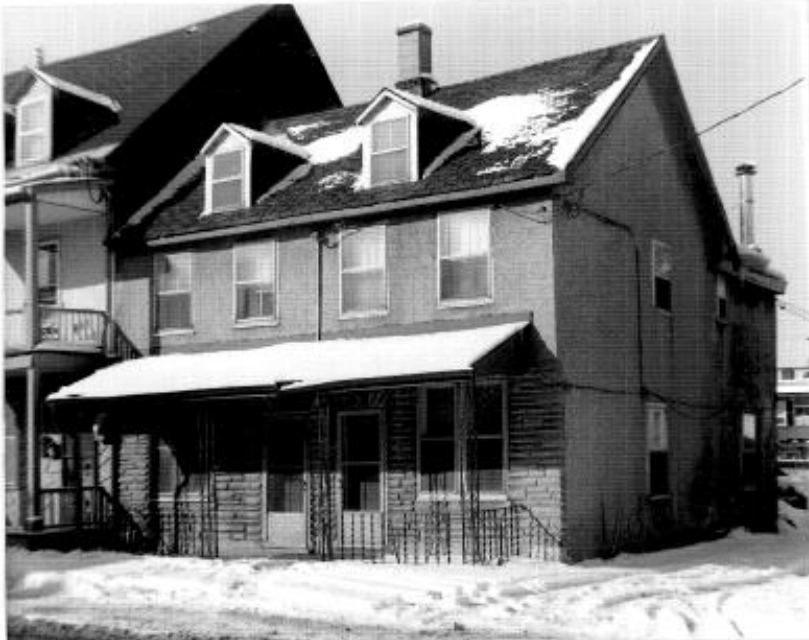
PHOTO DATE: Jan 1990
VIEW:
SOURCE: H Schade
NEGATIVE NUMBER: 86A-8

Architectural Design (Plan, Storeys, Roof, Windows, Materials, Details, Etc.): 2 1/2 storey double residence. Traditional side gable form. Imitation stone and stucco siding, recent wrought iron porch, reworked windows and doors, asphalt shingle roof with dormers.

Architectural Integrity (Alterations): Basic form intact. Changes to materials and detailing

by 1901 - 2 storey addition extended to join stone shed, small one storey addition of E half also

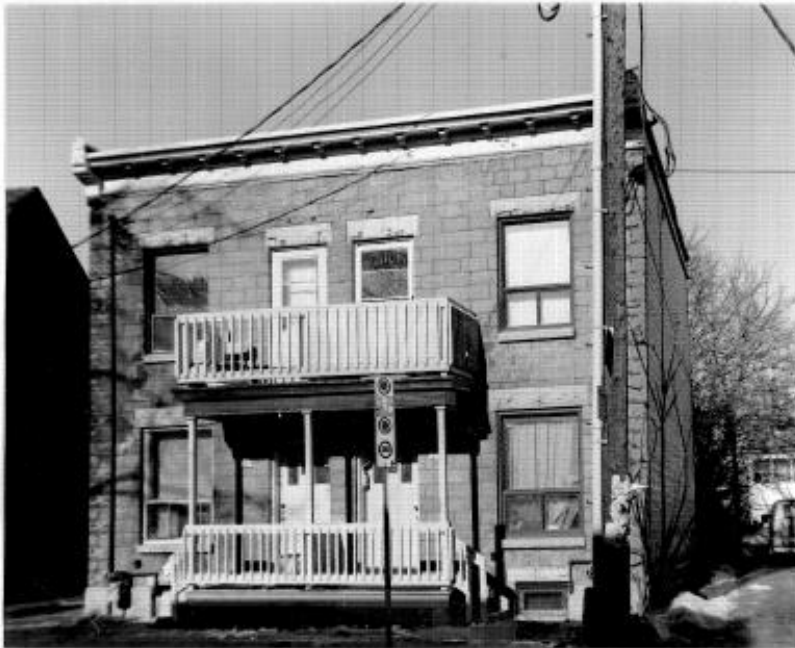
PHOTO DATE: Jan 1990
VIEW:
SOURCE: H Schade
NEGATIVE NUMBER: 86A-9

Architectural Design (Plan, Storeys, Roof, Windows, Materials, Details, Etc.): 2 storey flat roofed double residence. Decorative precast block facade, reworked wood porch, substantial decorative wood cornice. Replacement windows and doors. Pressed metal cladding on sidewalls.
