Tree Conservation Report Addendum

Submitted as part of Site Plan Control Application

Address: 415 Hunt Club
Date of Report: August 26, 2024
Date of Site Visit: August 15 and A`, 2024
Prepared by: Astrid Nielsen, RPF, ISA Certified Arborist ®
Client: Costco Headquarters
Contact: Jasmine Paoloni, P-Squared Concepts, planning@p2concepts.ca

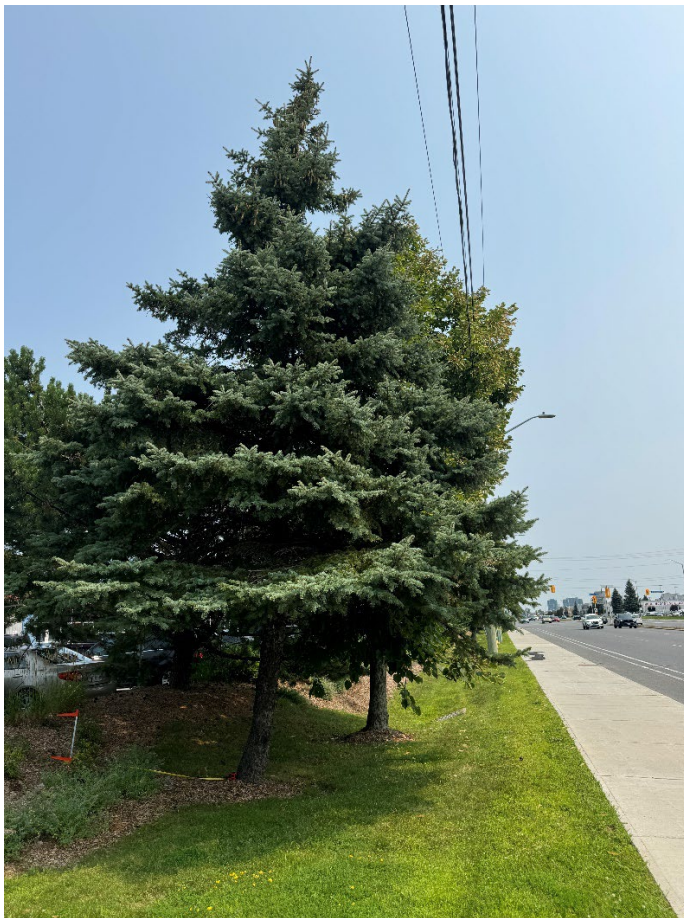
metre from trunk; conflict with new building and hydro lines
17	Basswood (<i>Tilia americana</i>)	28 cm	City	Fair; leaves skeletonized, possibly by Japanese beetle	Remove: excavation for foundation to occur less than a metre from trunk; conflict with new building and hydro lines
27	Basswood (<i>Tilia americana</i>)	33 cm	City	Good/fair; lean	Remove: excavation for foundation to occur less than a metre from trunk; conflict with new building and hydro lines
28	Basswood (<i>Tilia americana</i>)	34 cm	City	Good	Remove: excavation for foundation to occur less than a metre from trunk; conflict with new building and hydro lines
29	Basswood (<i>Tilia americana</i>)	30 cm	City	Good	Remove: excavation for foundation to occur less than a metre from trunk; conflict with new building and hydro lines

Figure 1: Trees 16 and 17, city-owned Colorado spruce and basswood

The proposed building will include a foundation that will require an excavation setback of 1.5 m from the foundation (as determined by the geotechnical engineers). The excavation would extend to within approximately 0.5 to 1.0 m from the city trees along Hunt Club (16, 17, 27, 28 and 29) and will cause significant root loss, possibly causing structural instability in some of the trees.

More importantly, however, is the conflict that the new building will have with the tree crowns, especially as they grow larger. All these trees are considered large-growing trees and can grow to double their current diameter, and more in crown area. Their crowns are currently restricted along Hunt Club as they were planted too close to the hydro lines and they will likely soon be pruned (possibly topped) by hydro crews as they expand in this direction. The building will be set back 2-2.5 m from the trees on the south side, leaving little space for their crowns. They would grow against the new building and require regular maintenance pruning. Furthermore, if scaffolding is required for the building construction, up to ½ of the crowns of the closer trees may require removal. Based on this limited spacing, retention of these trees is not recommended.
