**RE: TREE INFORMATION REPORT (LONG) FOR 49 ROTHWELL DRIVE, OTTAWA**

This report details pre-construction tree information for the above noted property in Ottawa. The need for this report is related to trees protected under the Urban Tree Conservation By-law 2020-340. The work proposed for the subject property consists of the construction of a new single-family dwelling. Presently the property is in a naturally forested state with no dwelling or infrastructure present.

DRAWING: Tree Information Plan

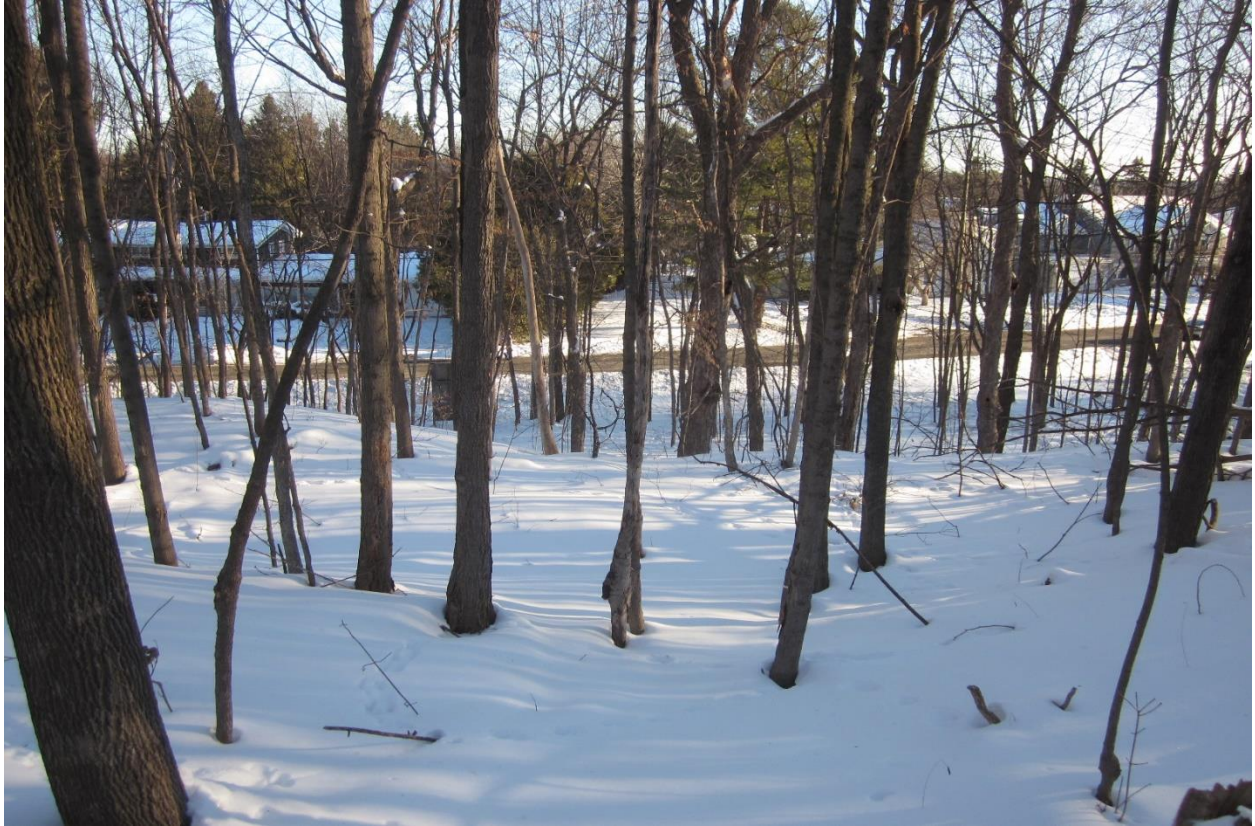
Pictures 1 and 2 on page 8 of this report show the typical forest conditions now present on the subject property.

Picture 1. Typical forest conditions now present at 51 Rothwell Drive (facing northward)

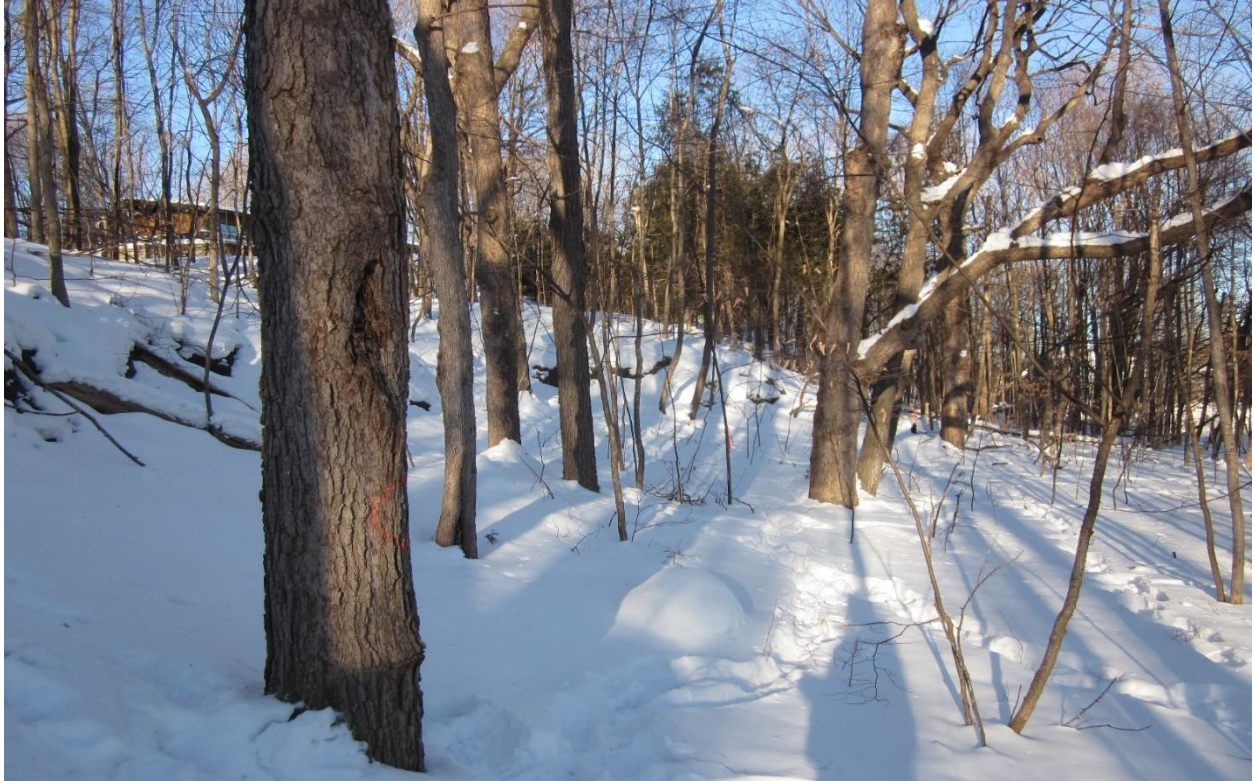
Picture 2. Typical forest conditions now present at 51 Rothwell Drive (facing southwestward)
