URBAN FORESTRY & FOREST MANAGEMENT CONSULTING

RE: REVISED TREE INFORMATION REPORT (FULL) FOR 160 SUNNYSIDE AVENUE, OTTAWA

Tree Information Plan
160 SUNNYSIDE
CITY OF OTTAWA

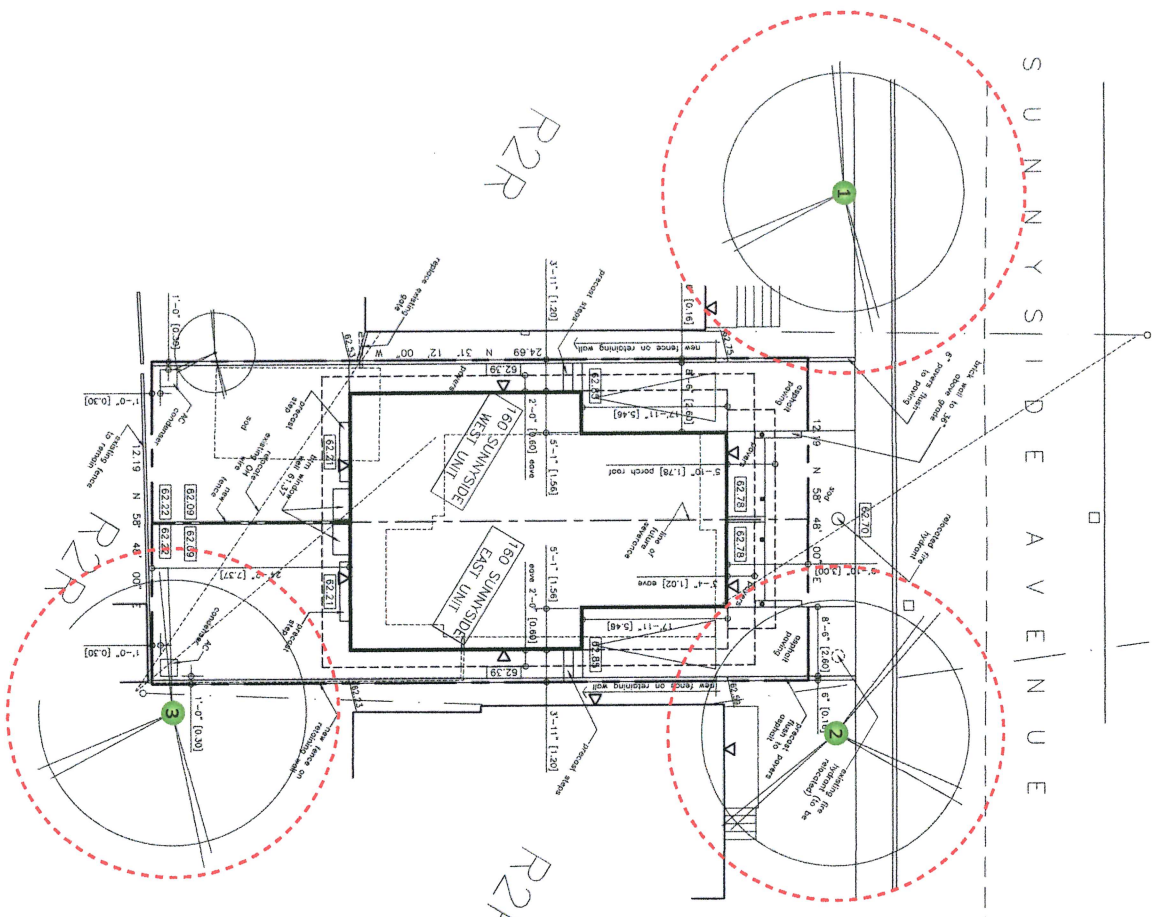
Table 1 below details the species, ownership, size (diameter), condition and removal status of the trees adjacent to the subject property. The tree information plan included on page 3 of this report shows the trees in relation to proposed construction.

As noted on the plan on page 3, the existing fire hydrant is to be relocated from within the CRZ of the maple on City property (tree #2). In order to help mitigate root loss, the following measures will be taken:

1. Hydro excavation of the area around the hydrant to carefully expose roots. Exposed roots will then be cleanly cut and sealed before being reburied. Excavation can then resume using traditional mechanical means. Sealing the cleanly cut root ends with a beeswax product will help prevent the loss of moisture and facilitate healing.
2. If the excavation is to be left open for any time a covering of at least three layers of moistened burlap is to be draped over the exposed face of excavation closest to the tree. This will help reduce the loss of moisture from cut root ends and the surrounding soil.

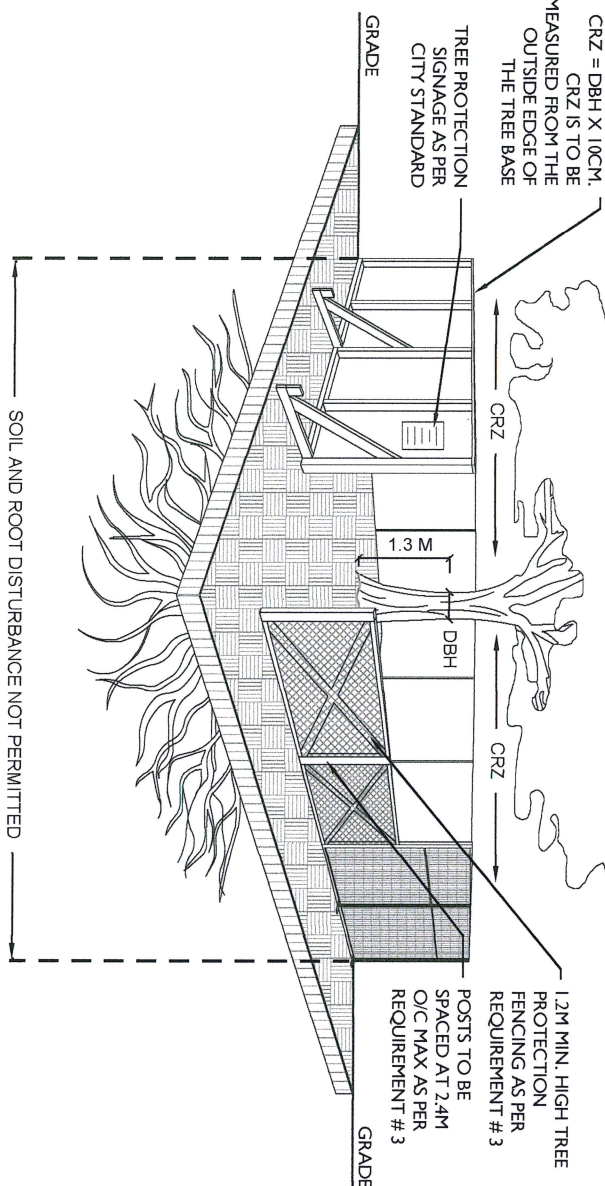
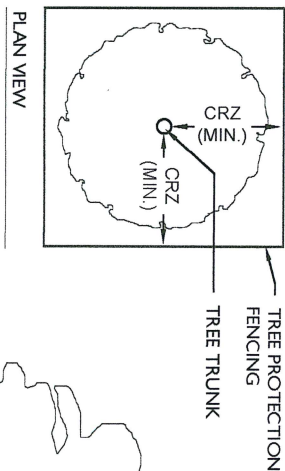
TREE PROTECTION SPECIFICATION

- TREE PROTECTION REQUIREMENTS:**
1. PRIOR TO ANY WORK ACTIVITY WITHIN THE CRITICAL ROOT ZONE (CRZ = 10 X DIAMETER) OF A TREE, TREE PROTECTION FENCING MUST BE INSTALLED SURROUNDING THE CRITICAL ROOT ZONE, AND REMAIN IN PLACE UNTIL THE WORK IS COMPLETE.

- DO NOT EXTEND HARD SURFACE OR SIGNIFICANTLY CHANGE LANDSCAPING
 3. TREE PROTECTION FENCING MUST BE AT LEAST 1.2M IN HEIGHT, AND CONSTRUCTED OF RIGID OR FRAMED MATERIALS (E.G. MODULOC - STEEL, PLYWOOD HOARDING, OR SNOW FENCE ON A 2"x4" WOOD FRAME) WITH POSTS 2.4M APART, SUCH THAT THE FENCE LOCATION CANNOT BE ALTERED. ALL SUPPORTS AND BRACING MUST BE PLACED OUTSIDE OF THE CRZ, AND INSTALLATION MUST MINIMISE DAMAGE TO EXISTING ROOTS. (SEE DETAIL)

TO BE IMPLEMENTED FOR RETAINED TREES, BOTH ON SITE AND ON ADJACENT SITES, PRIOR TO ANY TREE REMOVAL OR SITE WORKS AND MAINTAINED FOR THE DURATION OF WORK ACTIVITIES ON SITE.

1. Erect a fence as close as possible to the critical root zone (CRZ) of trees (City of Ottawa tree protection barrier detail included on page 6).
2. Do not place any material or equipment within the CRZ of the tree.
3. Do not attach any signs, notices or posters to any tree.
4. Do not raise or lower the existing grade within the CRZ without approval.
5. Tunnel or bore when digging within the CRZ of a tree.
6. Do not damage the root system, trunk or branches of any tree.
7. Ensure that exhaust fumes from all equipment are NOT directed towards any tree's crown.

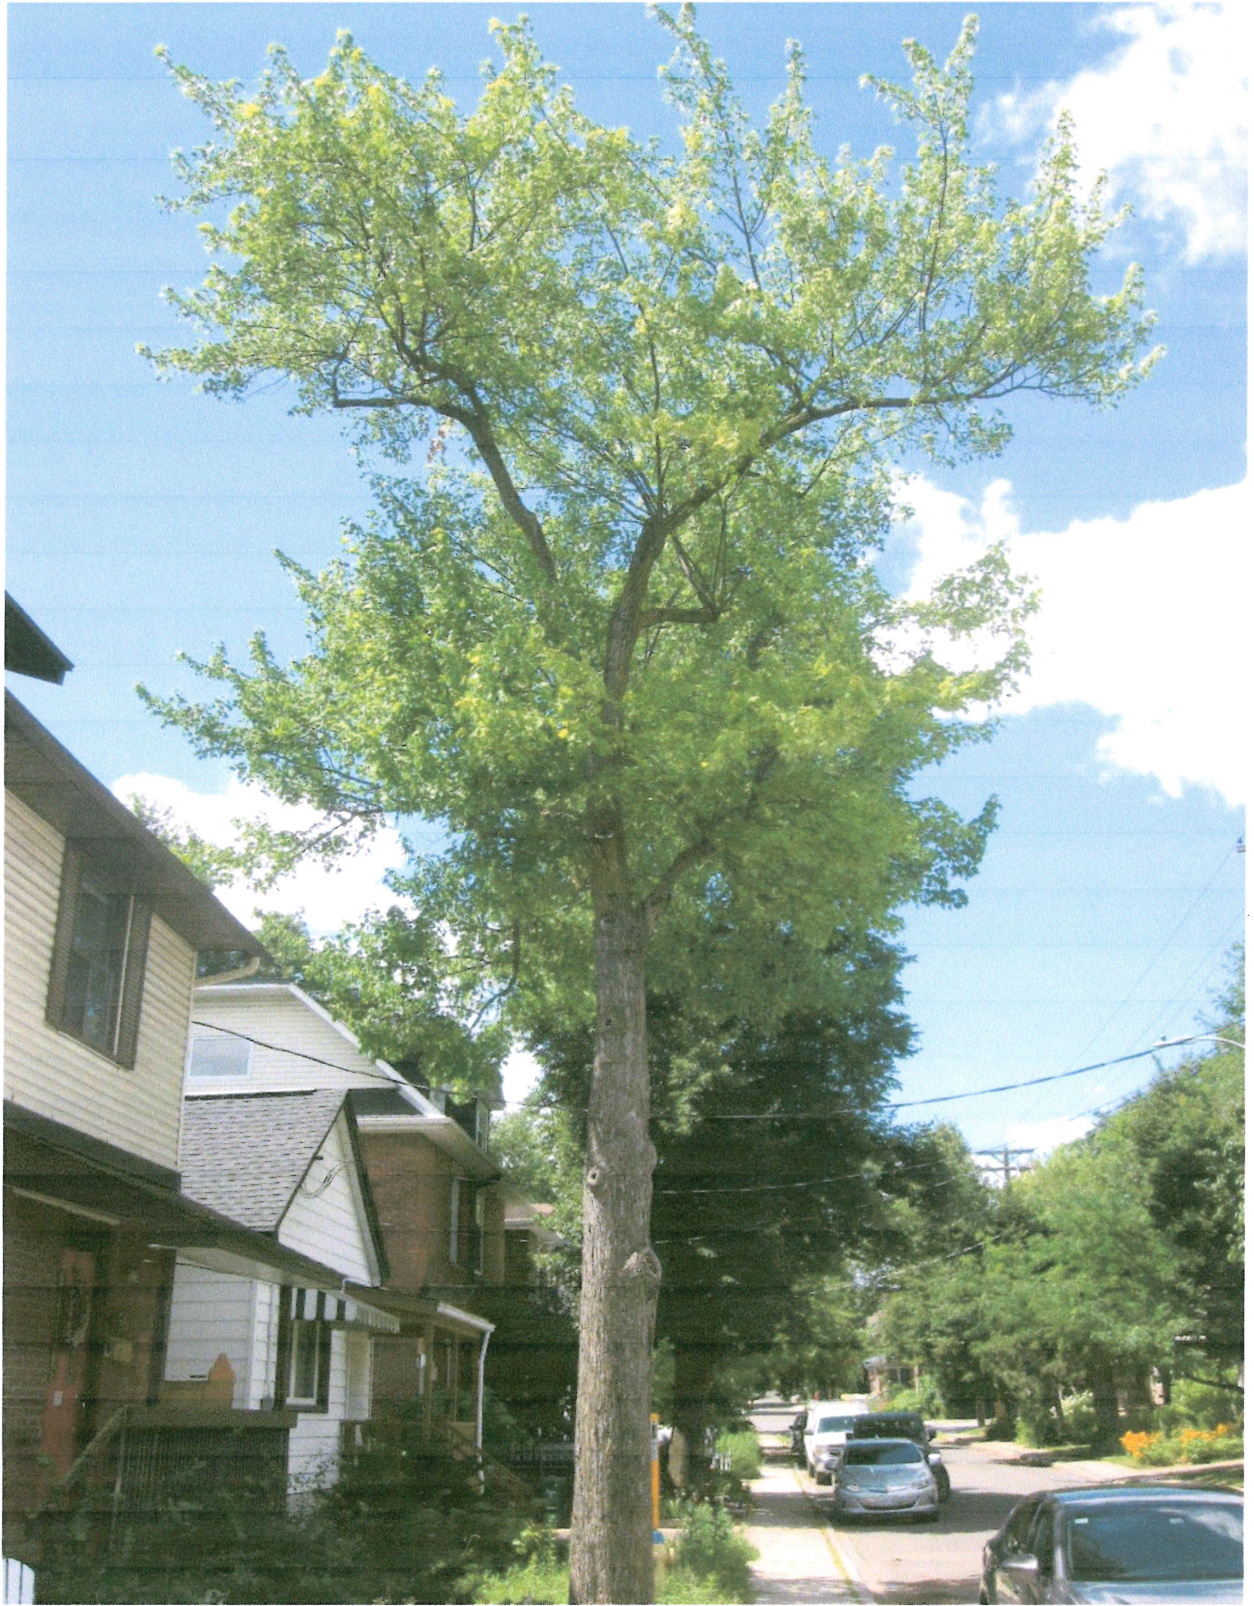
Picture 1. Tree #2, city owned red maple in front of 156 Sunnyside Avenue (note location of existing hydrant just behind tree).

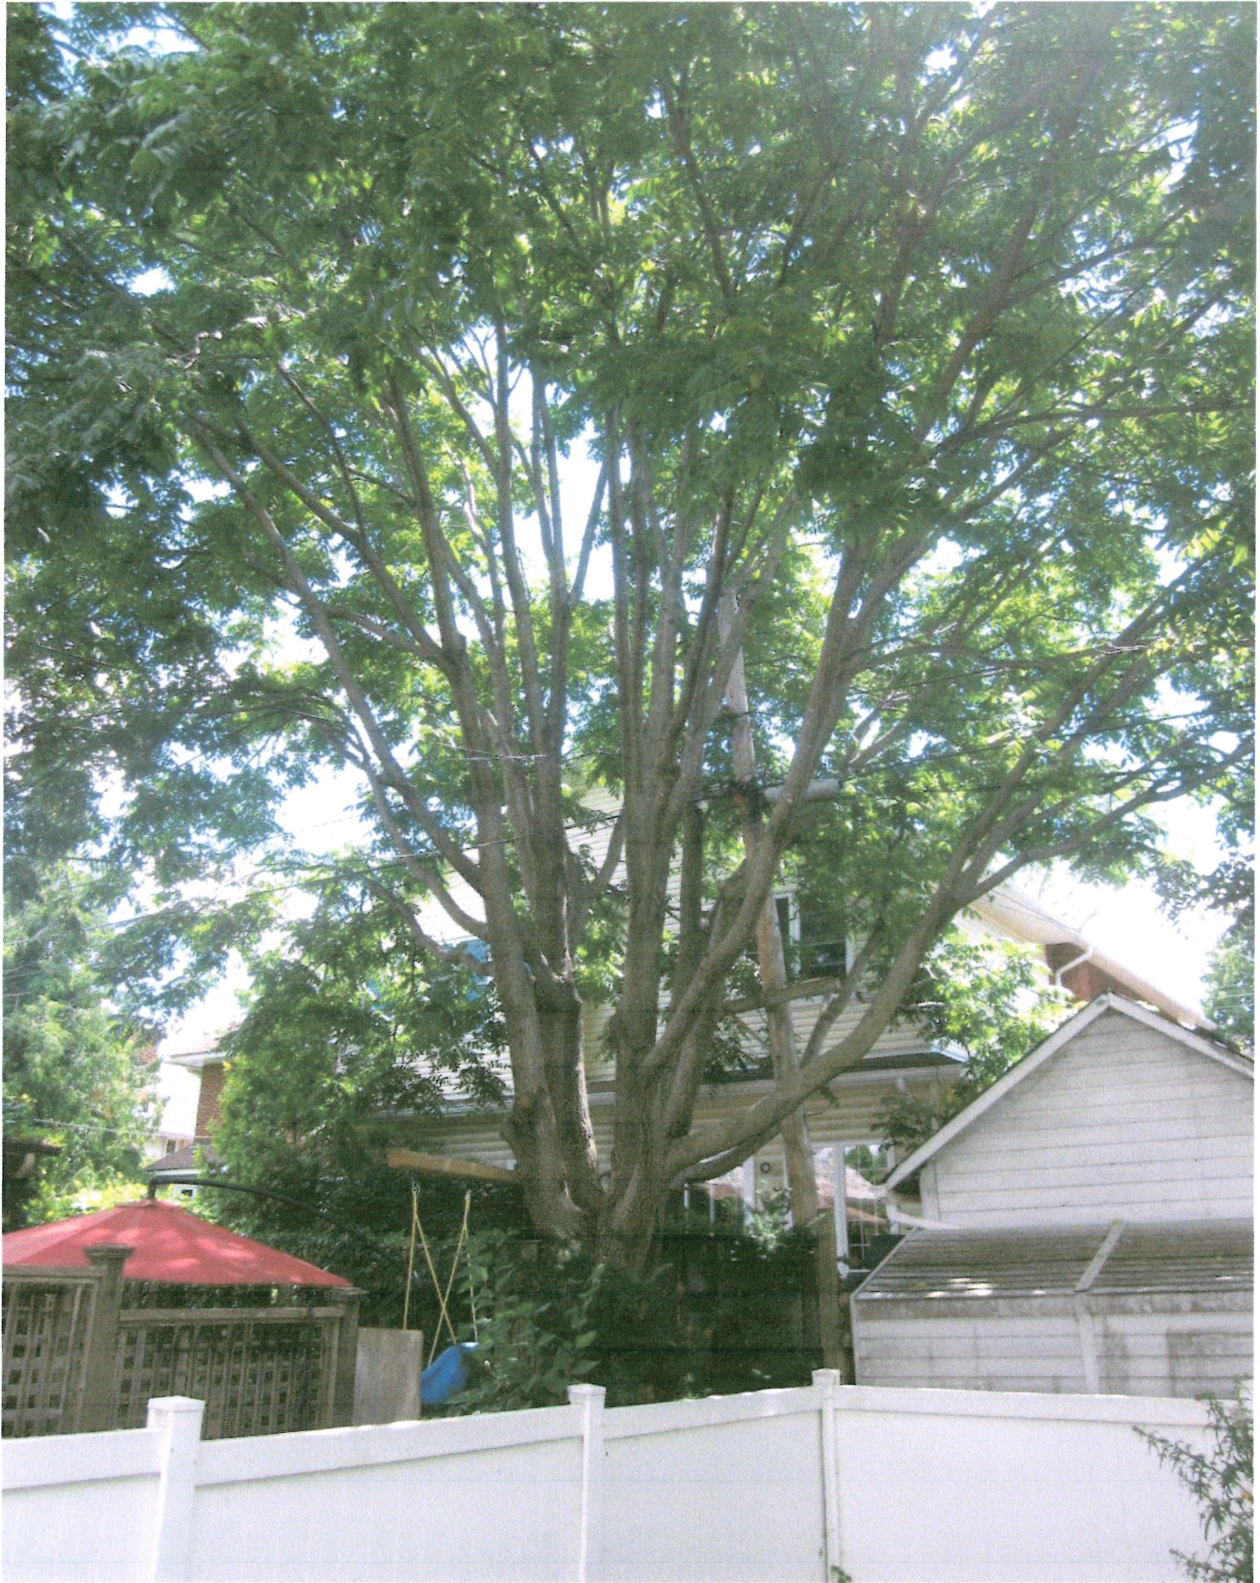
Picture 2. Tree #3, privately owned butternut in back yard of 156 Sunnyside Avenue
