**HYDROGEOLOGICAL AND TERRAIN  
STUDY  
PROPOSED RESIDENTIAL LOT SEVERANCES  
3970 STONECREST ROAD  
WEST CARLETON - MARCH WARD  
CITY OF OTTAWA, ONTARIO**

DATE September 24, 2023 (revision 1)

RE: HYDROGEOLOGICAL AND TERRAIN STUDY  
PROPOSED RESIDENTIAL LOT SEVERANCES  
3970 STONECREST ROAD  
WEST CARLETON - MARCH WARD  
CITY OF OTTAWA, ONTARIO

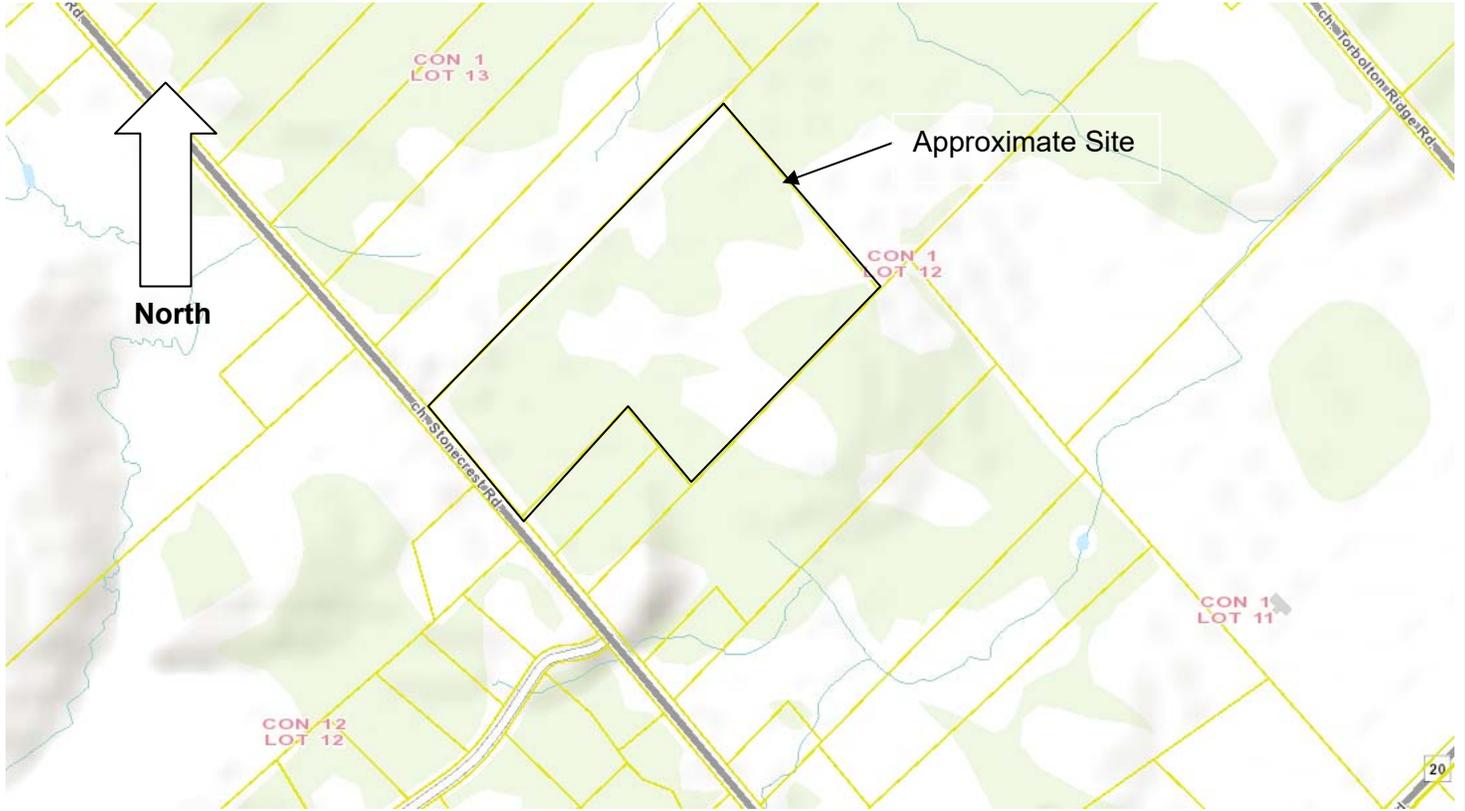
**FIGURE 1**

**KEY PLAN**

Kollaard Associates Inc. was retained by Mr. Hugh Thayer to undertake a hydrogeological and terrain study for proposed residential lot severances with frontage on Stonecrest Road in Woodlawn, Ontario (Key Plan, Figure 1).

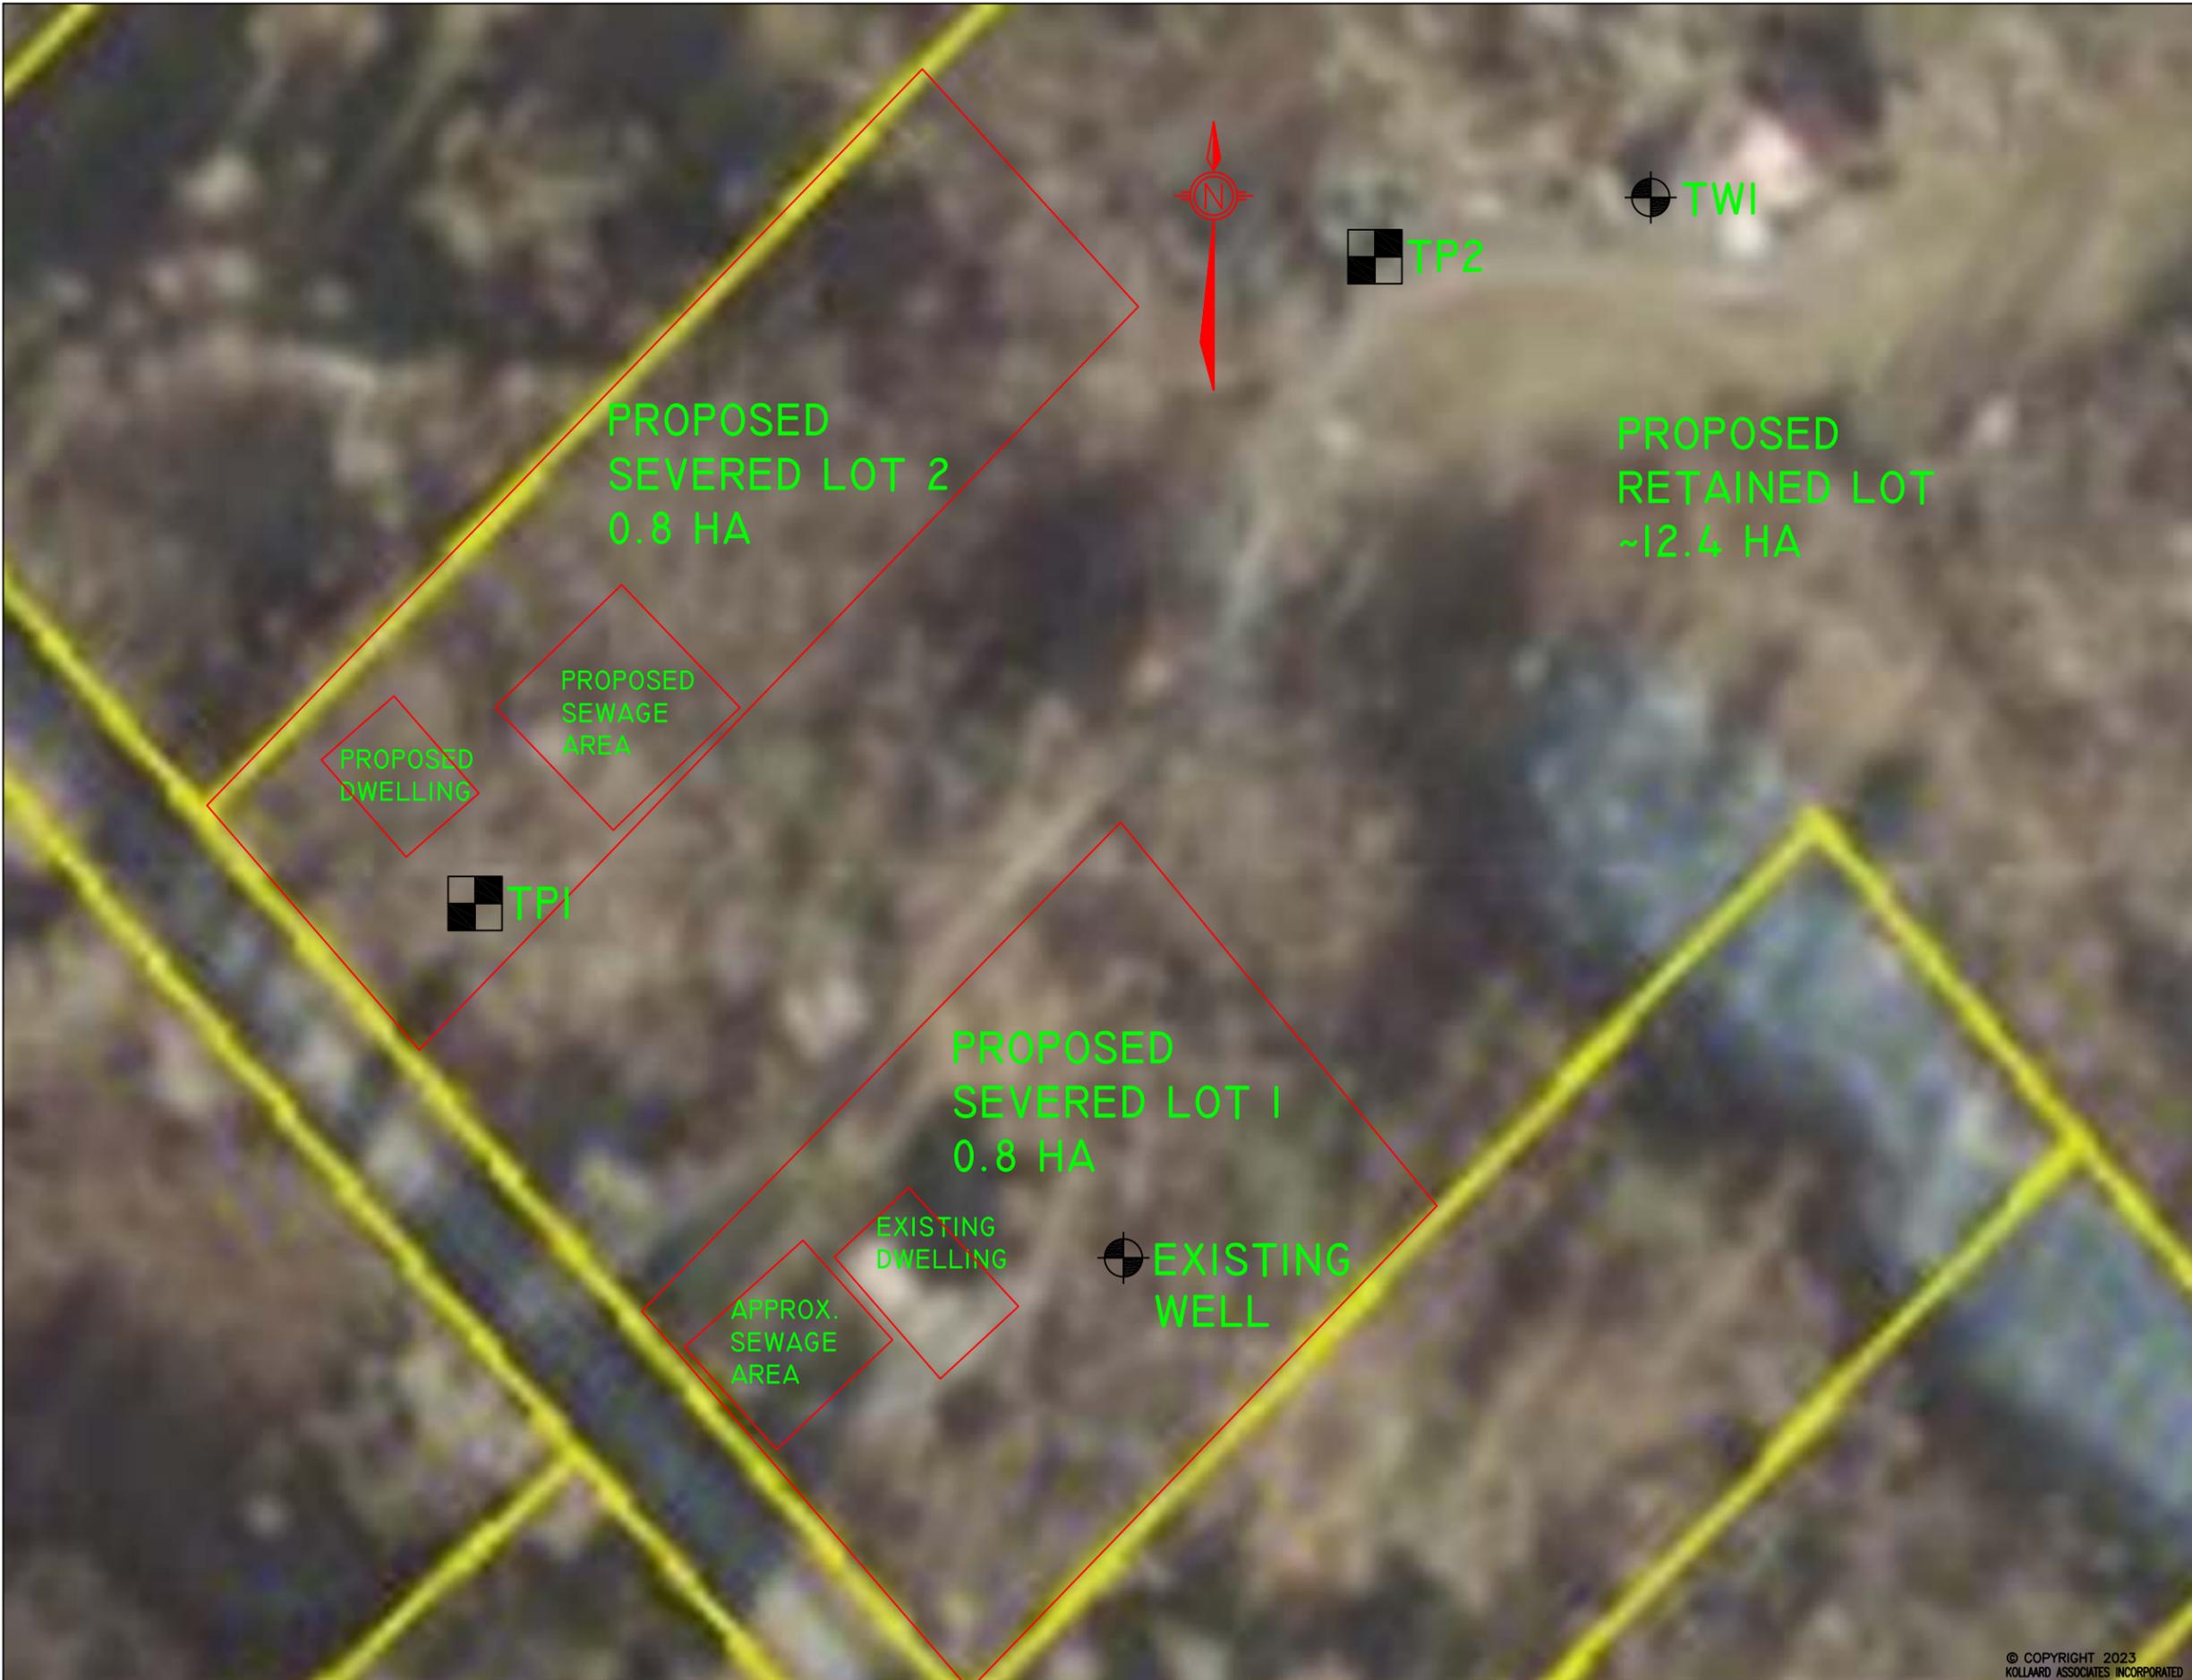
DRAWING NUMBER:  
FIGURE 2

Some groundwater observed at about 2.2 metres below the existing ground surface, August 9, 2023.

Two test pits were put down on August 9, 2023, in the approximate locations of the future sewage system areas for the proposed severed lot and the proposed retained lot. The test pit locations are shown on the Site Plan Sketch, Figure 2. The test pits were put down by the client using excavating equipment provided and operated by the client and were observed by a Kollaard Associates Inc. staff member. The test pit (TP1) put down on the proposed severed lot 2 (vacant lot) encountered about 0.30 metres of topsoil overlying red brown to grey brown silty sand. The test pit was terminated in the silty sand at 2.2 metres depth. No water was encountered in the test pit during excavating. Test pit (TP2) was put down on the retained lot. That test pit encountered red brown to grey brown silty clay and was terminated within the silty clay at 2.4 metres depth. No refusal was encountered in either test pit. TP2 encountered groundwater at about 2.2 metres below existing ground surface.

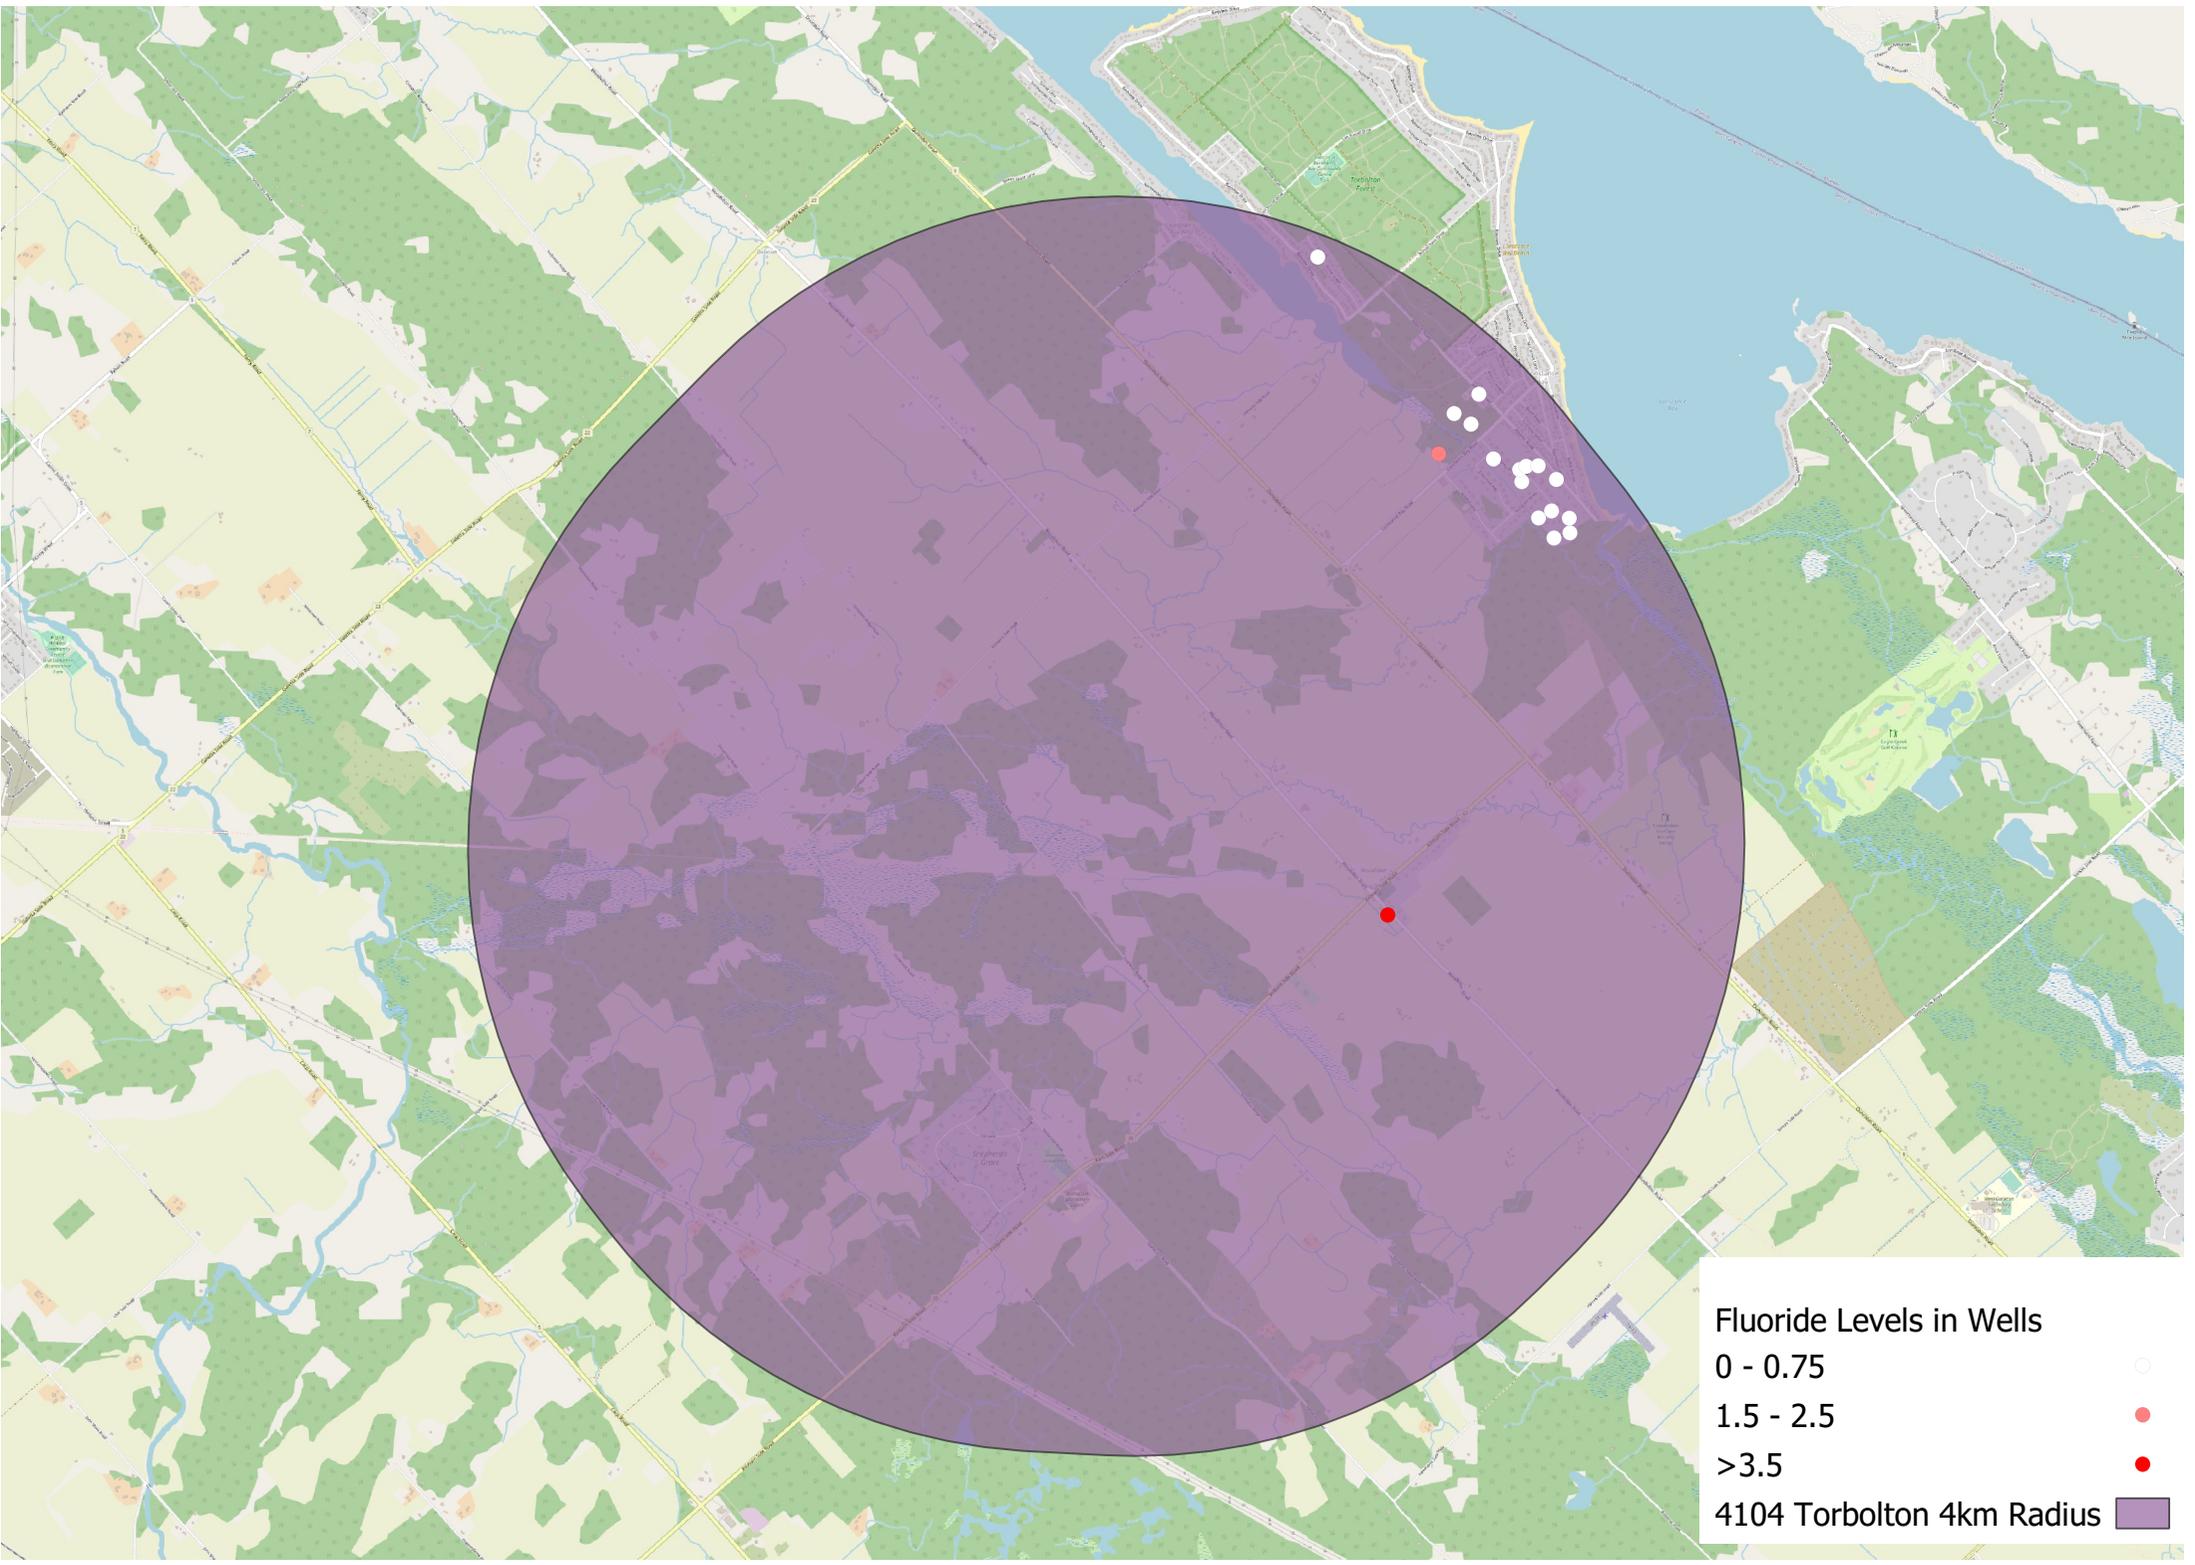
**Fluoride Levels in Wells**

ATTACHMENT F  
INFORMATION FROM CITY OF OTTAWA GROUNDWATER STUDY

local scale, then, considering the Ottawa Groundwater Study, the other well (Well ID 1515000) that is further east and has elevated fluoride may be partially due to the confining conditions caused by the clay deposit and that it is further along the flow path (hence longer residence time).
