## Tree Information Report

Submitted as part of Committee of Adjustment Application to the City of Ottawa

**Address:** 246 Westhaven

**Date of Report:** December 8, 2025

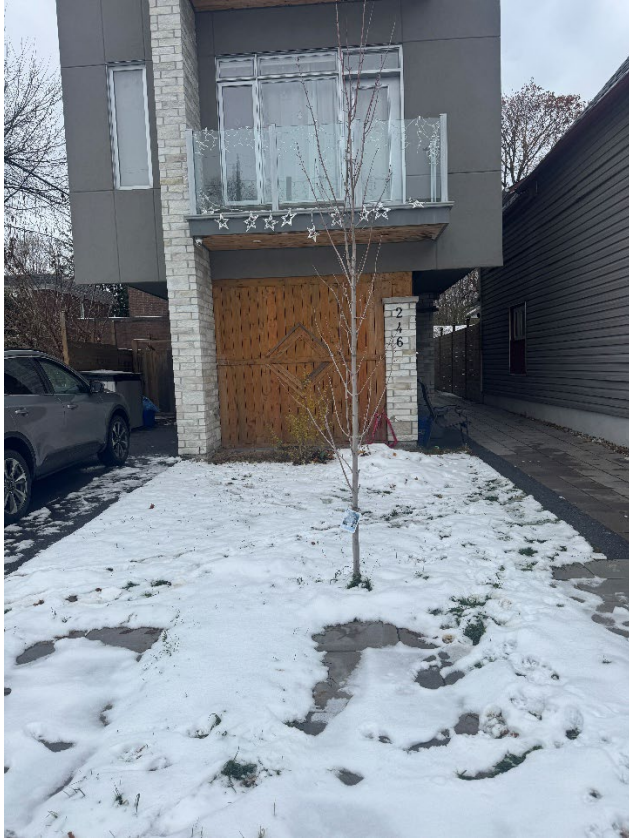
The small newly planted tree is an Armstrong maple with a diameter of 5 cm.
