**RE: TREE INFORMATION REPORT (FULL) FOR 116 MEADOWLANDS DRIVE WEST, OTTAWA**

This Tree Information Report (TIR) was prepared by Integrated Forestree Services Inc. (IFS Inc.) in support of a severance application for 116 Meadowlands Drive West. The need for this report is related to trees protected under the City of Ottawa’s Tree Protection By-law (By-law No. 2020-340). The work proposed for this address includes severing the lot and construction of a single-family dwelling on the newly created lot to the west (see plan on page 5 of this report).

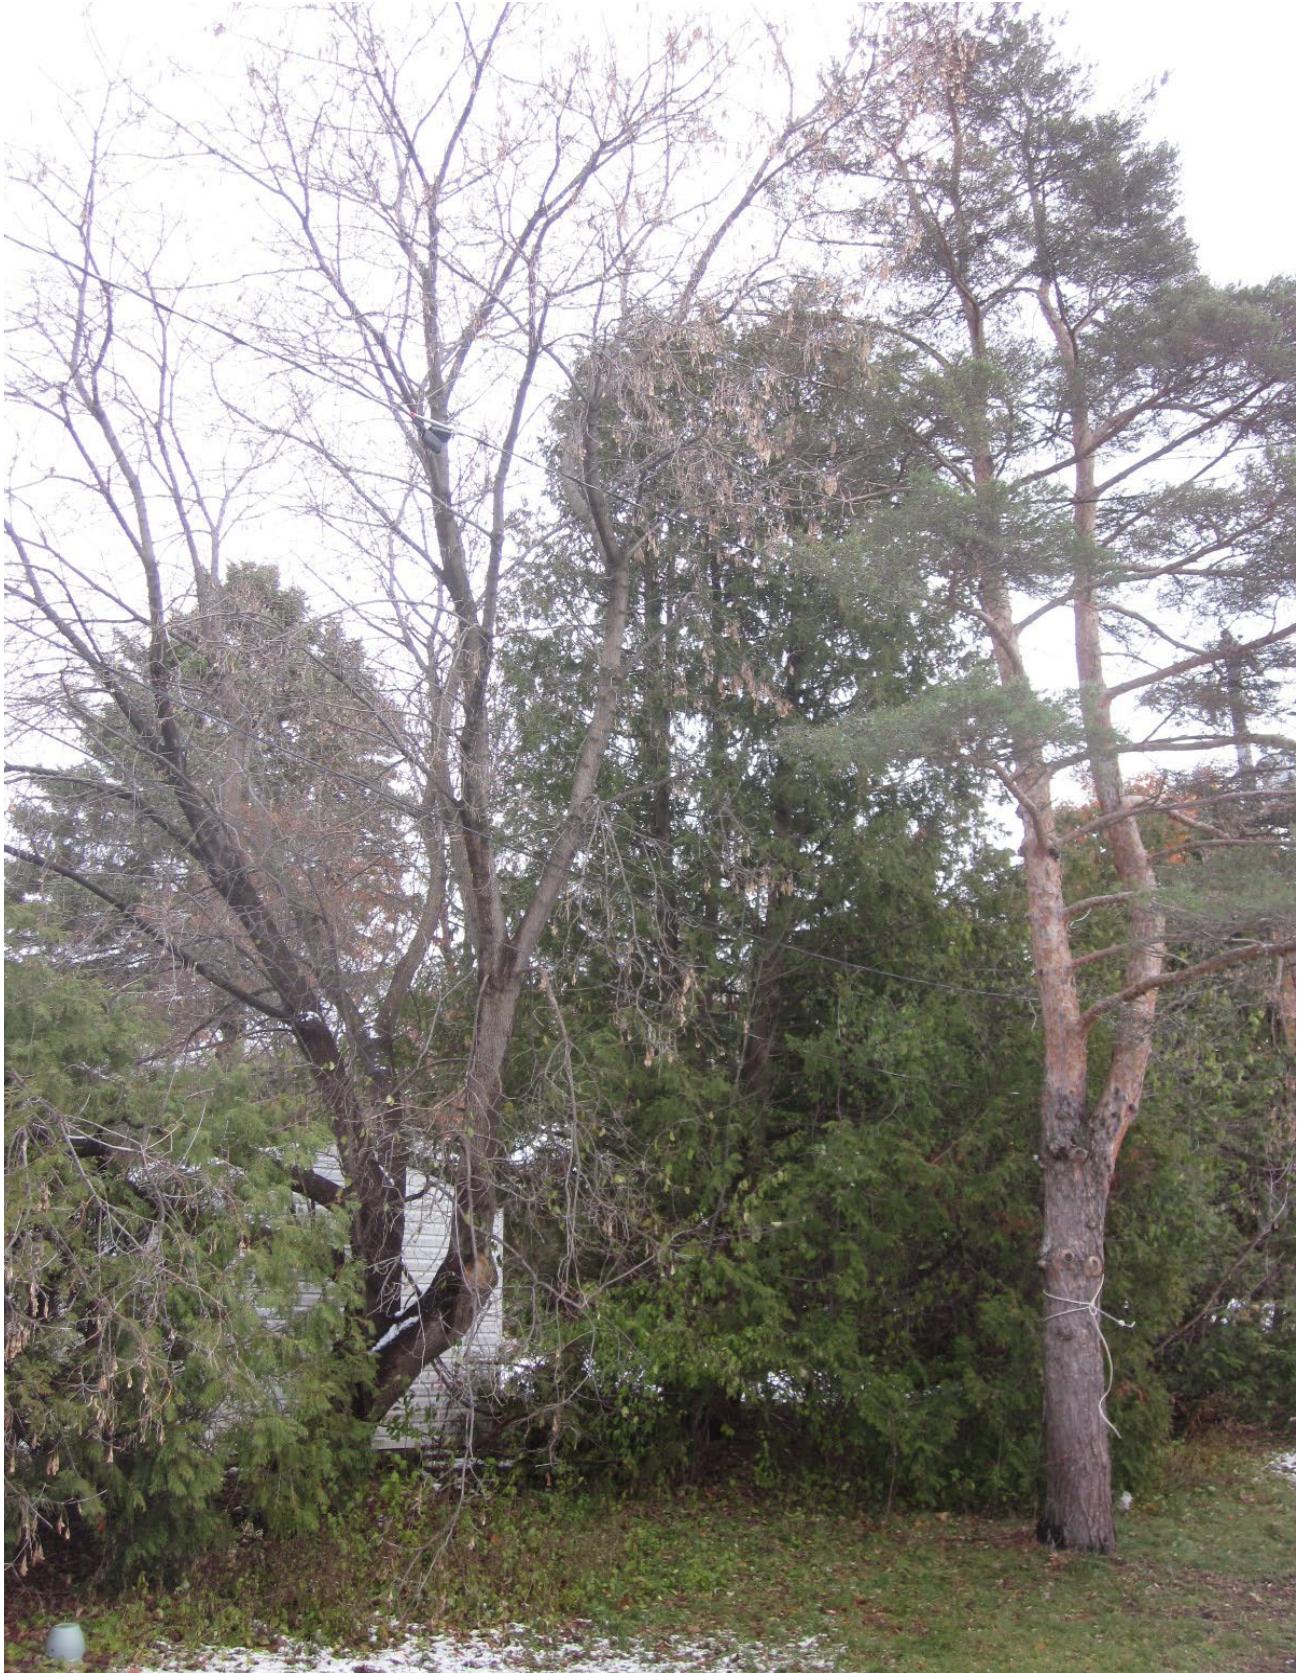
Picture 2. Trees #2 and 3 (left to right) at 116 Meadowlands Drive West

3	Scots pine ( <i>Pinus sylvestris</i> ) / Moderate - Good	Private	41.9	4.2	>10	Poor, mature; co-dominant stems at 3.25m; poor crown density, annual increment and needle colour; introduced invasive species; <b>to be preserved and protected</b>	Not applicable – to be preserved	N.A.
4	White spruce ( <i>Picea glauca</i> ) / Moderate - Good	Neighbour	+/-30	+/-3	>10	Poor, mature; topped by Hydro at 4m; good crown density, annual increment and needle colour; native species; <b>to be preserved and protected</b>	Not applicable – to be preserved	N.A.
5	Manitoba maple ( <i>Acer negundo</i> ) / Good	Private	72.7	-	-	Very poor, functionally overmature; central stem with major suppressed laterals extending over neighbouring back yard; crown asymmetric towards southwest; cavity with advanced decay in bole; barkless wound at base; naturalized species; <b>to be removed</b>	Hazardous	Tree and stump be removed

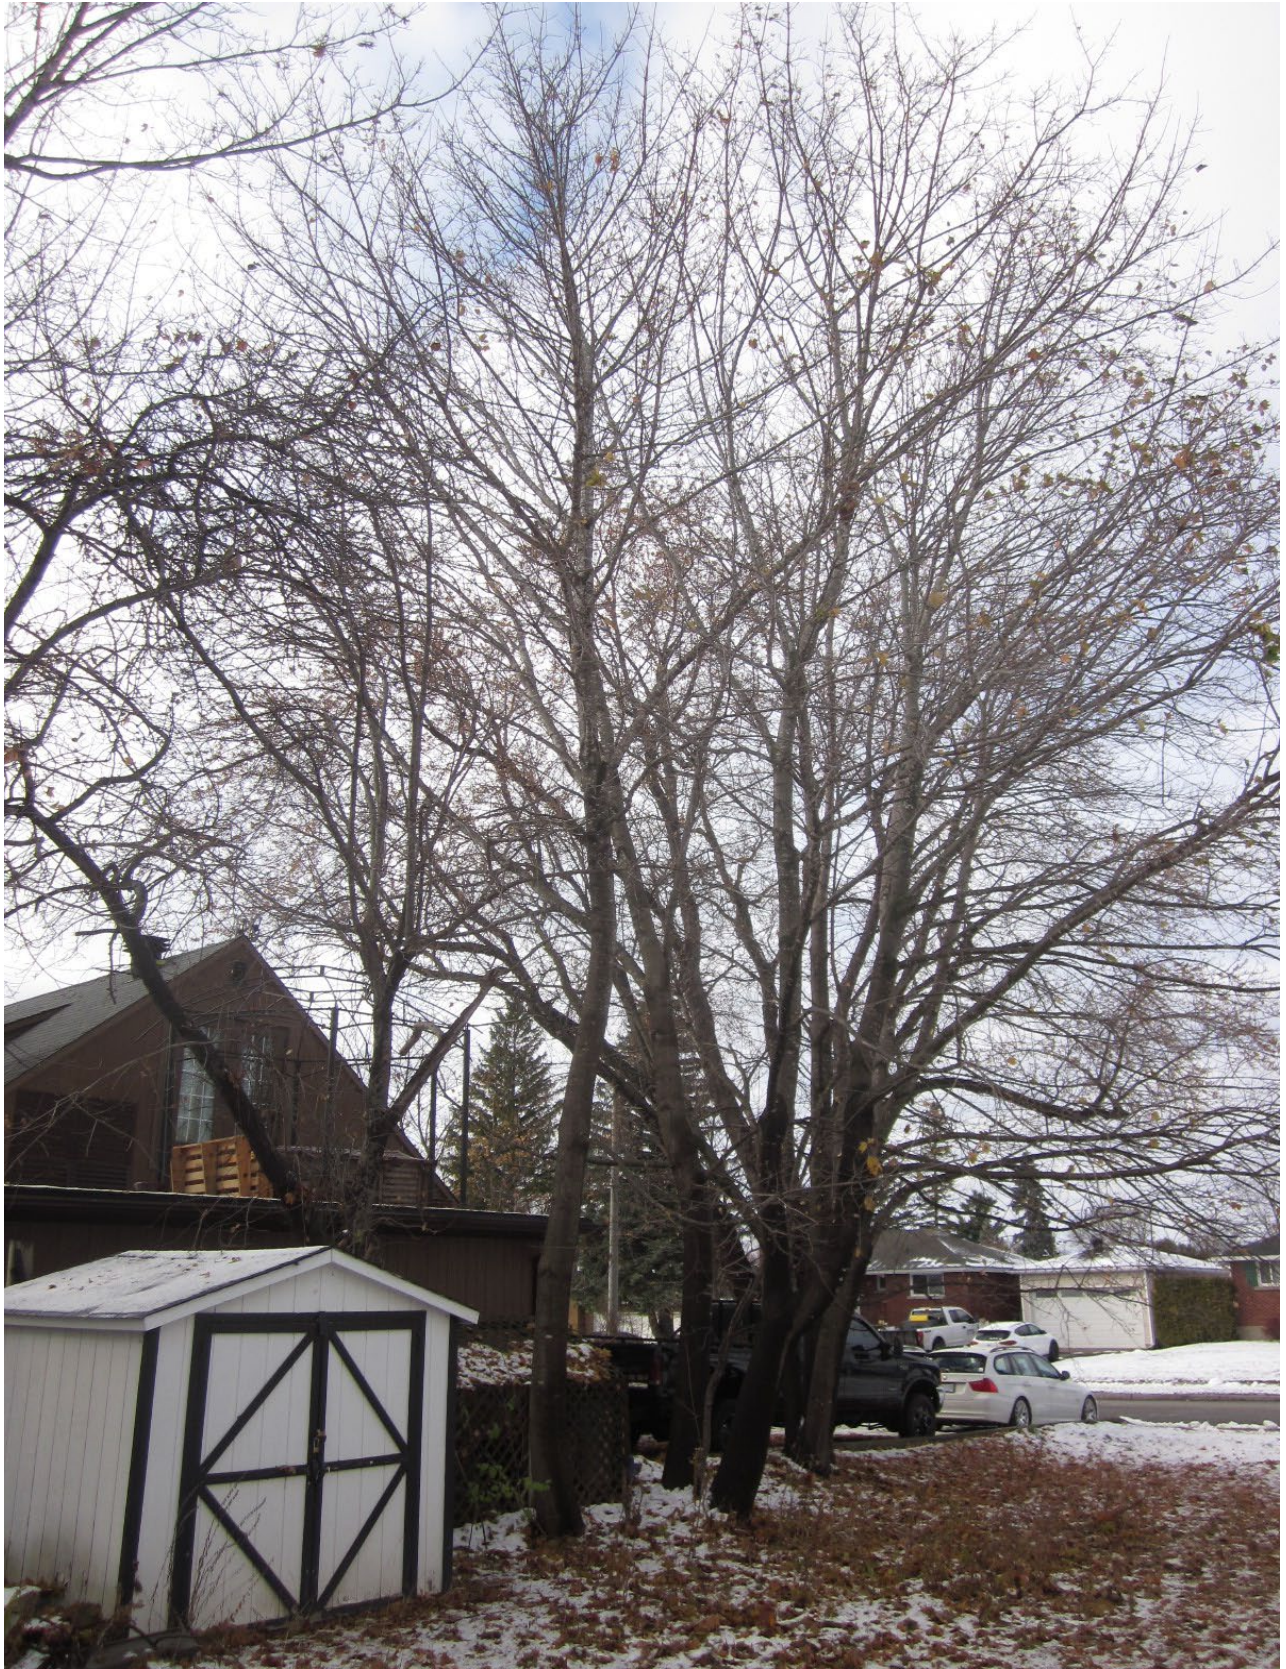
Picture 4. Trees #7 to 11 (left to right) at 116 Meadowlands Drive West

8	Norway maple ( <i>Acer platanoides</i> ) / Moderate - Good	Private	30.6	-	-	Good, mature; single dominant stem and leader; crown generally symmetric; introduced invasive species; <b>to be removed</b>	Conflicts with proposed footprint of house	Tree and stump be removed
9	Norway maple ( <i>Acer platanoides</i> ) / Moderate - Good	Private	37.3	-	-	Fair, mature; central stem with competing lateral at 2.25m on northeast; growth form divergent and crown asymmetric; introduced invasive species; <b>to be removed</b>	Conflicts with proposed footprint of house	Tree and stump be removed
10	Norway maple ( <i>Acer platanoides</i> ) / Moderate - Good	Private	32.9	-	-	Fair, mature; growth form mildly divergent and crown asymmetric towards west; introduced invasive species; <b>to be removed</b>	Conflicts with proposed footprint of house	Tree and stump be removed

The following ratios are used in terms of replacement tree planting: 2:1 for each removed distinctive tree measuring 30-49 cm in diameter and 3:1 for each distinctive tree measuring 50 cm or greater in diameter. Replacement trees must be at least 50mm in caliper if deciduous and 2m in height if coniferous. As noted on the plan on page 5, suggested locations of fifteen (15) new deciduous and coniferous trees are proposed in compensation for the loss of trees #5 though 11 inclusive.

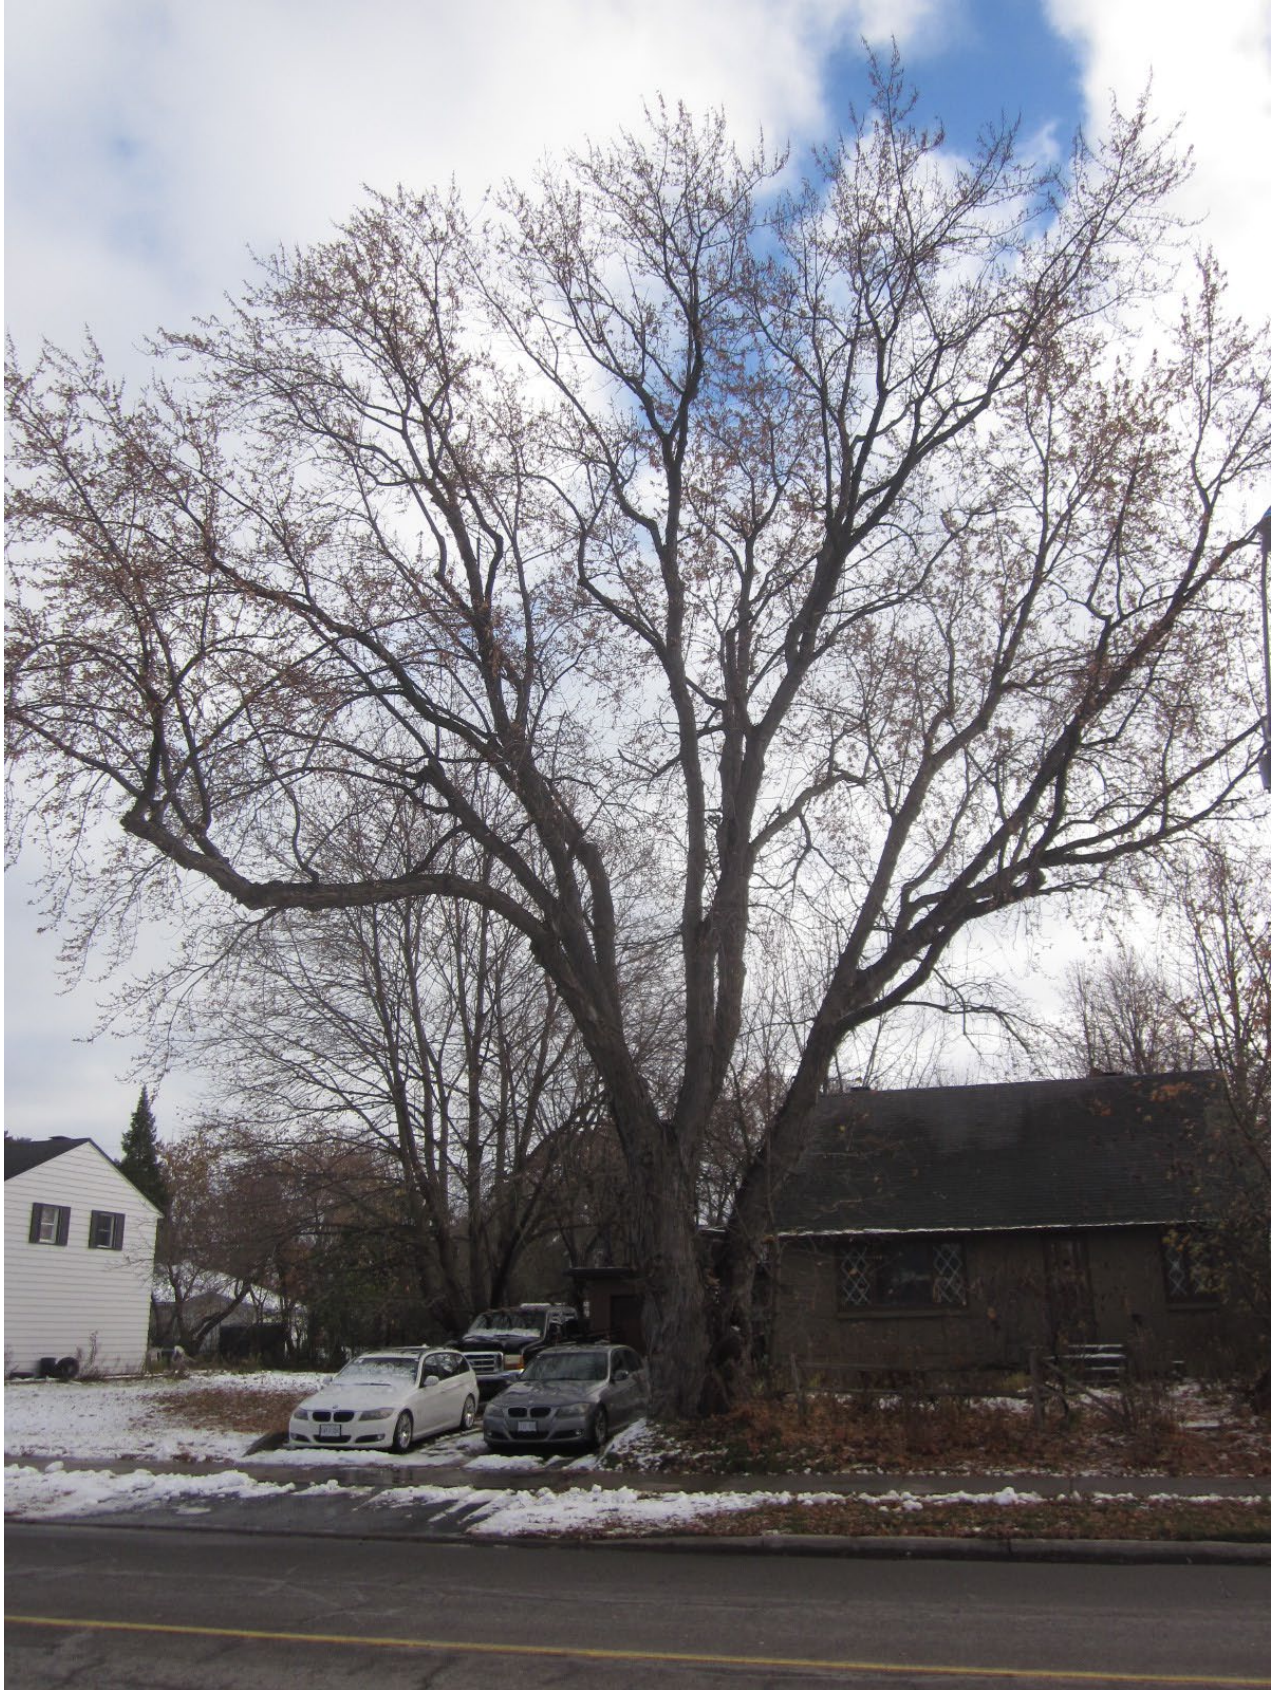
Picture 5. Tree #12 at 116 Meadowlands Drive West

Tree No.	Tree species /Tolerance to Construction <sup>1</sup>	Owner -ship <sup>2</sup>	DBH <sup>3</sup> (cm)	CRZ <sup>4</sup> (m)	Distance to excavation (m) <sup>5</sup>	Tree Condition, Age Class, Condition Notes, Species Origin and <b>Status (to be removed or preserved and protected)</b>	Reason for removal	Forester's Opinion re. Removal
11	Norway maple ( <i>Acer platanoides</i> ) / Moderate - Good	Private	32.4 & 32.2	3.2	<1	Fair, mature; double stemmed from grade with suppressed lateral on southwest; crown asymmetric towards west due to influence of adjacent trees; introduced invasive species; <b>to be removed</b>	Will not survive root loss from excavation	Tree and stump be removed
12	Silver maple ( <i>Acer saccharinum</i> ) / Poor - Moderate	City	161	16.1	8	Fair, very mature; pedestal holding three competing stems at 2.5m - very broad crown; good flower bud set for spring 20026; native species; <b>to be preserved and protected</b>	Not applicable – to be preserved	N.A.

As excavation occurs within the CRZ of tree #12, the following measures will be taken under the guidance and supervision of an arborist:

1. Hydro excavation along the edge of excavation in proximity to the tree to carefully expose roots. Exposed roots will then be cleanly cut and sealed before being reburied. Excavation can then resume using traditional mechanical means. Sealing the cleanly cut

root ends with a beeswax product will help prevent the loss of moisture and facilitate healing.

2. If the excavation is to be left open for any length of time a covering of at least three layers of moistened burlap is to be draped over the exposed face of excavation closet to the tree. A final covering of clear plastic will help retain moisture within the burlap. The use of burlap and plastic coverings will help reduce the loss of moisture from the soil surrounding the remaining roots.
