TREE CONSERVATION REPORT

65 and 85 Gemini Way

Tree Conservation Report submitted as Partial
Requirements for a Site Plan Control
Application, November 28, 2024 and Application
for Severance for 65 Gemini Way

Tree Conservation Report

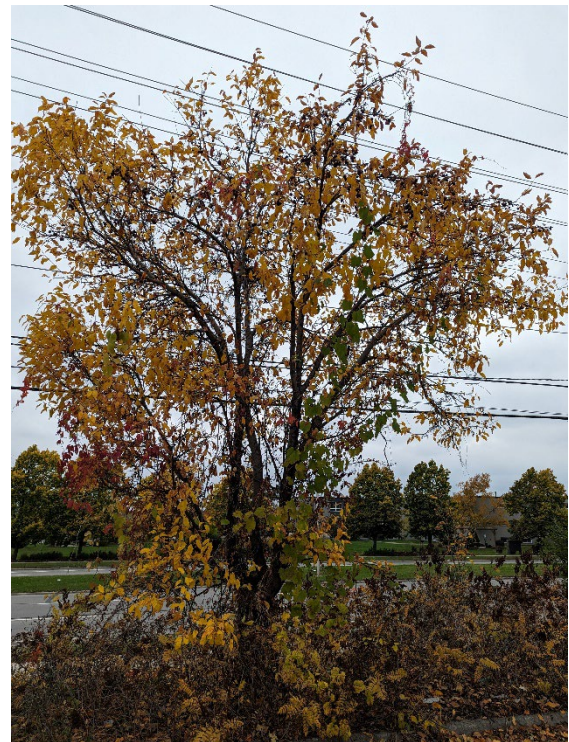
Tree 29 – private crab apple to be removed.
