Tree Information Report – 2052 Boyer Rd, Ottawa

This Tree Information Report is being submitted as a partial requirement for the development of this property. A site visit was conducted by Chris McIntyre, Certified Arborist ON-1219A, on March 3, 2026.

The focus of this report is to outline the current vegetation on the site, detailing species, size, and condition. While evaluating the impact the purposed development may have on the vegetation, and how to mitigate damage to retained trees.

TREE INFORMATION REPORT

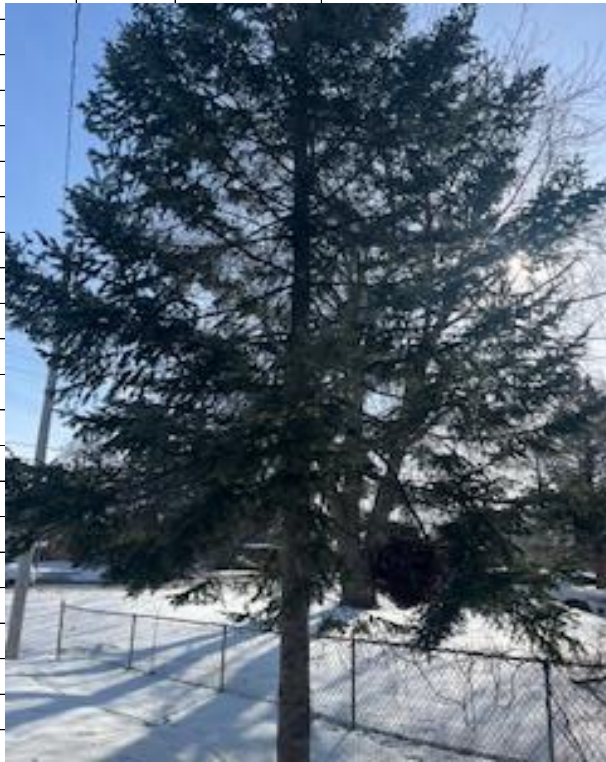
Tree 1

Tree No.	Species	D.B.H (cm)	Ownership	Condition of tree	Client's reason for removal	Arborist recommendation
1	Balsam fir	24	Private	Tree health, vigor and structure are all considered fair.	Too close to footprint of development.	Remove. CRZ cannot be adequately protected.
2	White cedar	35	Private	Tree health and vigor are fair. Structure is poor due to co-dominate stems.	Within footprint of development.	Remove. Conflict with construction.
3	Colorado spruce	42	Private	Tree health, vigor and structure are all considered good.	Within footprint of development.	Remove. Conflict with construction.
4	Silver maple	84	Private	Tree health and vigor are good. Structure is fair due to co-dominate unions.	Too close to footprint of development.	Remove. CRZ cannot be adequately protected.
5	White oak	10	Private	Tree health, vigor and structure are all considered good.	Tree to be retained.	Retain - protect. Install CRZ protection at 3ft, below protection measures to be implemented.

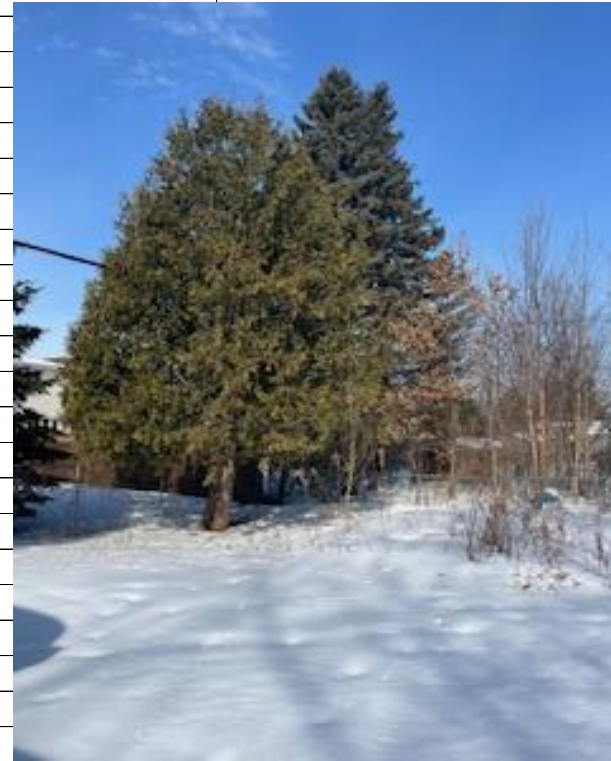
Tree 6

6	White cedar	25	Private	Tree health, vigor and structure are all considered fair.	Within footprint of development.	Remove. Conflict with construction.
7	Colorado spruce	38	Neighbour	Tree health, vigor are fair. Structure is poor due to co-dominate stems, union 2ft from base.	Tree to be retained.	Retain - protect. Construction fencing installed on property line to act as CRZ fencing, providing 6ft of protection. Below protection measures to be implemented.
8	Ash, silver maple, crab apple	All less then 15cm	Private, shared, neighbours	All considered fair.	Trees growing with fence will require removal.	No protection measures required, overhang should to pruned prior to construction to avoid damage.
