A CONSERVATION PLAN

CITY REGISTRY OFFICE 70 NICHOLAS STREET
OTTAWA, ONTARIO

PREPARED BY: COMMONWEALTH HISTORIC RESOURCE MANAGEMENT AND BARRY
PADOLSKY ASSOCIATES INC.

APRIL 26, 2022 FINAL

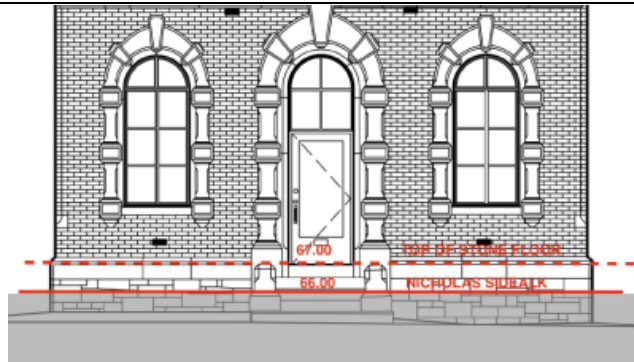
Figure 4: The red markers indicate the relationship of the building to Nicholas Street with a reduced grade difference. The shading at the base of the drawing indicates the new ground level.

<p>Due to soft lime-based mortar, localized removals of bricks can be completed effectively with minimal damage and a high rate of salvageability. Reintegration will require local repair and repointing masonry. Required masonry repairs should be performed, as directed by the masonry specialist including replacing damaged and cracked units. Both interior and exterior face brick should receive a light cleaning.</p>
<p>Stone Foundation</p>	<p>CONSERVATION APPROACH - Rehabilitation The stone masonry foundation walls at the exterior perimeter are ±40" thick with rough cut rubble coursed face stone and limestone rubble back-up. Within the building footprint the reclaimed stone units from the exposed east-west and south foundation walls will be reconstructed in their original positions. Stonework showing evidence of failure or potentially damaged in the dismantling procedure will be repaired or replaced with matching stone units. The details will be adjusted to accommodate between the revised and original finished floor level. The finished floor level of the relocated CRO at EL 67.00 will match the ground floor of the main building and a portion of the visible exterior stone foundation will be obscured.</p>

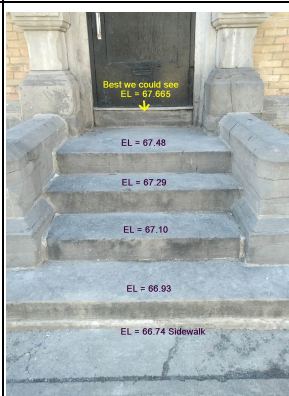
Figure 5 and 6: view and plan showing the existing steps with elevations noted and a plan view showing the planned rehabilitation of the steps being used as pavers.

<p>Entry Steps</p>	<p>CONSERVATION APPROACH - Rehabilitation. Cut stone entrance stairs will be removed, labeled, restored, and stored for future reinstallation with height adjusted. The details will be adjusted to accommodate the revised layout between the new finished floor level (67.00) and the final grade at the foot of the stairs (66.60) eliminating 5 risers to 2 risers to match the Nicholas Street sidewalk at the bottom of the steps. Re-setting the lowest three steps level with the Nicholas Street sidewalk as a stone "entrance apron."</p>
--------------------	---

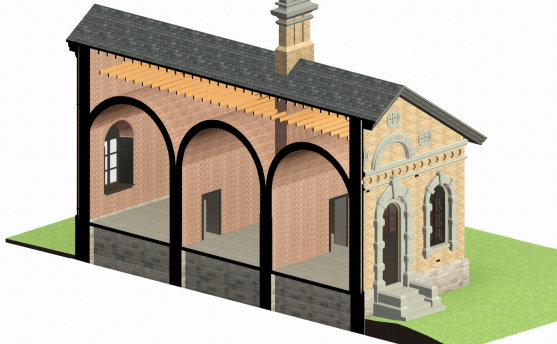
<div style="margin-left: 20px;"> <p>Figure 7: Longitudinal cross sections of the CRO.</p> </div> </div>
<p>Stone Slab Flooring</p>	<p>CONSERVATION APPROACH - Preservation. Stone flag floor composed of units 6"x40" supported on rubble stone foundation walls east-west walls at ±34" c/c to support the limestone floor slabs. The stone floor slabs will be cataloged, removed, and stored. Following the move the slabs will be integrated into their original positions on the new concrete structural slab using self leveling mortar. Grinding of the stone surfaces may be required to prevent a tripping hazard.</p>
<p>INTERVENTIONS</p>	
<p>Interior Brick vaults with plaster finishes</p>	<p>CONSERVATION APPROACH – Rehabilitation . Removal of the plaster finishes on the walls and vault ceiling to expose the original masonry brick vault system will be undertaken prior to the move.</p>

<p>Windows and Entry Door</p>	<p>CONSERVATION APPROACH - Preservation. The steel entrance door assembly, seven steel windows with interior steel shutters, iron bars and one steel interior door assembly will remain insitu during the move. The glass from windows will be removed and replaced with new insulated glass. Necessary protection will secure them during the move.</p>
<p>INTERIOR ATTRIBUTES</p>	
<p>Interior ceiling is a 3- wythe, 3-span brick vault</p>	<p>CONSERVATION APPROACH - Rehabilitation. The ceiling's 3-span brick vault spans east-west and bears on the east and west exterior walls and two interior brick walls. Two 1" diameter tie-rods tie the east and west exterior walls. The three sections of the office form are character defining features and will be retained. The dividing wall between the vaulted spaces, will be opened to accommodate new uses and to provide pass through and universal access. A metal beam painted black will support the roof structure.</p>

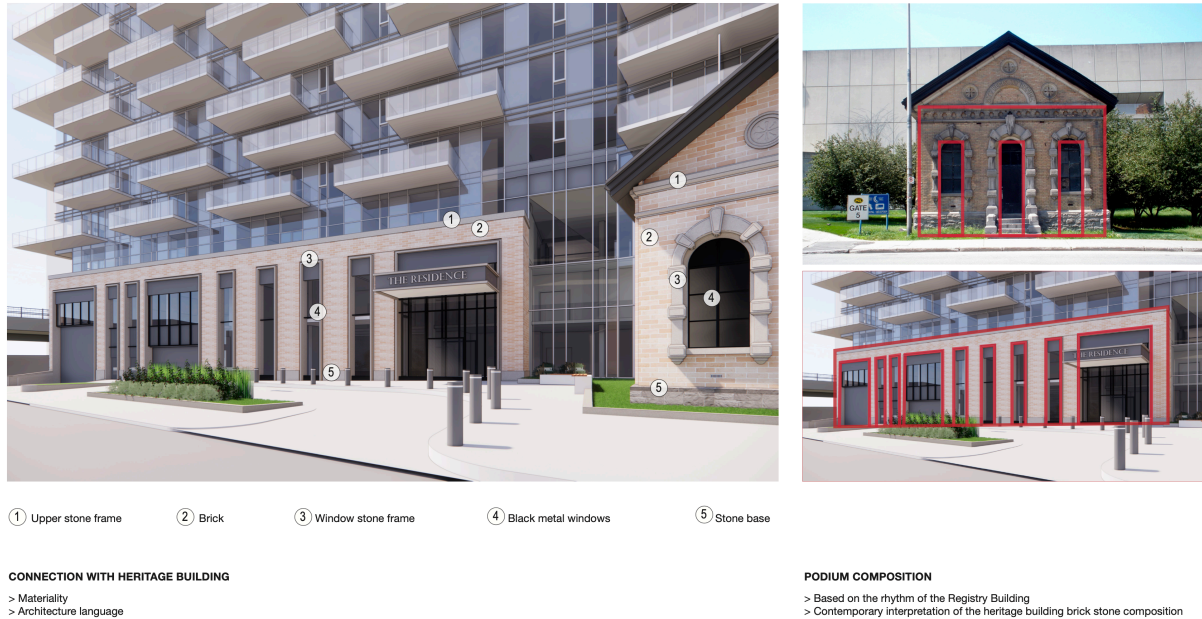
Figure 11: Relationship to Heritage - Given the differences in scale, it is considered key to its visual compatibility that the materiality, and colour of the base of the high-rise act as a backdrop to the CRO without overwhelming it. Introducing the salmon yellow brick with the limestone trim and the black metal into the new development’s podium successfully references defining features of the CRO. Source: Zeidler/Neuf 2022.

- the creation of a three-storey atrium to frame the CRO;
- the elimination of the dark frame encasing the tower; the introduction of a podium using yellow brick with the masonry trim that references the CRO; an,
- establishing the residential lobby, the CRO, and the Rideau Centre as three distinct expressions along Nicholas Street.

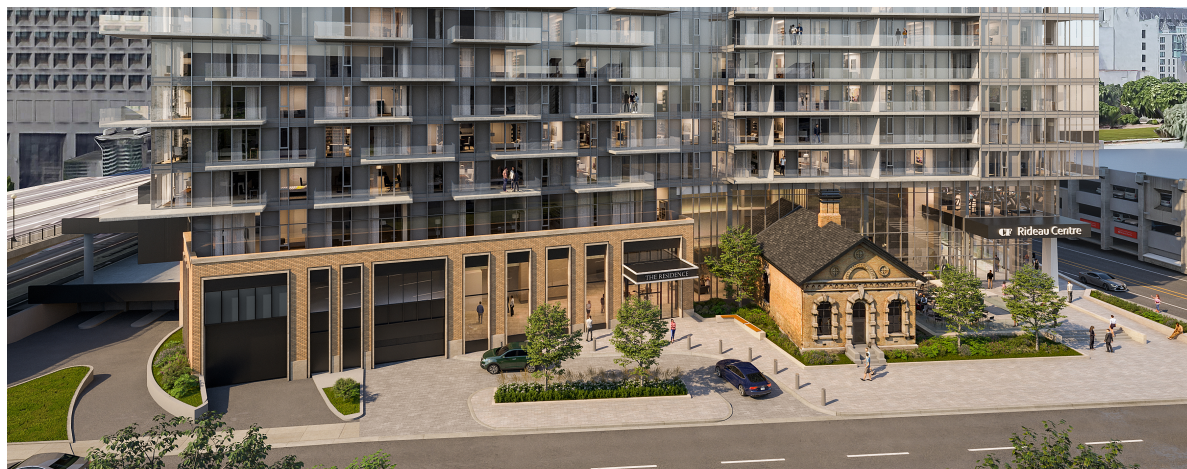
Figure 12: Bird’s eye view of the Registry Office set between the podium to the residential high-rise and the entrance to the Rideau Centre. Zeidler/Neuf 2022.

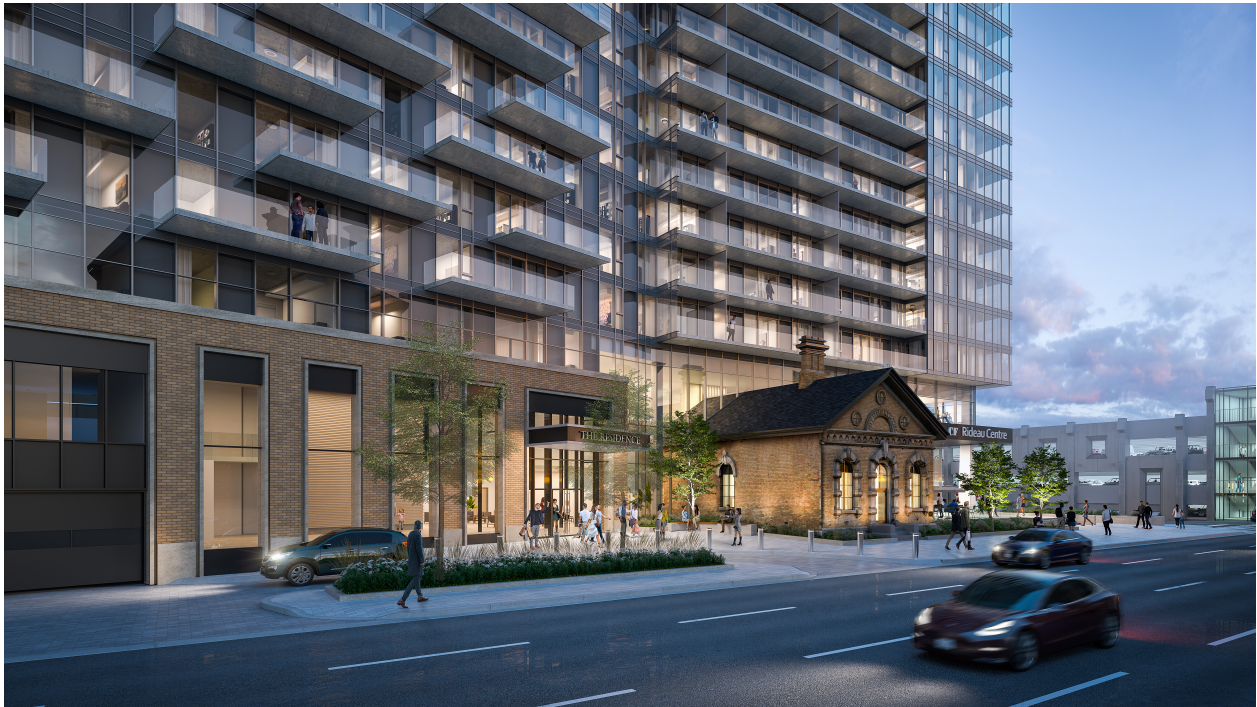
Figure 13: Night view along Nicholas Street. Source: Zeidler/Neuf 2022

The most effective way to conserve the heritage value of the CRO is to relocate the structure to a prominent location at the front of the proposed development. Such a move assures that its visibility is maintained and placing it forward on the site suggests that the new build is subservient. The relocation of the CRO will also establish a pedestrian scale and rhythm to the street between Daly and the bridge.

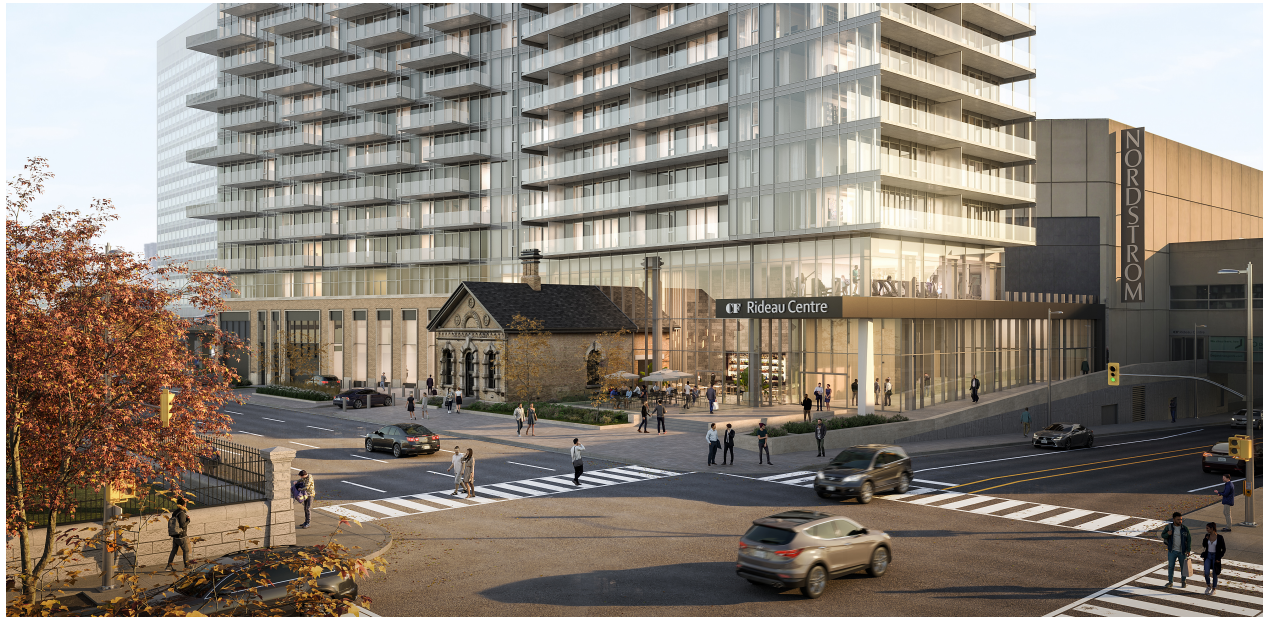
Figure 14: A view from the intersection of Nicholas Street and Daly Avenue. Source; Zeidler/Neuf 2022

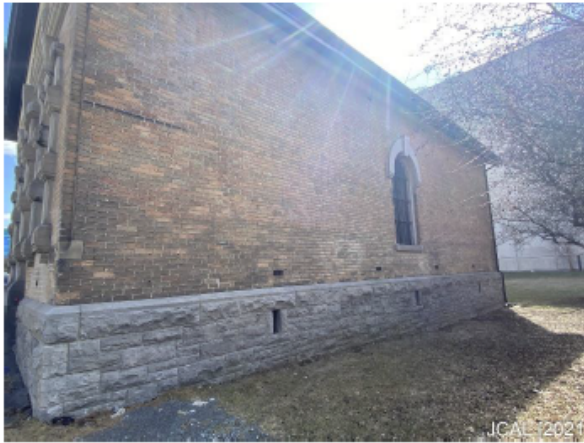
Photo 1a: North Elevation [JCAL (2021)]

In general, the structure is in fair to good condition. Restoration work was performed circa 2017 and appears to be performing well. No signs of distress at or surrounding the repairs were observed. Exploratory work was carried out to assess the ease of removal of the existing bricks at the areas of original construction and at areas of known restoration. In both cases, bricks were removed intact, and the mortar could be removed without too much effort. This is indicative of soft, lime-based mortars which are most compatible with the brick from this era. The mortar in the restoration work is performing comparatively well with the original mortar which was originally specified to be mixed at a ratio of 1:3 lime to sand. Higher-strength Portland cement-rich mortars are typically well adhered to bricks making the mortar challenging to remove without damaging the brick. Any localized removals of bricks can be completed effectively with minimal damage and a high rate of salvageability.

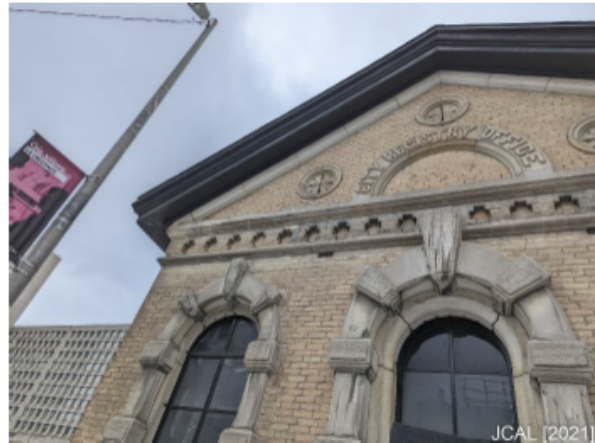
Photo 1b: Partial East Elevation [JCAL (2021)]

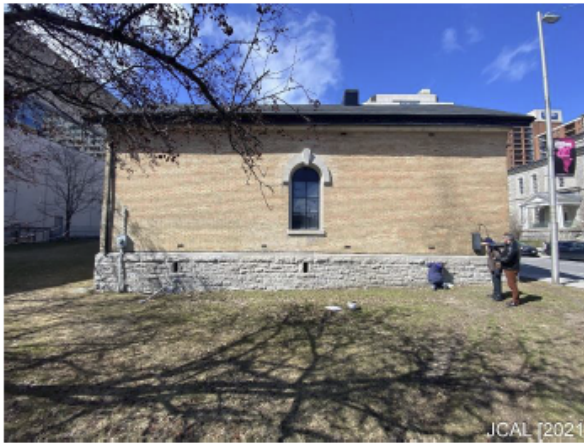
Photo 1c: South Elevation [JCAL (2021)]

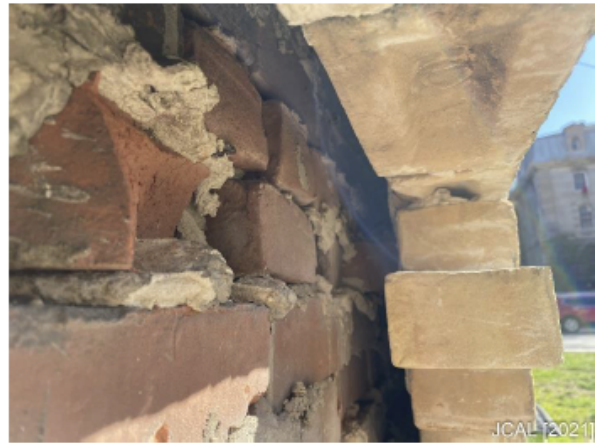
Photo 1d: Facing Brick and Cavity [JCAL (2021)]

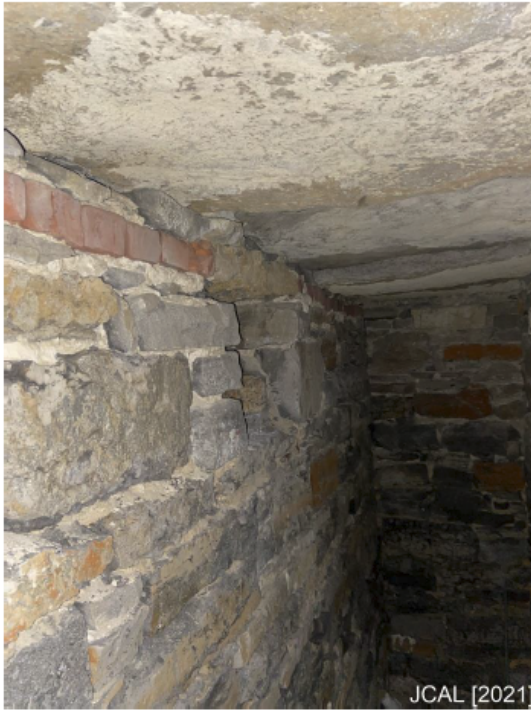
Photo 1e: Foundation and Stone Slabs [JCAL (2021)]

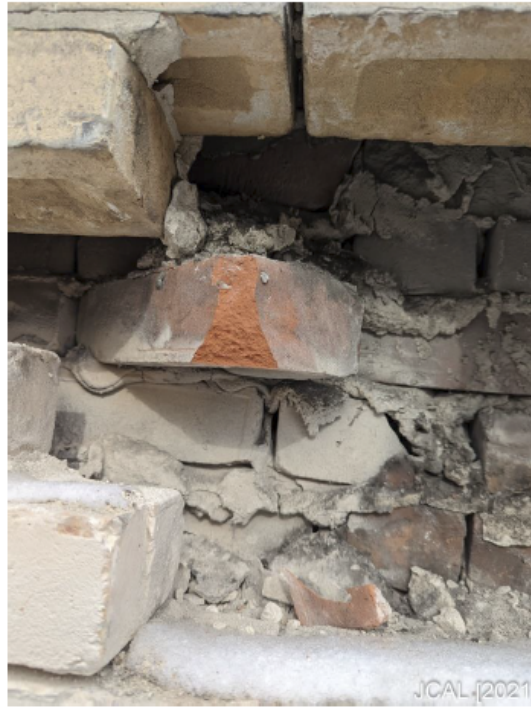
Photo 1f: Cavity and Diagonal Tying Brick [JCAL (2021)]

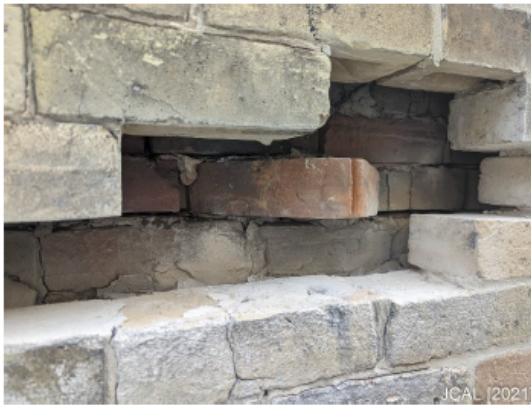
Photo 1g: Cavity and Diagonal Tying Brick [JCAL (2021)]

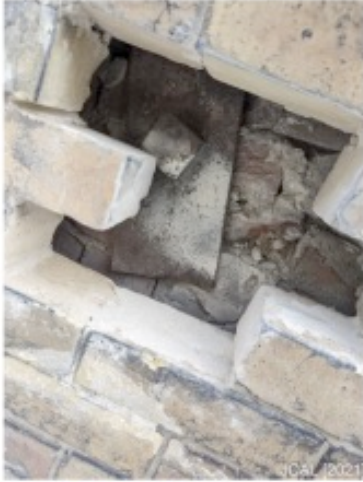
Photo 1i: Tie Rod End Plate [JCAL (2022)]

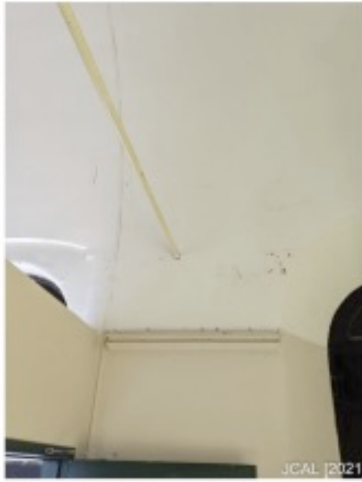
Photo 1j: Tie Rod [JCAL (2022)]

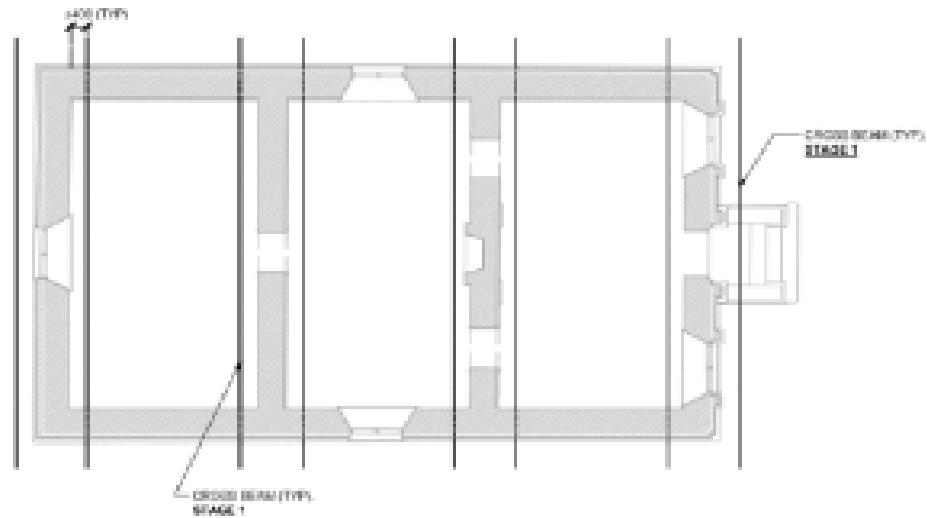
Stage 1: Cross Beam Installation

Stage 1: Install Cross Beams – The primary cross beams will be needed through the masonry walls. The cross beams will be the primary supporting elements for the north-south walls that support the vault. The

elevation of the cross beams has been selected to engage the top plinth course of stone. This takes advantage of the existing building attributes since this course of stone can act as lintels to support the facing brick above. At the locations of the beam penetrations, the masonry will be cataloged, dismantled, and stored for future re-integration. Once the opening is made, the beams will be slid into place, likely two sections will be spliced to span the entire length of the building.

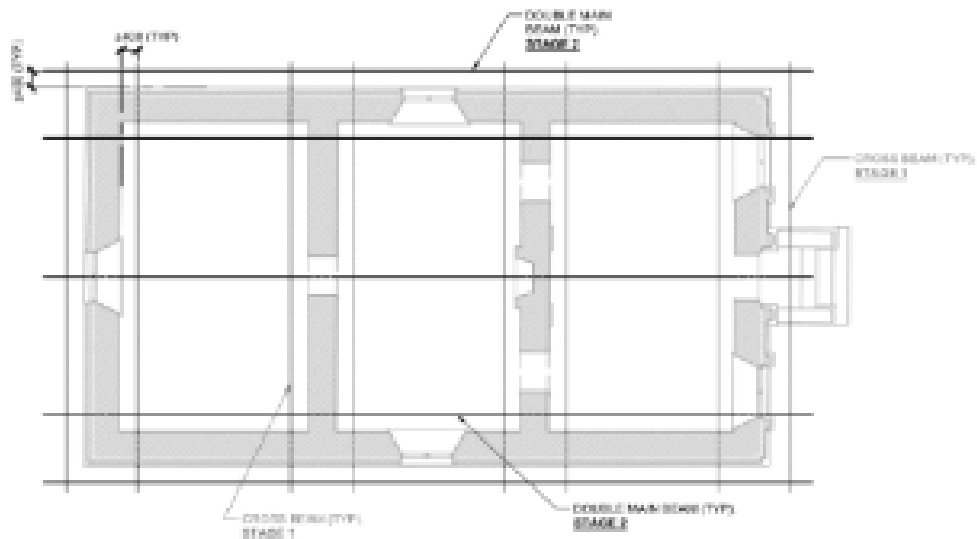
Stage 2: Main Beam Installation

Stage 2: Install Main Beams – The main beams will serve as the primary lifting point and provide support to the cross beams. As with the cross beams, masonry will be cataloged, dismantled and stored for future re-integration. Select needle beams will be installed strategically to provide support over the main beam locations during dismantling.
