A CONSERVATION PLAN

CITY REGISTRY OFFICE 70 NICHOLAS STREET
OTTAWA, ONTARIO

APRIL 26, 2022 FINAL

Building Relocation Feasibility

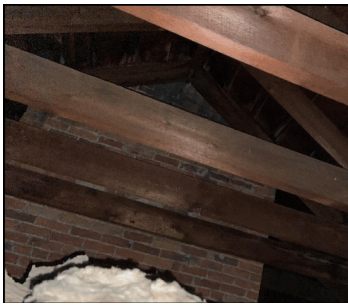
<p>CONSERVATION APPROACH - Rehabilitation. The wood roof trusses span north south and bear on the north and south exterior walls. The sawn lumber roof rafters, collar ties and decking will be replaced by a new non-combustible roof structure complying with current OBC Standards.</p> <p><i>Figure 3: Interior truss system to be replaced with east façade of chimney in the background.</i></p>

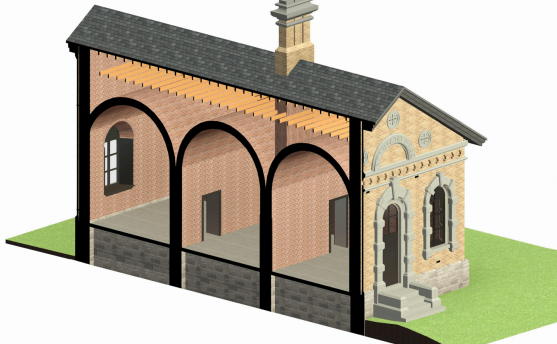
<div style="margin-left: 20px;"> <p>Figure 7: Longitudinal cross sections of the CRO.</p> </div> </div>
<p>Stone Slab Flooring</p>	<p>CONSERVATION APPROACH - Preservation. Stone flag floor composed of units 6”x40” supported on rubble stone foundation walls east-west walls at ±34” c/c to support the limestone floor slabs. The stone floor slabs will be cataloged, removed, and stored. Following the move the slabs will be integrated into their original positions on the new concrete structural slab using self leveling mortar. Grinding of the stone surfaces may be required to prevent a tripping hazard.</p>
<p>INTERVENTIONS</p>	
<p>Interior Brick vaults with plaster finishes</p>	<p>CONSERVATION APPROACH – Rehabilitation . Removal of the plaster finishes on the walls and vault ceiling to expose the original masonry brick vault system will be undertaken prior to the move.</p>

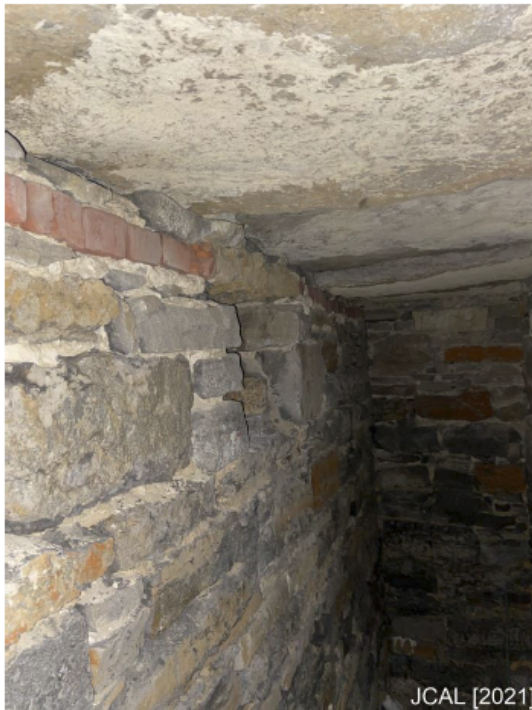
Photo 1e: Foundation and Stone Slabs [JCAL (2021)]

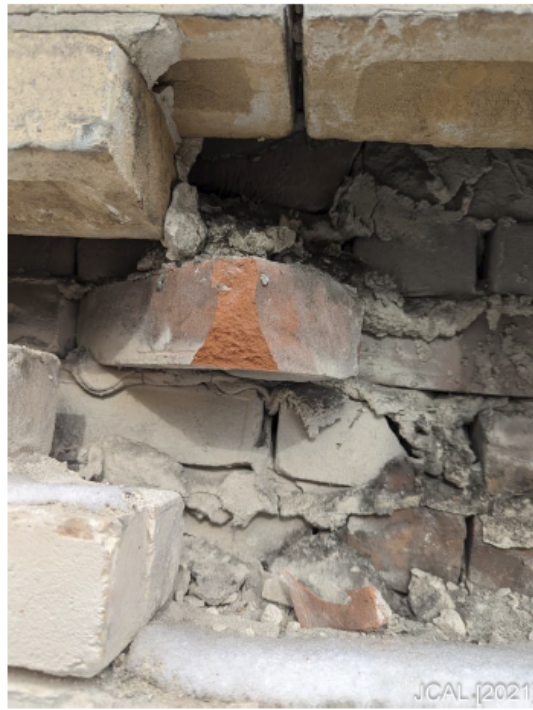
Photo 1f: Cavity and Diagonal Tying Brick [JCAL (2021)]

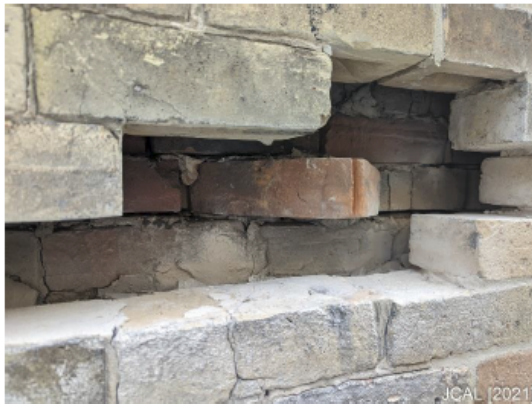
Photo 1g: Cavity and Diagonal Tying Brick [JCAL (2021)]
