CITY OF OTTAWA HERITAGE

SUMMARY SHEET

124 Boteler

**PHASE ONE SURVEY**

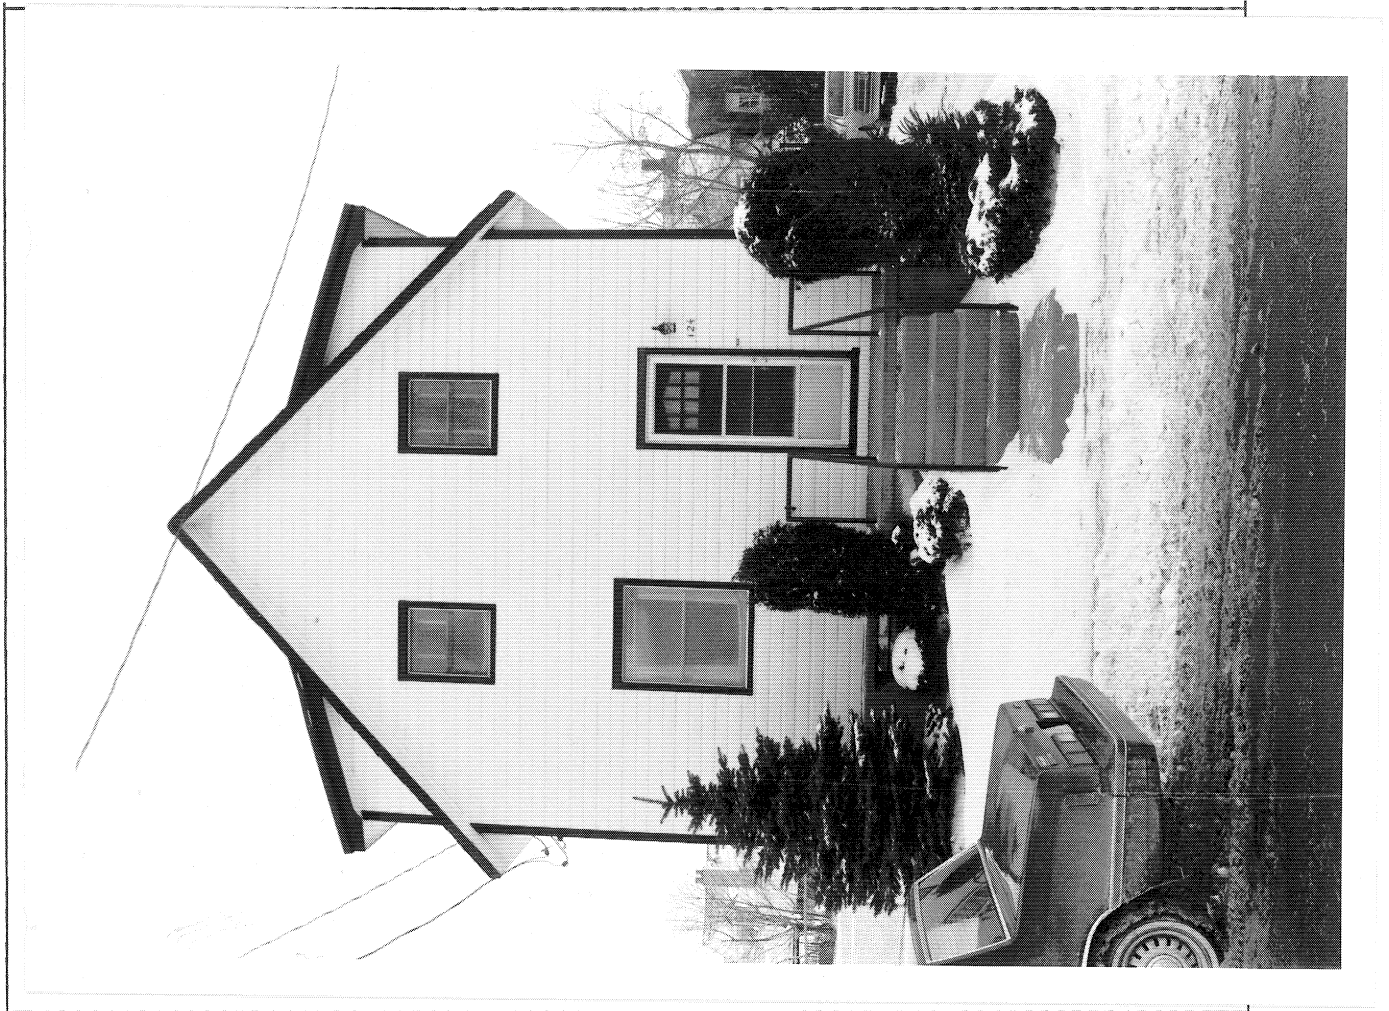
4. PICTURE

Excellent

1½ storey wood frame wood clad with gable roof and shed dormers; three  
double hung windows; off centre entrance. Between 1888 & 1922 shown to  
have a front veranda.

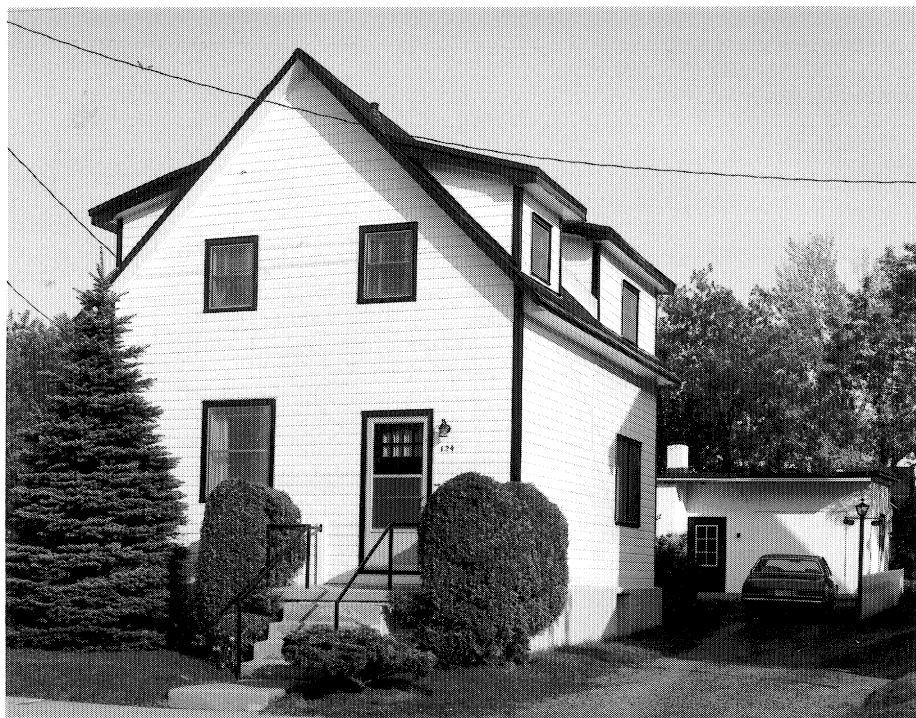
PHOTO DATE: June 1992  
VIEW:  
SOURCE: Gilberto Prioste  
NEGATIVE NUMBER:

1 1/2 storey gable fronted single family house with large shed dormers; porch removed; clapboard with corner boards; simple 1 over 1 sash. Recent garage building in rear.

Chief alterations include removal of front porch, addition of dormers, and possible alterations to the fenestration with the application of the wood siding. Possibly raised basement. (PRESENT OWNER SAID SHE STRIPPED THE BUILDING TO THE FRAME IN THE 1950S).

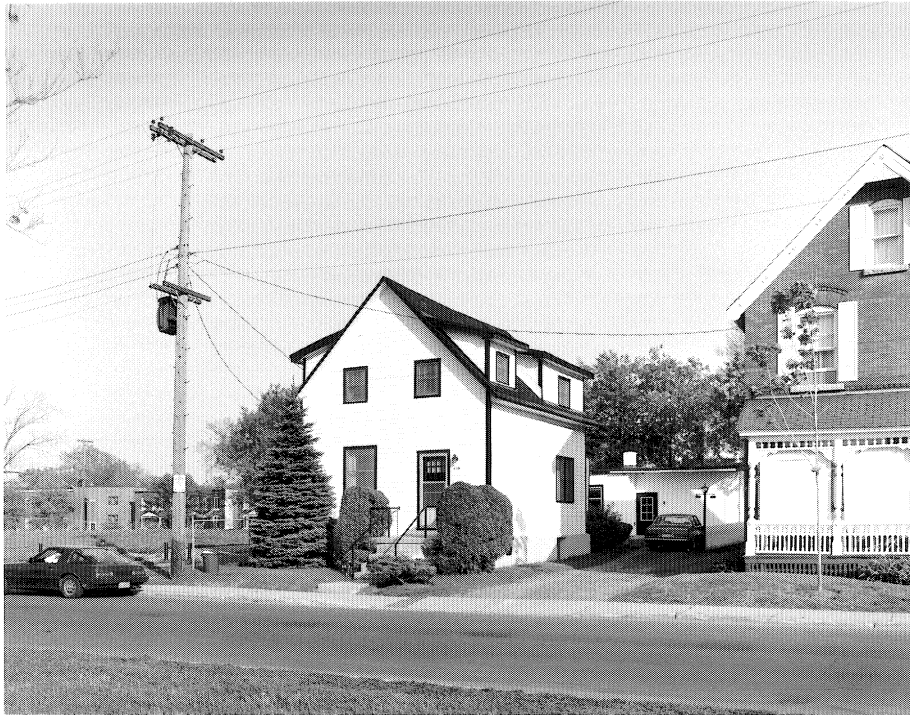
**PHOTO DATE:** June 1992  
**VIEW:**  
**SOURCE:** Gilberto Prioste  
**NEGATIVE NUMBER:**

The building is compatible in material, form, scale and character to other heritage buildings in Lowertown. The building is historically related to its neighbour, 120, also owned by the Bingham family.

Located on Boteler, the building is exposed on its east side by a development site.
