# Cultural Heritage Impact Statement

35-37 William Street, Ottawa

**RMA Project No.:** 19136

**Date:** January 23, 2020

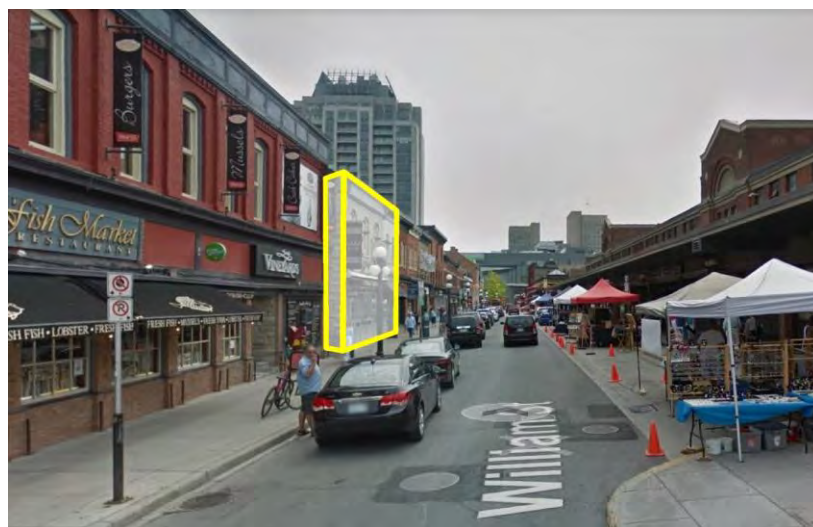
Figure 5: Location of the development project. (Google)

The site of the proposed development is situated on William Street at the proximity of York Street and facing the market building; a central and lively area of the market. Most buildings of this block are composed of two-storey buildings with continuous commercial activities on the ground floor and housing on the second floor. (See Figures 4 and 5).

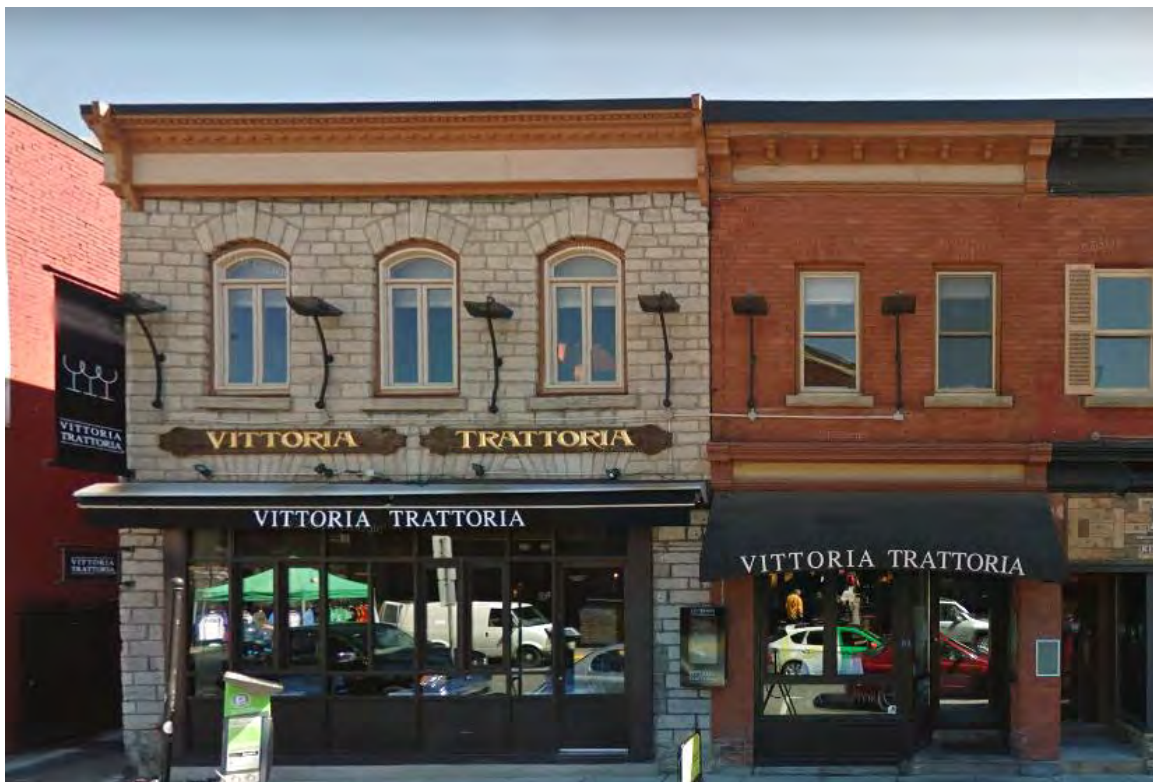
**Figure 6:** 35-37 William Street. (Google 2016)

- **35 William Street (constructed before 1872):** *Italianate commercial Vernacular style, 2 ½ storey stone building with flat roof and decorated wood cornice (original cornice was metal). Example of creative recycling of buildings that characterized the densely developed area of the market. Alterations to the building include significant reworking of ground floor façade and the replacement of the cornice; however, the façade is still preserving its integrity. The building is very compatible with heritage commercial environment in terms of scale, materials detailing, and function. It is a significant heritage component of one of the most important commercial rows in the city.*

- **37 William Street (constructed 1913):** Late 19<sup>th</sup> century commercial Vernacular style, 2 storey brick building with flat roof and decorated metal cornice. Reflects the transition of the street from a service area to a secondhand store center to a general retail area. The façade is simple but representing traditional composition of two-story commercial block. The scale, materials detailing, and function of the building are very compatible with heritage commercial environment. It is not an considered as a significant element individually, but it is an essential component of a very important commercial row defining the market core.

The two properties on the proposed development site are recognized as *Category 2* buildings listed under *Part V* of the *OHA* as part of the *Byward Market Heritage Conservation District*. This category is comprised of "buildings of heritage significance" (See Figures 6).

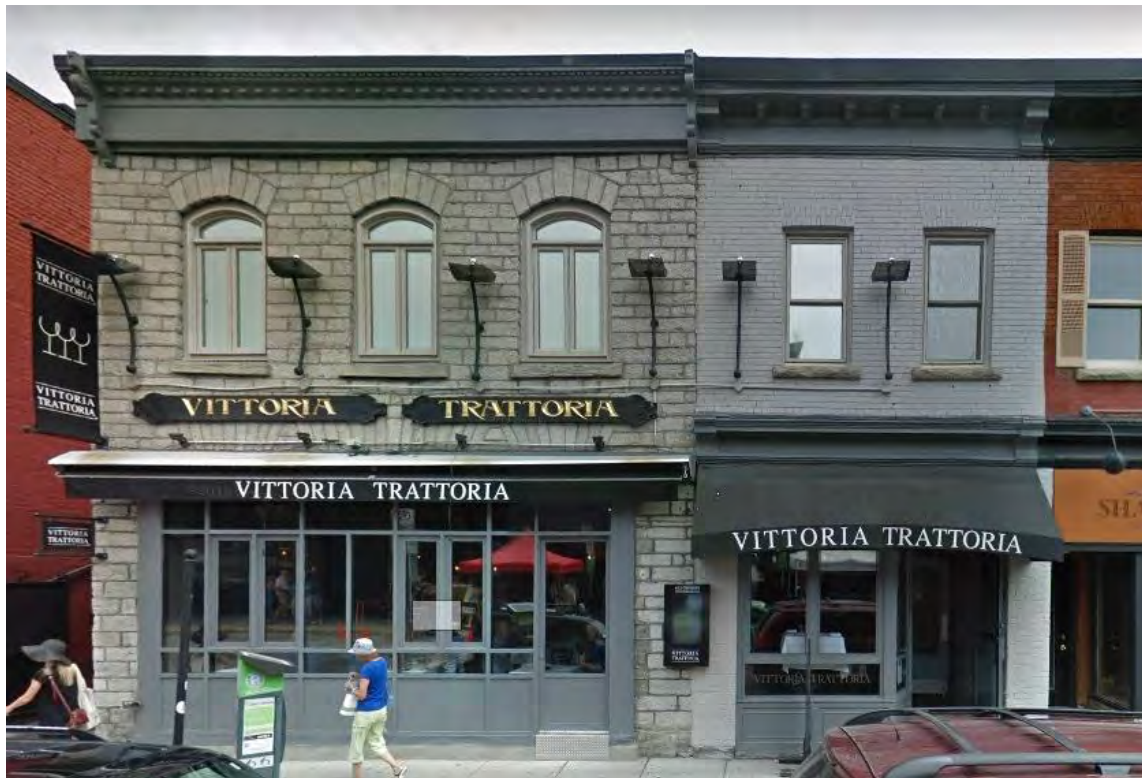
Figure 7: 35-37 William Street. (Google 2018)

Aside from some slight alterations, the existing buildings at 35-37 William Street have retained their architectural integrity.

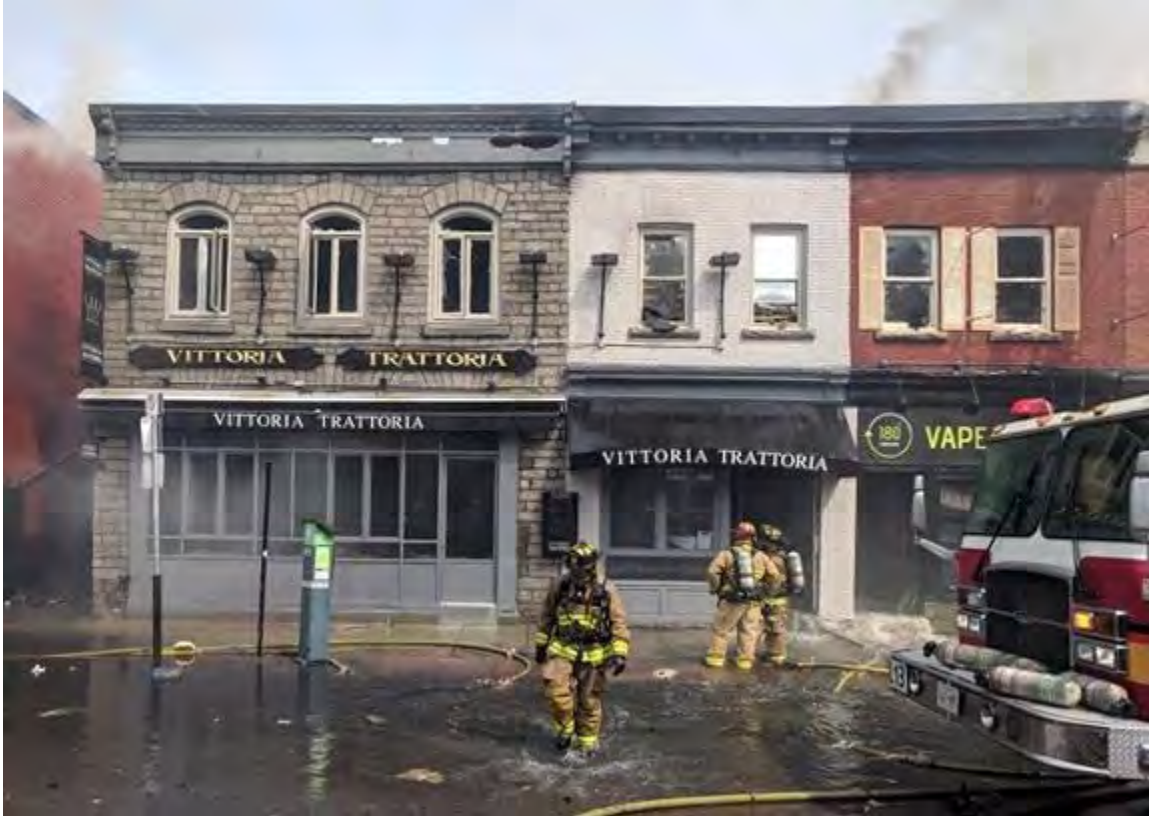
**Figure 8:** Fire at 35 William Street, April 12, 2019. Scott Stilborn/ Ottawa Fire Service

On April 12, 2019, the Vittoria Trattoria restaurant witnessed a massive fire, which resulted in the loss of both buildings at 35-37 William Street. (See Figures 8-11).

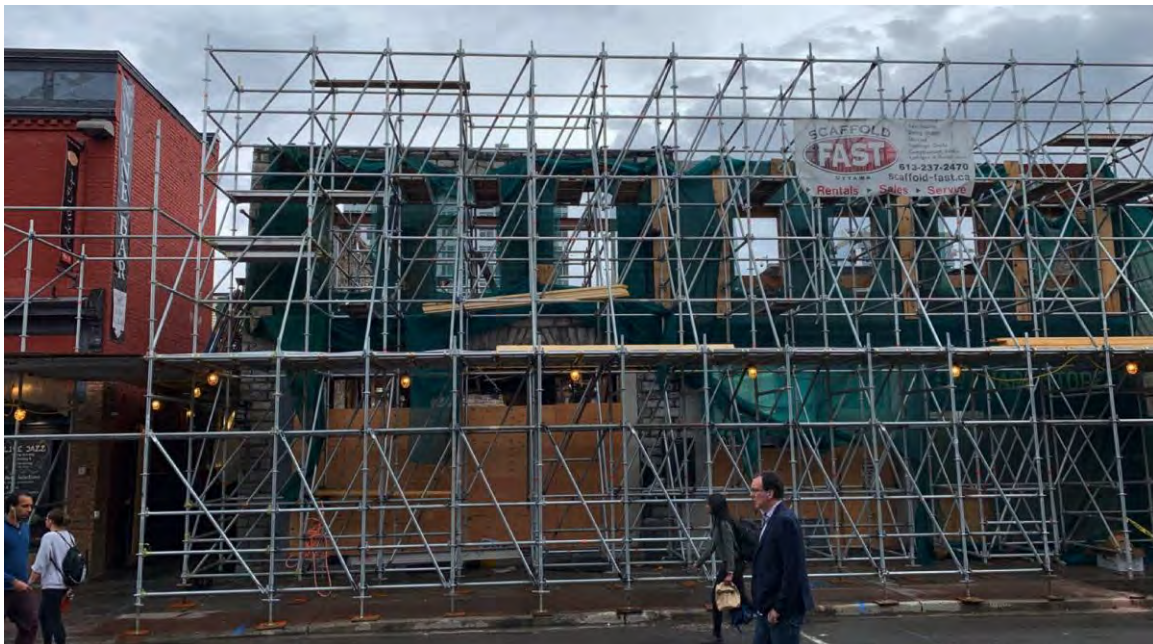
**Figure 9:** 35-37 William Street following the fire of April 12, 2019. (Barry Padolsky Associates Inc. Architects)

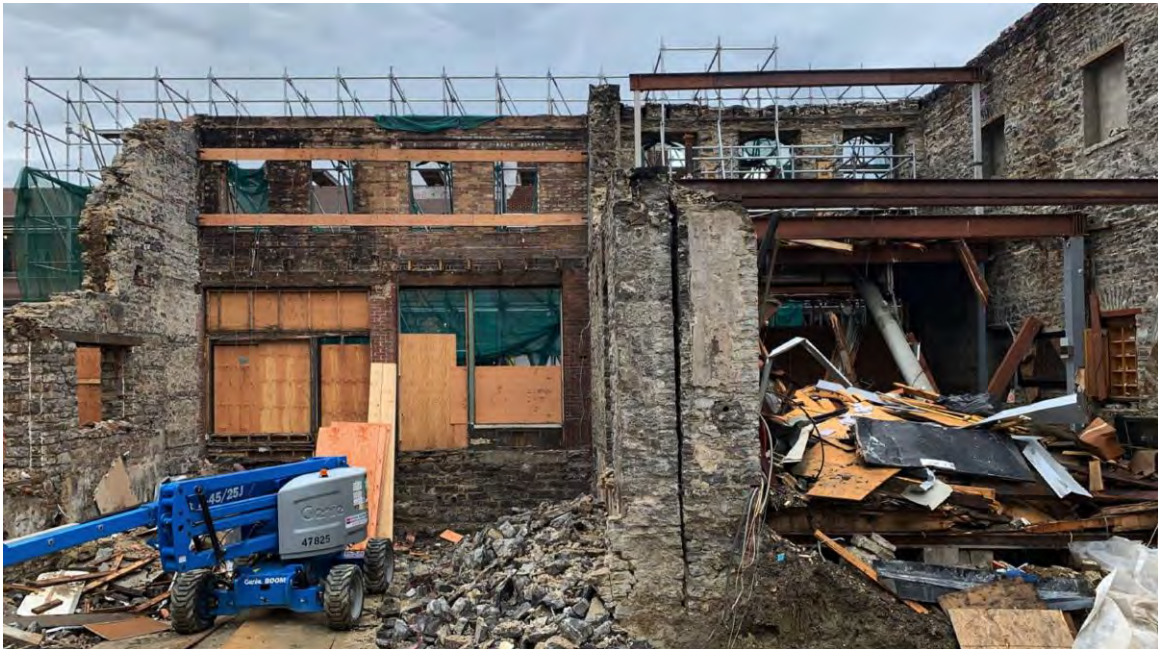
**Figure 10:** 35-37 William Street (inner structure) following the fire of April 12, 2019. (Barry Padolsky Associates Inc. Architects)

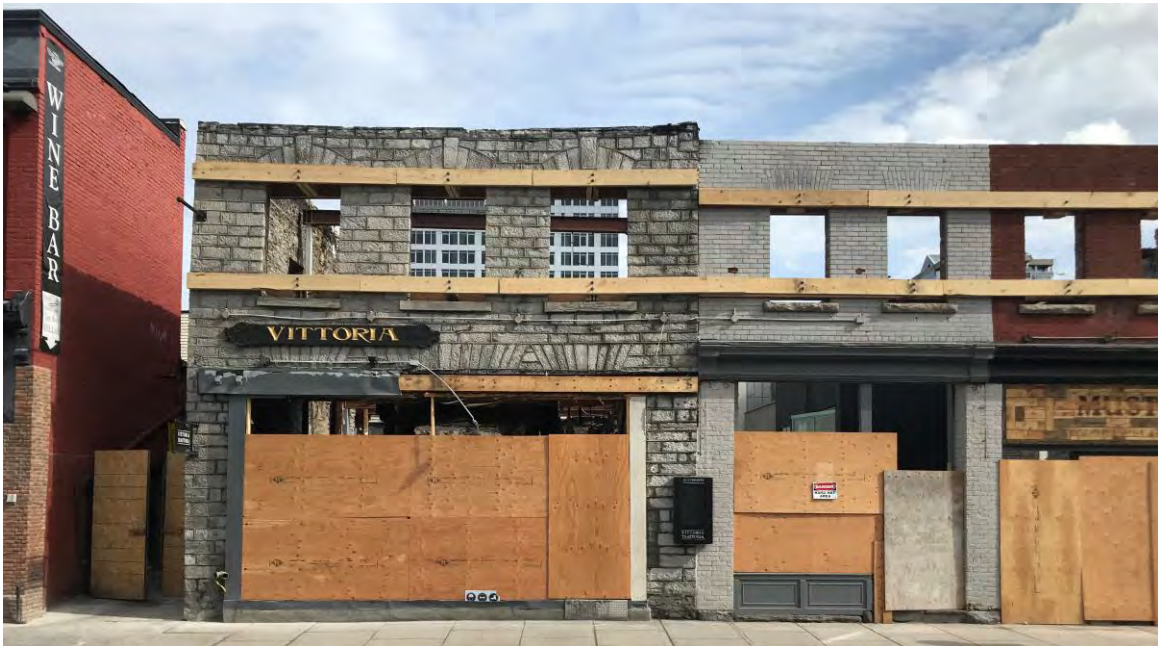
**Figure 11:** 35-37 William Street. RMA October 7, 2019.

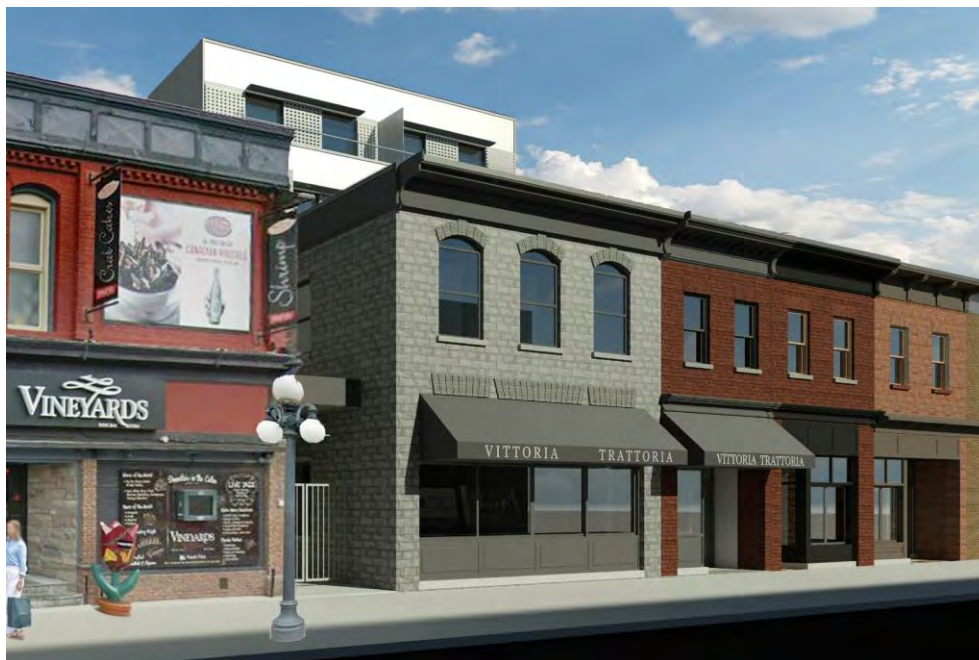
**Figure 12:** Model showing the development site within its urban context (KWC Architects)

Based on the comments received from the City of Ottawa Senior Heritage Planner Sally Coumts the *Architect* produced new Schematic Architectural sketches dated December 12, 2019 (received December 20, 2019) responding to the City of Ottawa's requests. As such, the *Architect* has produced a design more in keeping with the character of the overall neighbourhood making the additional floors lighter in appearance and impact to the original buildings. From the public street realm, the additions have low visual impact. (See Figures 12-25)

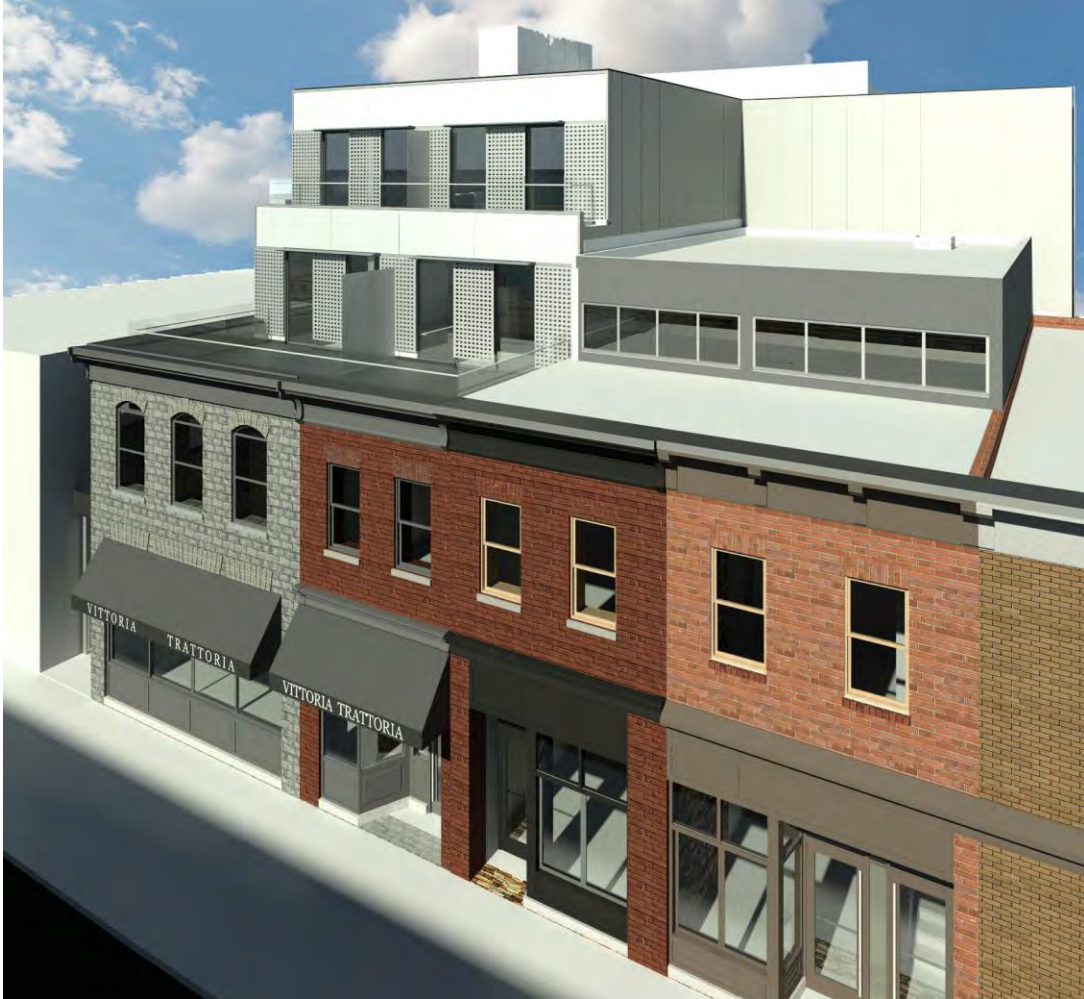
**Figure 13:** Model showing the development site within its urban context (KWC Architects)

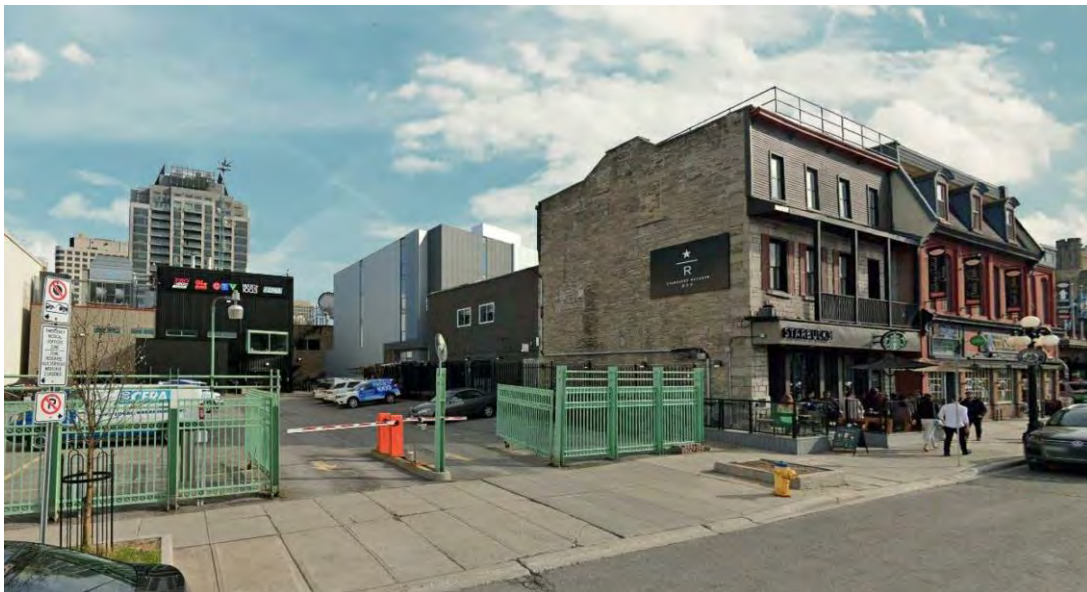
**Figure 14:** Model showing the eastern façade within its surroundings (KWC Architects)

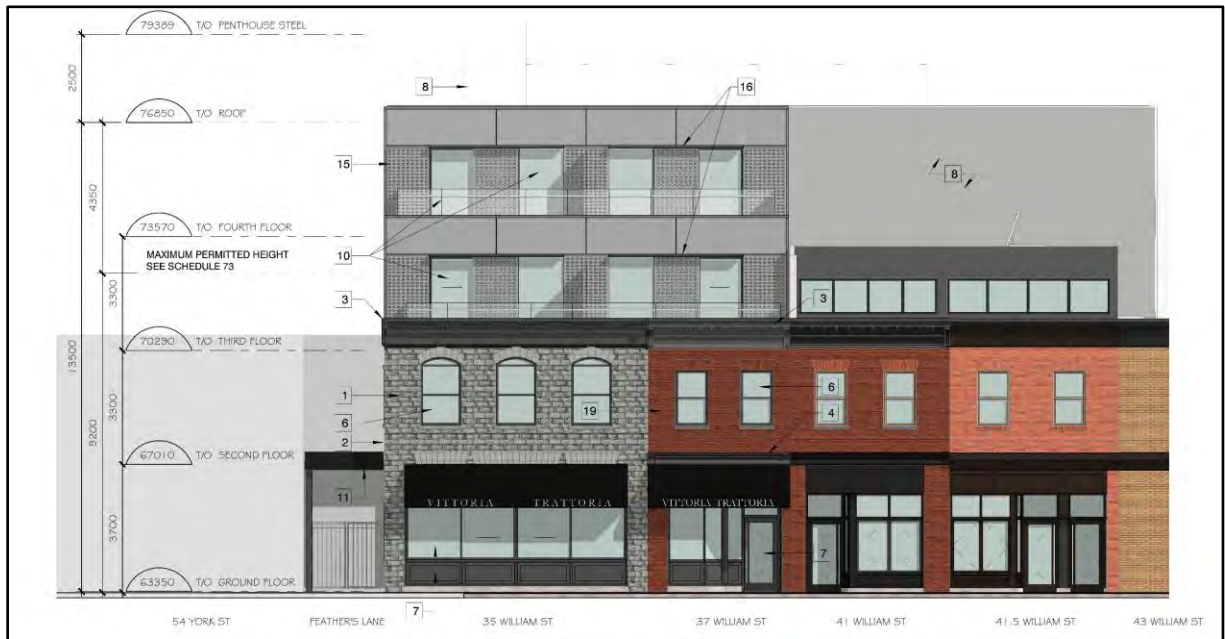
Figure 21: West Façade (KWC Architects)

The third and fourth floors of the main façade will have a prefinished perforated metal screen on top of new exterior wall assembly/curtain wall glazing. The new façade at Feathers Lane will have sintered ceramic façade panel cladding and corrugated metal cladding. The south façade is setback and has similar cladding to the main façade. The enclosure of the new north, south, east and west facades of the third and fourth floors of the building is proposed as sintered ceramic facade panel (dark grey, white above roof). The apartment entrance from the York Street Lane will be clad with the reclaimed stone from 35 William Street.

The new one-over-one metal clad wood windows at the second-floor level of 37 William Street, the metal window and patio door systems within curtain wall glazing system at the second (east and south façades), third and fourth floors (dark grey frames) with horizontal metal fin on curtain wall mullion and clear glass balcony railings around the outdoor terraces and "Juliet" balconettes, and the new glazed metal framed store fronts and metal panel at the ground floor level of 35 and 37 William Street will be installed to match the heritage character of these buildings. It is of note that neither the colour of Feathers Lane's façade's windows, nor the colour of William Street façade's windows are specified on the drawings submitted for construction permit; RMA presumes that dark grey metal clad wood windows are installed on the entire development structure.

The new wood cornice at the top of the second-floor of 35 and 37 William Street will match the details of the former cornices destroyed by the fire. In addition, a new wood panel aligned with the wood cornice at front of 35 William street will be added. The exterior Feathers Lane passage will be covered by a steel light-structure roof supported by freestanding steel posts along the exterior back wall of 54 York Street. Both ends of this structure will have metal dark grey fascia.

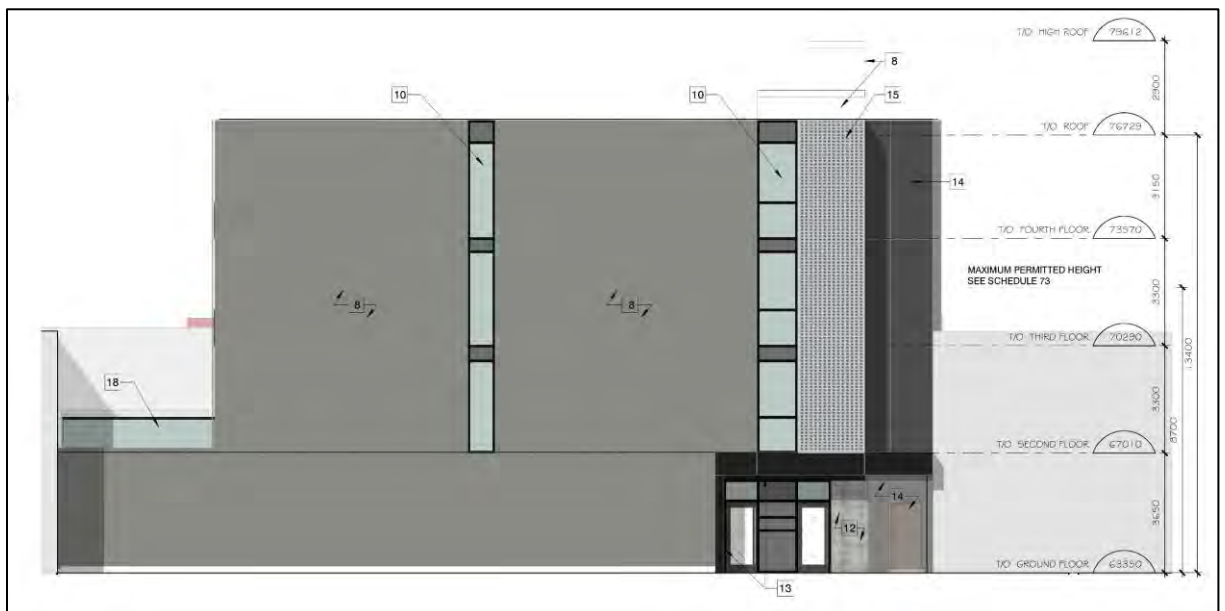
Figure 22: East Façade (KWC Architects)

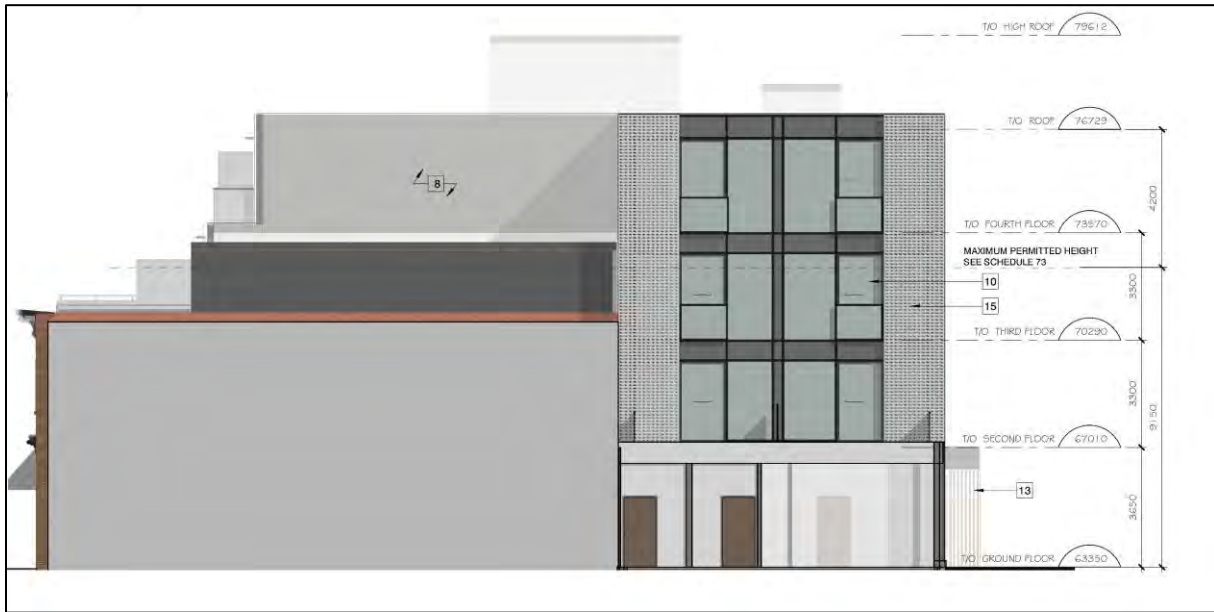
Figure 23: South Façade (KWC Architects)

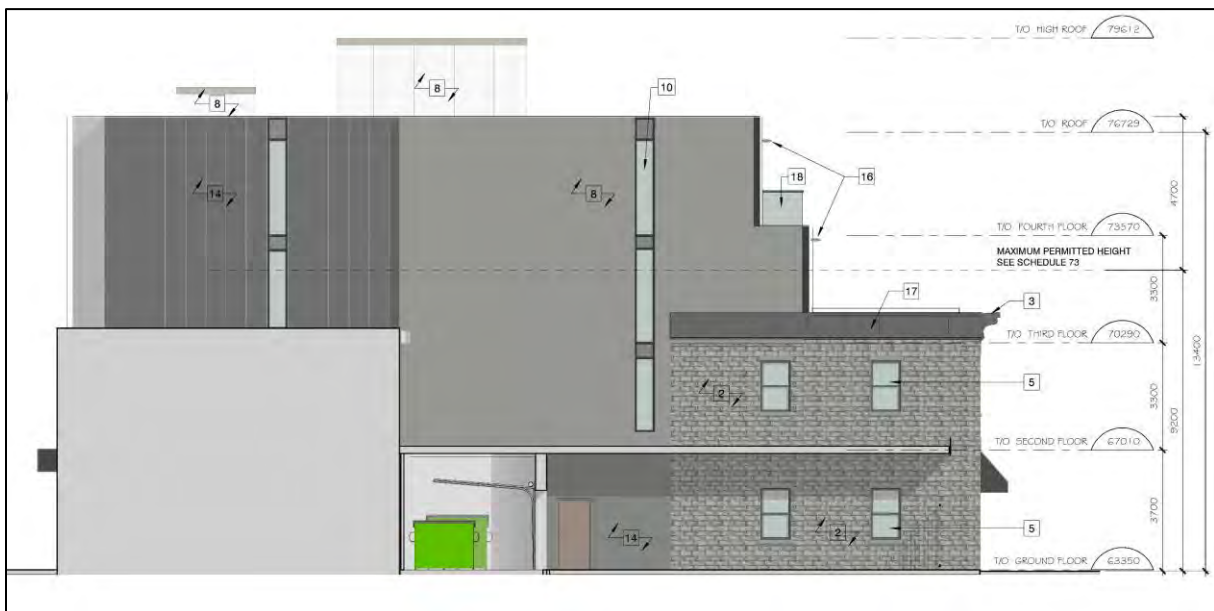
Figure 24: North Façade (KWC Architects)

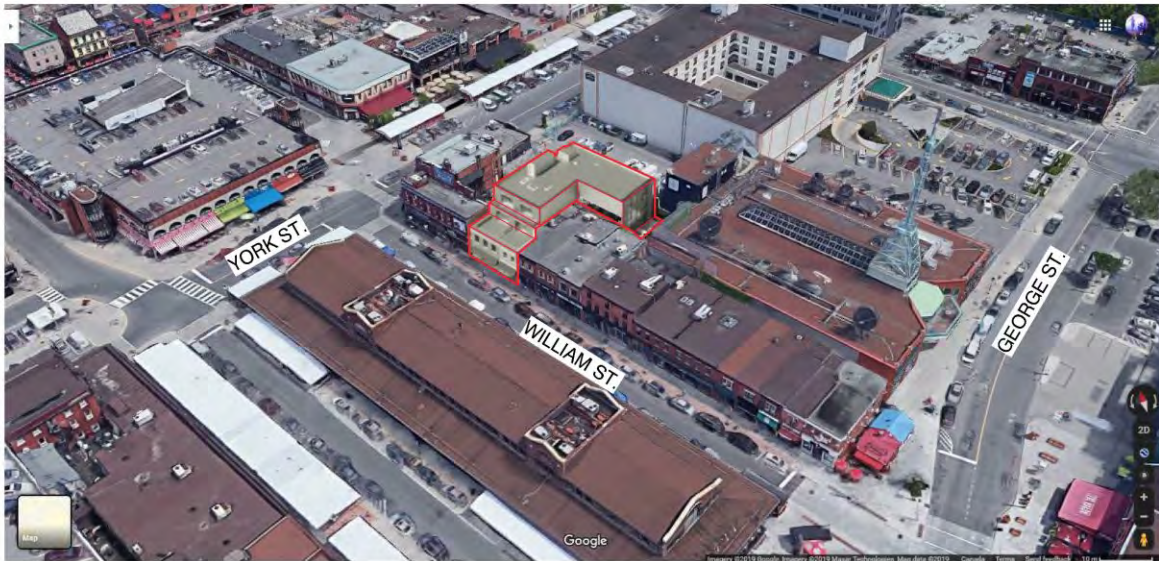
H-01

SITE PLAN  
1 : 300

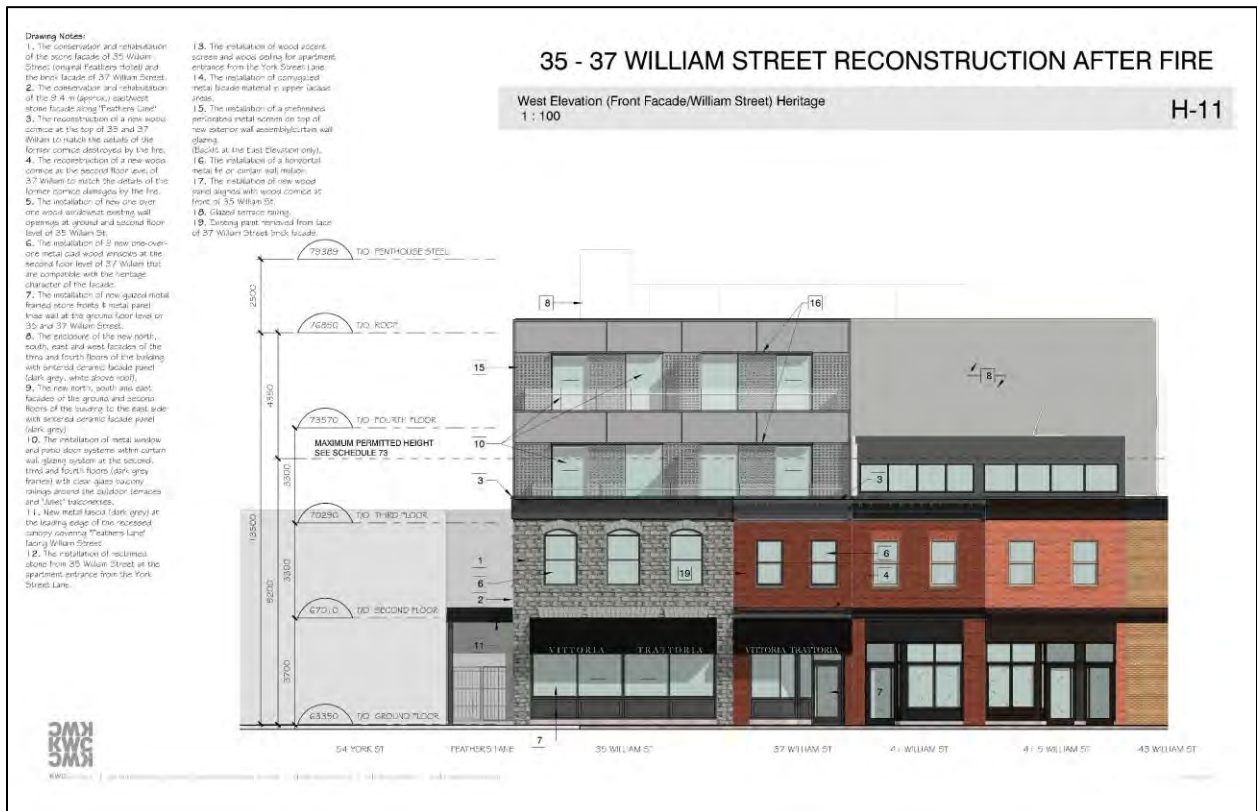
1. The conservation and rehabilitation of the stone facade of 35 William Street; (original Featherstone Hotel) and the brick facade of 37 William Street.

16. The installation of a horizontal metal fin or curtain wall railing.
17. The installation of new wood sand against with wood cornice at front of 35 William St.

18. Clipped cornice coping.
19. Existing paint removed from facade of 37 William Street brick facade.

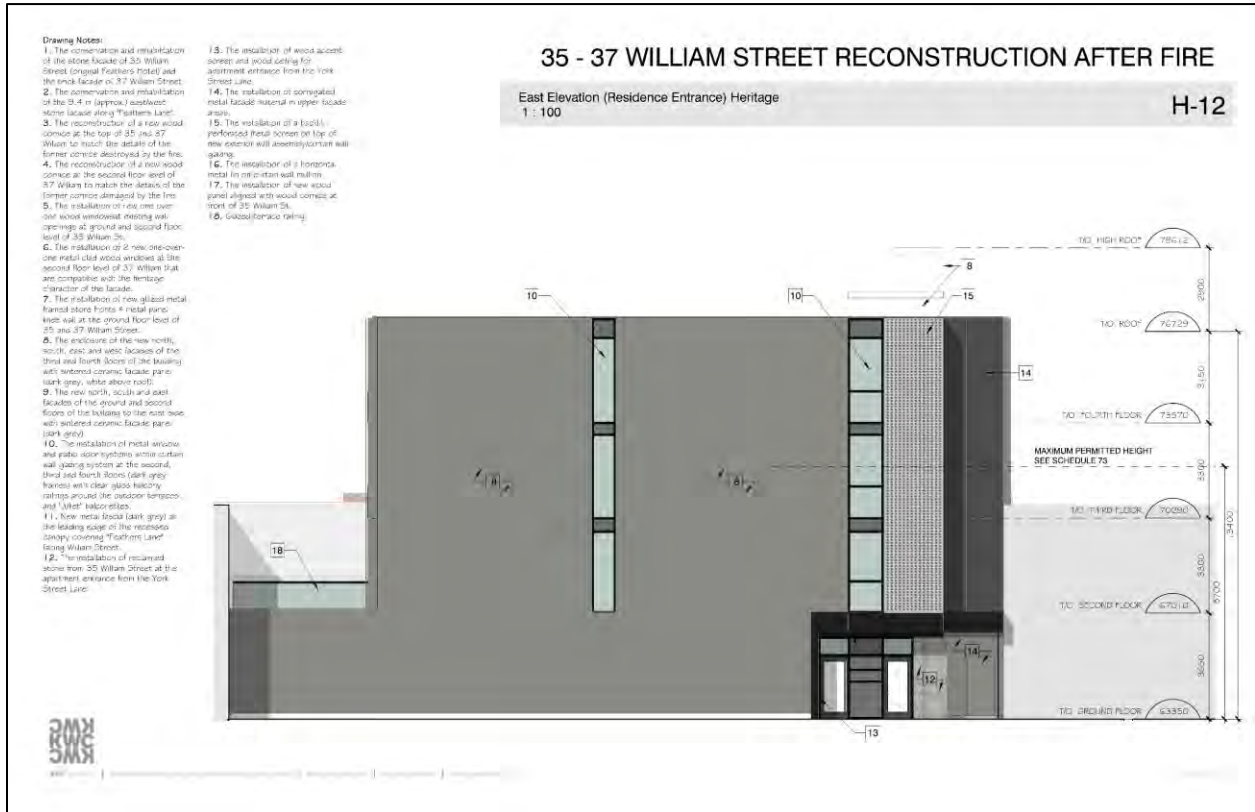
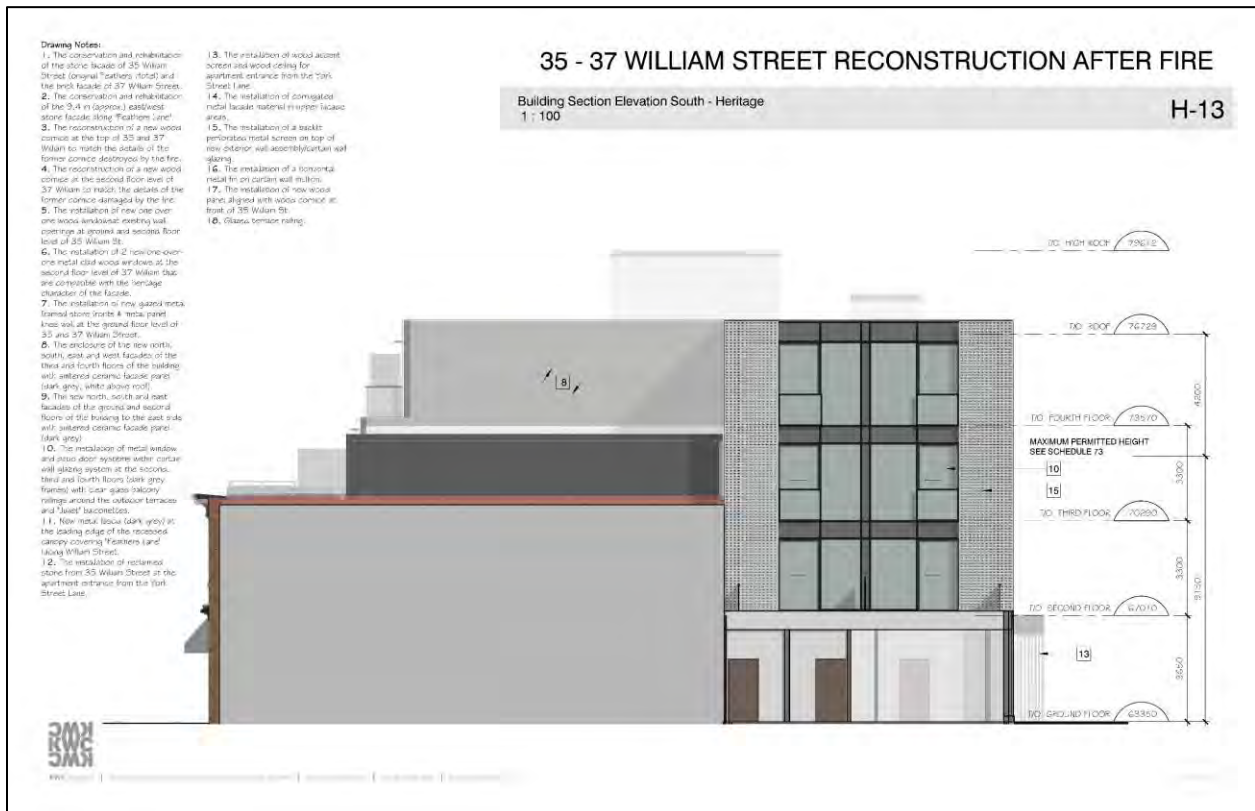
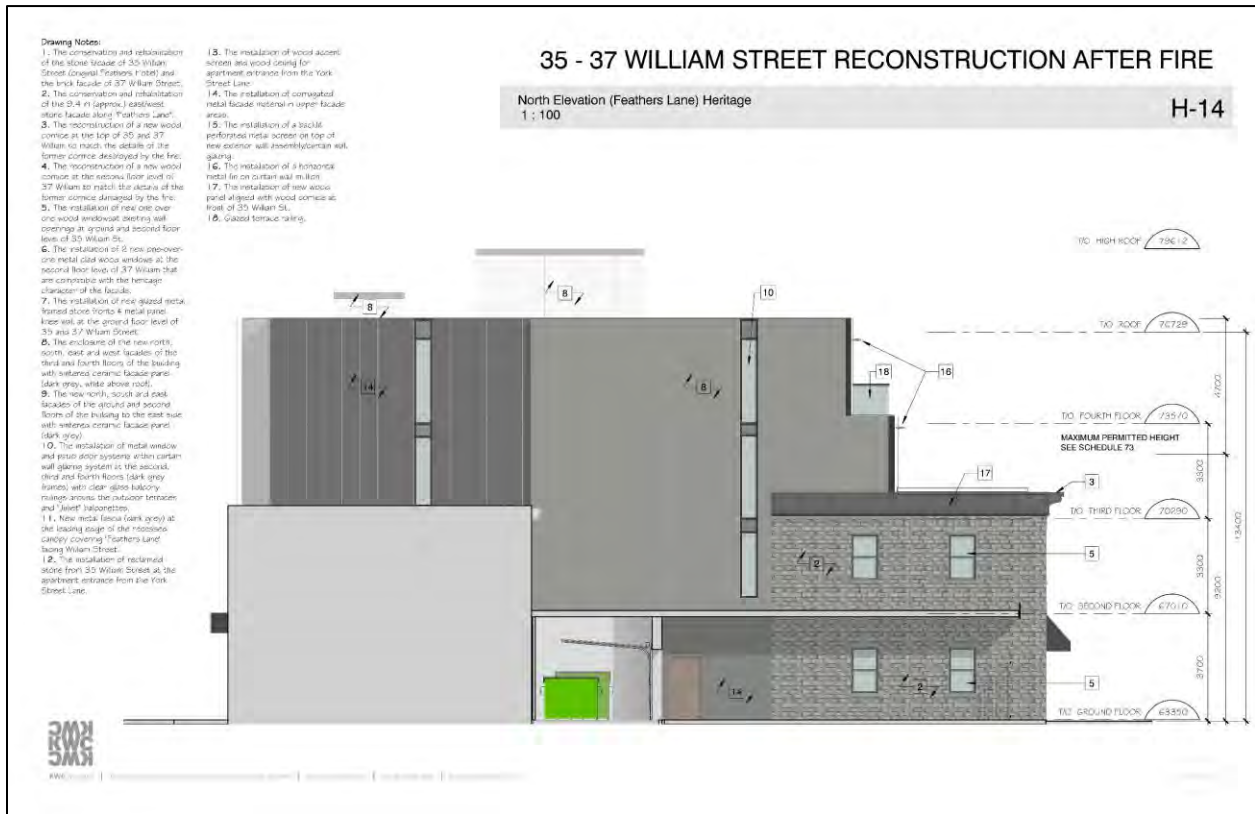
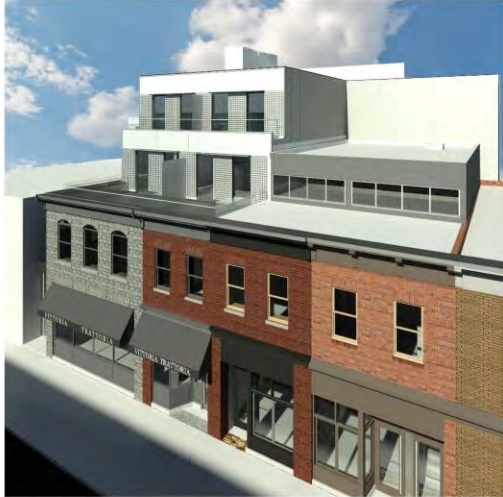
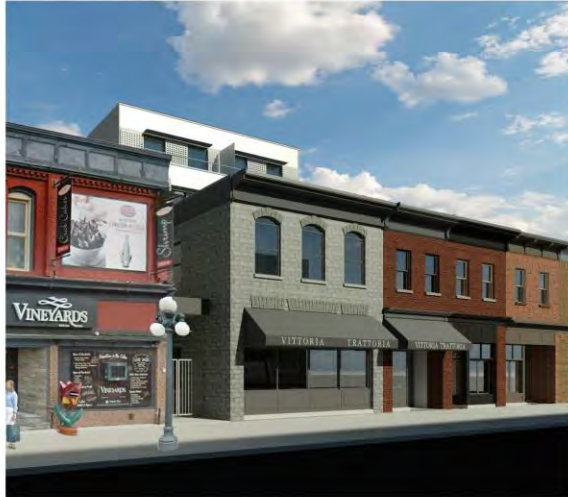
H-16

### 35 - 37 WILLIAM STREET RECONSTRUCTION AFTER FIRE

View from William St

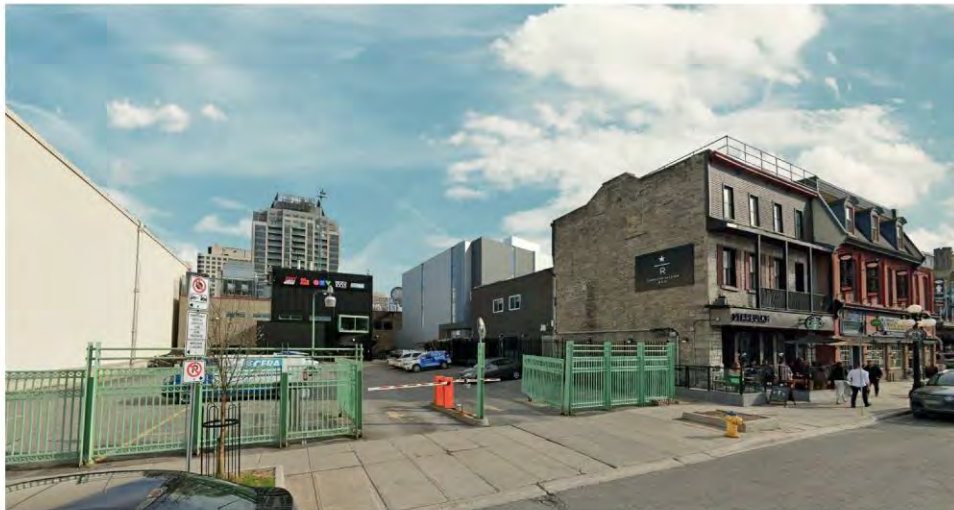
### 35 - 37 WILLIAM STREET RECONSTRUCTION AFTER FIRE

Renderimage View from York St.
