Municipal Address: 35 William St.
 Building Name: Sunset Seafood
 Legal Description: Pt York S
 Date of Construction: before 1872
 Original Use: Feathers Hotel
 Present Use: restaurant
 Present Zoning: CAH-x-1C*13*
 Planning Area: Central Area N.E.

PHASE ONE SURVEY

HERITAGE DISTRICT NAME:
 Byward Market

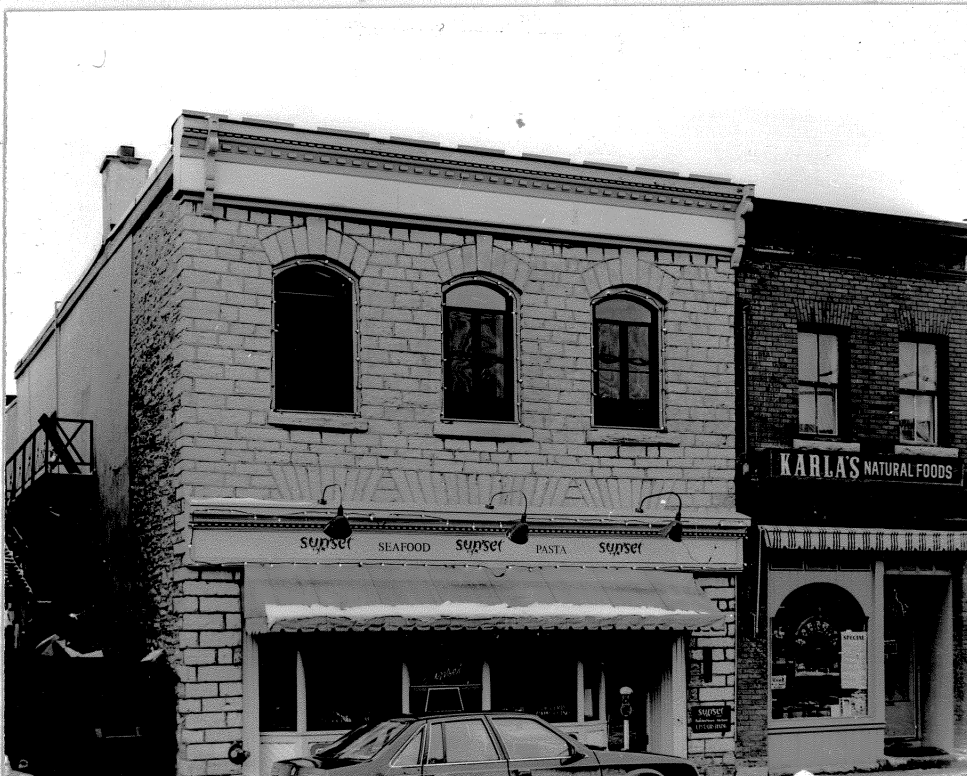
NEGATIVE NUMBER: 92-3

Architectural Design (Plan, Storeys, Roof, Windows, Materials, Details, Etc.): 2 1/2-storey stone commercial block. Original ground floor pattern of openings still visible in stonework, but modified to asymmetrical wood storefront. Second floor segmental-arch windows - original openings with new sashes. Decorative wood cornice not original. Regular coursed dressed limestone on front facade, random course rubble elsewhere.

Architectural Integrity (Alterations): Significant reworking of ground floor facade; changed cornice.

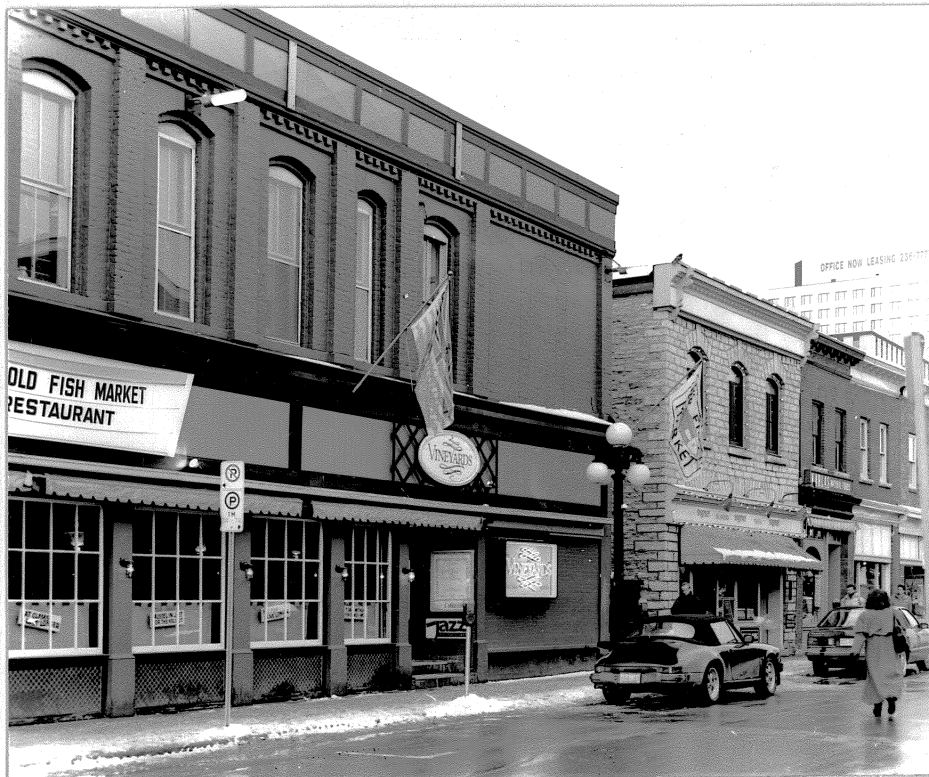
PHOTO DATE: Jan 1990
VIEW:
SOURCE: H Schade
NEGATIVE NUMBER: 92-A

Compatibility With Heritage Environs: Very compatible with heritage commercial environment in terms of materials, scale, detailing and function. Strong contributing element to the eclectic heritage character of this commercial row.
