HERITAGE SURVEY
 AND
 EVALUATION FORM

Municipal Address: 41 1/2 William St.
 Building Name: Pepper Pot / Duvet Shop
 Legal Description:
 Date of Construction: 1913
 Original Use: second hand store
 Present Use: commercial
 Present Zoning:
 Planning Area: Central Area N.E.

HERITAGE DISTRICT NAME:
 Byward Market

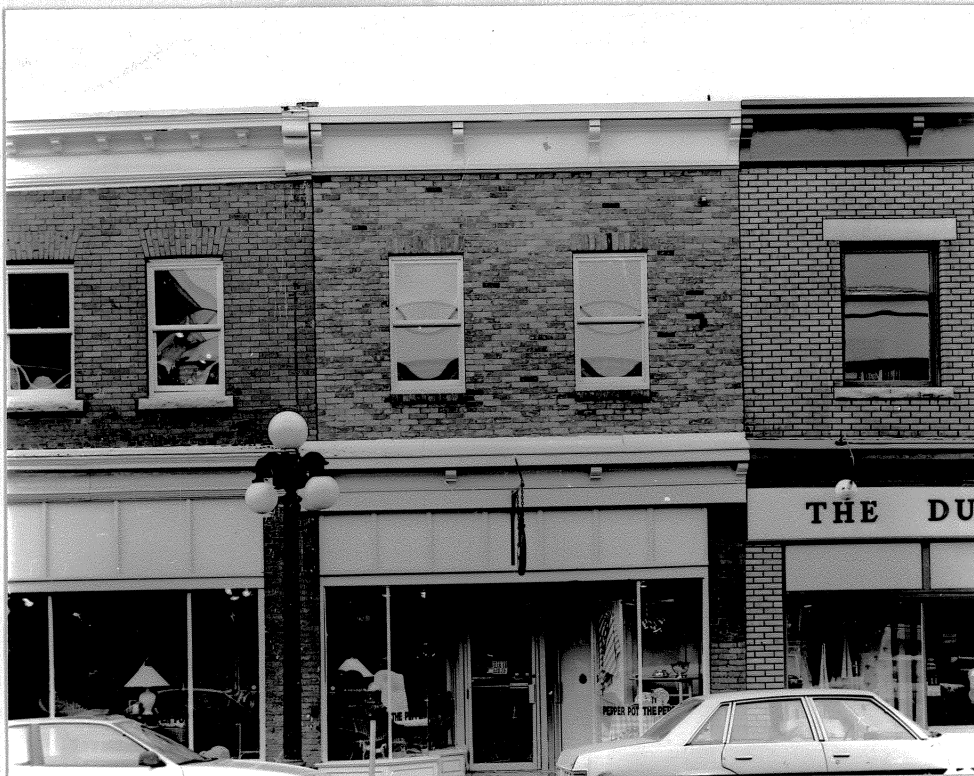
PHOTO DATE: Jan 1990
 VIEW:
 SOURCE: H Schade
 NEGATIVE NUMBER: 92-6B

Architectural Design (Plan, Storeys, Roof, Windows, Materials, Details, Etc.): Simple two-storey brick commercial block. Reworked ground floor storefront, second floor brick veneer with regular window openings, decorative metal cornices above storefront and at roofline.

Architectural Integrity (Alterations): Reworked ground floor, brick veneer may have been redone.
