| <p>1. APPLICATION TO DEMOLISH 234 O'CONNOR STREET, A PROPERTY DESIGNATED UNDER PART V OF THE <i>ONTARIO HERITAGE ACT</i> AND LOCATED IN THE CENTRETOWN HERITAGE CONSERVATION DISTRICT</p> <p>DEMANDE DE DÉMOLITION VISANT LE 234, RUE O'CONNOR, UN BIEN DÉSIGNÉ EN VERTU DE LA PARTIE V DE LA <i>LOI SUR LE PATRIMOINE DE L'ONTARIO</i> ET SITUÉ DANS LE DISTRICT DE CONSERVATION DU PATRIMOINE DU CENTRE-VILLE</p> |

File Number: ACS2016-PIE-PGM-0157

**SUBJECT:** Application to demolish 234 O'Connor Street, a property designated under Part V of the *Ontario Heritage Act* and located in the Centretown Heritage Conservation District

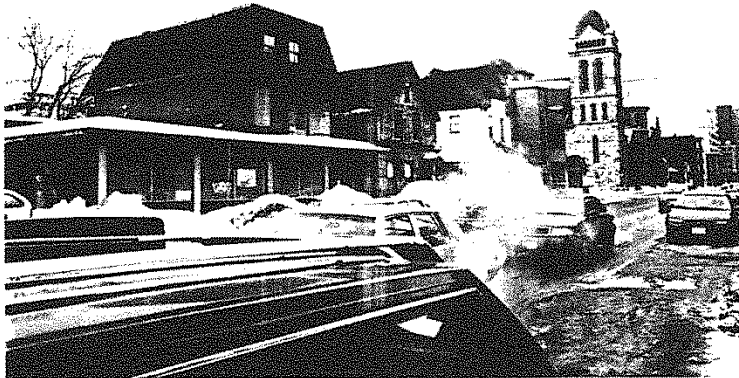
PHOTO DATE: Winter 1996  
VIEW: NW  
SOURCE: *DA*  
NEGATIVE NUMBER: *OCO-21*
