Appendix F

East Urban
Project: Community

Subject: Pre-Development Hydrogeological and Water Budget Assessment, East Urban Community
Mixed Use Centre Development – Preliminary Findings

EAST URBAN COMMUNITY PHASE 3 AREA COMMUNITY DESIGN PLAN GRADING PLAN

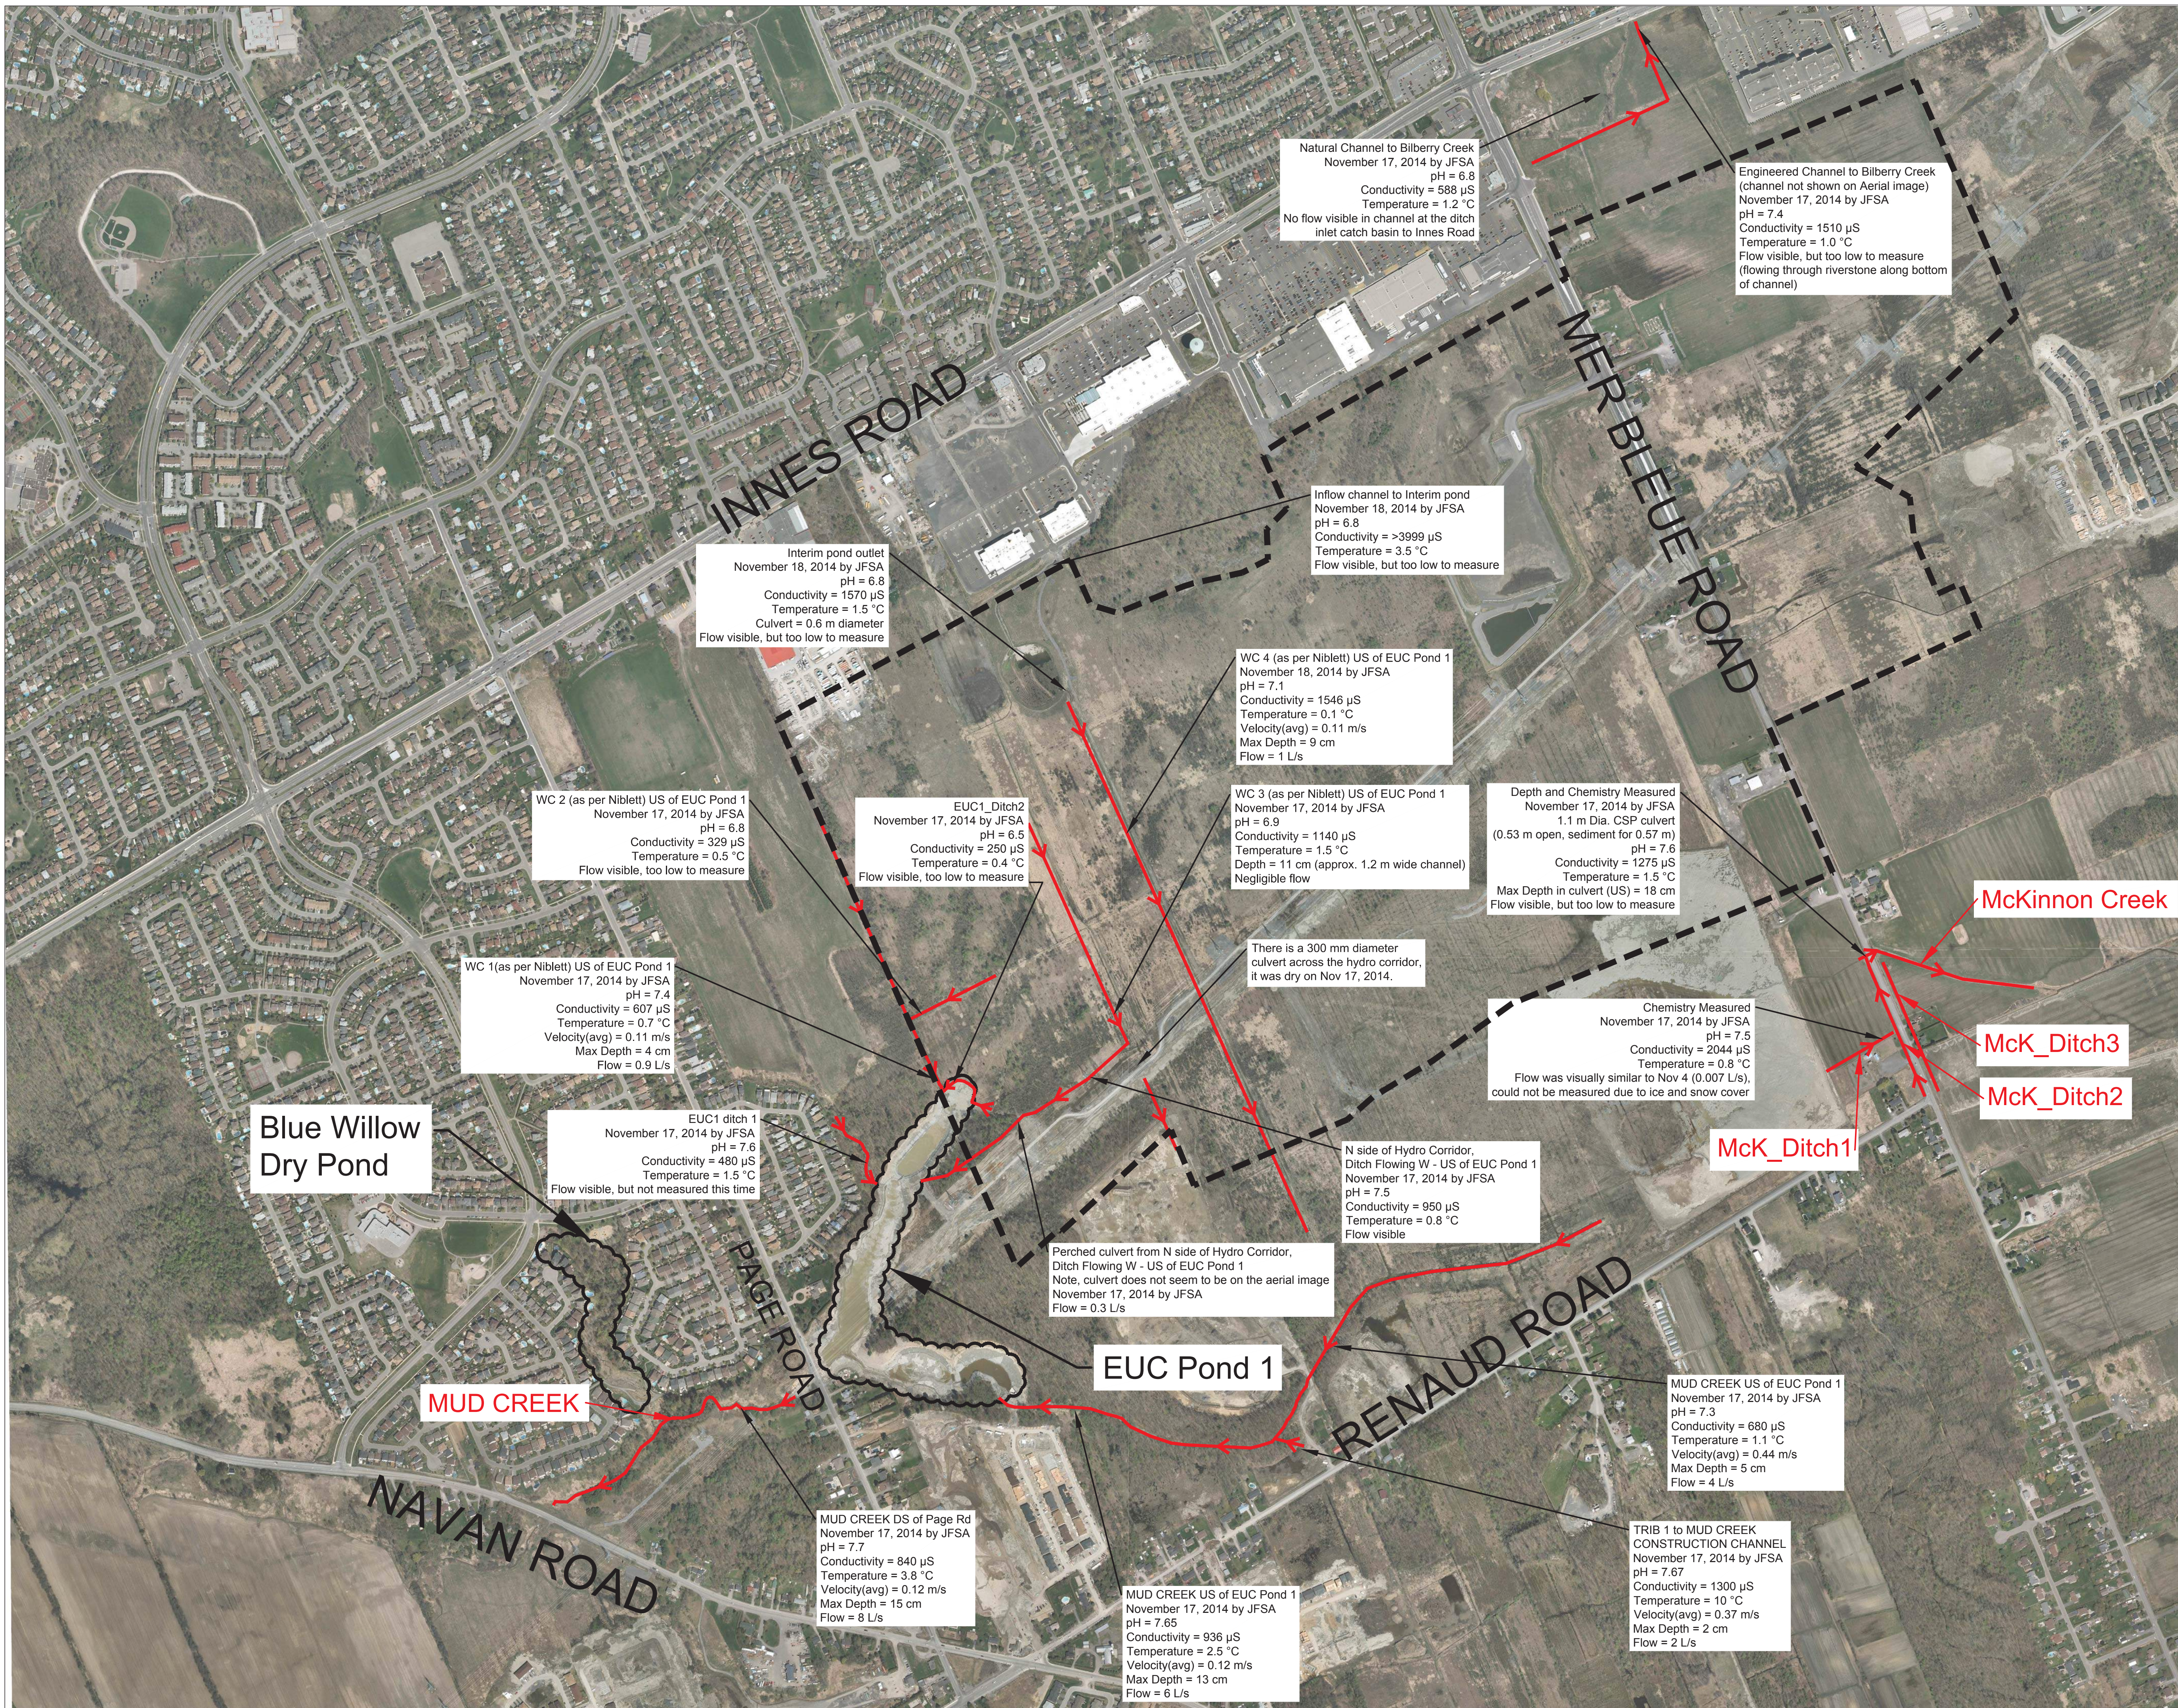
(November 17 and 18, 2014)

(from J.F. Sabourin and Associates Ltd.)

- EUC MUC SITE BOUNDARY
- DITCHES WHERE MEASUREMENTS WERE TAKEN

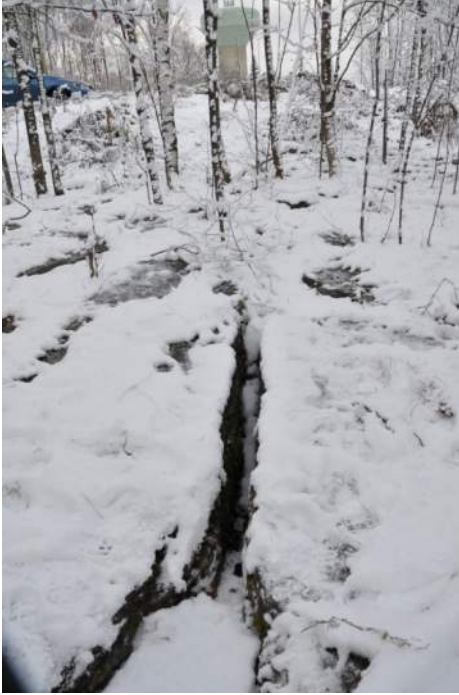
Photograph 1 ↑. Lindsay Formation Bedrock. Solution enhanced fracture at the end of Belcourt Blvd. Note the elevation drop from the parking lot. This is believed to correspond to a bedrock escarpment.

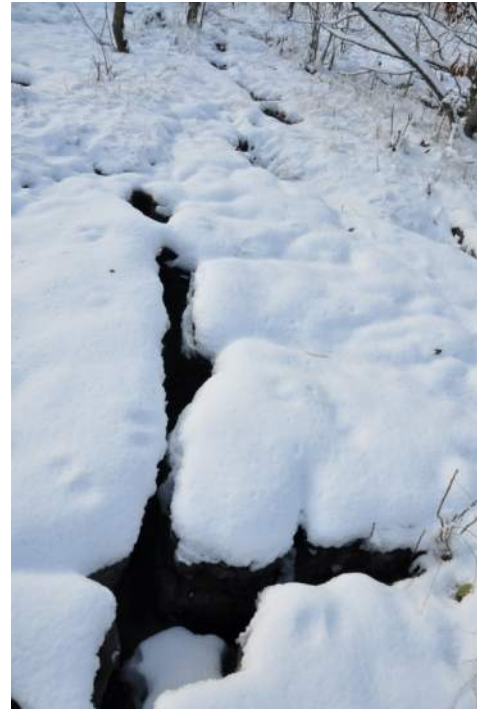
**Photograph 2 ↑
Lindsay Formation Bedrock. Solution enhanced fracture.**

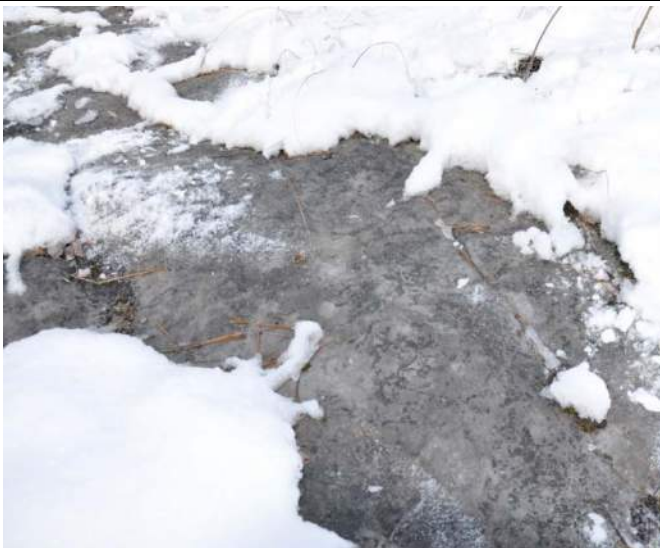
**Photograph 3 ↑
Lindsay Formation Bedrock.**

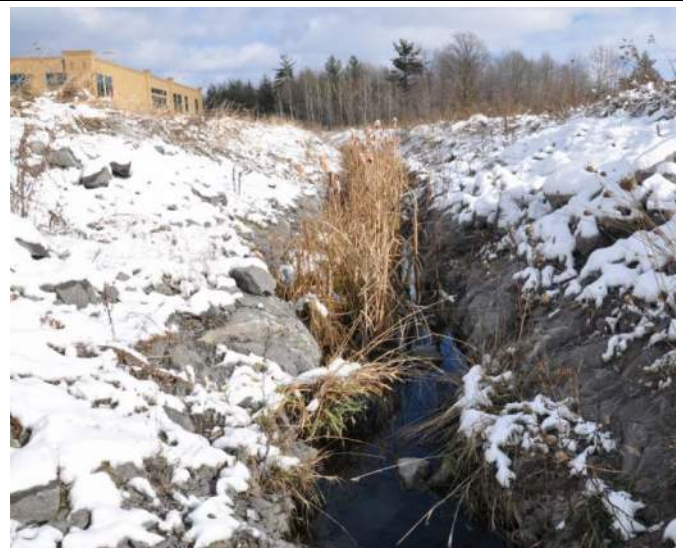
**Photograph 4 ↑
Lindsay Formation Bedrock within the drainage channel leading into the Interim SWM Pond.**

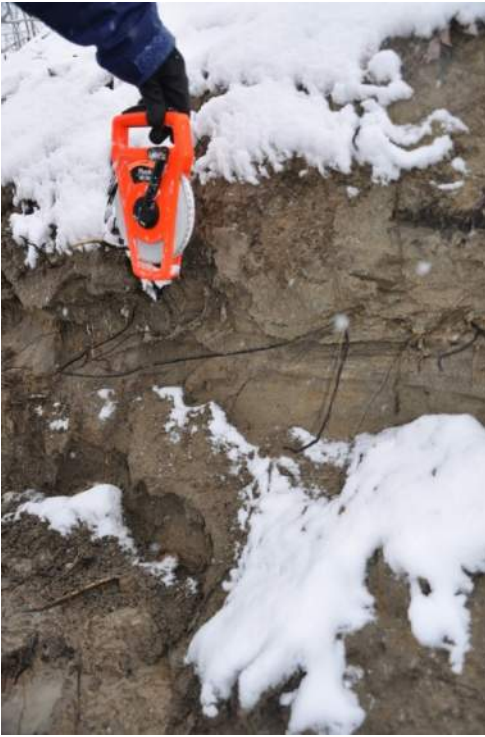
Photograph 5 ↑
Close up of side wall in groundwater fed channel. Note the 1m thick layer of fine sand over clay.

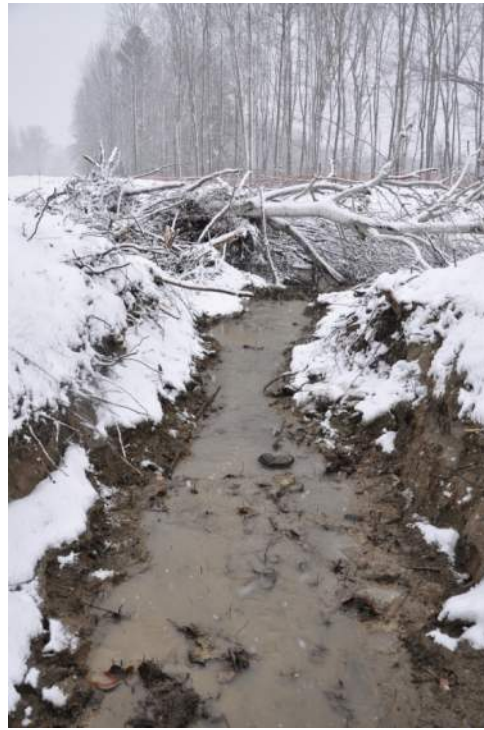
Photograph 6 ↑
GW Trib (Figure 1) Mud Creek. Groundwater fed cut channel flowing towards Mud Creek.

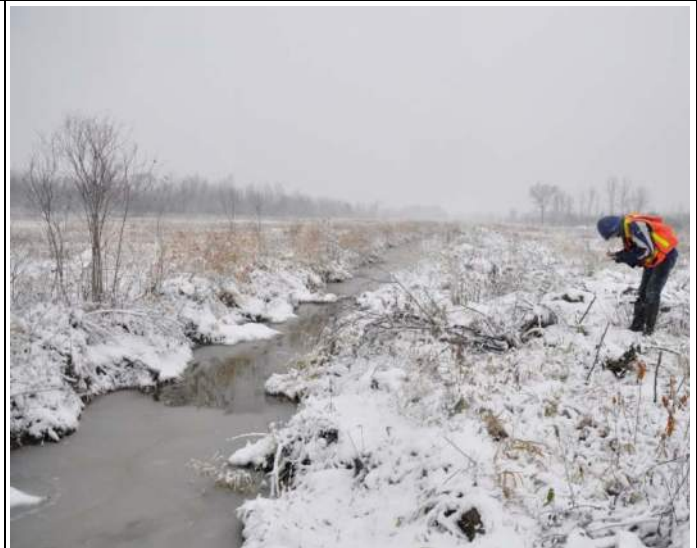
Photograph 8 ↑
WC3 surface water flow station.

The Mud Creek watershed within the site is drained by a series of shallow artificial drainage channels (photo 8). These channels were created to remove surface water and are not groundwater supported, although some very localized minor seepage from the perched water table may occur. South of the study area, the headwaters of Mud Creek are found within a well-defined channel, originating from groundwater discharge from the surficial sand aquifer (photo 7). At the time of the field visit, Mud Creek had a flow of approximately 8 L/s on the west side of Page Road, where it leaves the EUC MUC site (**Figure 1** and **Appendix A**). The site itself contributed about 2 L/s combined from the various artificial drainage features (WCs and Ditches). The main branch of Mud Creek (south of the site) before the EUC SWM Pong 1 was measured at approximately 6 L/s, with much of this flow interpreted to be directly from the surficial sand aquifer.

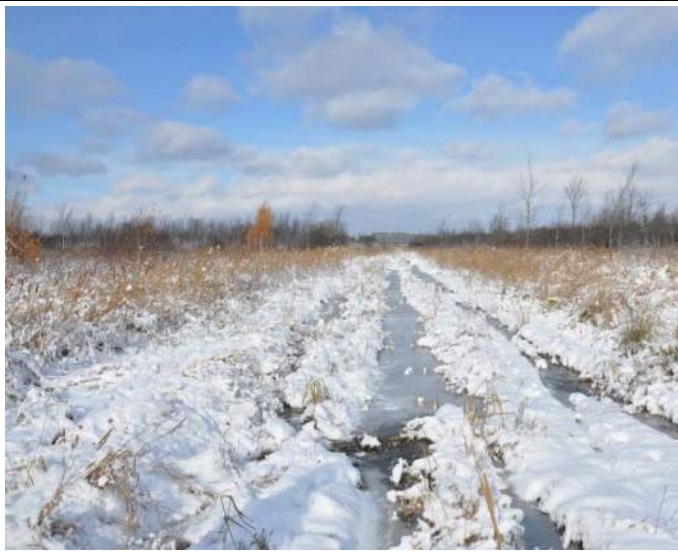
Photograph 9 ↑
Ponded water on the road leading north towards the Interim SWM Pond. WC4 is on the left.

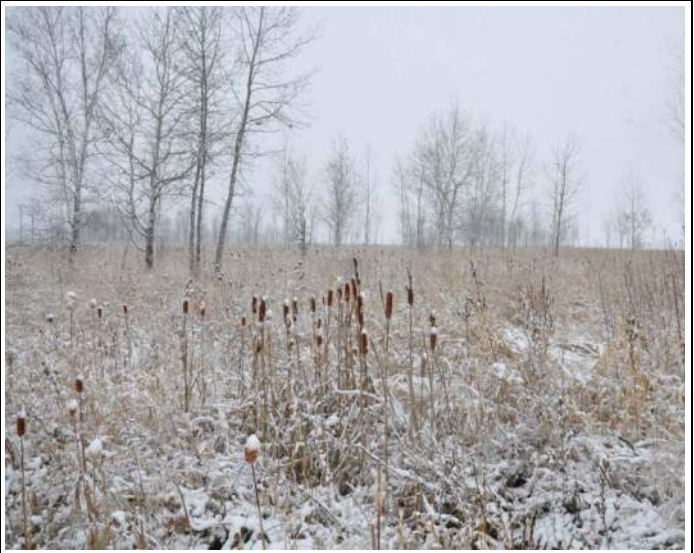
Photograph 10 ↑
Typical Cattail Shallow Marsh Community. Water is ponded at the base of the grasses.

The vegetation communities within the study area consist of wet meadows (photo 10), thicket swamps (photos 11 and 12), open field meadows (photo 12), and deciduous forests (Niblett Environmental Associates Inc., 2014). Niblett (2014) describes the formation of the standing water within wetland communities as a result of “pooling water”. This description matches what was observed during the November 2014 site visit by PECG and JFSA staff. None of the identified vegetation communities on the site are designated natural heritage features, and based on our understanding, are not protected under provincial policy. We also understand that the Innes Park Woodlot is not within the site boundary.

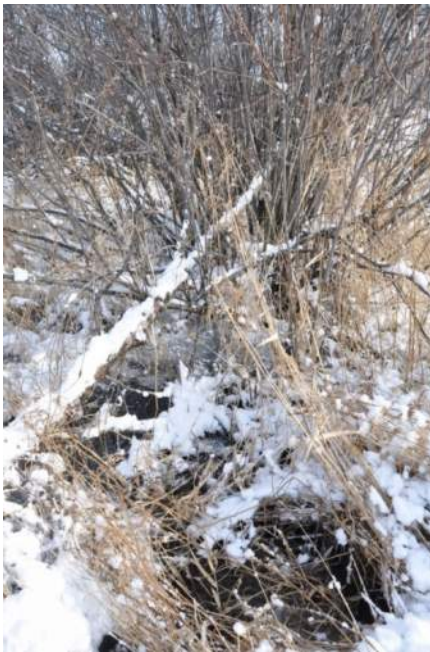
Photograph 11 ↑
Ponded water at the base of a dog wood tree.

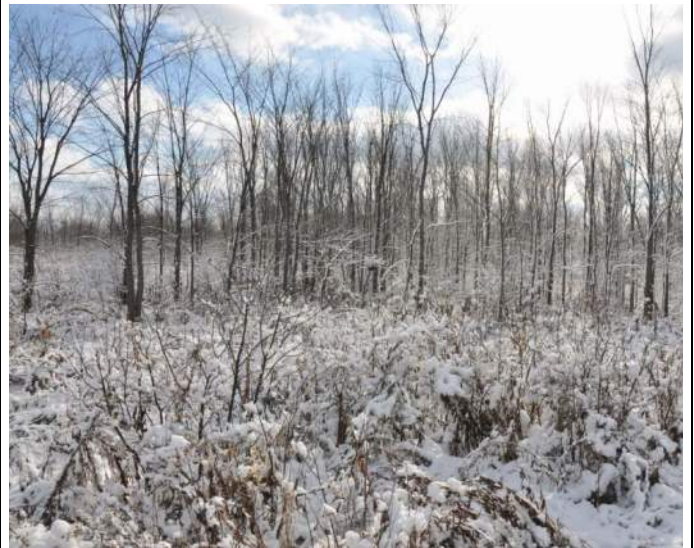
Photograph 12 ↑
Typical Ash Mineral Thicket Swamp Community. Water is ponded around the low shrubs.

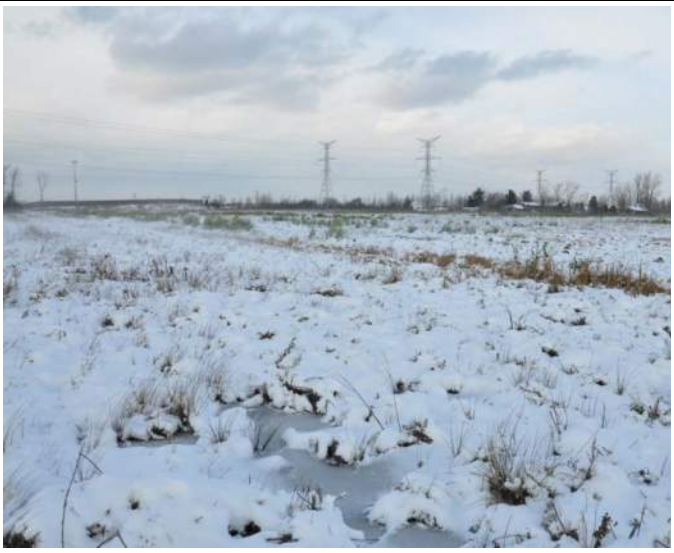
Photograph 13 ↑
Ponded surface water condition within the McKinnon Creek watershed

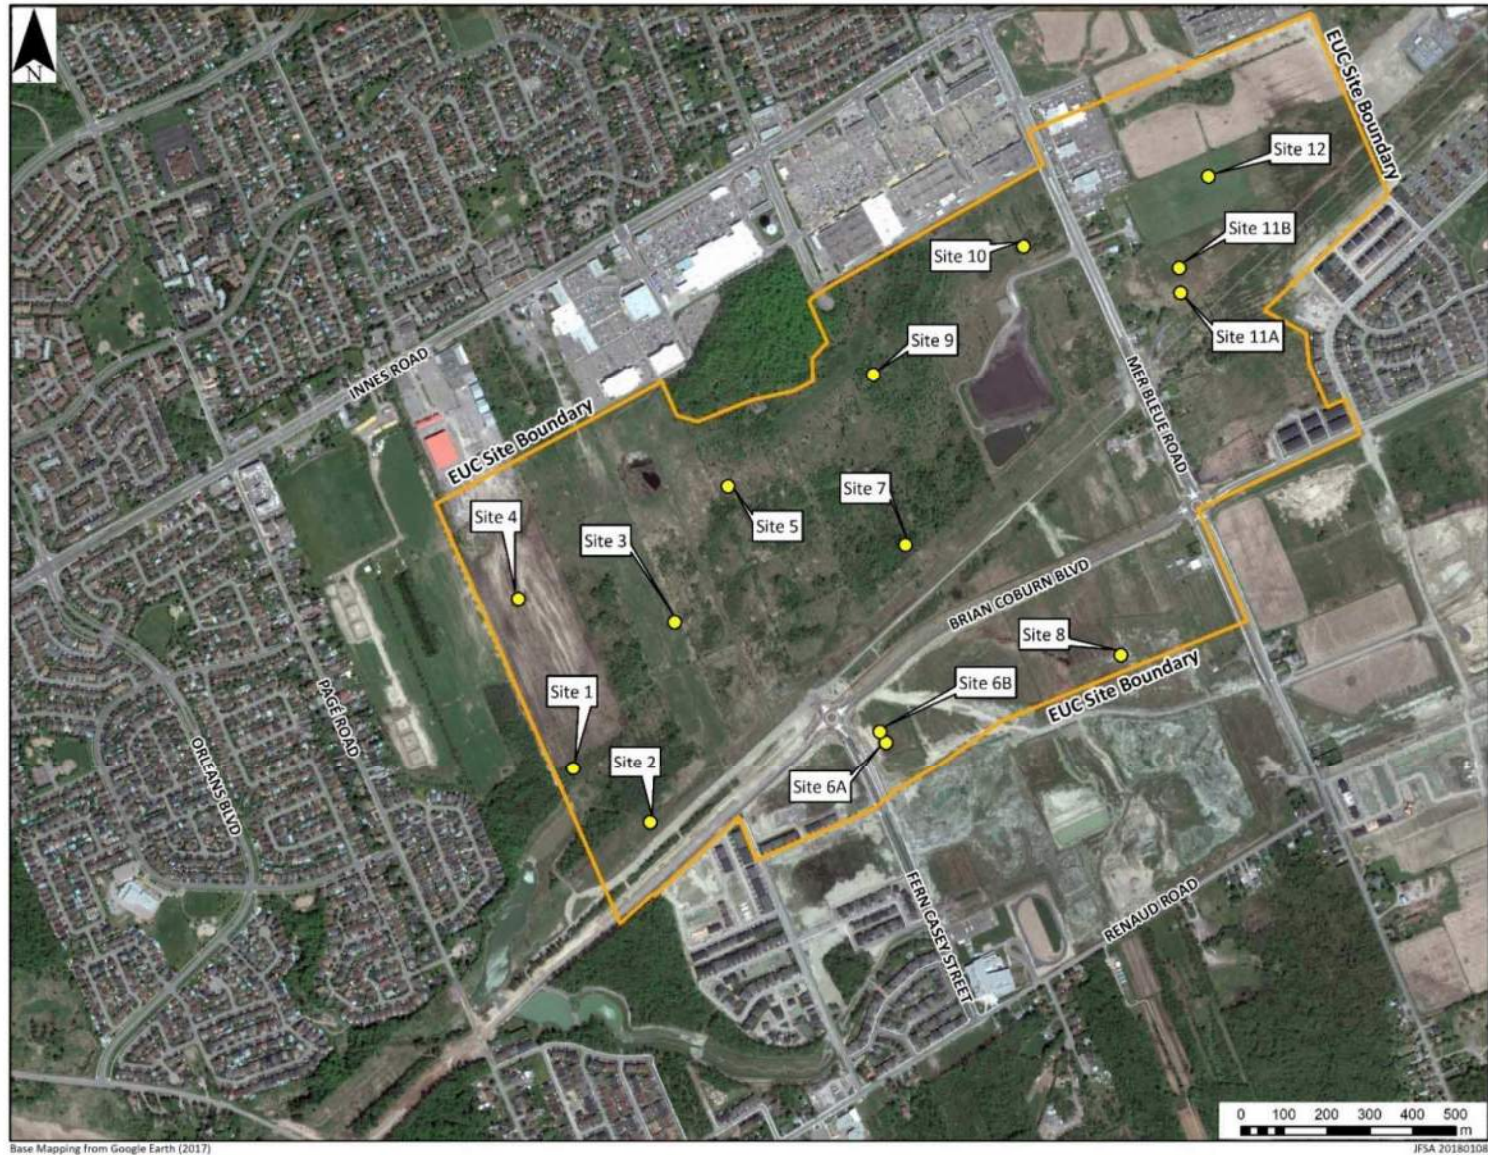
Figure 1: Infiltration and percolation measurement site locations and EUC site boundary

The infiltration testing sites were selected to obtain infiltration and percolation information focused on the different soil types (sand, marine clay and silty clay, and thin clay over bedrock), within both watersheds (Mud Creek and McKinnon's Creek), and to provide a good spatial distribution across the site. The 12 potential testing locations are shown on **Figure 1**.

The sites where field observations were made, and infiltration and percolation measurements were collected are shown in **Figure 1**. The sites are numbered 1 through 12, and subscript letters (ex. Site 11A) are used to indicate cases where tests were not conducted immediately adjacent to one another due to field conditions. Typically, all tests at a given site were conducted within a few metres of each other.

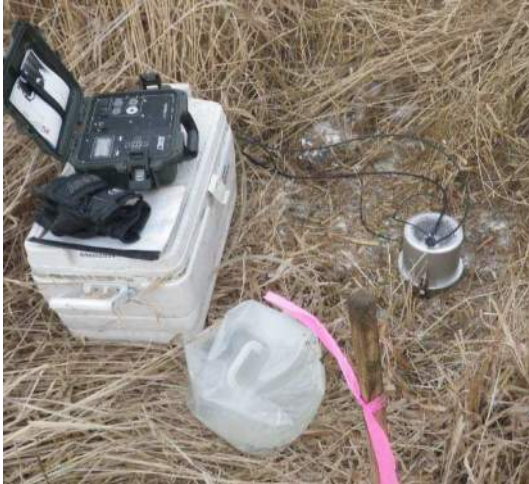
Figure 2: Dual-Head Infiltrometer Setup, control unit shown on the left, flexible water reservoir near the bottom and DHI unit setup on the right side of the image.

Infiltration testing was conducted at the ground surface using a Dual-Head infiltrometer (DHI), shown on **Figures 2 and 3**. The DHI was developed by Meter Environment, following theory described in Reynolds and Elrick (1990). The DHI setup consists of a ring inserted into the soil and a closed chamber connected to a water supply, wherein water is ponded on the soil and air pressure is used to create two different pressure heads. The instrument maintains water levels, measures inflow rate and performs the calculations to determine field saturated hydraulic conductivity (K_{fs}).

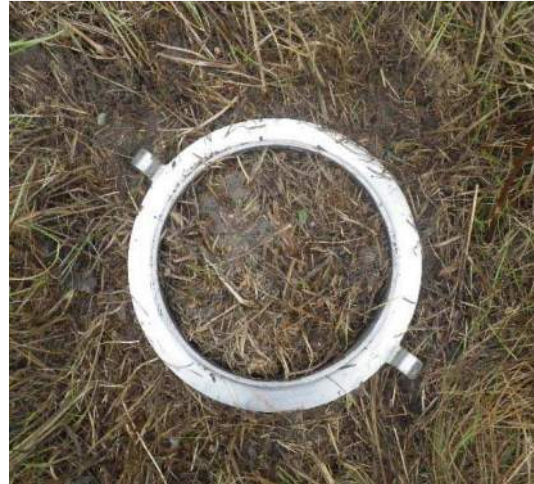
Figure 3: DHI cylinder installed at the ground surface (cylinder penetrates to 5 cm deep), prior to attaching the top of the unit and starting a test.

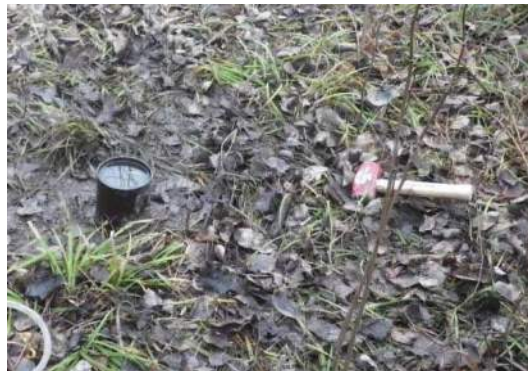
Figure 4: Single Ring Infiltrometer Setup, 11 cm diameter steel ring shown on the left of the image, failing head test in progress with water near the ring top.

The falling head tests were conducted using a 20 cm high, 11 cm diameter steel cylinder, Single Ring (SR) that was inserted into the soil, see **Figure 4**. Water was poured into the cylinder and the rate of fall of the water level in the cylinder over time was recorded to provide an infiltration rate estimate.

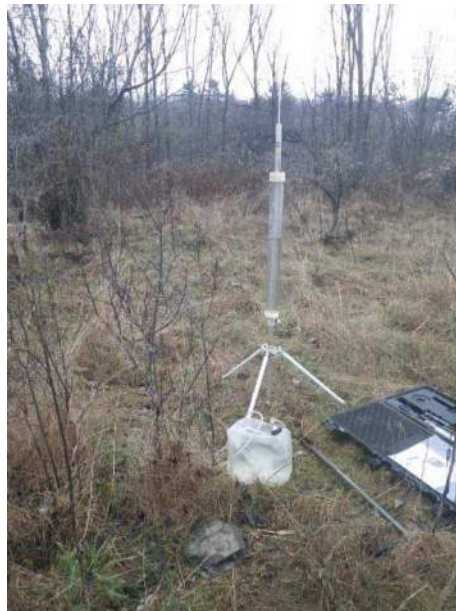
**Figure 5: Guelph Permeameter setup in the field.
Flexible water reservoir and hand auger in the foreground.**

Percolation testing was conducted between depths of 0.1 mbgs and 0.8 mbgs using a Guelph Permeameter (GP), shown on **Figure 5**. This method involves measuring the steady state rate of percolation within a 2-3/8" diameter auger hole, through maintaining a constant hydraulic head pressure (H) within the GP water reservoir (Reynolds and Elrick, 1986). Once the head pressure is applied, the rate of fall within the reservoir is monitored until a steady state of change (r) is achieved. This value is used to determine the field saturated hydraulic conductivity (K_{fs}) by applying it to the Reynolds and Elrick (1985) equations.
