Appendix H

Environmental Impact Statement for SWM Pond Expansion in East Urban Community Mixed Use Centre

September 5, 2018

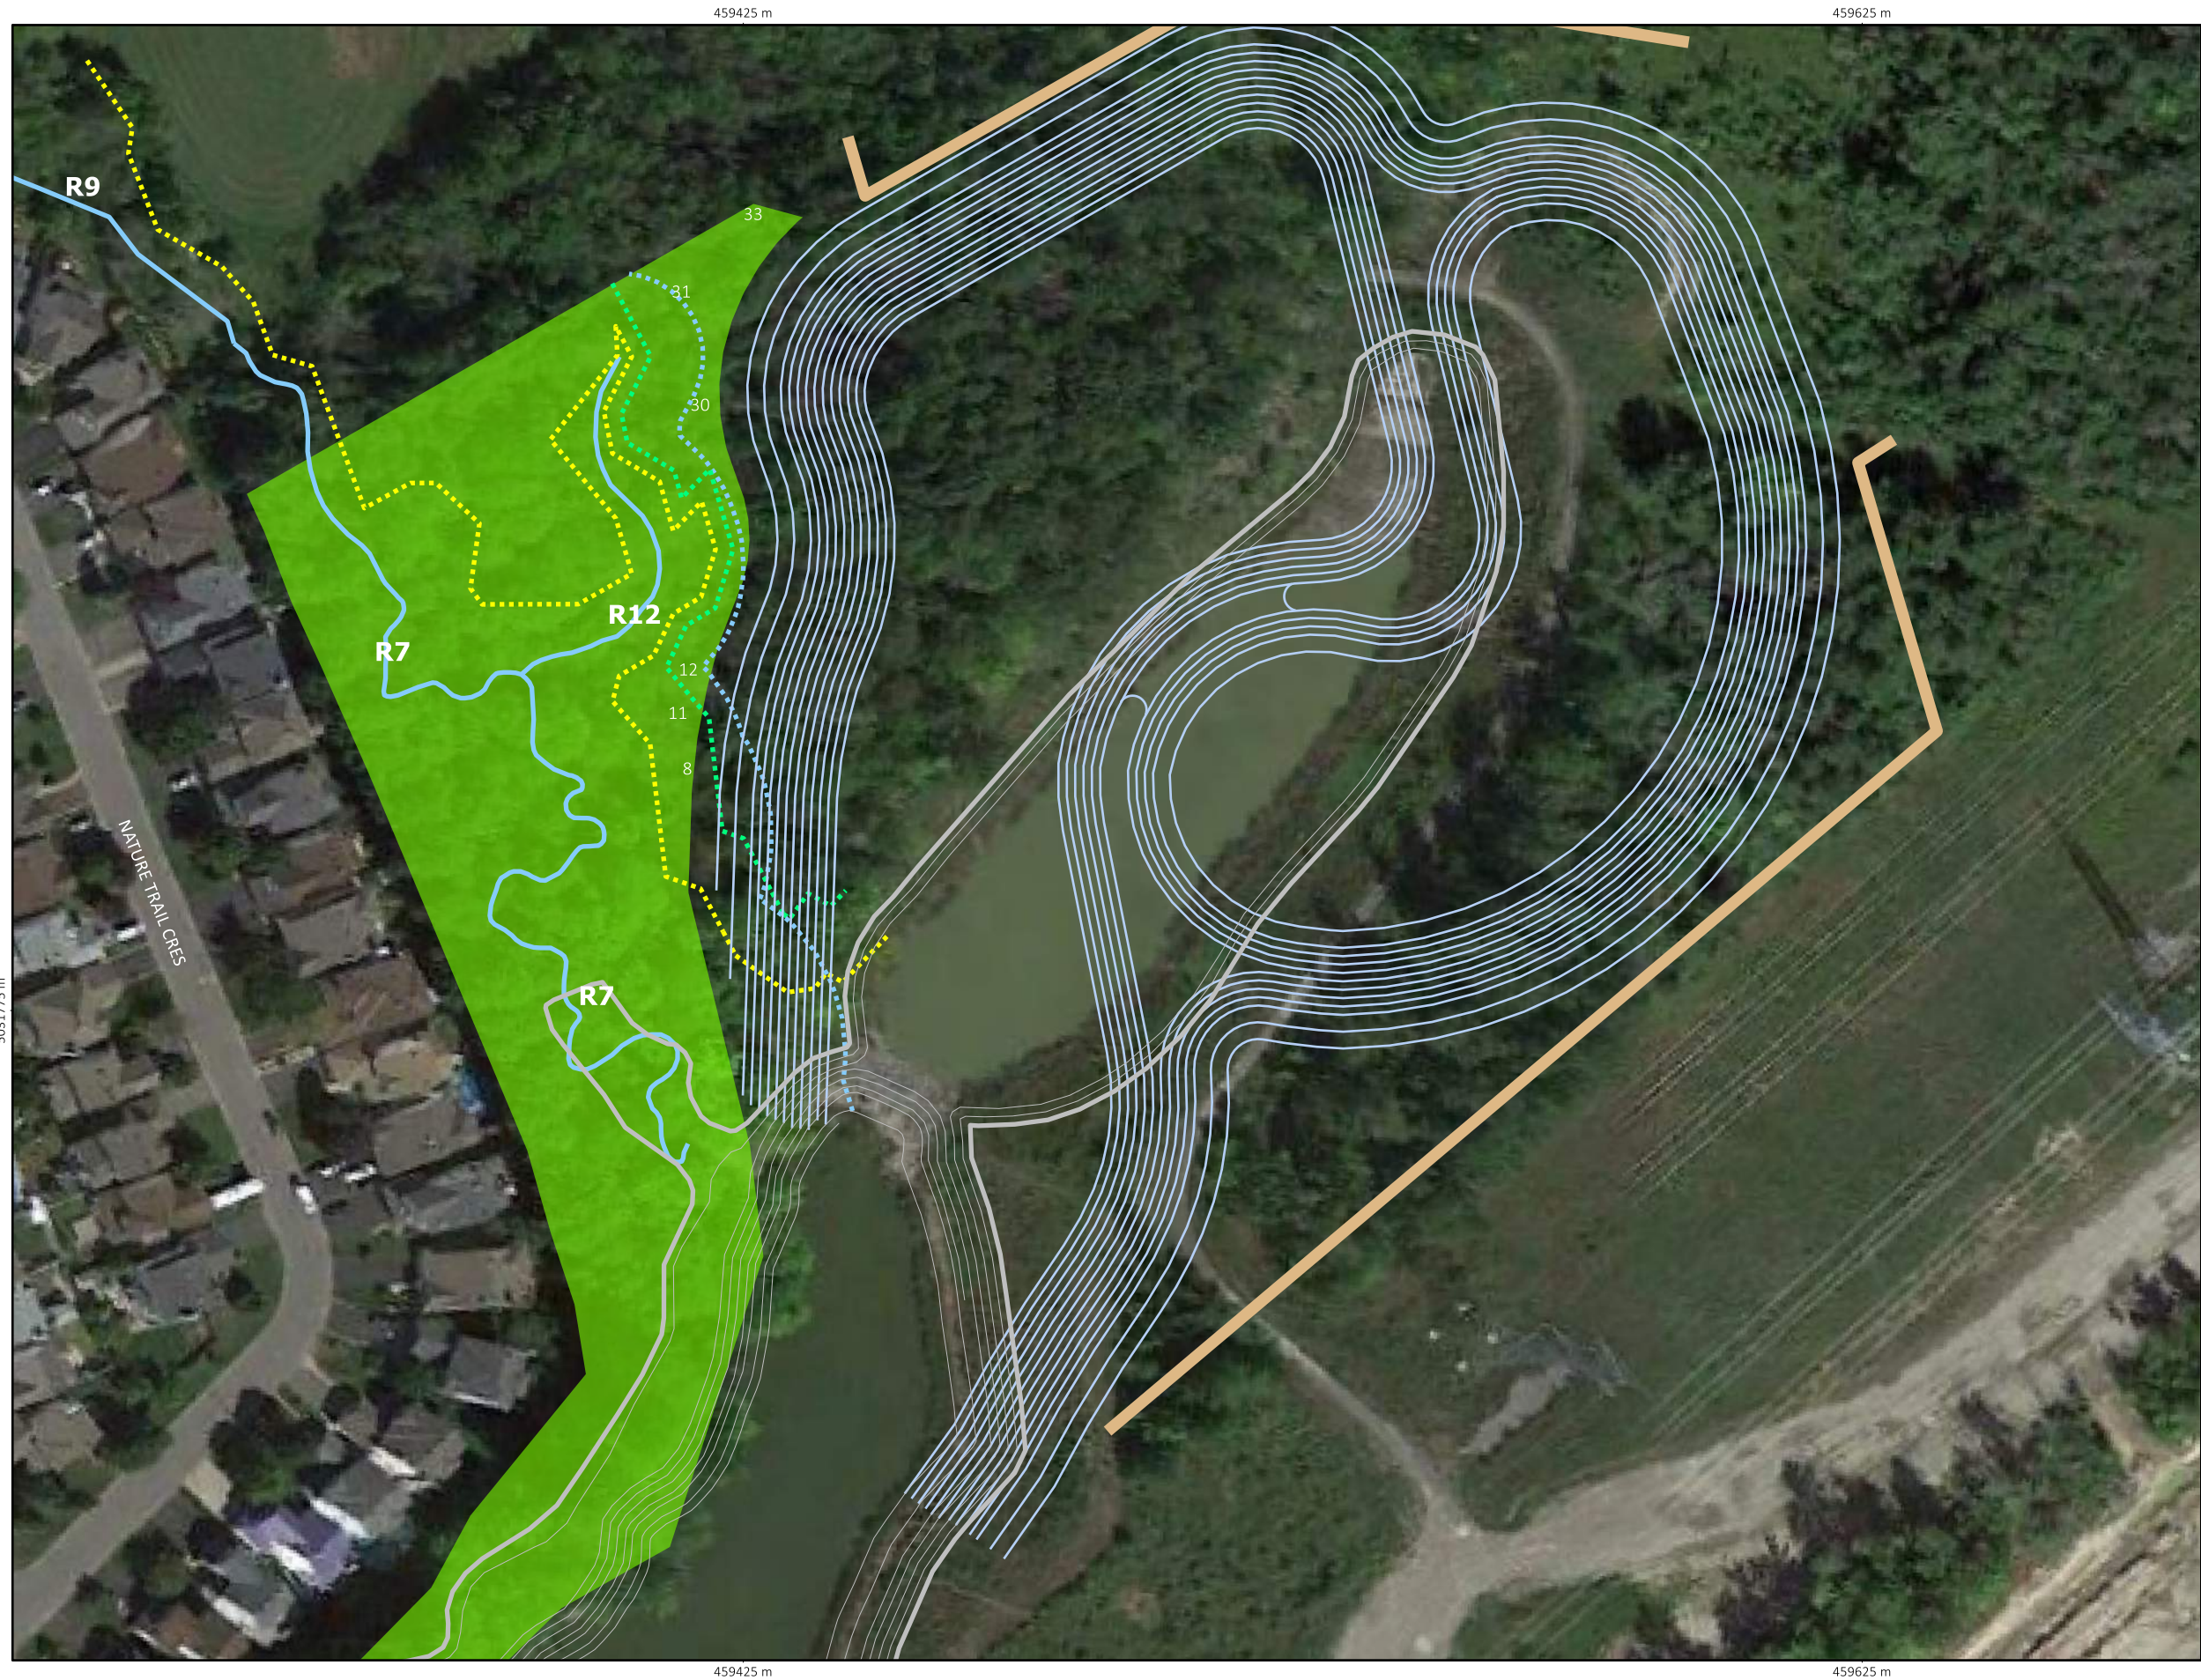
Figure 2 Proposed development

The proposed project is the expansion of the existing SWMP needed to support additional residential development in the surrounding area. The pond expansion will result in the removal of a total 2.19 ha of wooded area. This includes, all of the FOD2-1 and FOD8-1 ecosites, which do not constitute Significant Woodland, and 0.89 ha (41%) of the FOD7 ecosite, which is Significant Woodland. This retains 1.27 ha of the oldest portion of the FOD7 forest area along the forest stream through the western portion of that feature.

The current proposed pond configuration is a modification of the original design concept, which required the removal of the same amount of forest area, but left less of a buffer along the forest stream and a narrower forest swath nearest to the existing houses to the west.

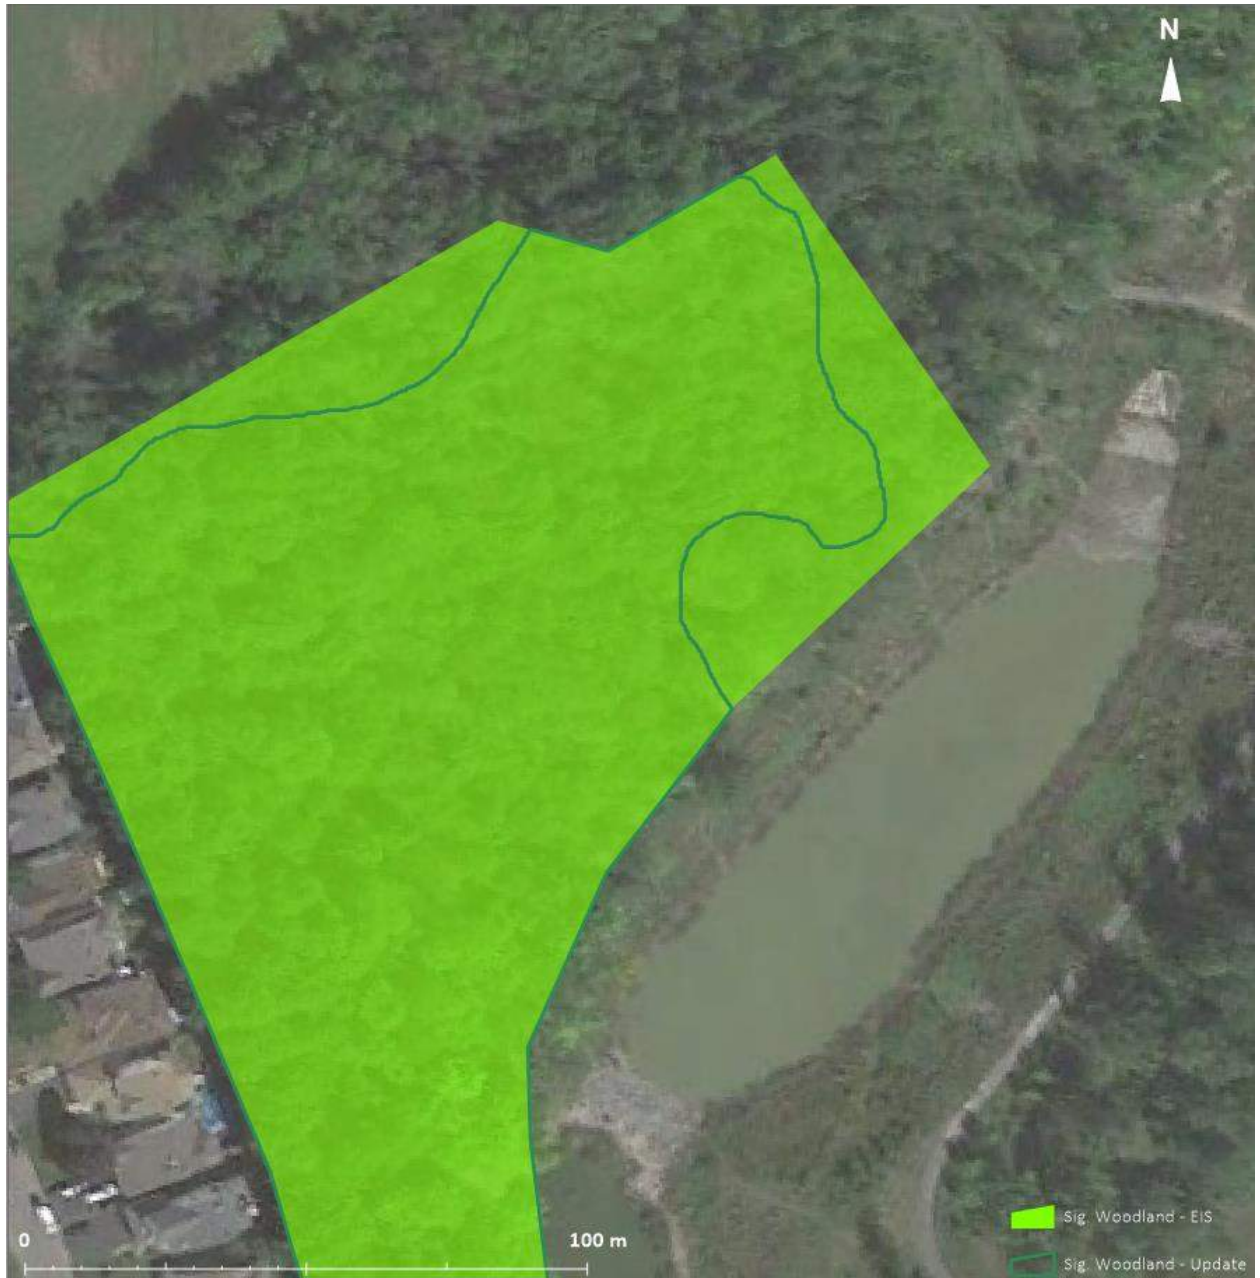
Figure 1. A comparison of the extent of significant woodland under previous and current City policies

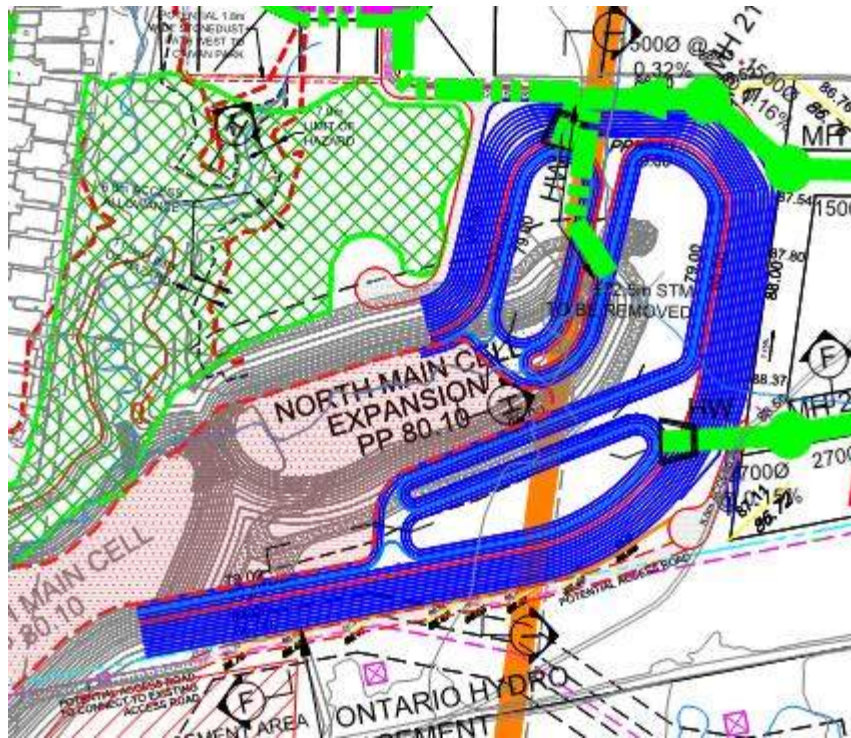
Figure 2. The most recent SWM pond expansion concept in relation to the updated significant woodland boundary

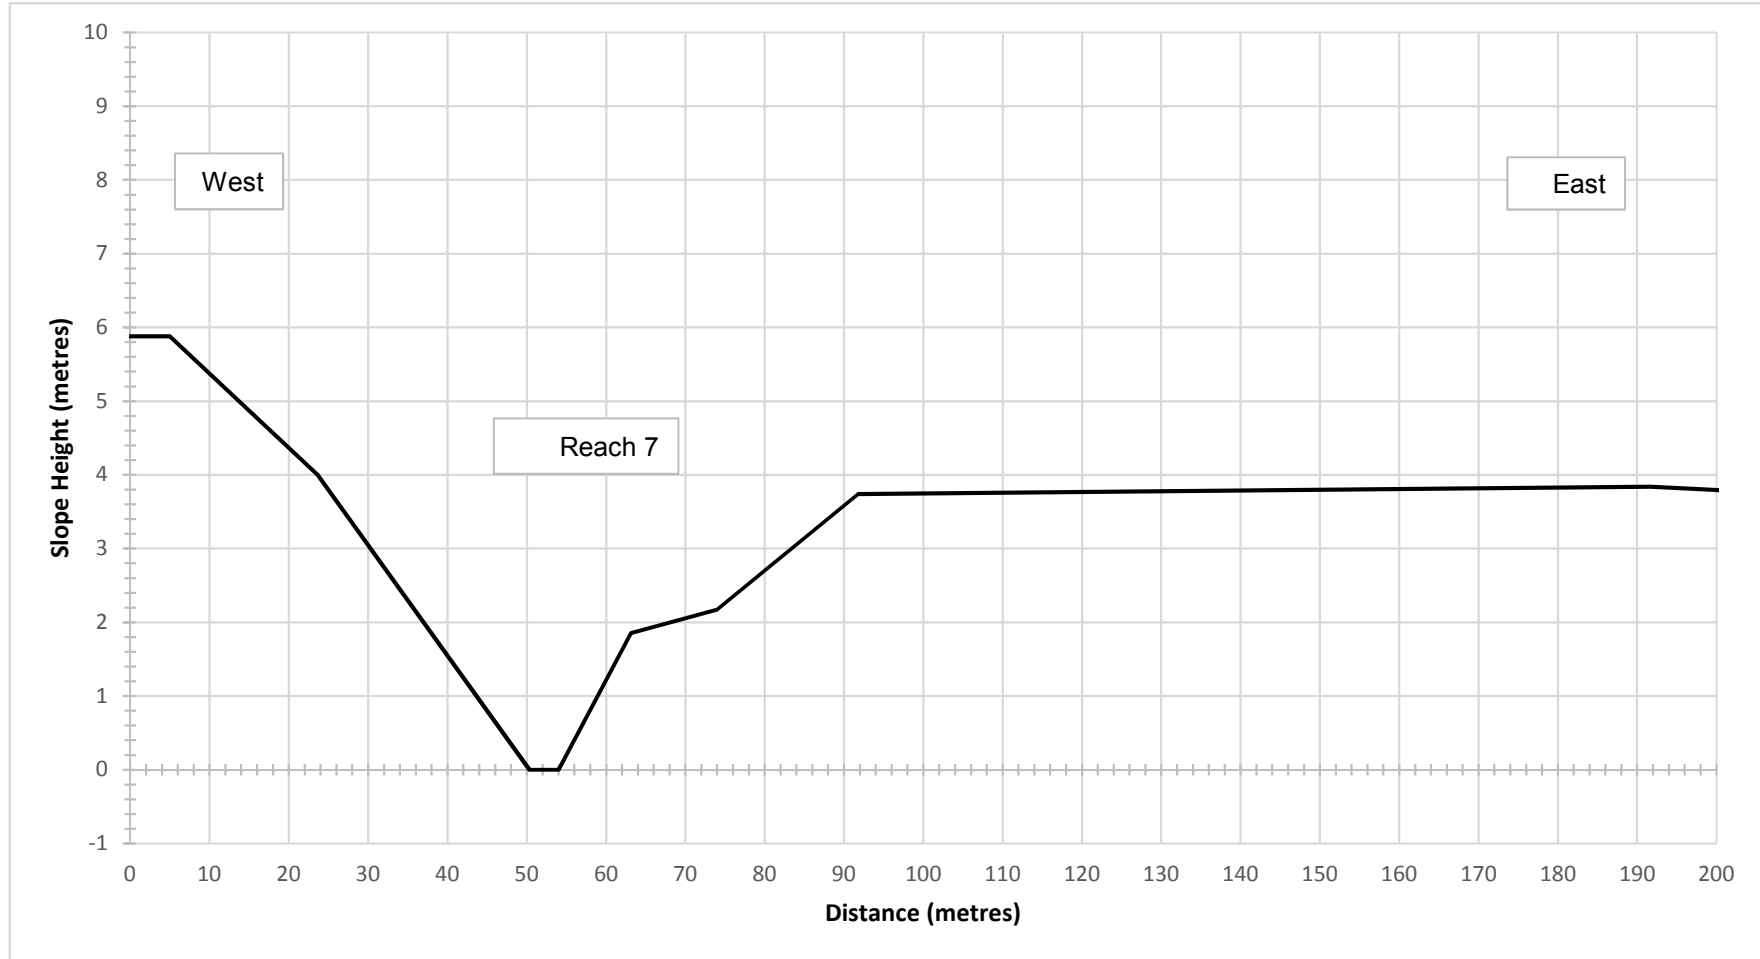
SLOPE CROSS SECTION
PROPOSED STORM WATER MANAGEMENT POND BLOCK
3490 INNES ROAD, OTTAWA

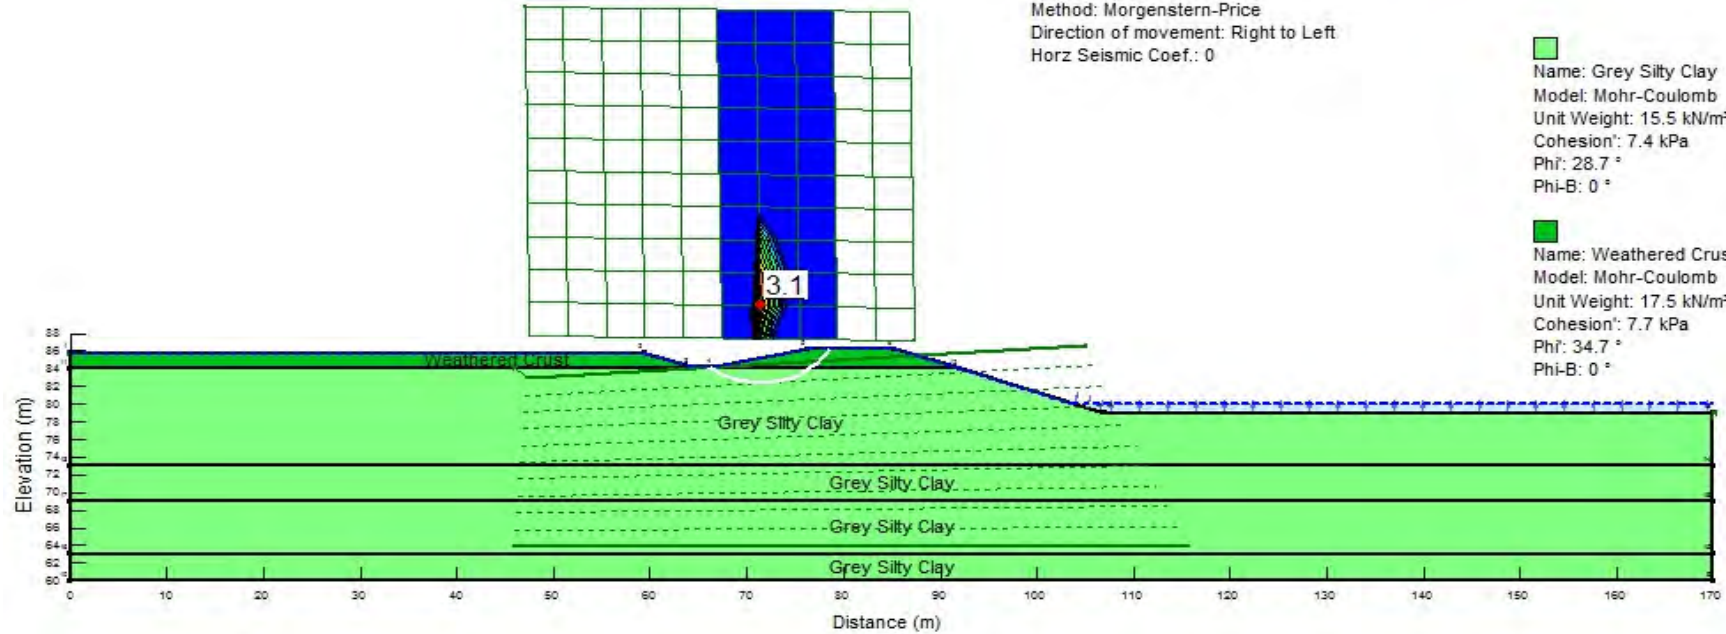
FIGURE 11

█ Name: Grey Silty Clay
 Model: Mohr-Coulomb
 Unit Weight: 15.5 kN/m³
 Cohesion: 7.4 kPa
 Phi: 28.7 °
 Phi-B: 0 °

█ Name: Weathered Crust
 Model: Mohr-Coulomb
 Unit Weight: 17.5 kN/m³
 Cohesion: 7.7 kPa
 Phi: 34.7 °
 Phi-B: 0 °

STATIC SLOPE ASSESSMENT - REACH 12 (SECTION H-H)
PROPOSED STORM WATER MANAGEMENT POND BLOCK
3490 INNES ROAD, OTTAWA

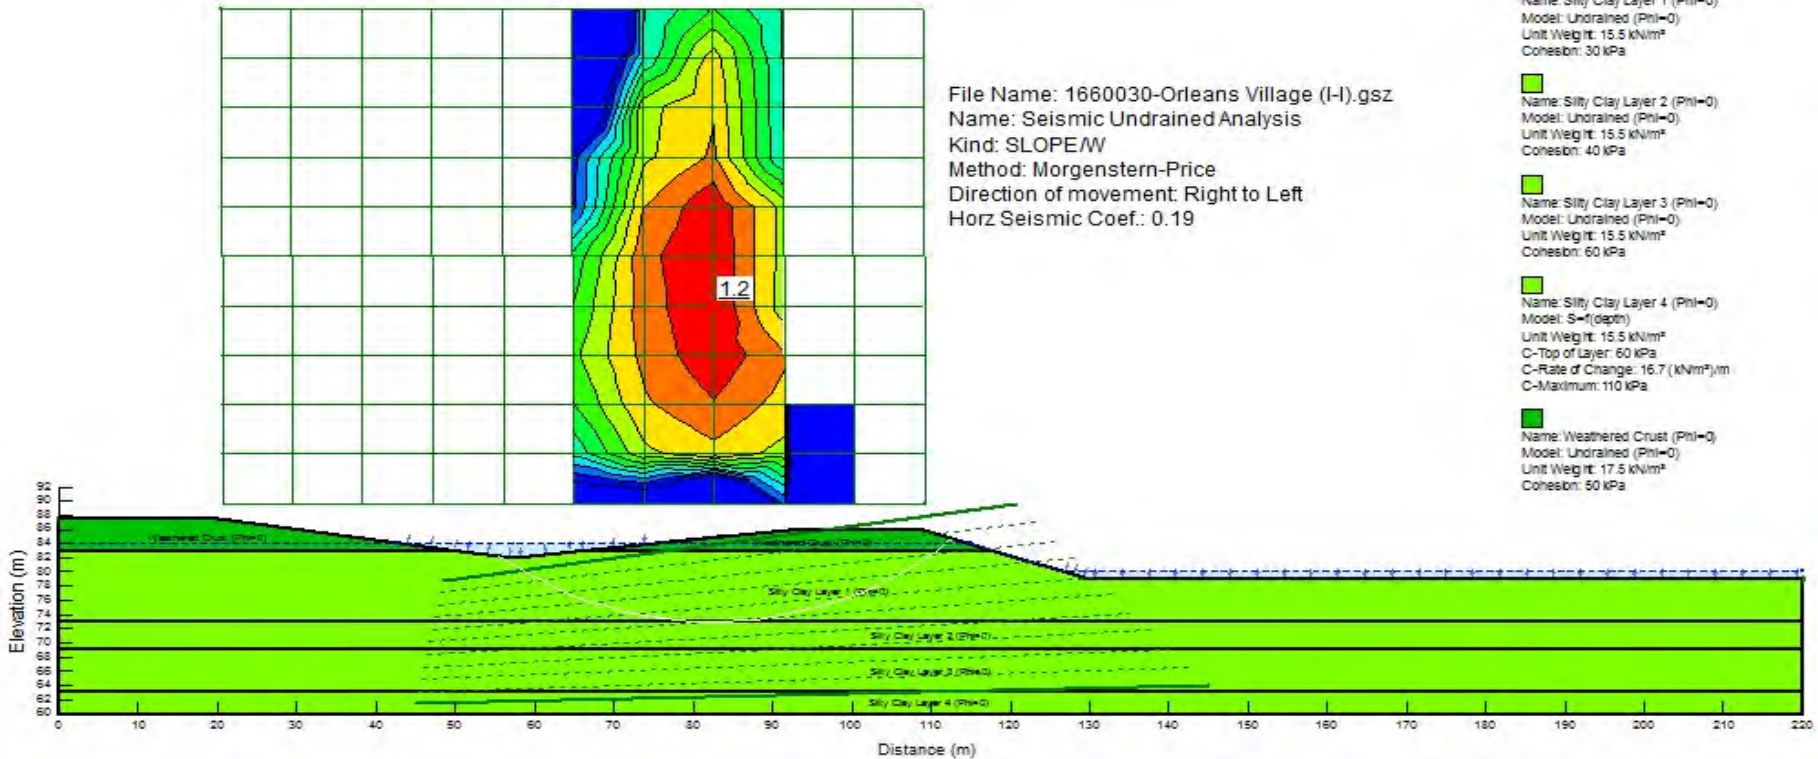
File Name: 1660030-Orleans Village (I-I).gsz
 Name: Seismic Undrained Analysis
 Kind: SLOPE/W
 Method: Morgenstern-Price
 Direction of movement: Right to Left
 Horz Seismic Coef.: 0.19

- Name: Silty Clay Layer 1 (Phi=0)
 Model: Undrained (Phi=0)
 Unit Weight: 15.5 kN/m³
 Cohesion: 30 kPa
- Name: Silty Clay Layer 2 (Phi=0)
 Model: Undrained (Phi=0)
 Unit Weight: 15.5 kN/m³
 Cohesion: 40 kPa
- Name: Silty Clay Layer 3 (Phi=0)
 Model: Undrained (Phi=0)
 Unit Weight: 15.5 kN/m³
 Cohesion: 60 kPa
- Name: Silty Clay Layer 4 (Phi=0)
 Model: S-r(depth)
 Unit Weight: 15.5 kN/m³
 C-Top of Layer: 60 kPa
 C-Rate of Change: 16.7 (kN/m³)/m
 C-Maximum: 110 kPa
- Name: Weathered Crust (Phi=0)
 Model: Undrained (Phi=0)
 Unit Weight: 17.5 kN/m³
 Cohesion: 50 kPa

SEISMIC SLOPE ASSESSMENT - REACH 7 (SECTION I-I)
PROPOSED STORM WATER MANAGEMENT POND BLOCK
3490 INNES ROAD, OTTAWA

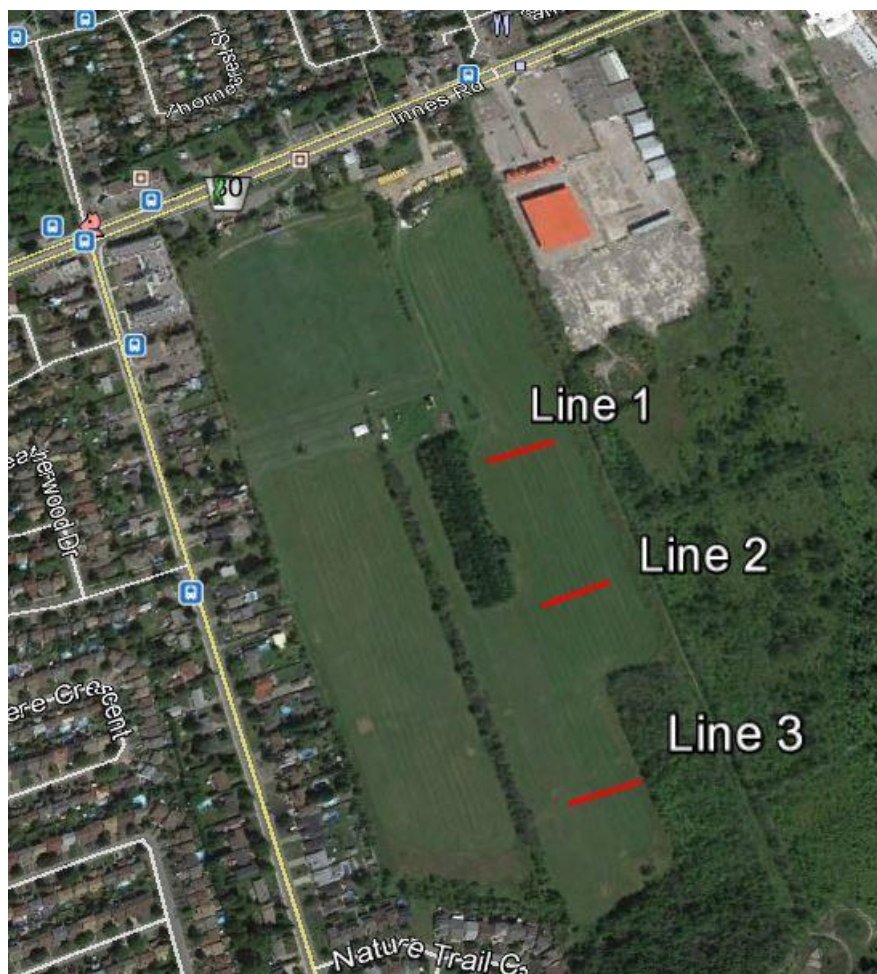
Figure 1: MASW Location Site Map (MASW Lines in red)
