Descriptive sheet

231 Cobourg St

Municipal Address	231 Cobourg Street	Building name	231 Cobourg St
Legal description		Lot:	Block: Plan:
Age/Date of Construction	1935-1947	Original use	
		Present use

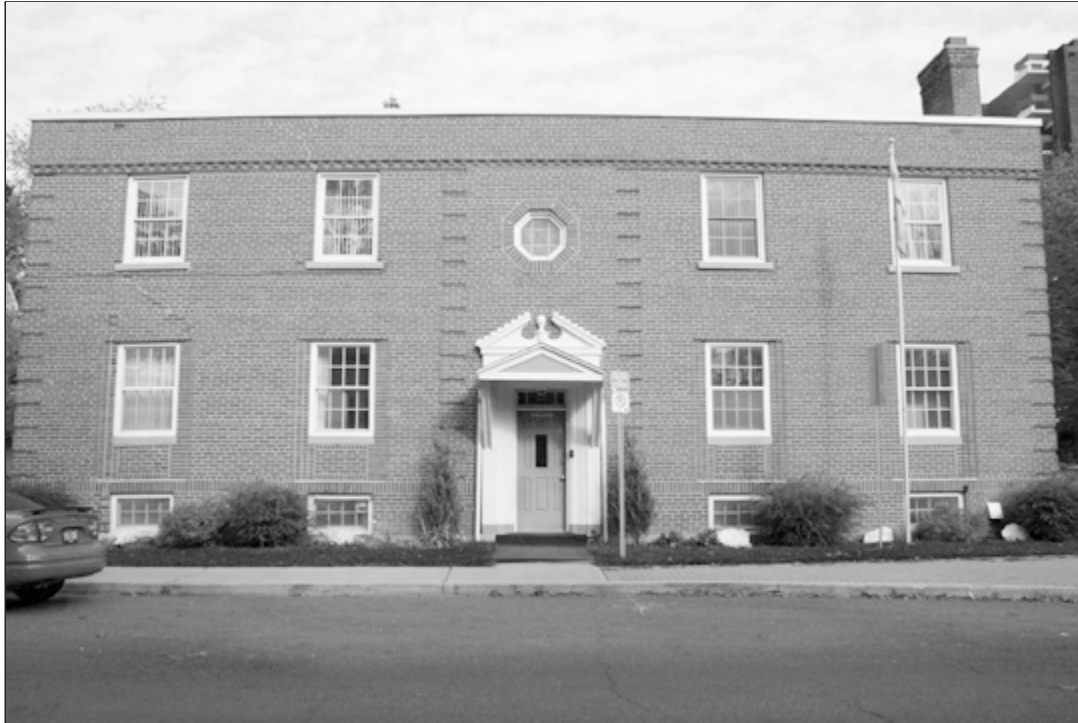
Property characteristics: Single use institutional. Detached, 2 storey with rectangular plan, center entry and occupied basement. Site features consist of parking lot at side.

Exterior elements: Flat roof of unknown material; 1 brick chimney. Decorative roof elements include a raised parapet. Exterior brick wall with string courses, brick corbels, stone sills, quoins of brick and decorative brick patterns. Parged foundation.

Windows and doors: Rectangular wood double hung 1 x 1 8 x 8 windows. Metal storm windows. Octagonal window on upper storey. Single metal front door with transom window in door.

Other features: 1 storey wood porch with flat roof, pediment and wood brackets.

Medium to high: Non-original door, storm windows, and some other windows affect integrity.

This is one of a small number of purpose-built apartment buildings in Sandy Hill dating from the middle years of the 20th century. It is somewhat atypical in its modest Federal stylistic influence, characterized by the broken pediment at the door surround surmounted by an octagonal window. The symmetrical composition, the double hung windows with divided lights, and the implied Classical detailing of the brick quoins and cornice are all significant elements of the facade and should remain in future renovations.

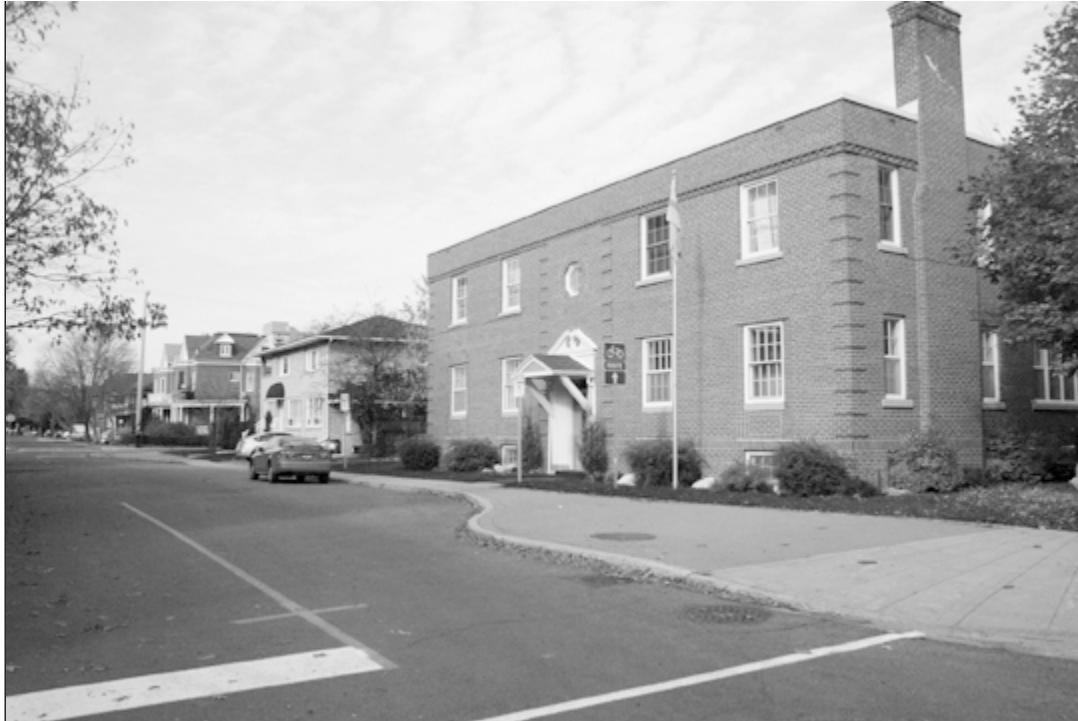
Pattern of site use: Atypical (corner site facing Cobourg, rather than Wilbrod)
 Use: Typical (residential)
 Height/Volume: Typical
 Materials: Typical (brick)
 Typology: Type 8 (apartment)
