**Cultural Heritage Impact Statement  
231 Cobourg Street, Ottawa**

Report Prepared for: **Ten 2 Four Architecture Inc.**  
RMA Project No.: **17008**  
Date: **November 22, 2017**

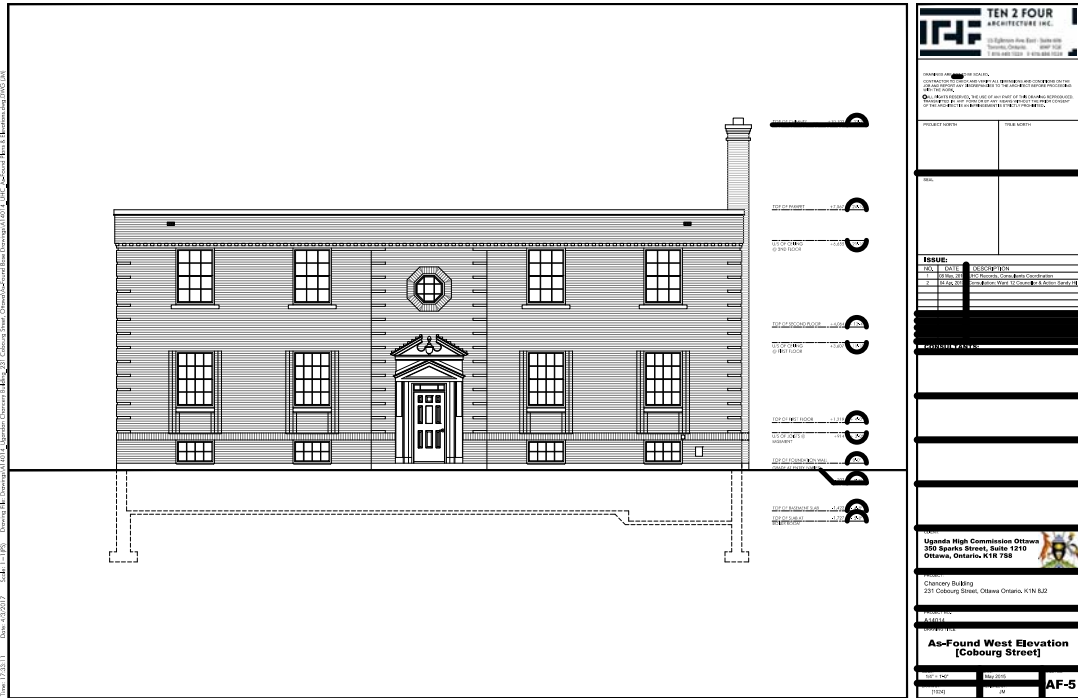
Figure 3: As Found West Elevation

The red brick building style is fairly atypical, detailed in a symmetrical low-relief and Federal/Classical style. An entrance canopy has been clumsily added to the original classical entrance. Windows are simple 6-over-6 and 8-over-8 double-hung style framed with shallow decorative brick recesses and stone sills. Brick quoins and a corbelled parapet provide some relief in a mostly flat façade.

- symmetrical formal compositions;
- smooth facades with medium sized window apertures;
- brickwork with string courses, corbels and decorative patterns;
- wood double hung windows (6x6 and 8x8);
- Octagonal window above entry;
- classical detailing at entryway pediment.

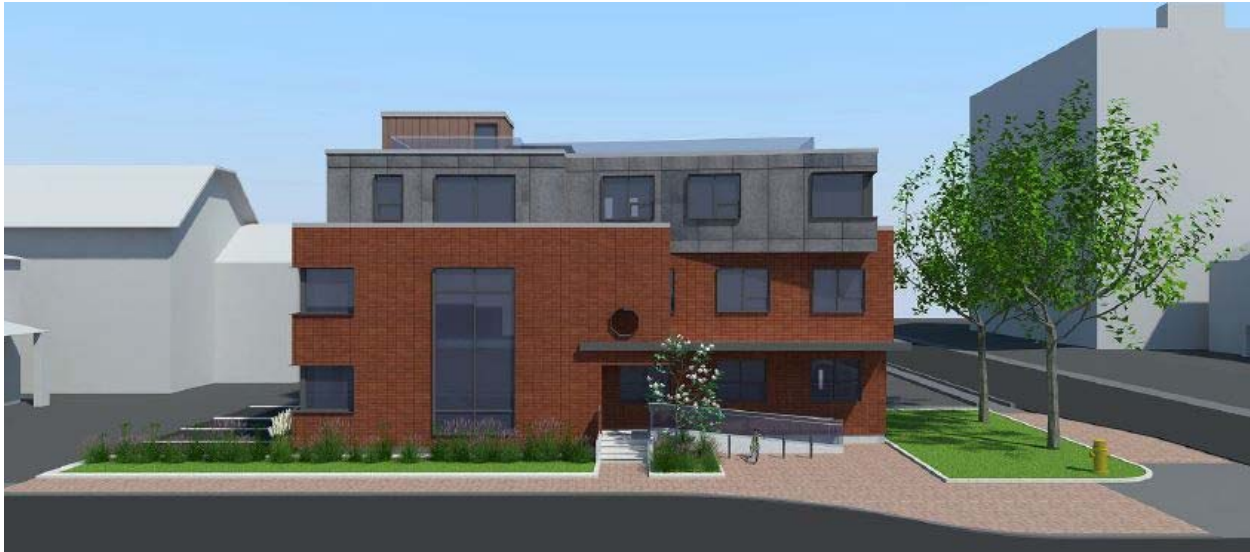
**Figure 6:** (Above) Proposed West Elevation

The two-storey flat roofed massing will be replaced with a three storey flat roofed massing slightly higher than adjacent buildings but still within the district’s prevailing range of two to three stories. The two-storey red brick massing of the original building, characteristic of the neighbourhood, will be retained floor the first two stories; dark grey porcelain, set back from the brick, will clad the third storey to tie-in more closely with the grey shingling found throughout the neighbourhood. The rooftop terrace and elevator projection is located away from both primary facades, limiting its visual presence.

To further reduce the visual impact of the proposed third floor volume, it has been set back approximately 1 metre from the edge of the second floor parapet along the south, west, and

north sides. The overhanging southwest angled corner serves to add an element of visual interest addressing the main intersection of Wilbrod and Cobourg streets.

An octagonal window echoes the original building feature on the west facade. Punched windows, based on a common module with protruding frames, and a small brise-soleil add a degree of shadow relief to the facades.

The reuse of an octagonal window above entry is seen as a small playful nod to the original building.

Similarly, the use of dark grey porcelain to clad the third floor is reminiscent of the predominant grey single roofing throughout the neighborhood and lends to the proposed development's thoughtful integration in the area.
