# HERITAGE SURVEY AND EVALUATION FORM

Municipal Address: 73-77 Guigues Street

73-77 Guigues St.

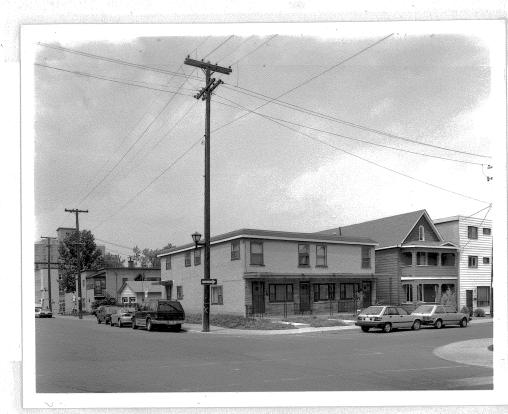
PHOTO DATE: June 1992 VIEW: SOURCE: Gilberto Prioste NEGATIVE NUMBER:

2 storey flat roof row of three houses; angelstone and stucco finish, full width porch executed in metal.

This very altered building with angelstone veneer reveals little of its early appearance. In style it appears to reflect mid-twentieth century design ideas with the angelstone and the metal porch.

Very altered - "picture windows" on the ground floor; replacement of most finishes. (permit for alterations 1956).

The vernacular quality of this building can still be appreciated in its use of materials, but it is very altered and does not reflect its earlier appearance.
