KANATA NORTH

COMMUNITY DESIGN PLAN

ENVIRONMENTAL MANAGEMENT PLAN

FINAL DRAFT
JUNE 28, 2016

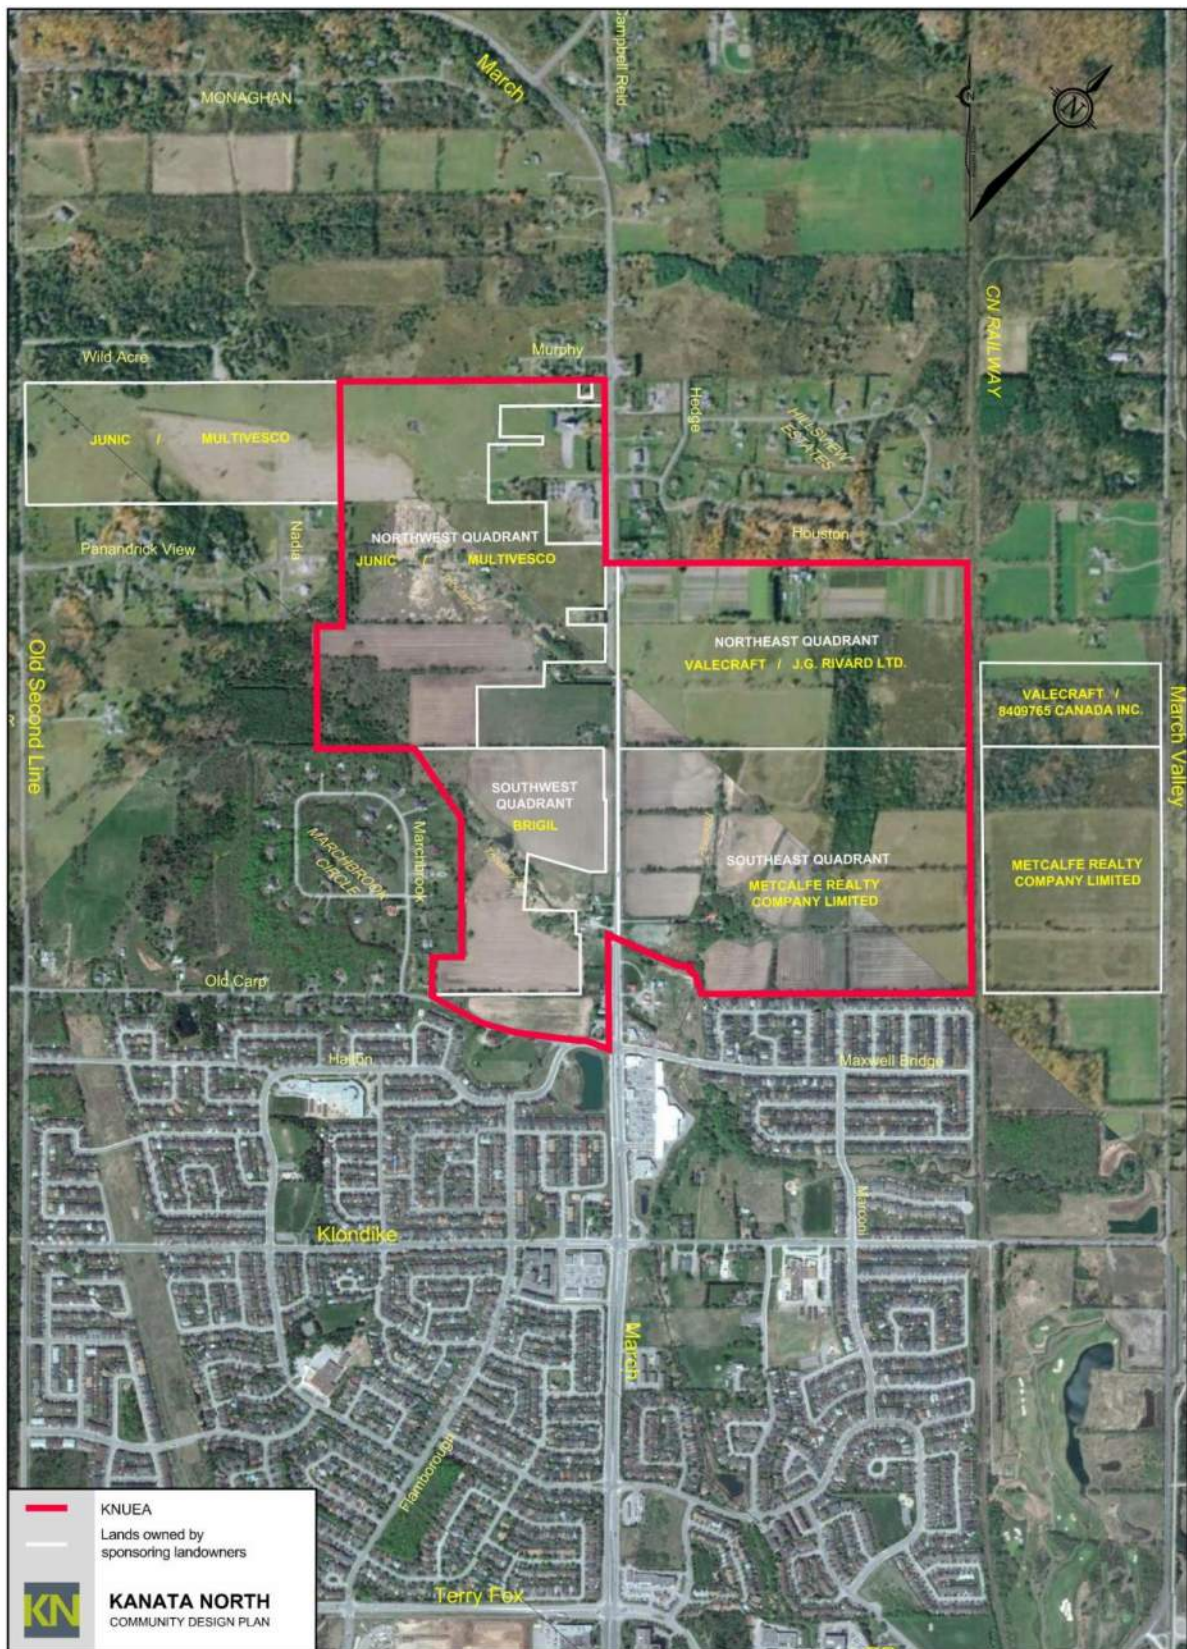
Figure 1.2: KNUEA Boundaries and Properties of Sponsoring Landowners

Early in the process formal invitations were sent to other landowners to participate; however, none other than the group listed above chose to join the KNLOG. Non-participating landowners have been involved in the CDP process through consultation and opportunities to comment as the plan evolved. **Figure 1.2** provides a map showing the ownership of lands within the KNUEA. Adjacent properties owned by members of the KNLOG are also shown. For clarity, the KNUEA is sometimes referred to as being divided into quadrants, east and west of March Road and north and south roughly based on property ownership. The quadrants are labeled on **Figure 1.2**.

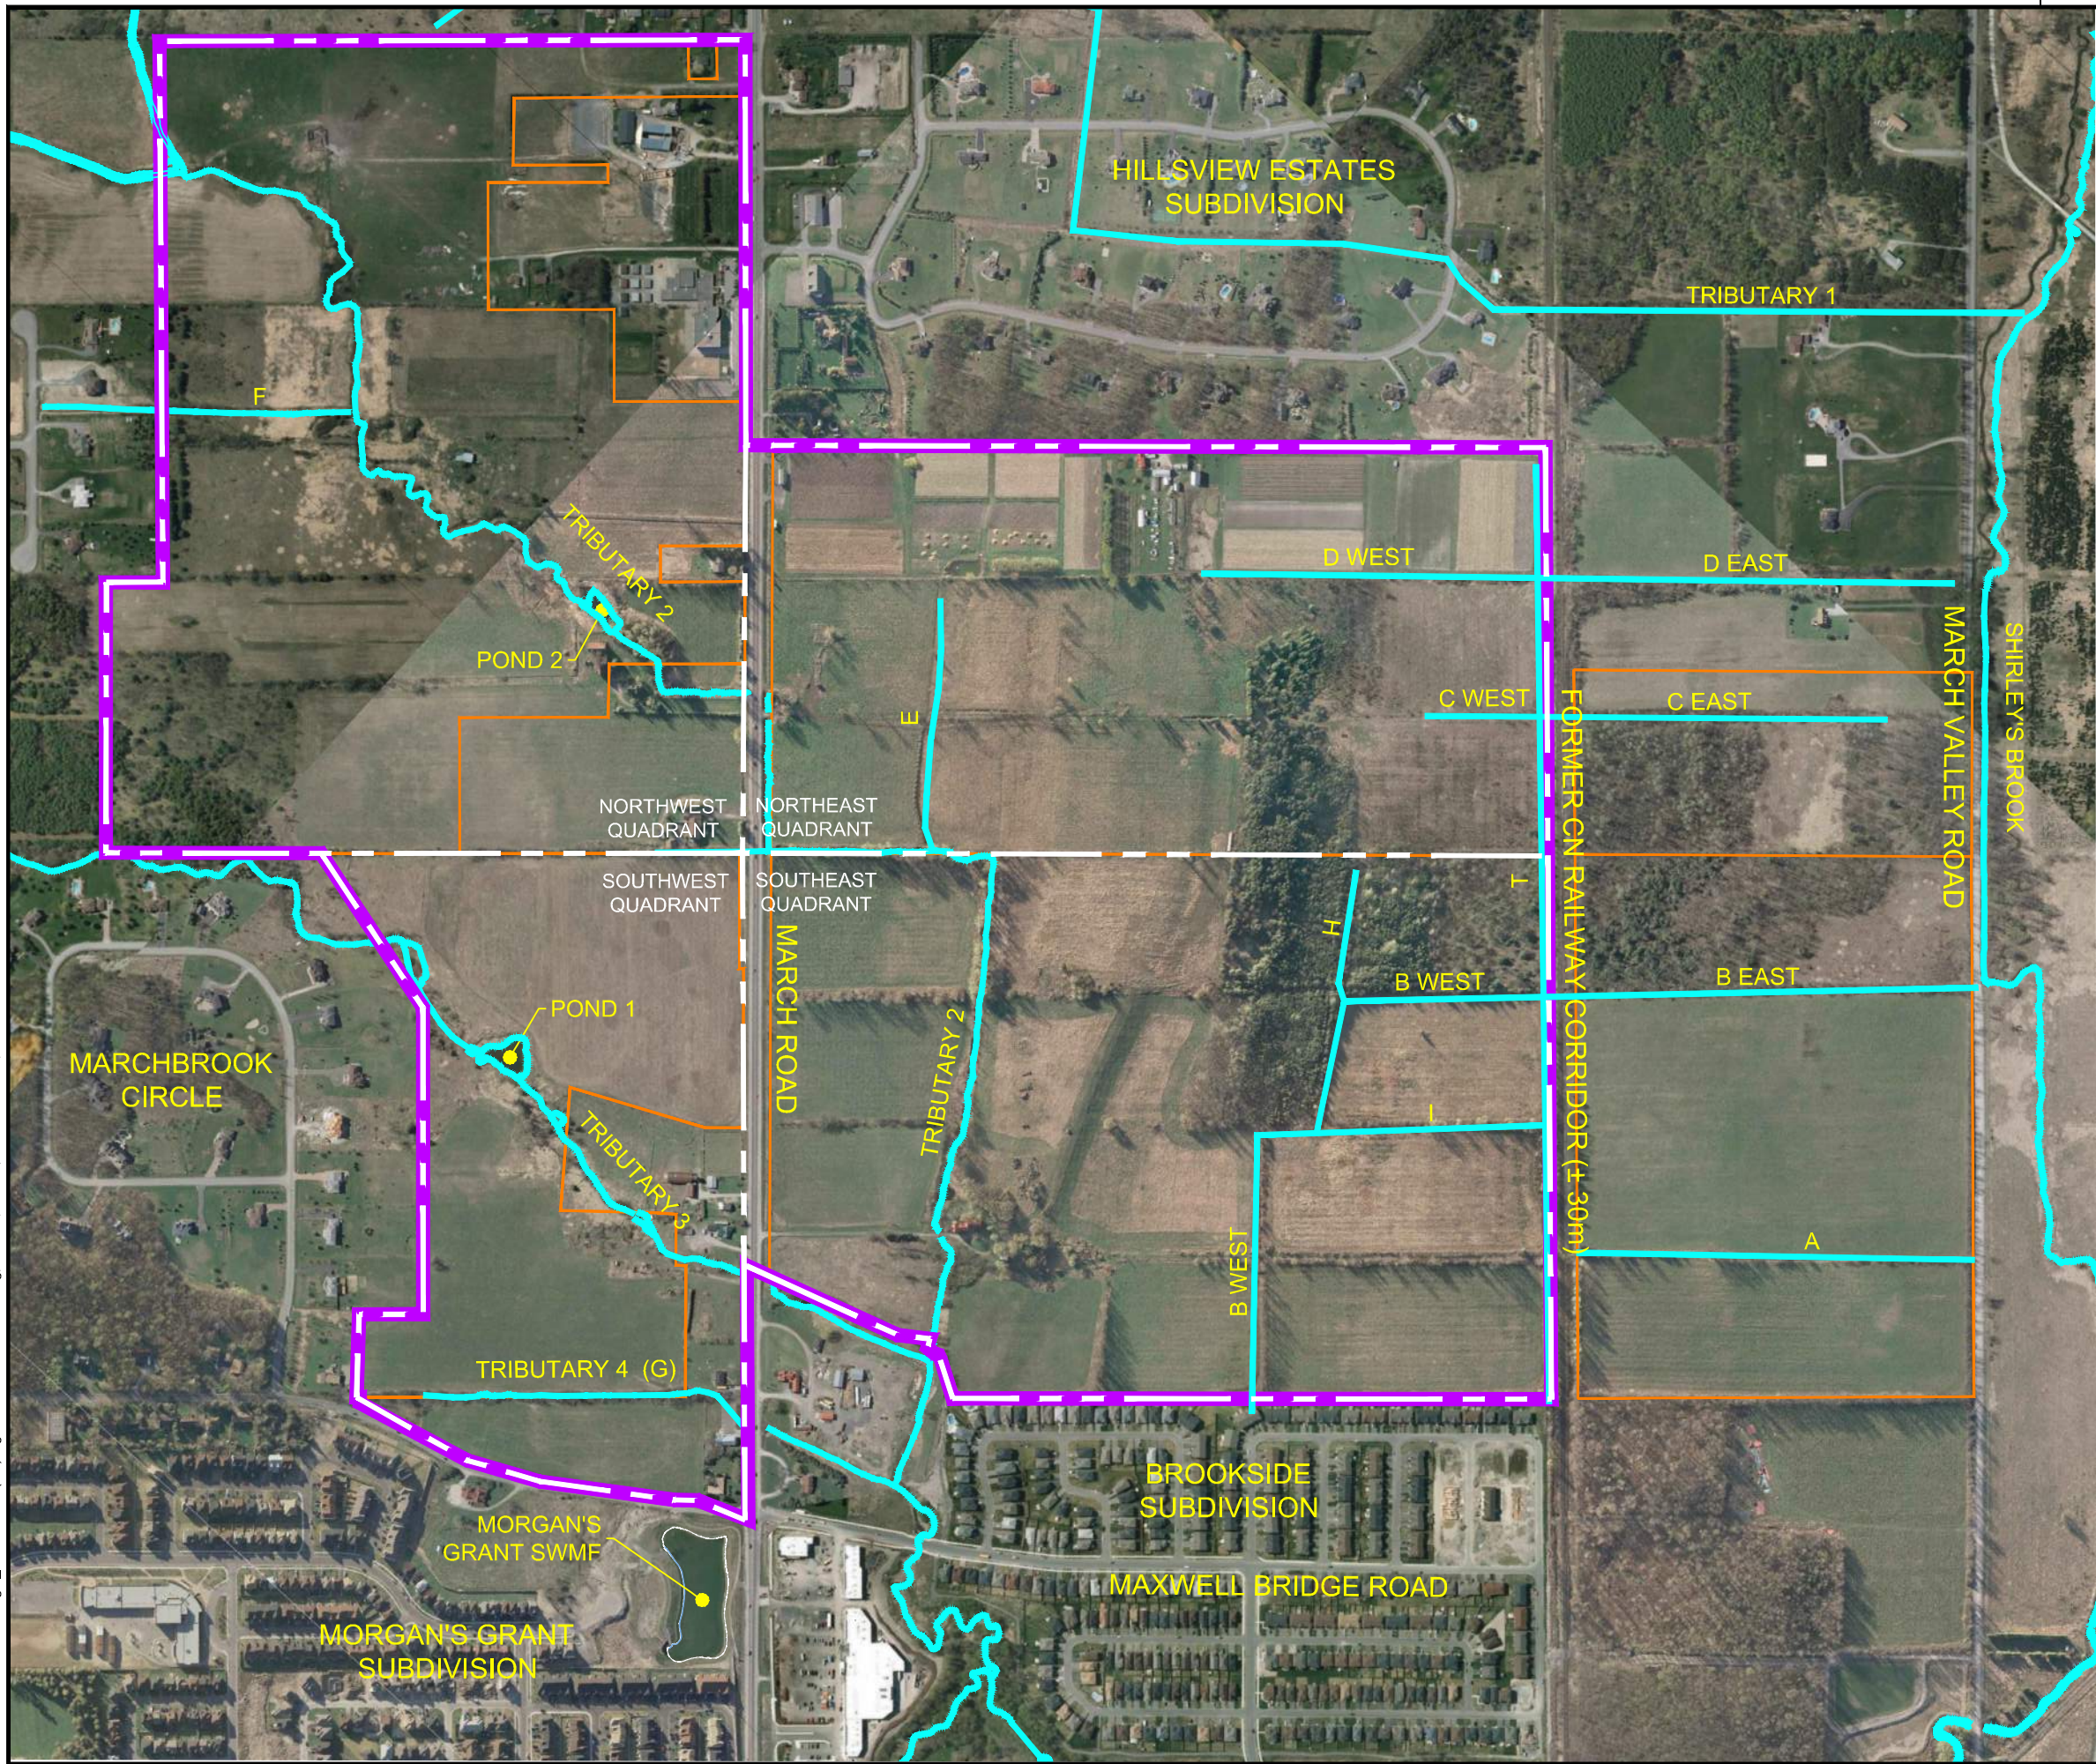
M:\2012\112117\CAD\Design_EMP\MEMO (CS)\Figure 3.1 Watercourses.dwg, FIG-3.1, Mar 24, 2016 - 11:51am, kbanks

The KNUEA contains a variety of aquatic features (ponds, watercourses, headwater channels) which have been evaluated as part of the various existing conditions studies. Many of these drainage features have no formal names, and have been referred to under a variety of names in the existing conditions reports prepared by the various subconsultants. **Figure 3.1** identifies all of the aquatic features within the KNUEA using the following naming convention:

The banks of the inline pond located between fish sampling stations 4 and 5 (refer to Figure 3.1) are fully vegetated primarily with herbaceous species such as reed canary grass, spotted jewelweed, and purple loosestrife. There is intermittent woody vegetation in the area consisting of pussy willow, Manitoba maple, white cedar, white spruce, and white ash, but with no appreciable canopy cover over the pond. Within the pond, aquatic vegetation consists of broad-leaved cattail, common arrowhead, chara species, giant bur-reed, and sago pondweed.

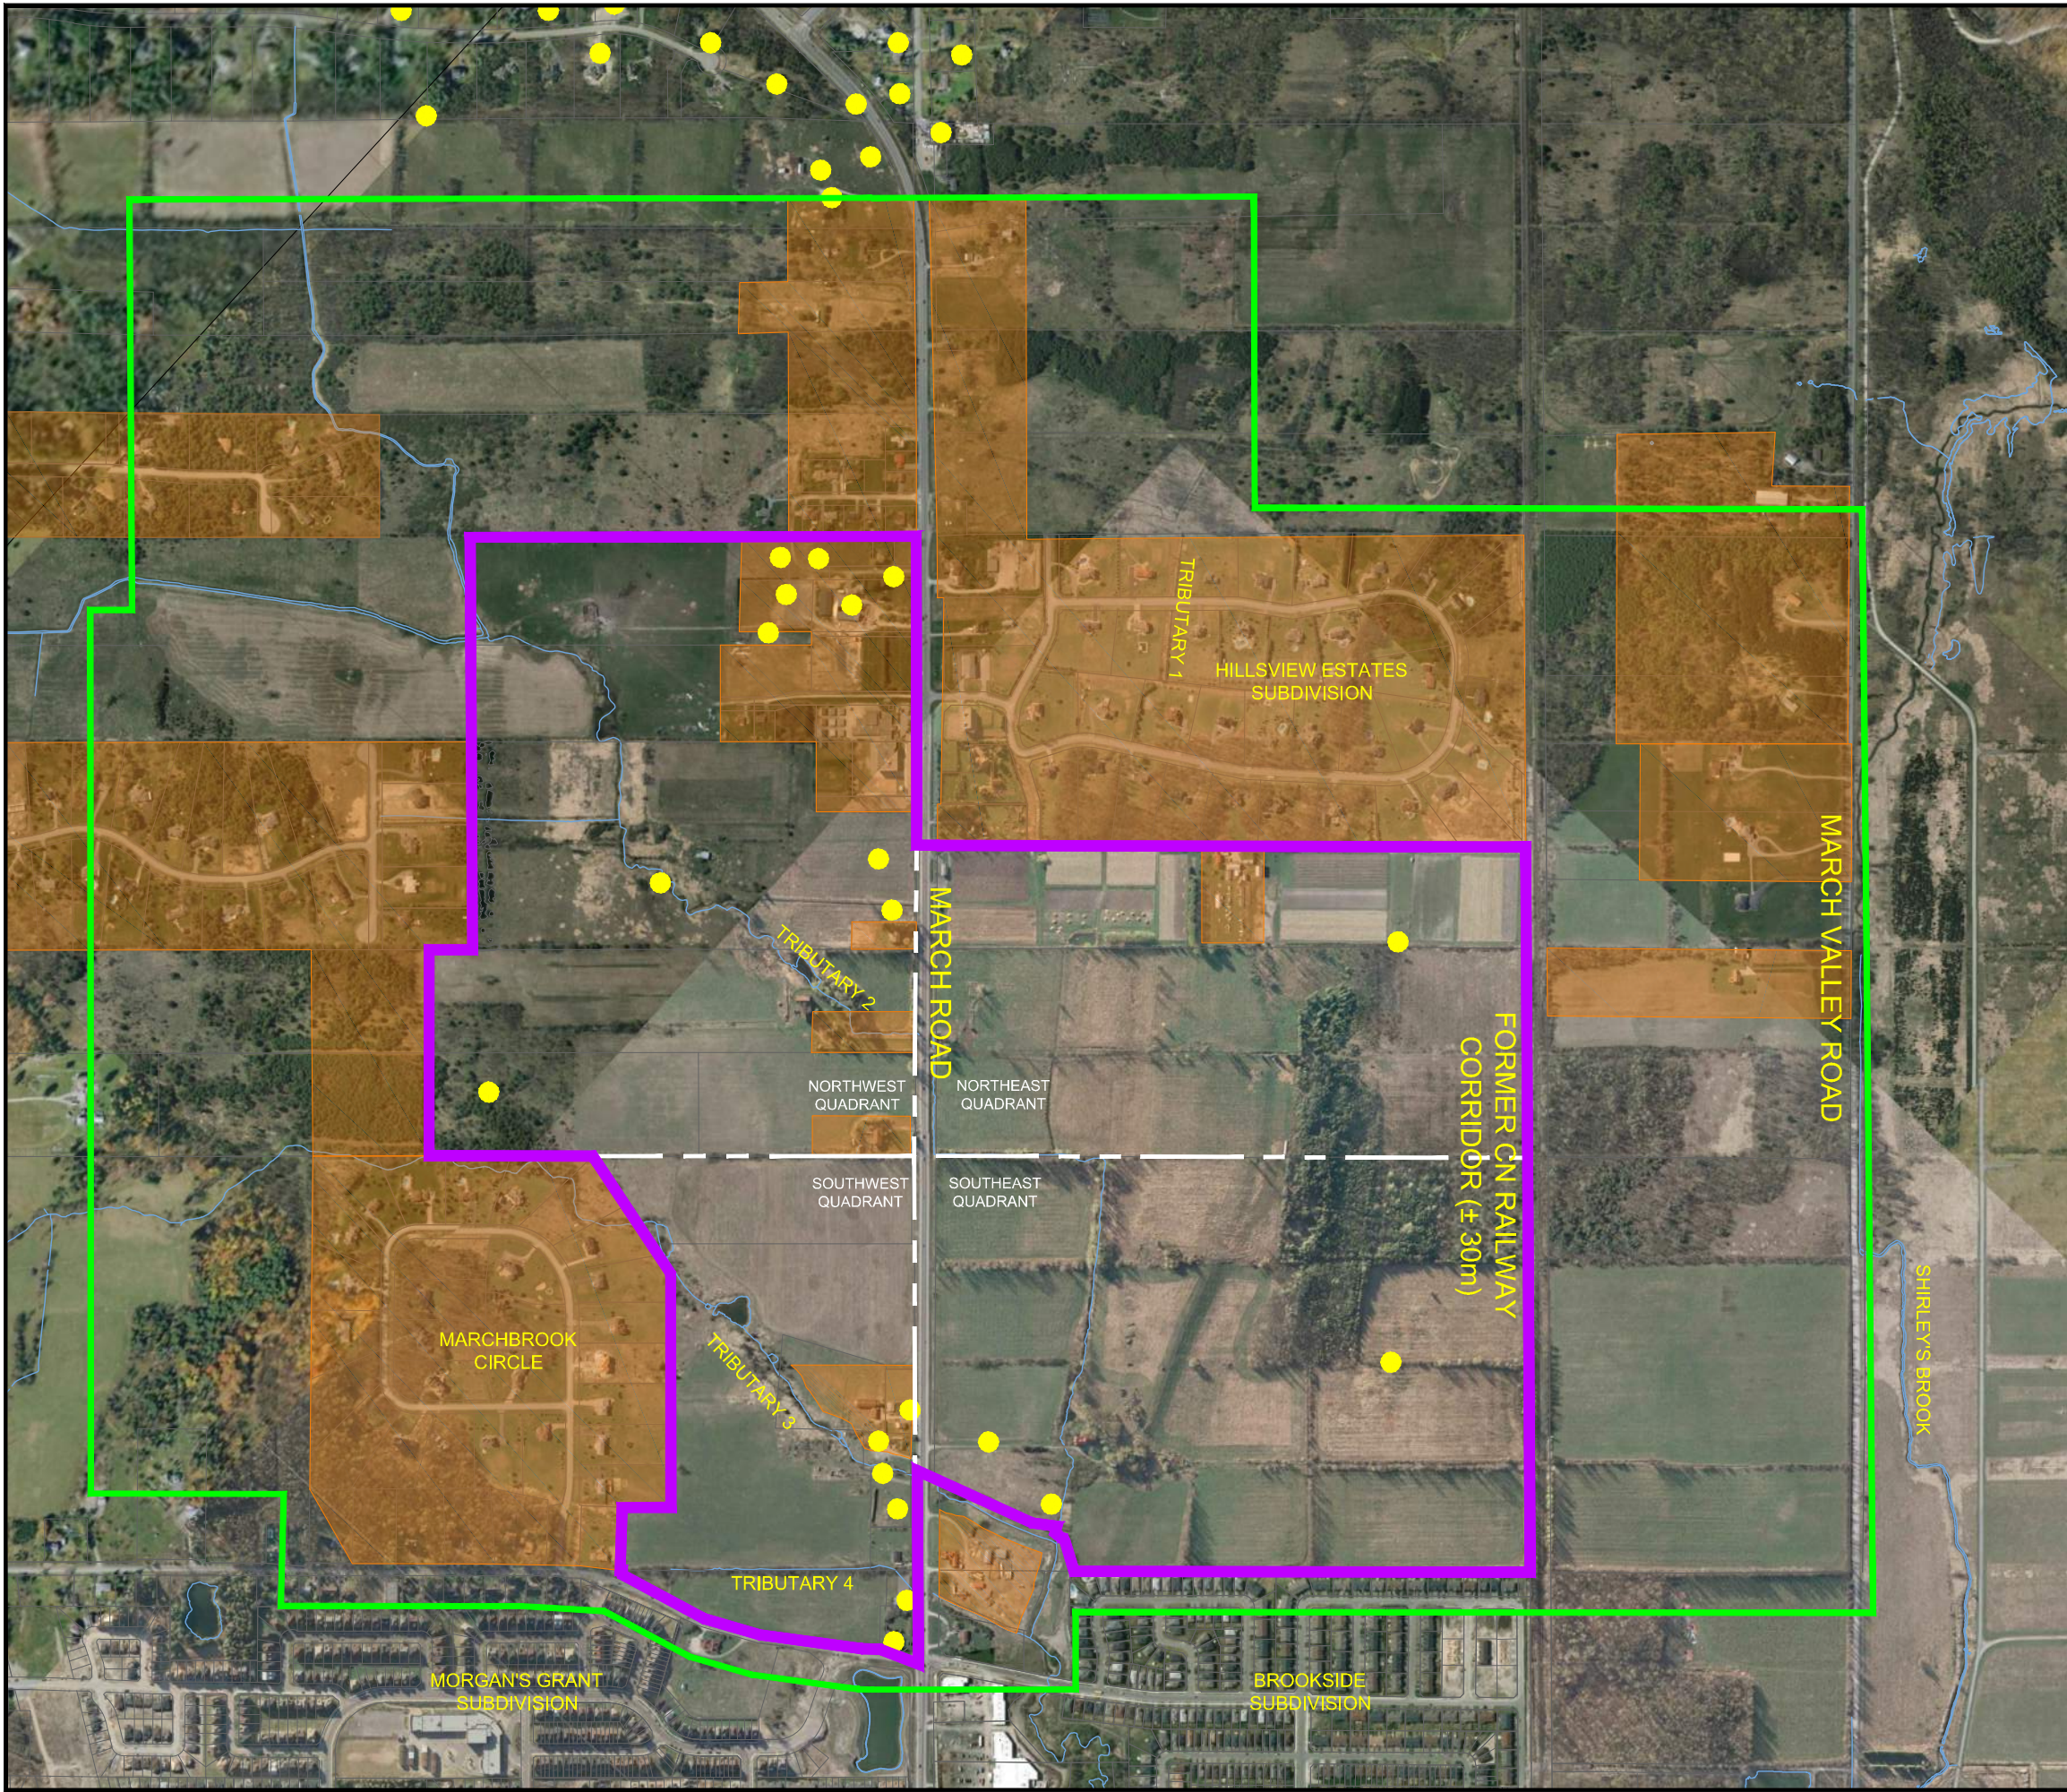
M:\2012\112117\CAD\Design_EMP\MEMO (CS)\Figure 3.6 Water Supply Wells.dwg, FIG-3.6, Jun 24, 2016 - 10:17am, kbranks

For the properties that are adjacent to the KNUEA, primary source of drinking water is varied. For the rural properties each dwelling has its own private water supply well, whereas the urban properties are serviced with municipally supplied drinking water. The known locations of existing water supply wells for surrounding properties are shown on **Figure 3.6**.
