EXECUTIVE SUMMARY

Dr. Andrew McKinley, Consultant, is working through DST Consulting Engineers Inc. (DST) on behalf of the Kanata North Landowners Group (the Owners) to create a Blanding's Turtle (*Emydoidea blandingii*) Habitat Compensation Plan (the Compensation Plan) in collaboration with Novatech Engineering Consultants (Novatech) and Muncaster Environmental Planning (MEP). This Compensation Plan will inform the development of the Kanata North Community Design Plan (KNCDP). As previously discussed with the Ontario Ministry of Natural Resources and Forestry (OMNRF) Kemptville District staff in our joint meeting on September 23rd, 2014, the purpose of this report is to create an overall habitat management and compensation plan that will be acceptable to the regulatory agencies and which will establish a coordinated approach among the Owners to fulfill future permitting and compensation requirements. It is understood that the individual landowners will be required to pursue their own authorizations under the Ontario Endangered Species Act (ESA) and will also conduct their own Environmental Impact Statements (EIS) and other analyses to complete the approvals process. The Compensat

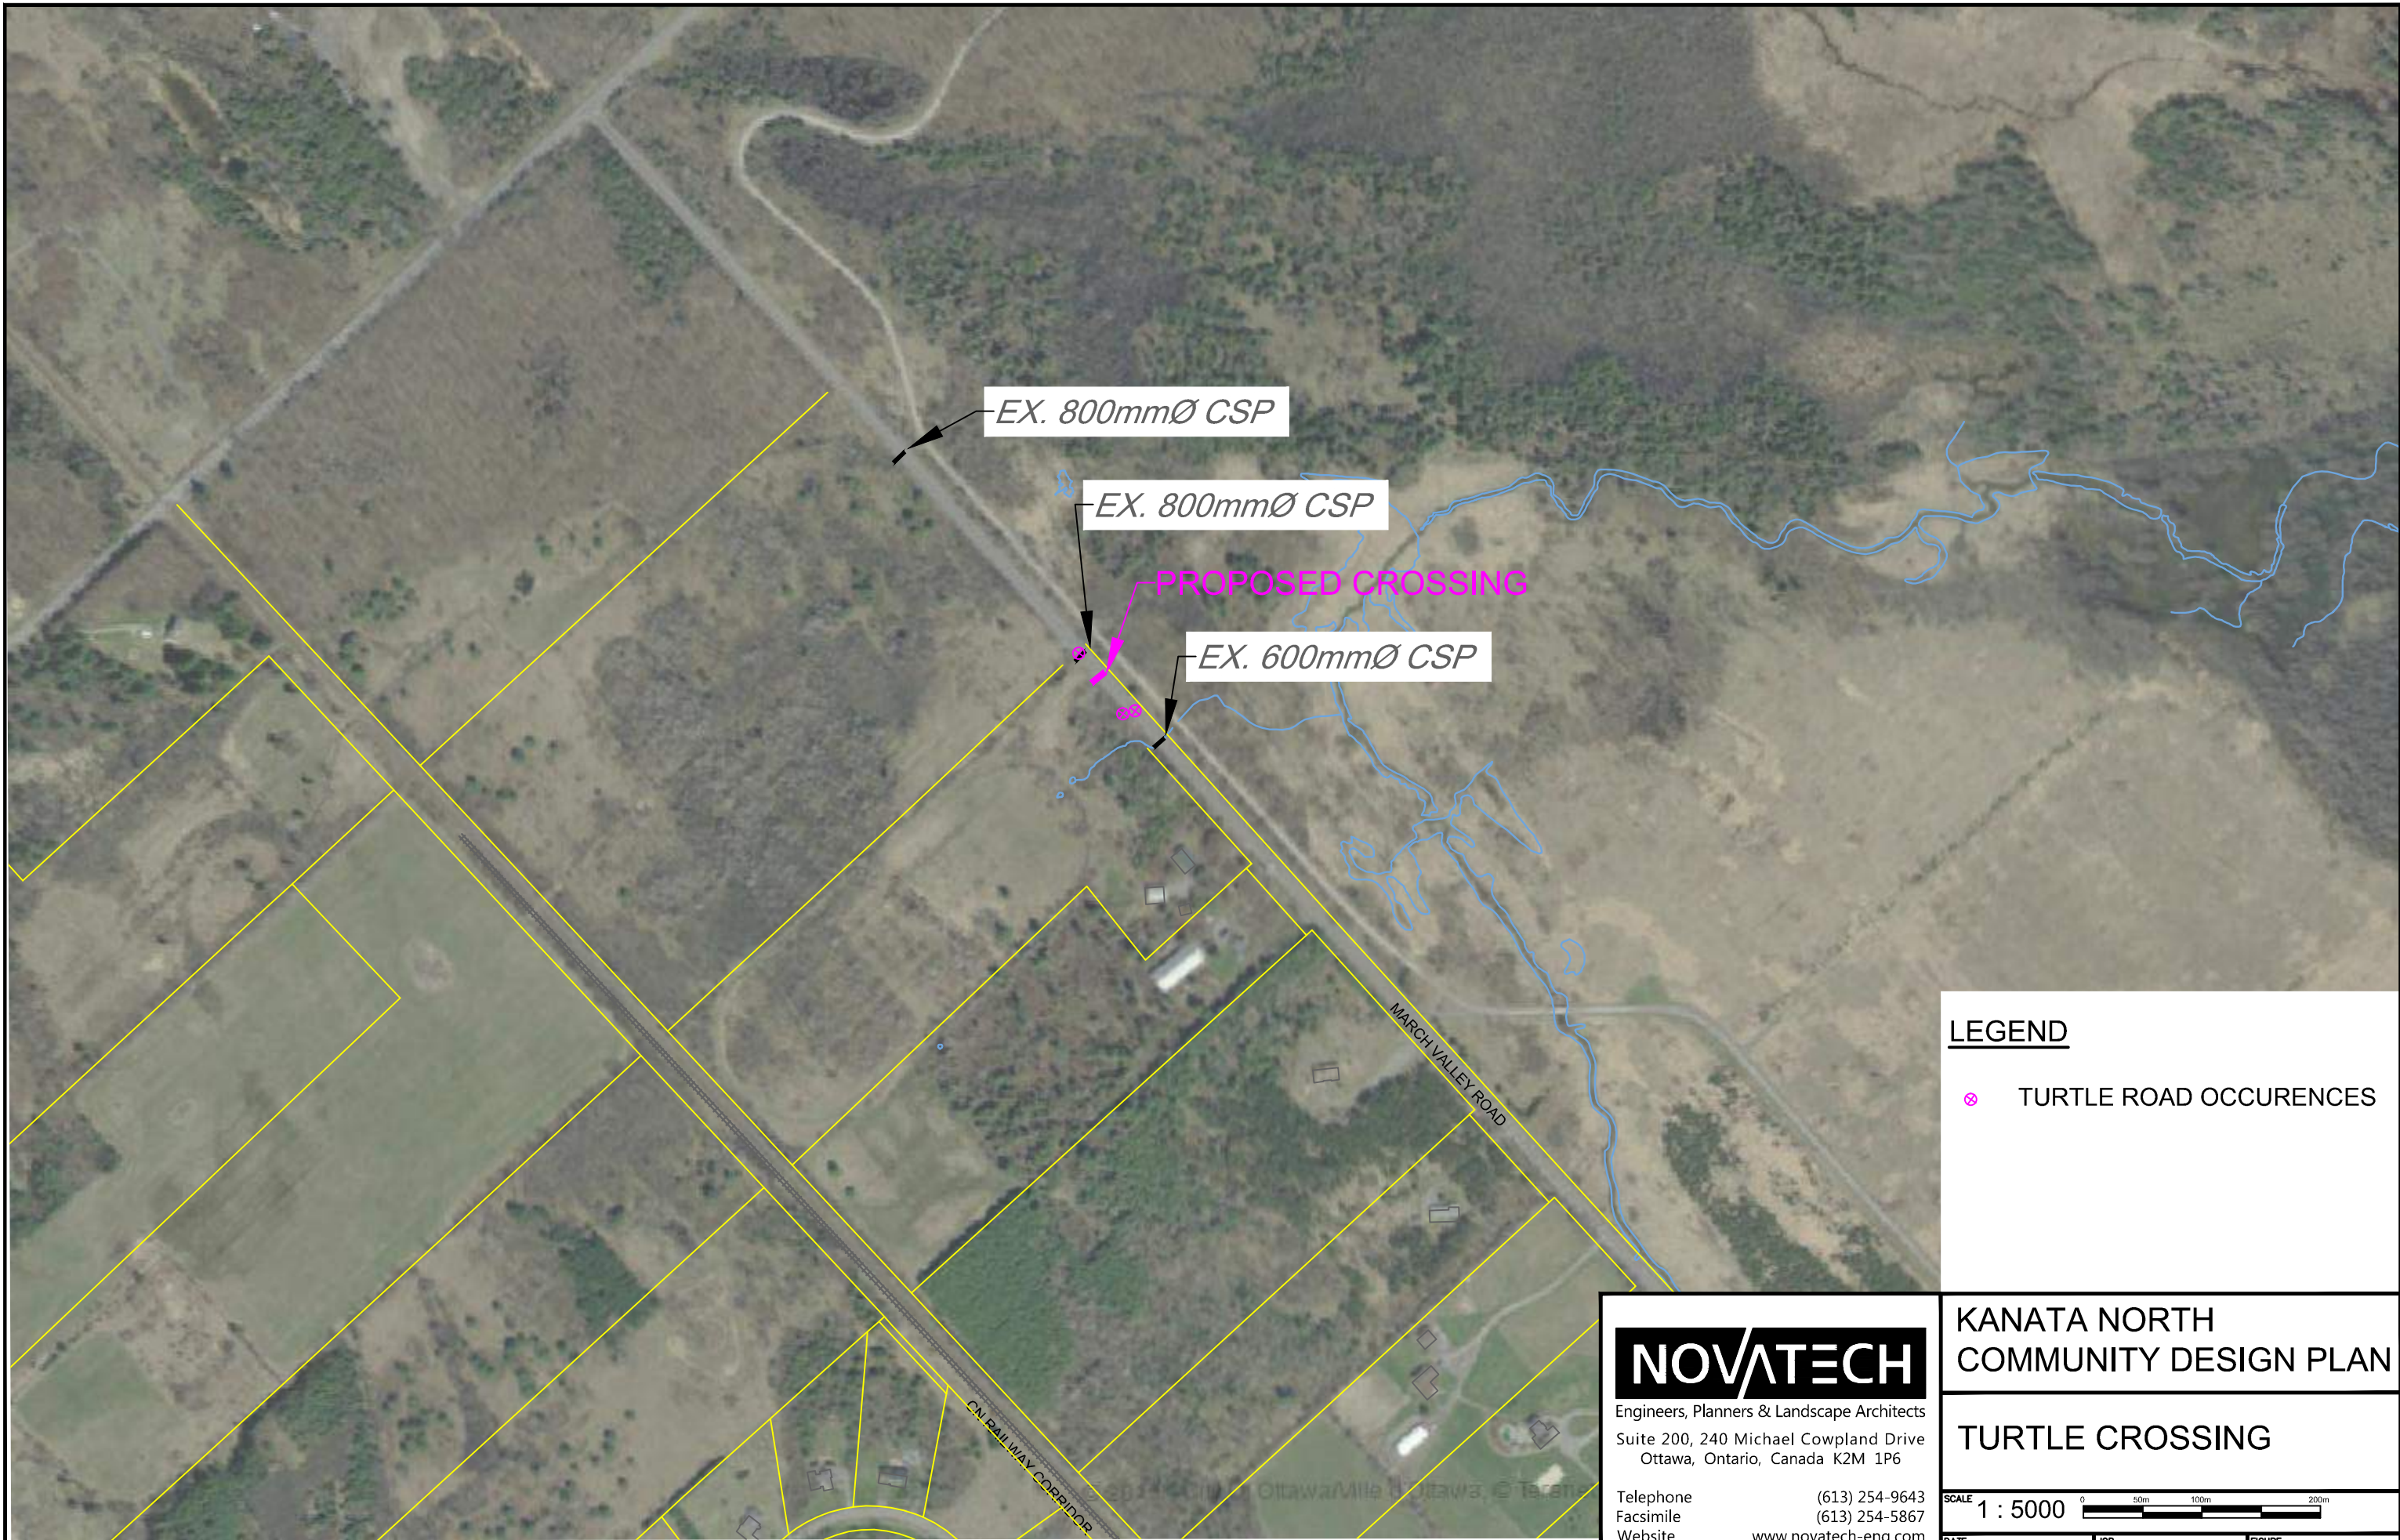
M:\2012\112117\CAD\Design\ MSSI\112117 - BP.dwg, FIG- TRTLE XING, Jan 25, 2016 - 11:52am, tbrooks

As recommended by OMNRF, the possibility of developing a road crossing for Blanding's Turtle along the northern section of March Valley Road has been investigated. This forms the foundation of our second submission. The second submission is meant to be read as an alternative to our initial submission, and would be undertaken *instead* of the works described in the first submission.

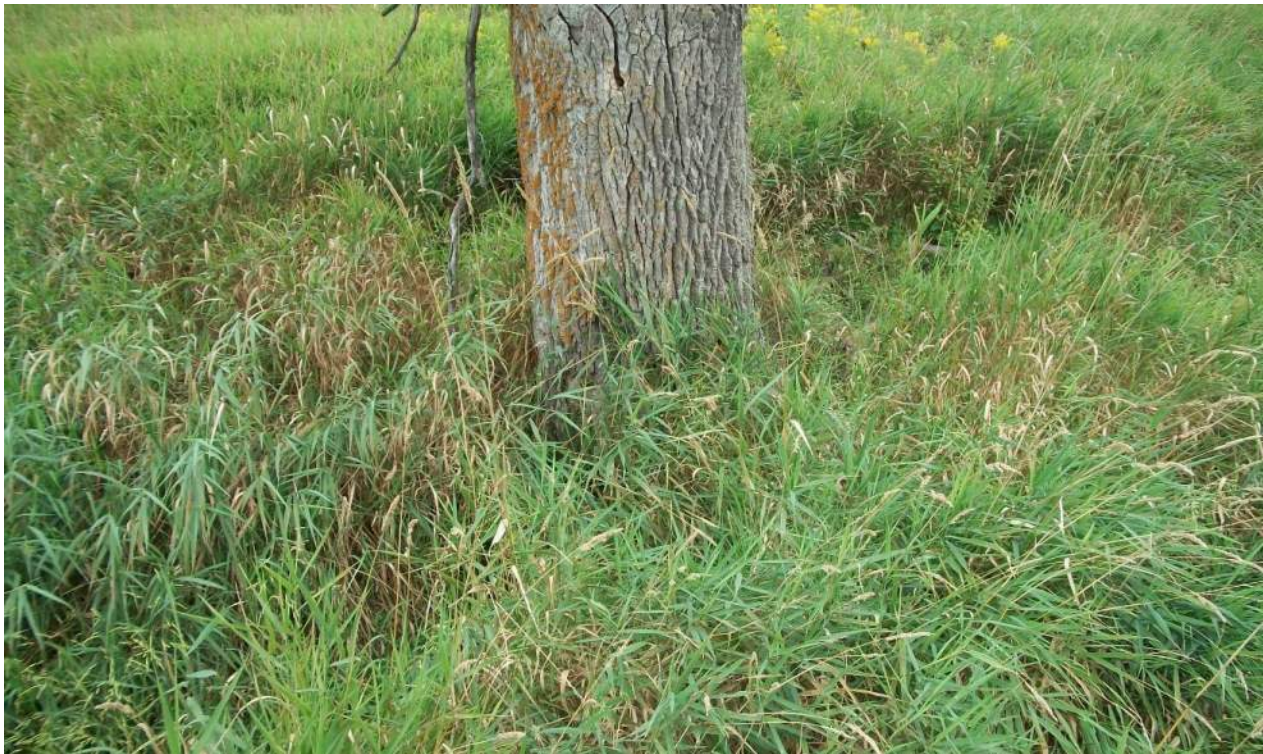
Image 2: Northwest Branch - Tributary 2 (August 24, 2015)

Note: There was approximately 22mm of rain between August 20 and August 24. Even so, the Northwest Branch Tributaries were observed to be dry on August 24, 2015.
