3.2 HYDROGEOLOGY

A hydrogeological report was completed by DST Consulting engineers in order to assess the existing hydrogeological conditions of the Former CFB Rockcliffe CDP site and to determine the expected potential impacts of the proposed redevelopment on groundwater and groundwater users (see Appendix A (4)).

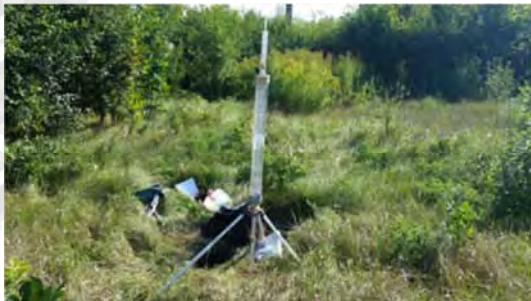
1. Guelph Permeameter Testing apparatus and protocols were utilized to determine the in-situ field saturated hydraulic conductivity (Kfs) at depths ranging from 5 to 30cm (average depth of 15cm) below ground surface (BGS).

Guelph Permeameter at Former CFB Rockcliffe

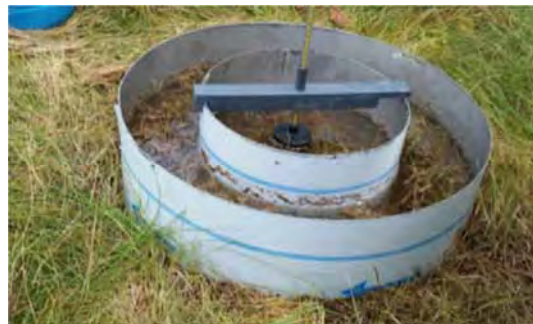
2. Double Ring Infiltrometer was utilized to determine the in-situ field saturated hydraulic conductivity (Kfs) of shallow soils at the existing land surface. This was intended to provide an indication of Kfs at the likely interface of the proposed grade raise (as discussed previously), to account for the effects of micro-tubules, rootlets and other macropores.

Double Ring Infiltrometer at Former CFB Rockcliffe

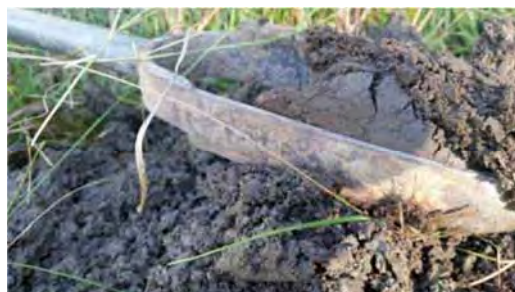
Silty Clay at Former CFB Rockcliffe

Locations with undisturbed soils were selected corresponding to the two dominant soil types of silty clay and sand/silty-gravel (see Figure 4A).

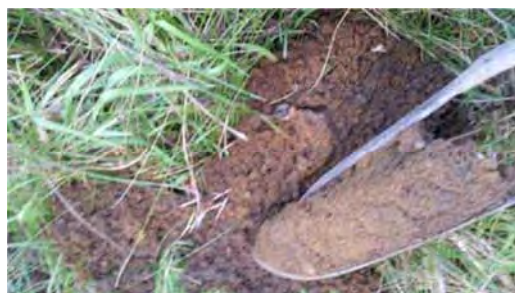
Sand/ Silty Gravel at Former CFB Rockcliffe
