AQUATIC HABITAT ASSESSMENT: WESTERN AND EASTERN CREEKS, FORMER CFB ROCKCLIFFE

SITE PLAN

Figure 21: Inventory of Existing Trees and Tree Groupings in the Study Area

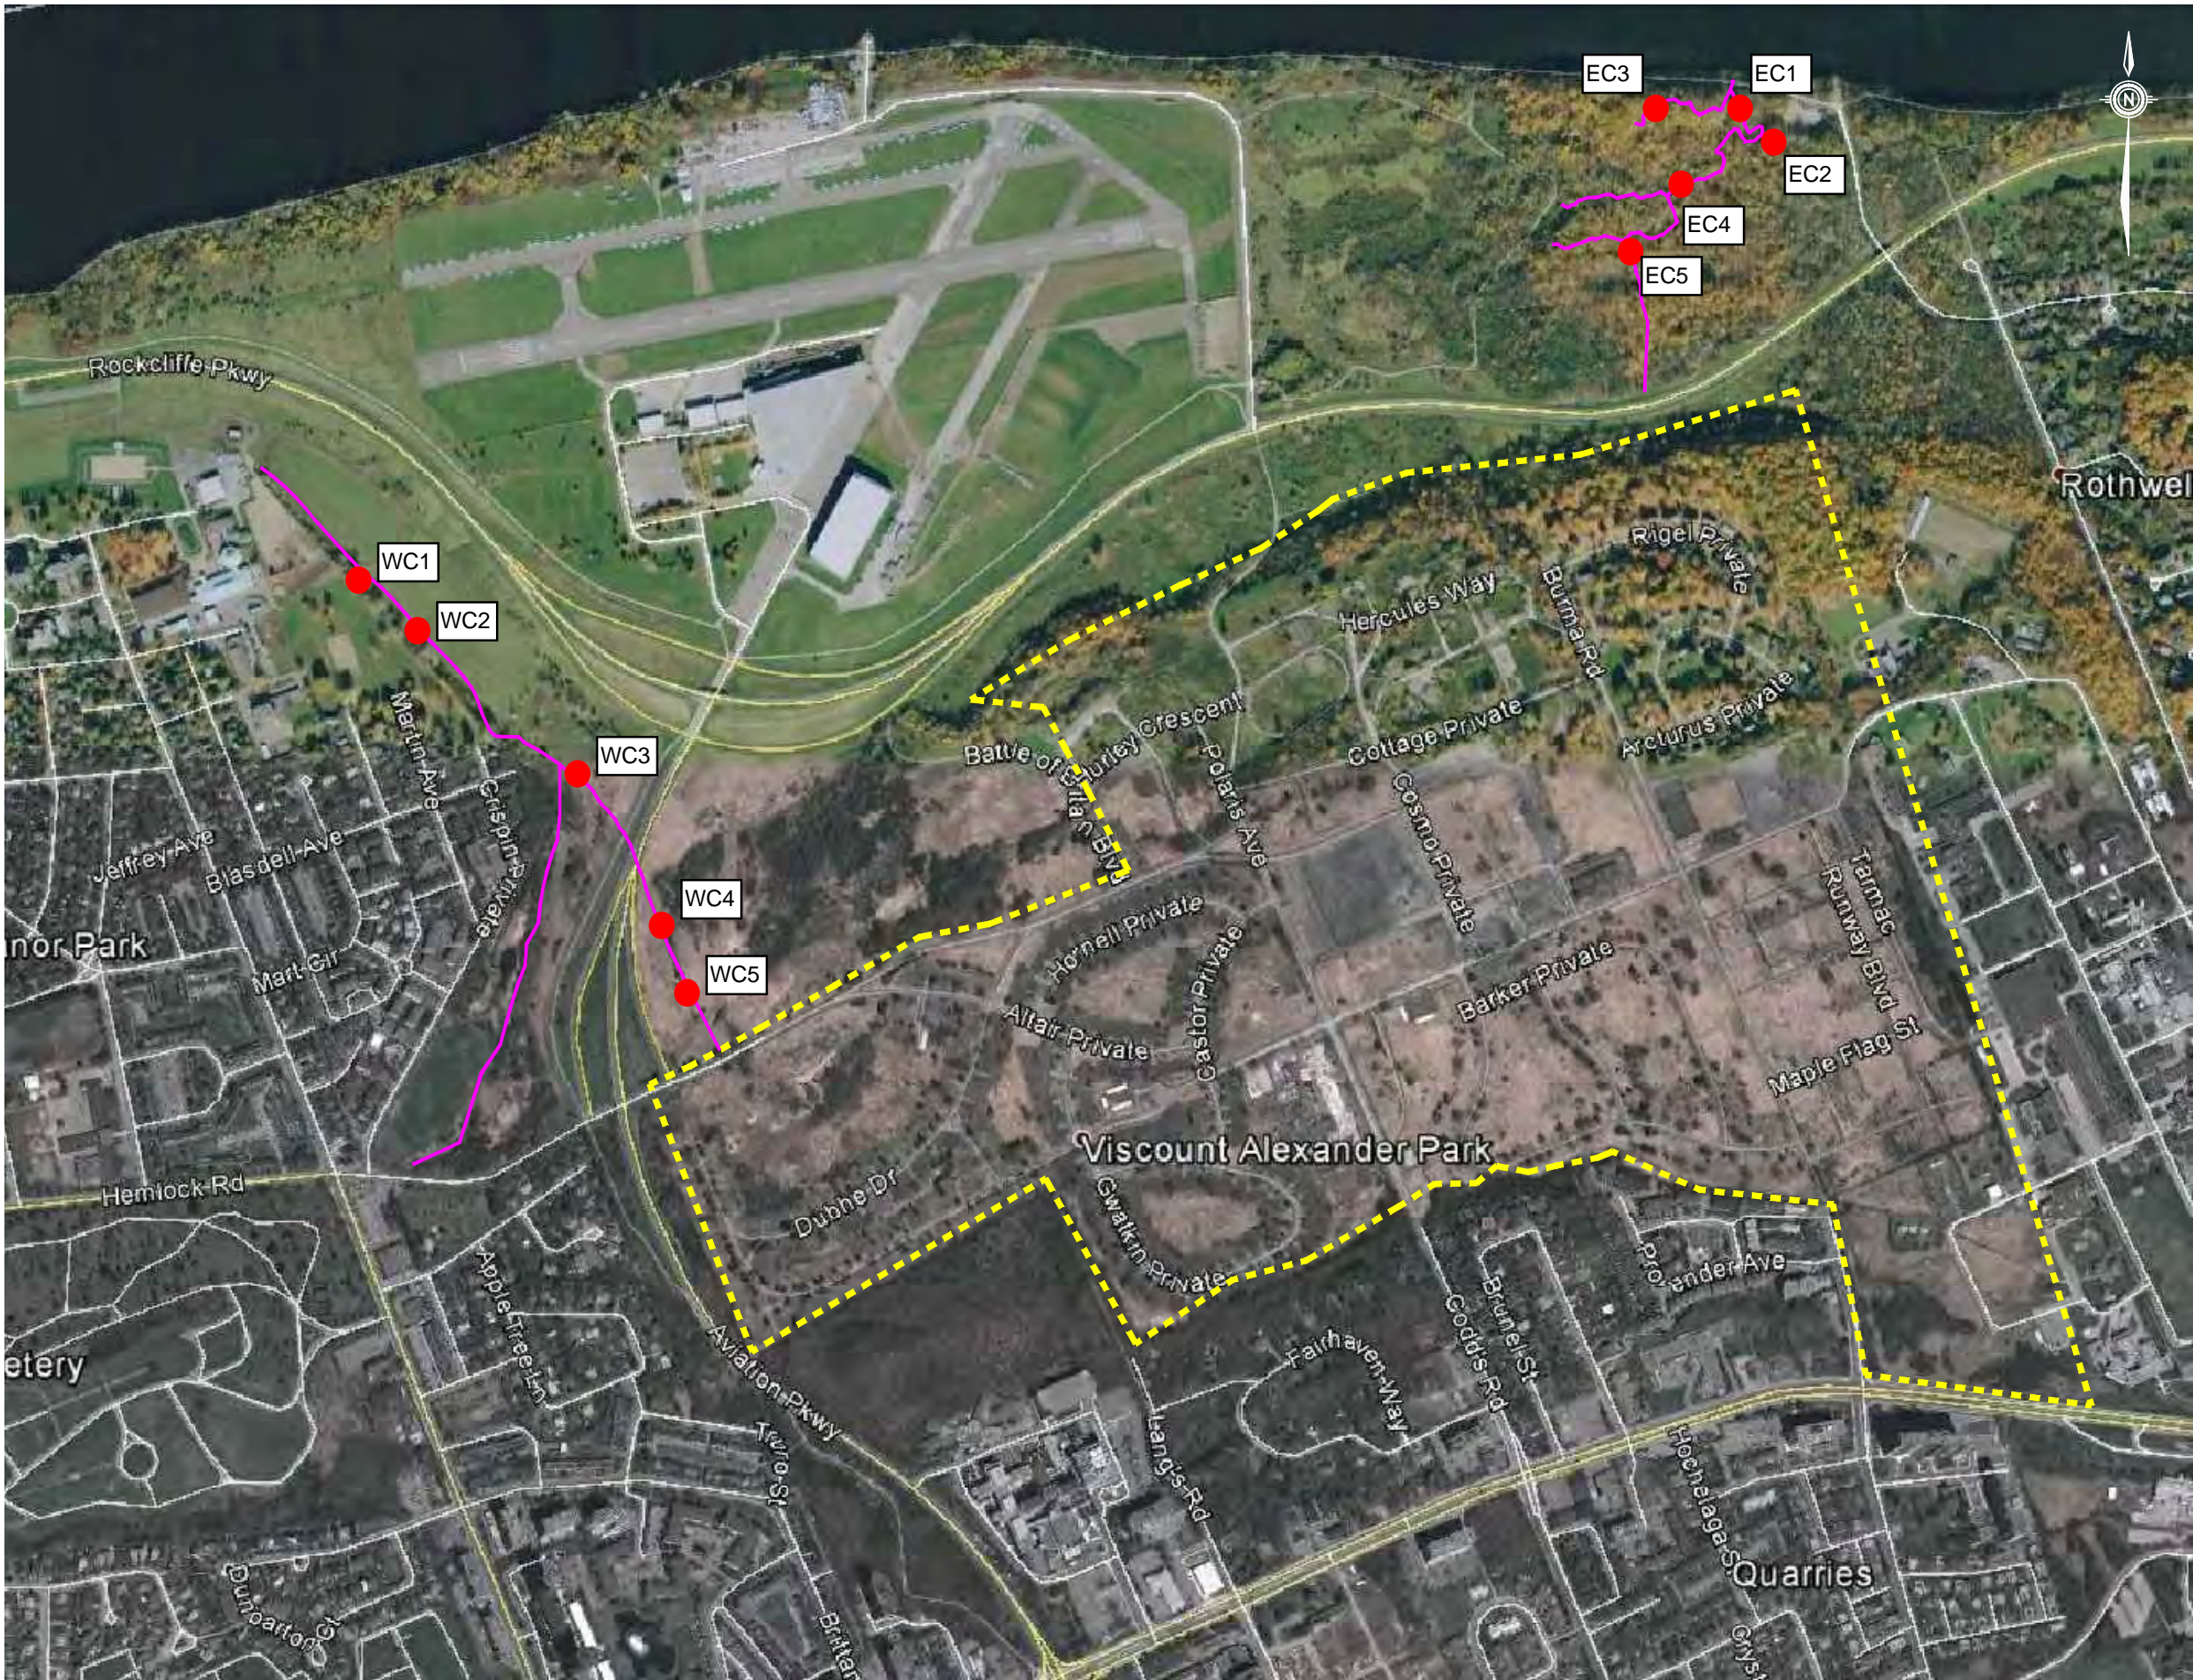
CREEK LOCATIONS
 -

OSAP SURVEY LOCATION
 -

SITE BOUNDARY

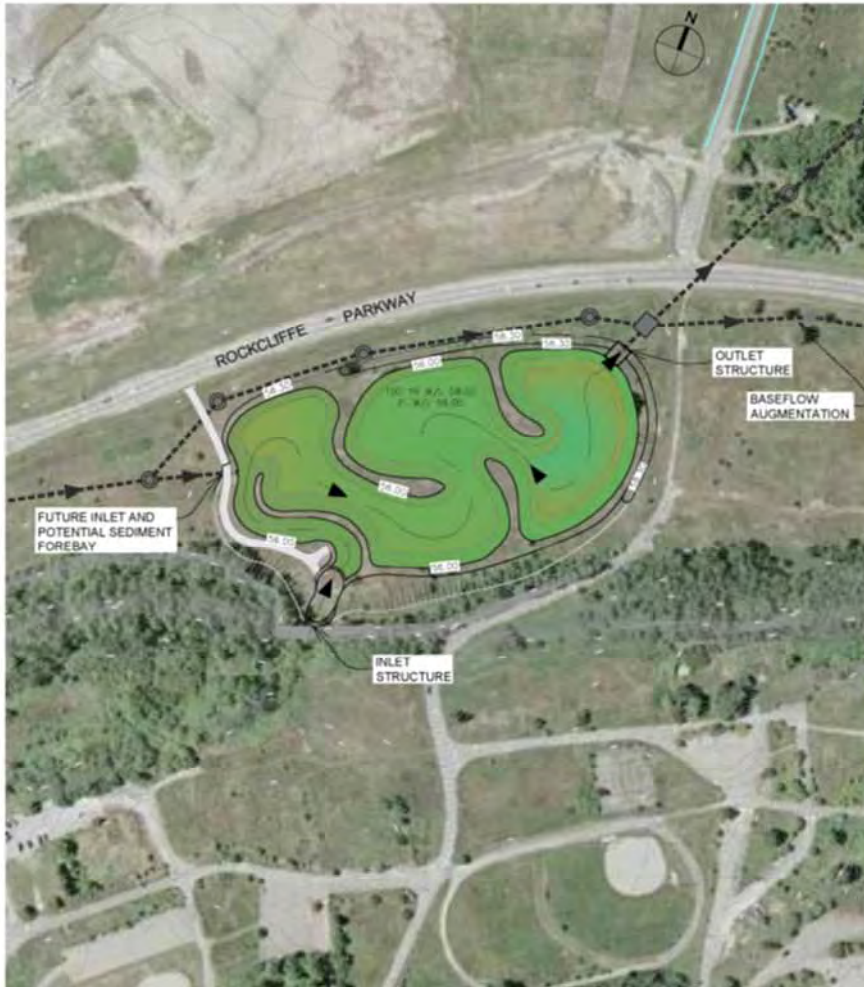
Figure 27: Eastern SWM Facility – Layout, Grading and Facility Attributes

It is proposed that the Eastern SWM Facility provide baseflow augmentation to the Eastern Creek by means of a small diameter pipe. Based on a volumetric calculation, 51,081cu-m/year is to be conveyed from the pond to the creek. The MSS recommends that this be confirmed at the detailed design stage, supported by continuous modeling.

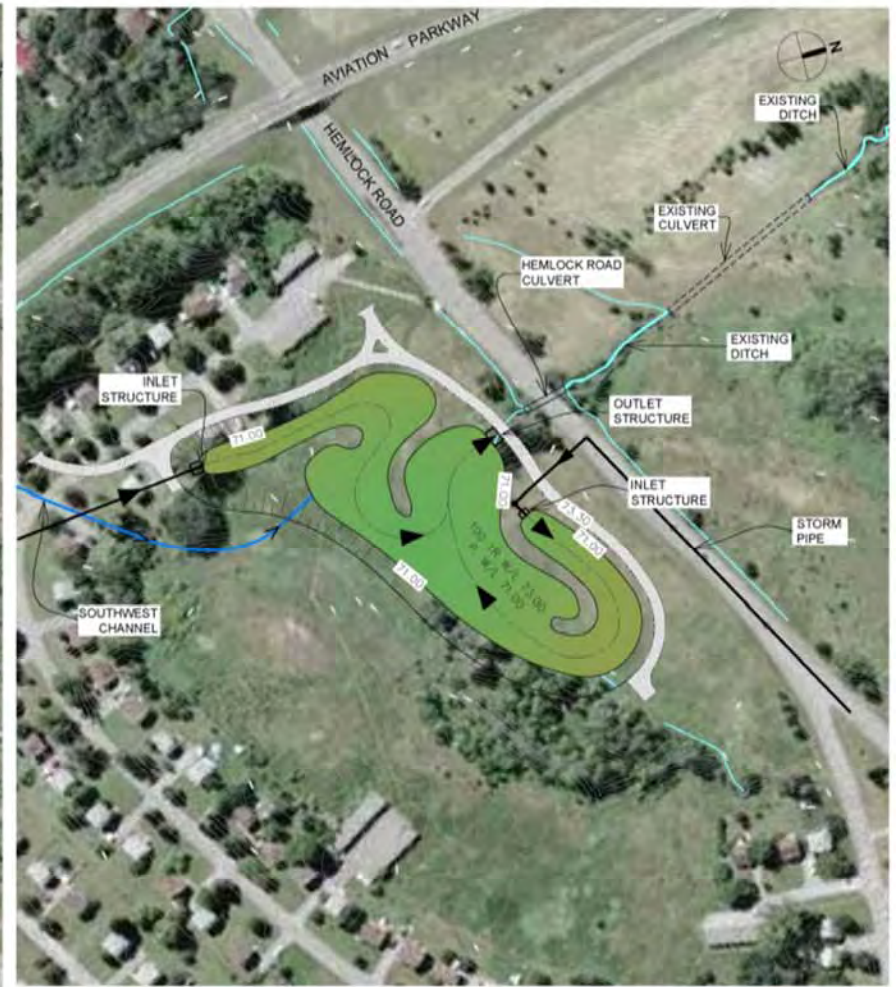
Figure 28: Western SWM Facility – Layout, Grading and Facility Attributes

Outflow from the facility is conveyed downstream via the Hemlock Road culvert, where it will flow overland towards the existing Aviation Parkway culvert. Downstream, flow will discharge to the Western Creek via the Aviation Parkway culvert during frequent storm events. During infrequent storm events, flow in excess of the Aviation Parkway culvert capacity will be conveyed east via the proposed channel-pipe configuration (Figure 29).
