212, James St

Construction Time Frame c. 1905

Descriptive sheet

326 Wilbrod

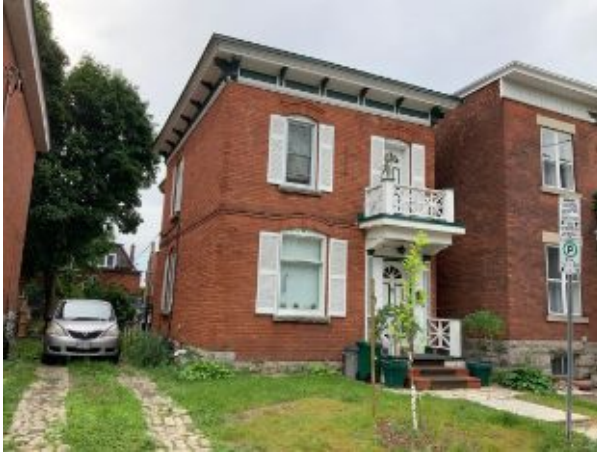
Architectural Description
Red brick residence.

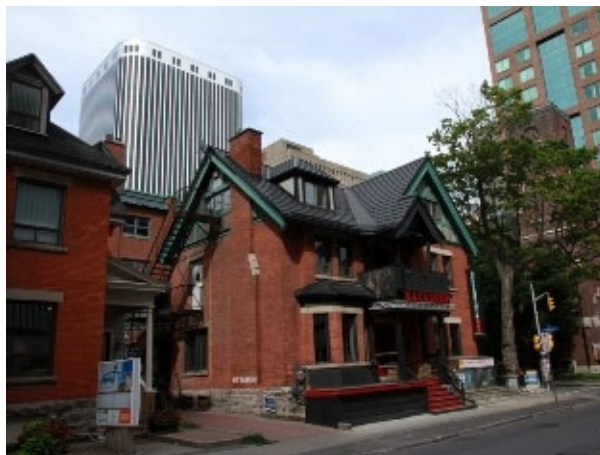
160, Metcalfe St

Corner property with red brick and a stone foundation, half timbering at gable end, smooth-faced stone lintels and rough-faced stone sills.

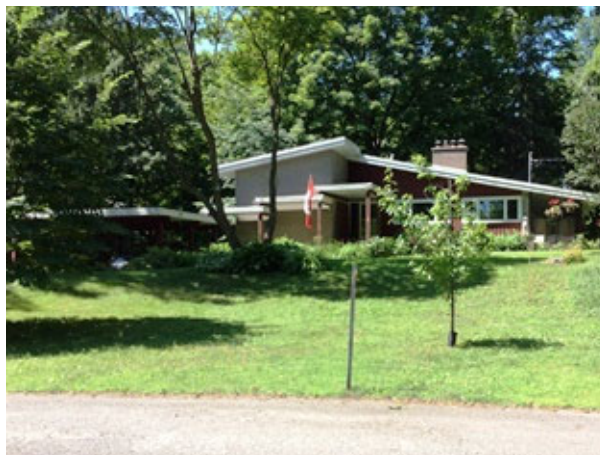
53, Oriole Dr

Split-level residence with asymmetrical roof, overhanging eaves, prominent chimney, and adjacent flat-roofed carport connected by stepped-roof walkway. Horizontal windows and recessed entry with sidelight. Brick and board-and-batten cladding.

Integrated into graded landscape in a park-like setting. Property is adjacent to small creek.

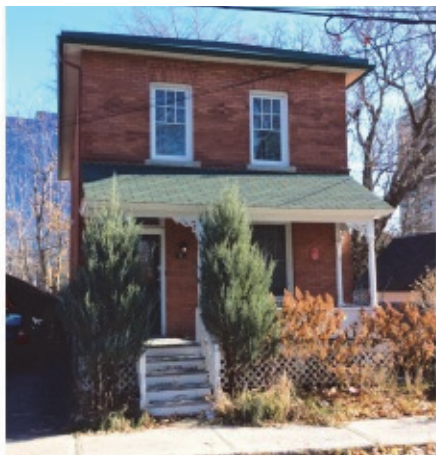
353, Gardner St

Brick stringcourse; brick voussoirs; stone sills; exposed stone foundation; transom window; over-hanging eaves; veranda with decorative millwork.

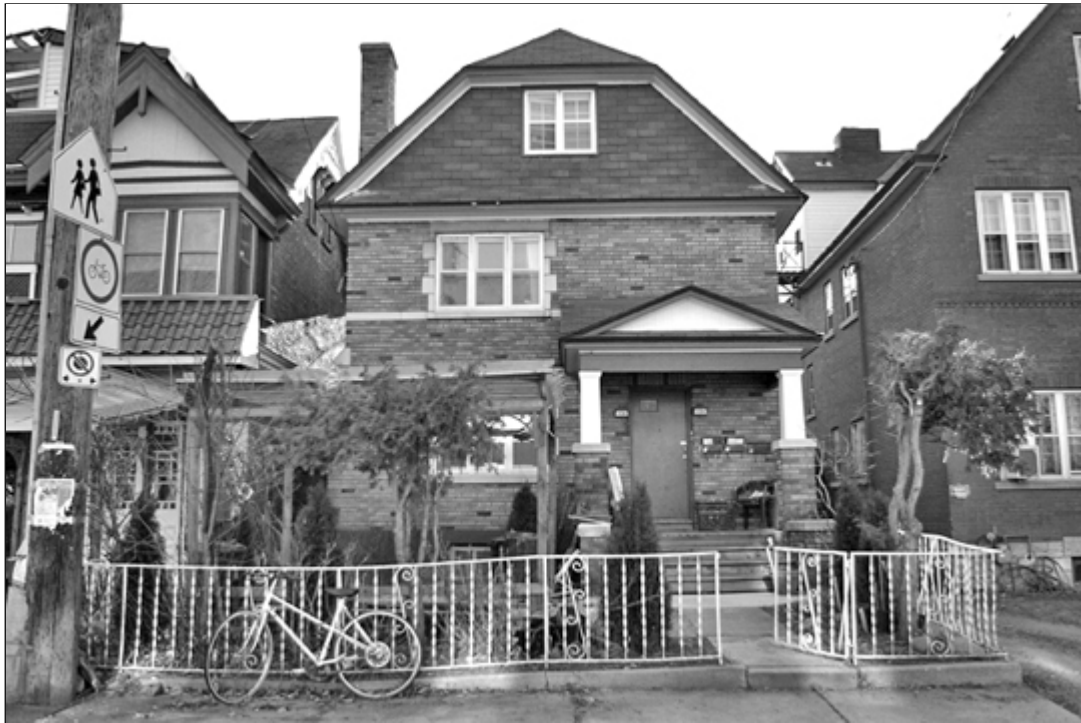
Property characteristics: Single use residential. Multi-unit, 2 1/2 storey with rectangular plan, off-center entry and occupied basement. 1 storey addition with metal siding, at rear. Site features consist of a driveway and fence at street.

Exterior elements: Sloped hipped roof of asphalt shingles with gable end; dormers and 1 brick chimney. Exterior with concrete sills and lintels. Parged foundation.

Windows and doors: Rectangular wood casement windows. Metal storm windows. Single wood front door.

Other features: 1 storey wood porch with brick base, wood columns, sloped roof and pediment.

Medium: storm windows and replacement roof elements have diminished the architectural integrity.

The architectural significance of this house lies in the sloped hipped roof with gable end and projecting eaves, the variegated brick that is typical of this period of construction in Sandy Hill and the porch with tall brick column bases and pedimented roof.

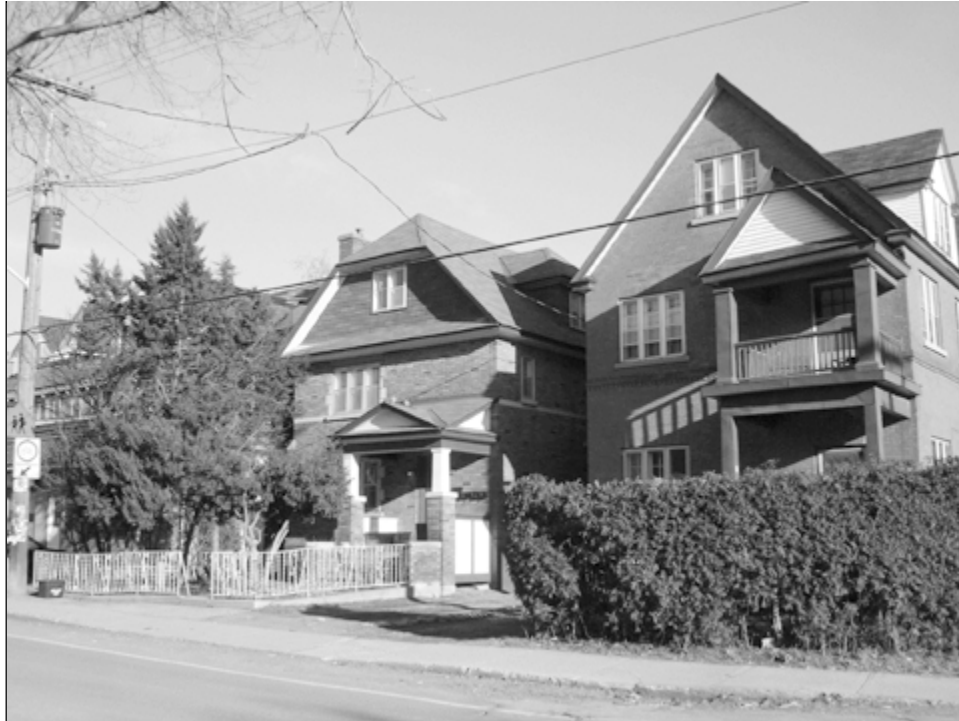
Pattern of site use: Typical front and side setbacks, atypical fence at front property line
 Use: Typical (residential)
 Height/Volume: Typical
 Materials: Typical (brick, shingle)
 Typology: Type 3(p)

This property is compatible with the block in which it sits. The fence at street is atypical for this block.

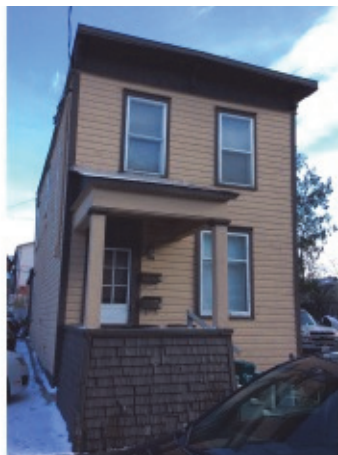
147, Forward Ave

Modest residence with wood trim, wood cornice, wood brackets and wood window surrounds, one-storey porch. Door and many windows appear original.

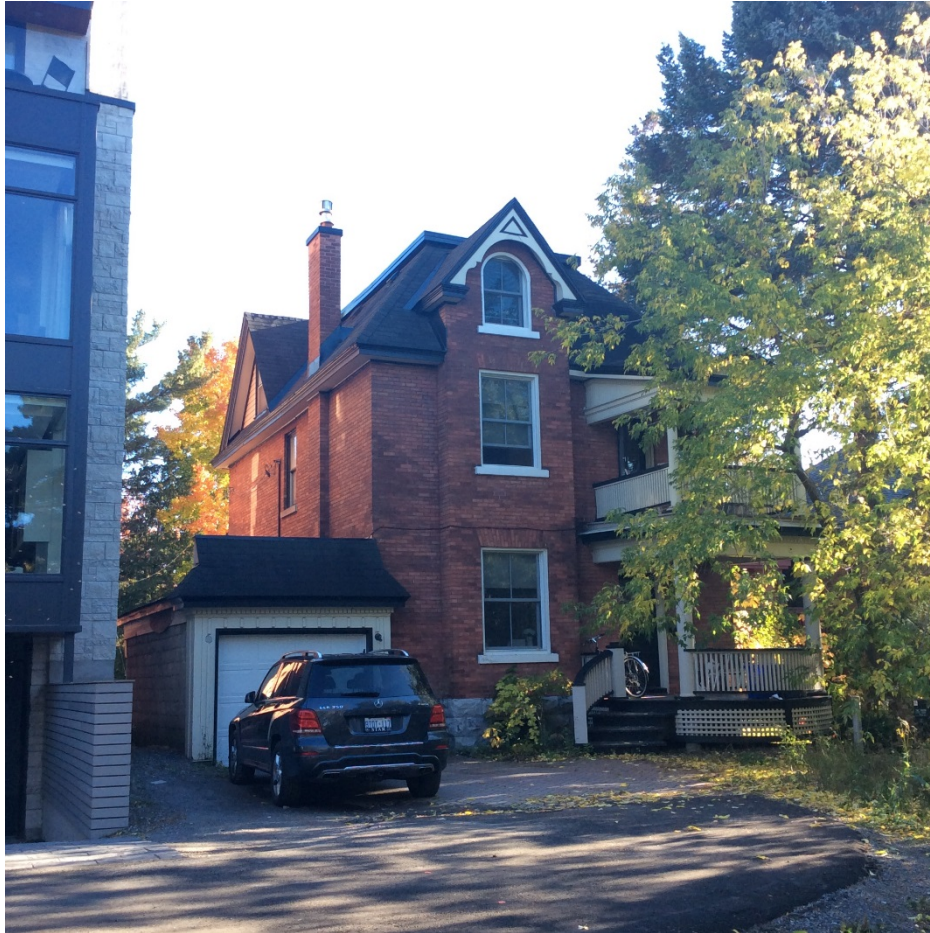
860, COLONEL BY DR

Built As	Detached House
Currently Used As	Residential
Construction Time Frame	c.1892
Primary Architectural Style	Edwardian Classicism
Degree of Integrity	Good
Roofline	Truncated Hip
Storeys	2.5
Primary Cladding	Brick
Dormers	Dormer – Gabled
Architectural Description	Three-storey gable bay with decorative bargeboard and semi-circular window in the gable. Slightly curved porch and balcony with Doric columns supporting a shed roof. Windows are vertically oriented with subtle voussoirs and sills. House faces canal.
Landscaping	Altered
Theme	Early urban settlement
Previous Reference List	Yes
Heritage Evaluation	Contributing

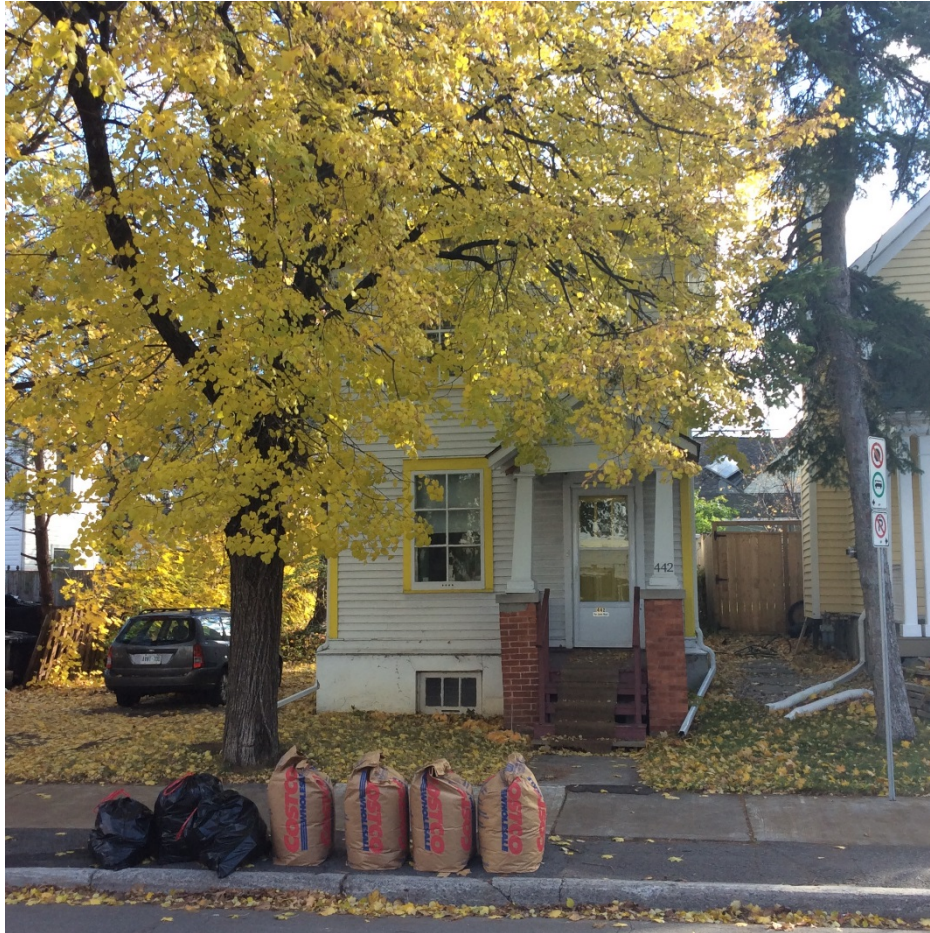
442, SUNNYSIDE AVE.

Built As	Detached House
Currently Used As	Residential
Construction Time Frame	c.1911
Primary Architectural Style	Vernacular
Degree of Integrity	Good
Architectural Integrity	
Roofline	Flat
Storeys	2
Primary Cladding	Wood – Shiplap
Dormers	None
Architectural Description	Simple house with painted wood framed windows, original muntins and mullions. Painted yellow trim, including dentils along roofline. Gabled portico with exposed rafter tails.
Landscaping	Original
Theme	Early urban settlement
Previous Reference List	Yes
Heritage Evaluation	Contributing

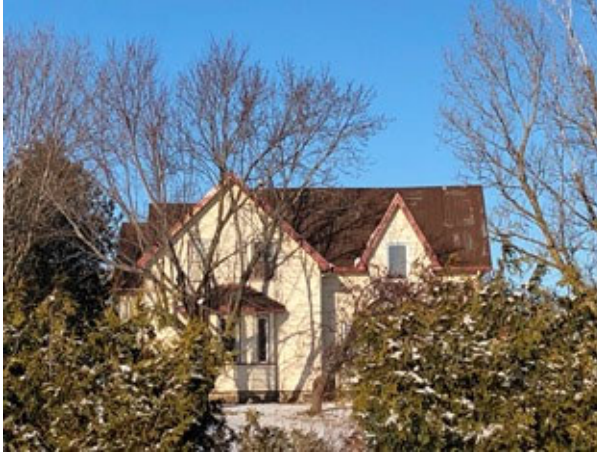
1613, Devine Rd

Ontario farmhouse design with metal roof, gables, one-storey projecting bay, exposed stone foundation.

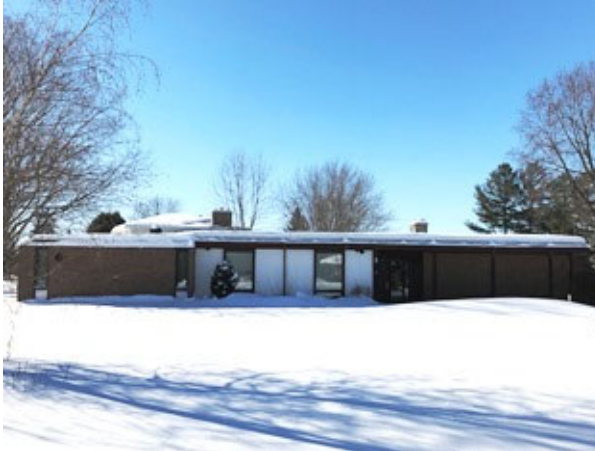
2, Melva Ave

Residence with wide, horizontal massing, central stone chimney, and attached two-car garage. Vertical windows arranged in pairs. Recessed main entry accessed via integrated covered walkway. Breezeblock wall at side. Brick and solid panel cladding.

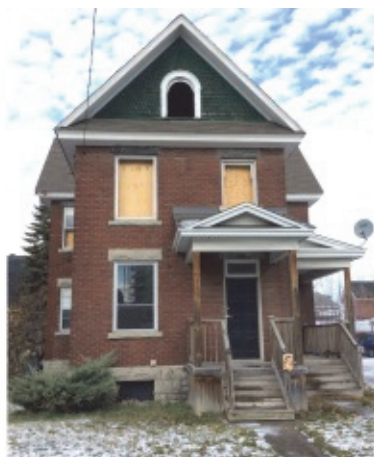
177-179, Armstrong St

Red brick residence with cross-gable roof, well set back from the street; cedar shingle in gable-end; stone lintels; stone sills; exposed stone foundation; one-storey porch with pediment; transom window. Window panes are missing. Likely re-clad in 1940s.

Large lot shared with 1-storey building built c. 1952.
