# City Registry Office

70 Nicholas Street, Ottawa

## Building Relocation Feasibility

JCAL Project No. 21143

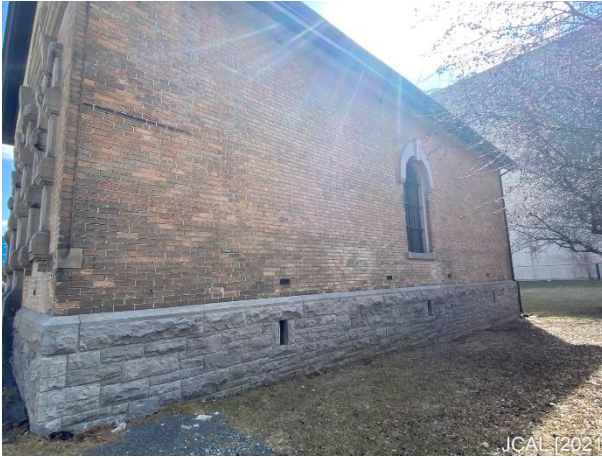
**Photo 1a:** North Elevation [JCAL (2021)]

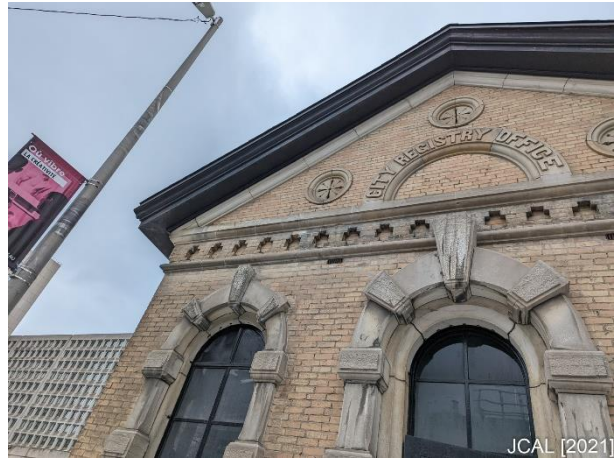
**Photo 1b:** Partial East Elevation [JCAL (2021)]

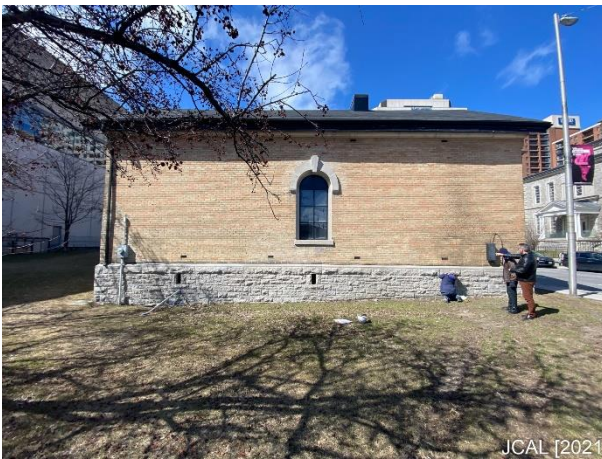
**Photo 1c:** South Elevation [JCAL (2021)]

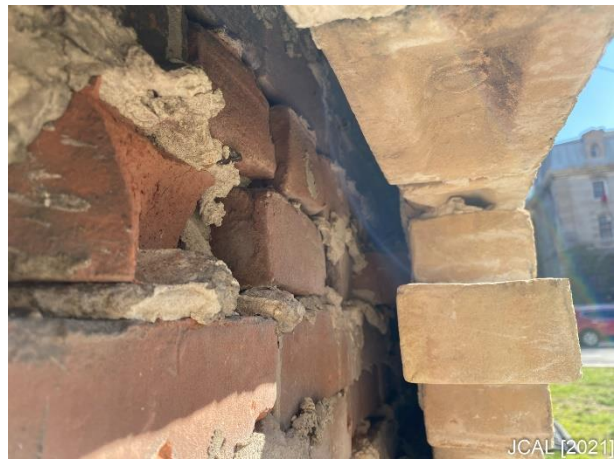
**Photo 1d:** Facing Brick and Cavity [JCAL (2021)]

The wood roof trusses span north-south and bear on the north and south exterior walls. The ceiling is a 3-wythe, 3-span brick vault that spans east-west and bears on the east and west exterior walls and two interior brick walls. Two 1" diameter tie-rods connect the east and west exterior walls and are terminated by a 12"x5"x1/2" steel plate within the wall composition. The interior and exterior brick masonry structural walls are approximately 6 wythes thick. An additional exterior facing wythe of brick is included at the exterior walls. This facing wythe is separated from the loadbearing structure by a 1" cavity and is laterally connected to the structural wall with diagonal bonding bricks that span the cavity, spaced every  $\pm 16"$  horizontally and approximately every 4 courses vertically. The facing brick is complemented by ashlar stone at the window and door surrounds, cornice, and gable/pediment ornamentation. Exploratory work has revealed that the ashlar stones bridge the cavity and provide bonding into the depth of the structural wall.

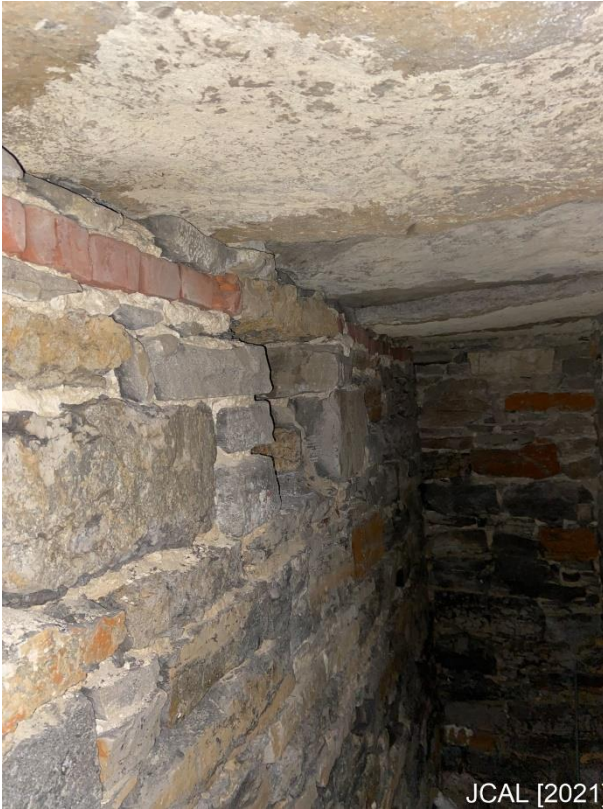
**Photo 1e:** Foundation and Stone Slabs [JCAL (2021)]

The stone masonry foundation walls at the exterior perimeter are  $\pm 40"$  thick with rough-cut rubble coursed face stone and limestone rubble back-up. Within the building footprint are rubble stone foundation walls supporting the intermediate loadbearing north-south brick walls with additional east-west walls at  $\pm 34"$  c/c to support the 6"x40" limestone floor slabs. The interior foundation walls are approximately 19" thick and  $\pm 13'$  high, presumed to be founded on bedrock. Exploratory work has confirmed that the stone slabs abut the interior face of the structural walls and do not pass under the brick.

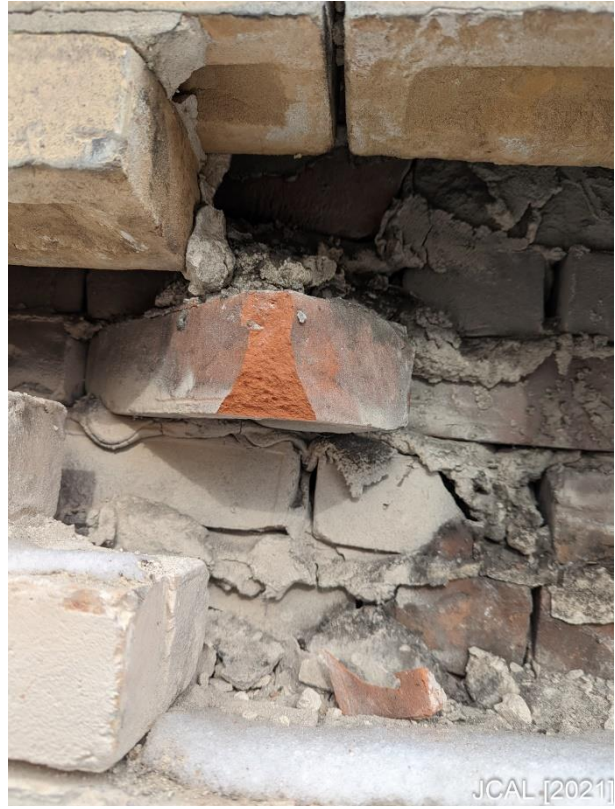
**Photo 1f:** Cavity and Diagonal Tying Brick [JCAL (2021)]

- Pinning of fractured stones throughout the elevations, primarily around window and door surrounds;
- Supplementary tying of the exterior facing brick to the backup structural wall. Observations and past experience suggest that the diagonal bonding bricks are fractured in many locations. This bonding technique between wythes of brick is very susceptible to failure as it offers a very small area of interaction between the tying and wall bricks.

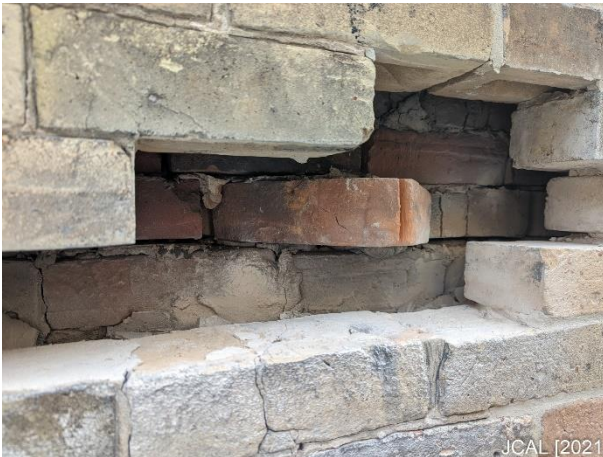
**Photo 1g:** Cavity and Diagonal Tying Brick [JCAL (2021)]

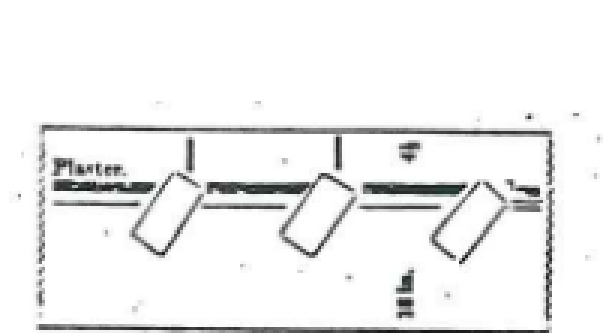
**Photo 1h:** Diagonal Tying Brick [Specifications 1874]

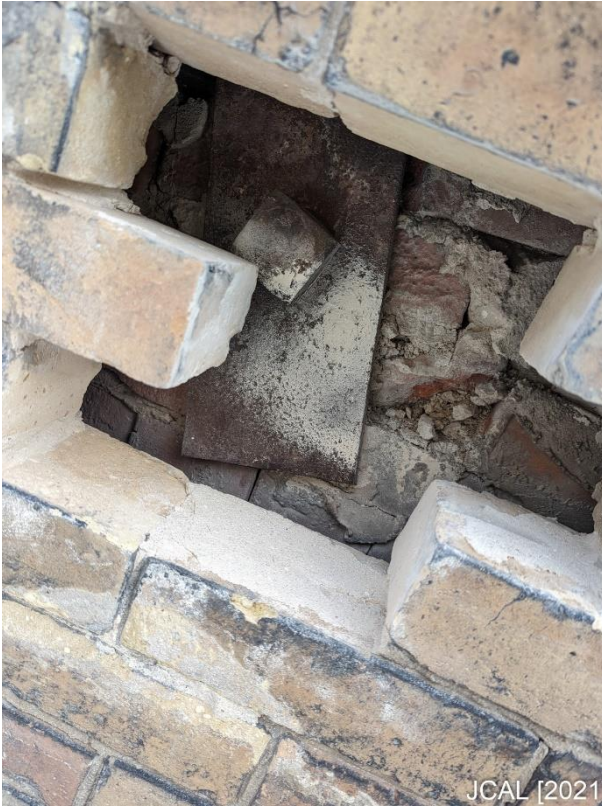
**Photo 1i:** Tie Rod End Plate [JCAL (2022)]

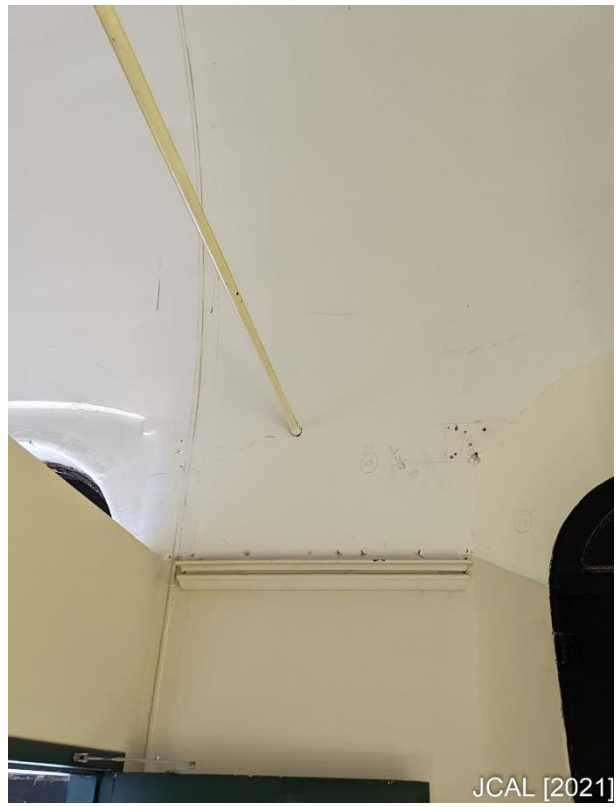
**Photo 1j:** Tie Rod [JCAL (2022)]

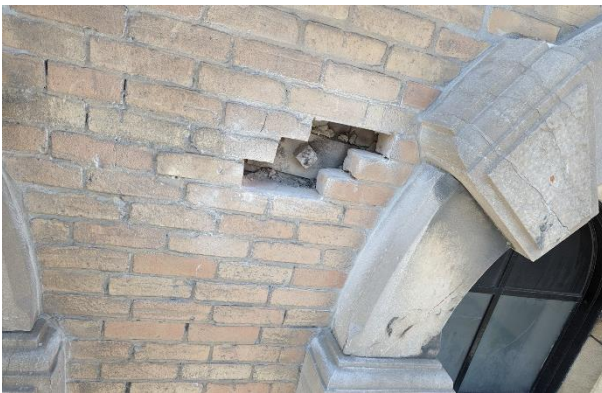
**Photo 1k:** Tie Rod End Plate [JCAL (2021)]

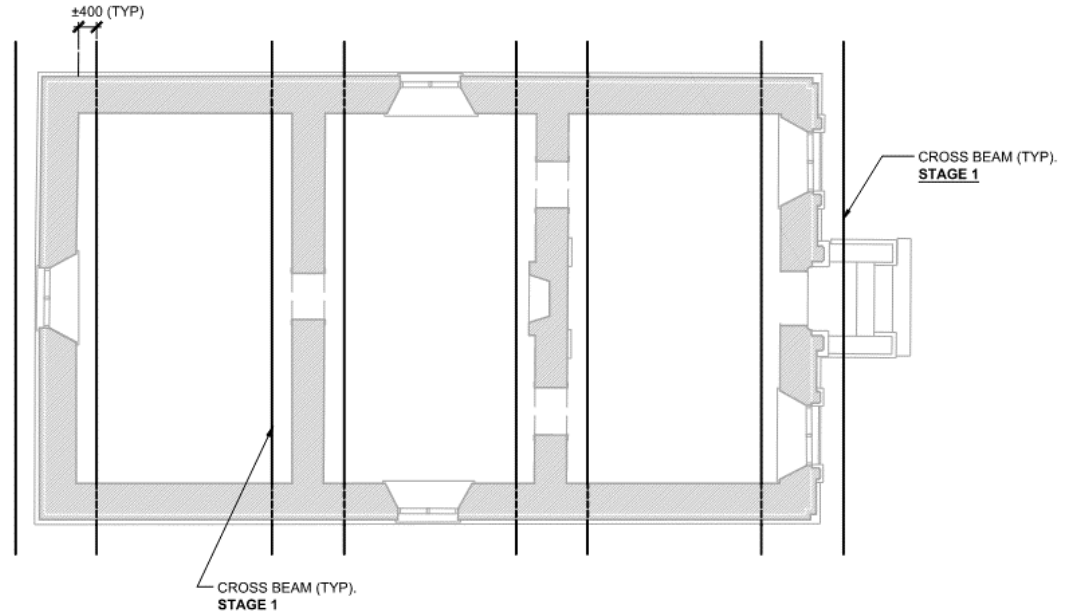
#### Stage 1: Cross Beam Installation

Stage 1: Install Cross Beams – The primary cross beams will be needled through the masonry walls. The cross beams will be the primary supporting elements for the north-south walls that support the vault. The

elevation of the cross beams has been selected to engage the top plinth course of stone. This takes advantage of the existing building attributes since this course of stone can act as lintels to support the facing brick above. At the locations of the beam penetrations, the masonry will be cataloged, dismantled, and stored for future re-integration. Once the opening is made, the beams will be slid into place, likely two sections will be spliced to span the entire length of the building.

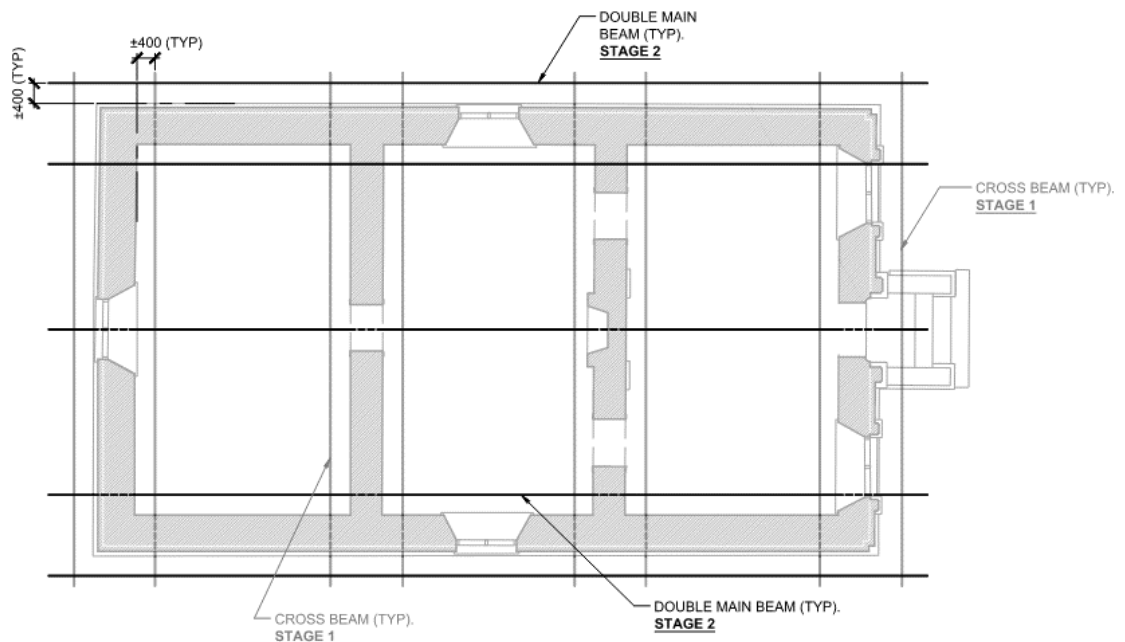
#### Stage 2: Main Beam Installation

Stage 2: Install Main Beams – The main beams will serve as the primary lifting point and provide support to the cross beams. As with the cross beams, masonry will be cataloged, dismantled and stored for future re-integration. Select needle beams will be installed strategically to provide support over the main beam locations during dismantling.

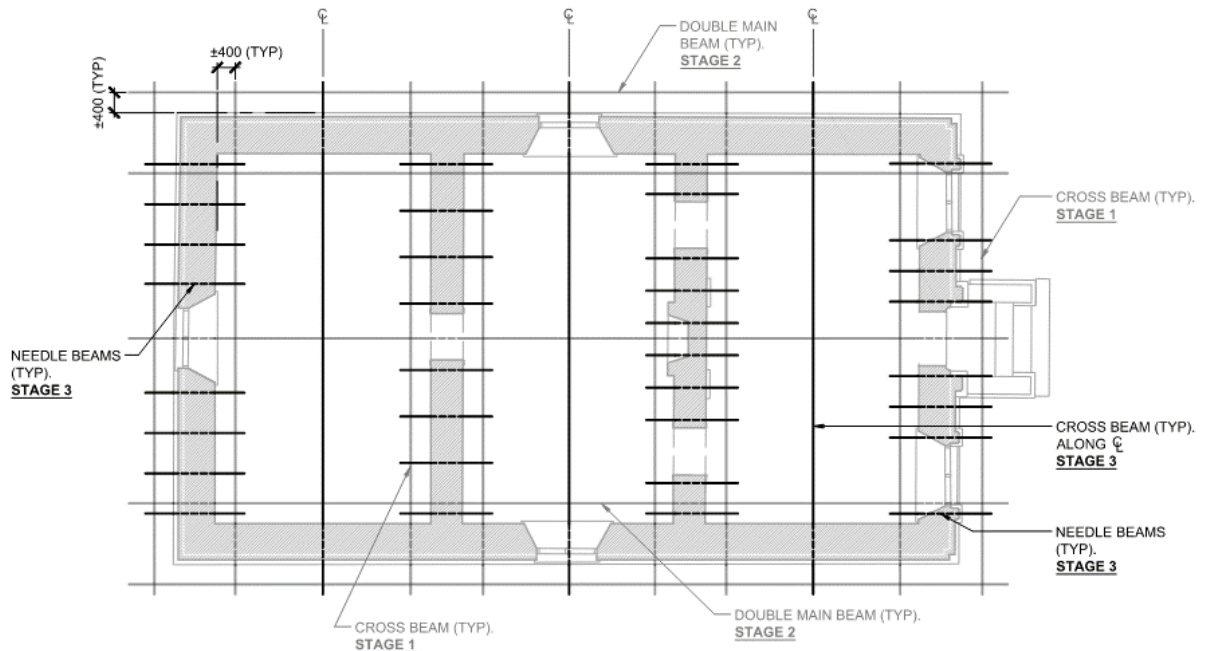
Stage 3: Needle Beam Installation

**Stage 3: Install Needle Beams** – At this stage the needle beams under the north-south walls will be installed in the same manner as the previous beams. These are the beams that interact directly with the north-south masonry wall and transfer load to the cross beams.

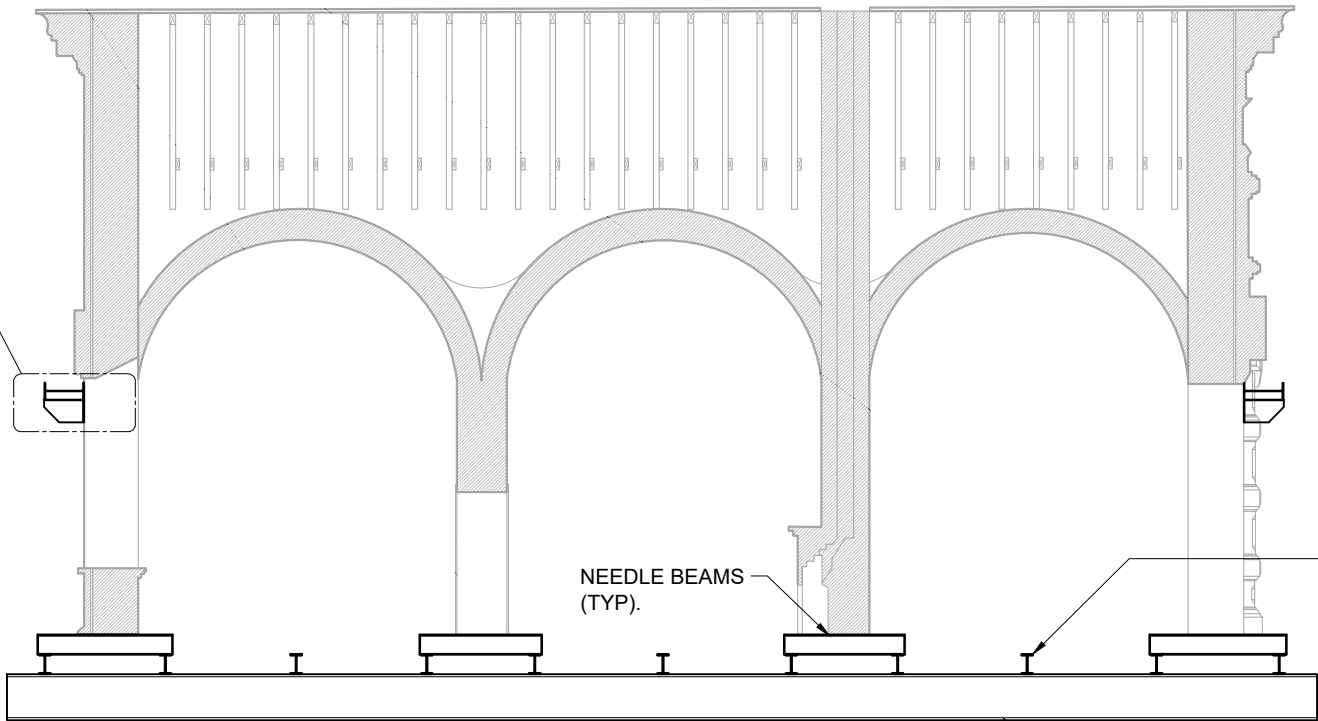
SK-S2

NEEDLE BEAMS  
(TYP.)

CROSS BEAM  
(TYP.)

DOUBLE MAIN BEAM  
(TYP.)

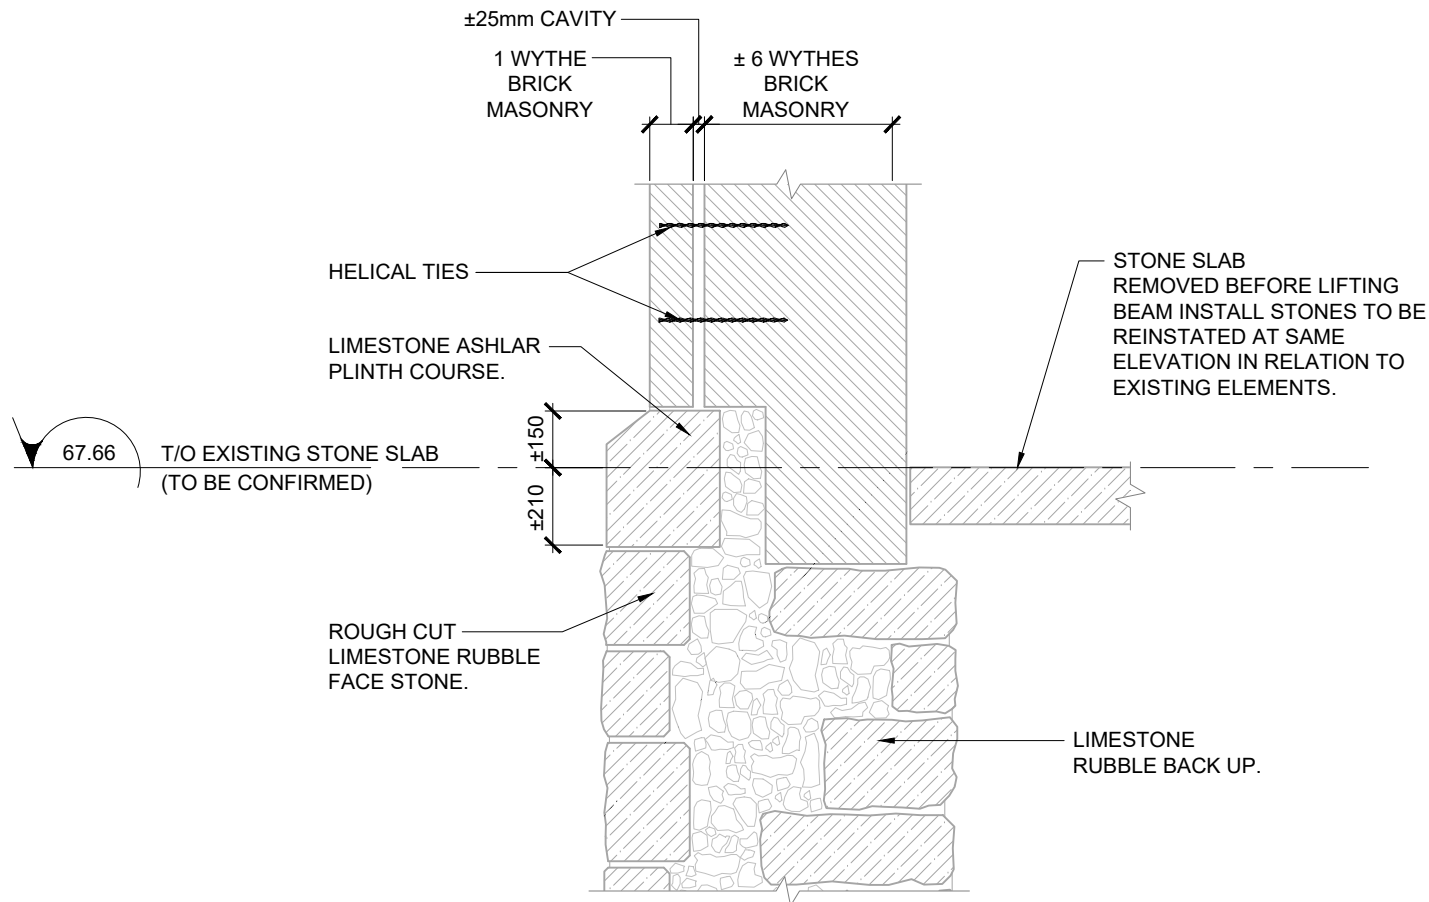
**SK-S3**

DETAIL: EXISTING WALL SECTION

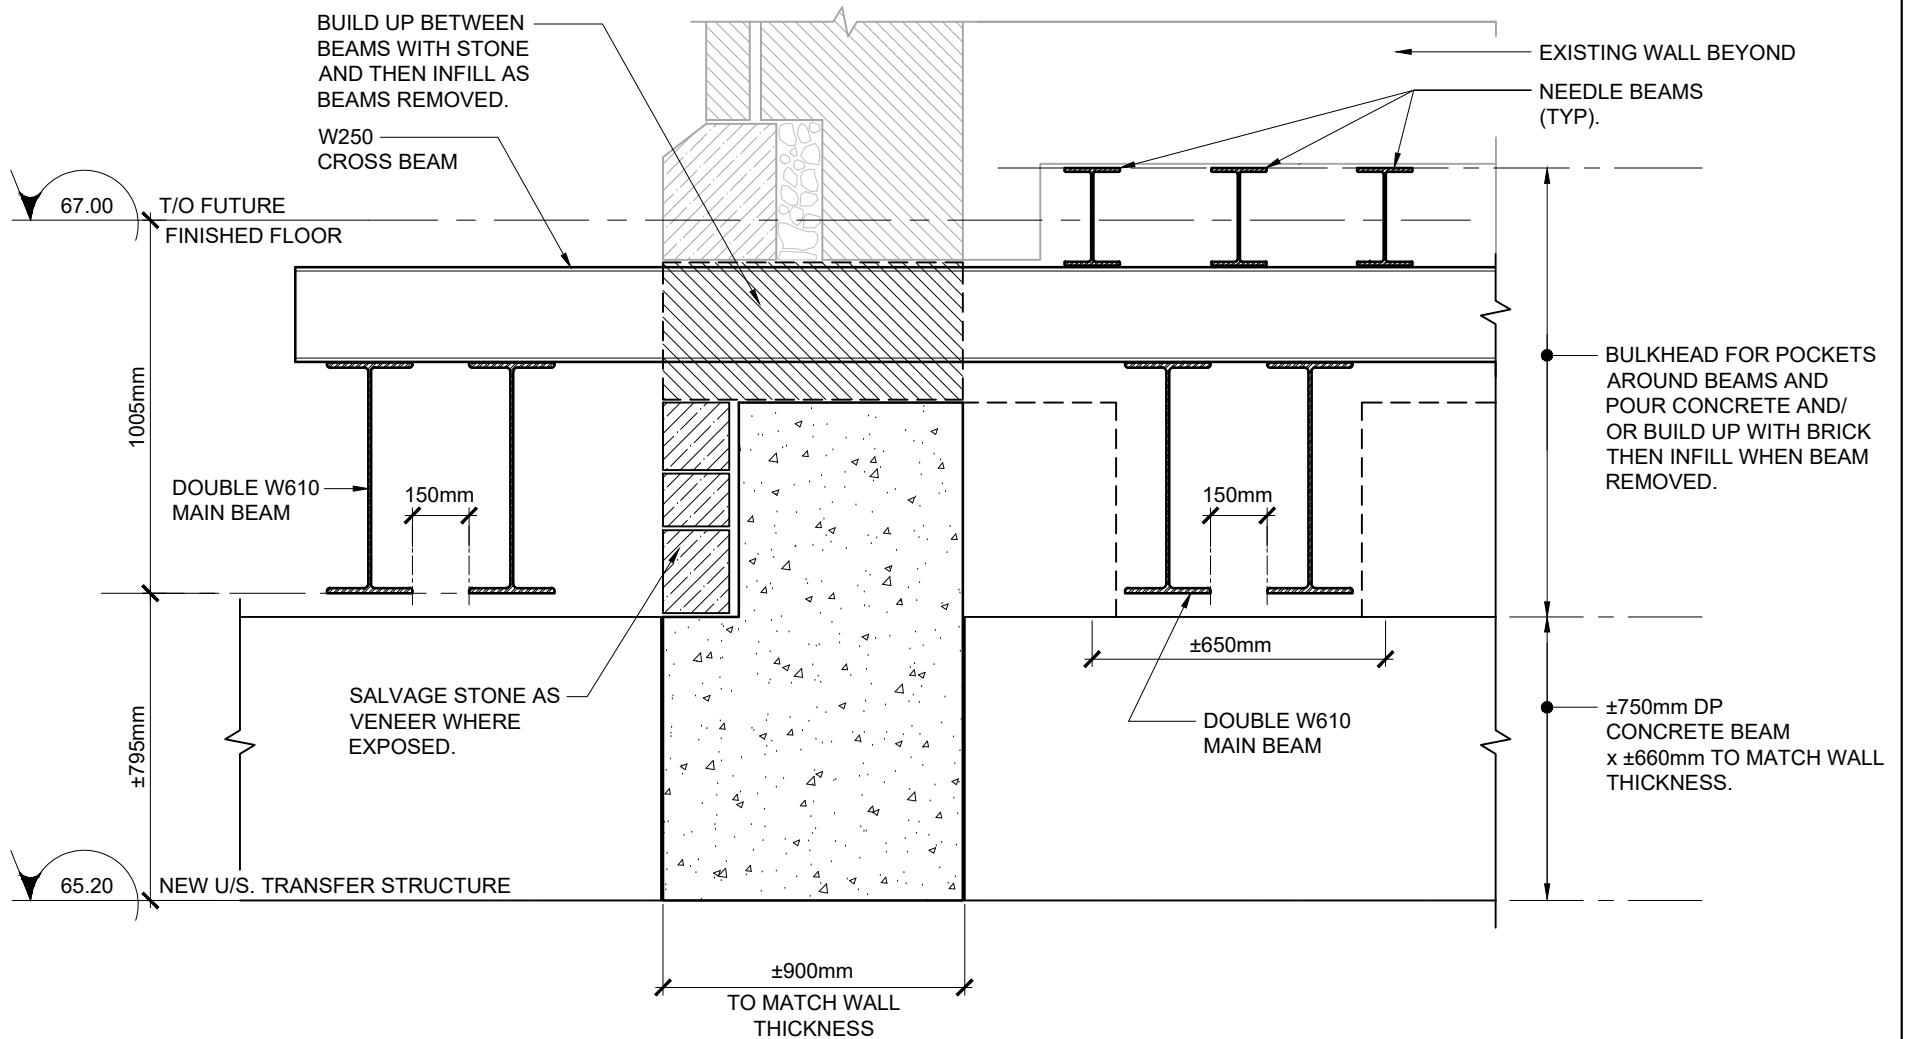
**SK-S4**

**DETAIL: NEW LOCATION - SECTION**

The support provided by the new structure is presently considered as a structural transfer slab or series of transfer beams and slabs. The final design is being coordinated at this stage, considering the most efficient solutions that will maximize the use of the garage levels below. The type of structure selected will offer the same constraints, so the discussion here can be equally applied to both options. The most challenging constraint to accommodate is the future top of finished floor elevation, the available space below to accommodate adequate parking capacity, the proposed grading at the exterior to encourage drainage, and the most economical lifting point at the underside of the ashlar plinth course of the existing building. Based on preliminary sizing of lifting beams, we have developed schematic section SK-S4 to illustrate the most likely strategy for integration into the new structure. To achieve the desired elevation, the main beams will be set onto the transfer structure and shimmed as needed. Once in position, the space between the top of new structure and the current underside of existing building will be bridged by materials sympathetic to the existing building, or as an extension of the structure below. The exact detailing of this will be established through discussions with Reliance and whether bridging this gap with poured concrete or building it with masonry is most efficient. The opportunities we see as most likely are as follows:

- Pour the new structural concrete with slots to receive the moving beams. The space between the top of the new structure and the moved walls would be filled with brick masonry to suit the existing walls, leaving keying for future masonry. Once the building is supported on the new structure through the new masonry, the beams can be slid out one at a time and the slots filled with masonry keyed into the previously completed work.
- Pour the new structure to a consistent level to receive the moving beams. Between the moving beams, fill with brick masonry to suit the existing walls to meet the elevation of the moved building. Once the building is supported on the new structure through the new masonry, the beams can be slid out, one at a time, and the slots filled with masonry, keyed into the previously completed work.

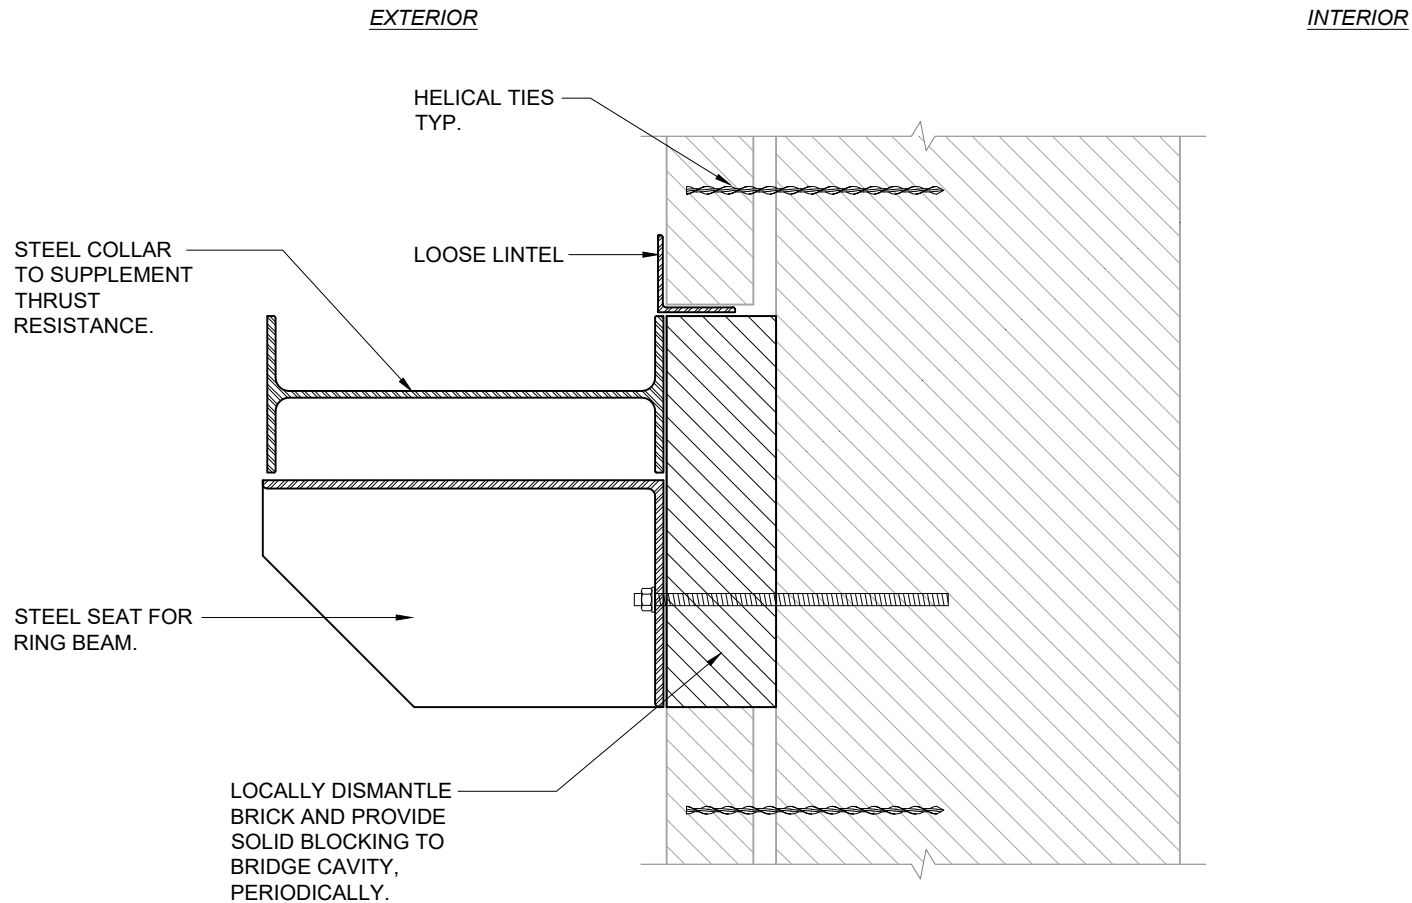
**SK-S5**

**DETAIL: VAULT TRUST RESTRAINT**

Temporary bracing will be required to protect the heritage building asset. The element that presents the most considerable risk is the ceiling vaults. Masonry arches are dependent on compression from self-weight. This compression presents an outward thrust to the gravity supporting elements that must be resisted. At the two interior walls, the thrust is resisted by the matching thrust of the neighbouring arch. The thrust at the exterior walls is presently resisted by the mass of the 6-wythe brick wall and two 1" diameter rods that span from the western to eastern exterior walls. In its present state, the forces are resolved and there are no signs of any distress in the system. Despite being unlikely, we are concerned with the potential of accidental eccentric loading that could change the loading at the arch. We have explored options of providing tie-down of the vaults to an internal scaffolding system connected to the lifting beams. This has been discarded because of potential movement of the lifting beams being translated through the scaffold and into the vaults. The currently proposed concept is to provide restraint at the springing point elevation of the vaults using a tension ring (shown on SK-S2, SK-S5, and SK-S6). A steel beam will be supported periodically for its dead load on east and west elevations. We have determined the total thrust of the arch under its dead load and the resistance provided by the two tie rods. The beams will be designed for the net force presently resisted by the masonry wall. The beam will be designed with strict deflection limitations (<2mm) and connected to tie beams along the north and south walls.
