# TD PLACE FUNCTIONAL OBSOLESCENCE REPORT

NOVEMBER 26, 2019

**ROSSETTI**

### 1 TD PLACE FUNCTIONAL OBSOLESCENCE REPORT

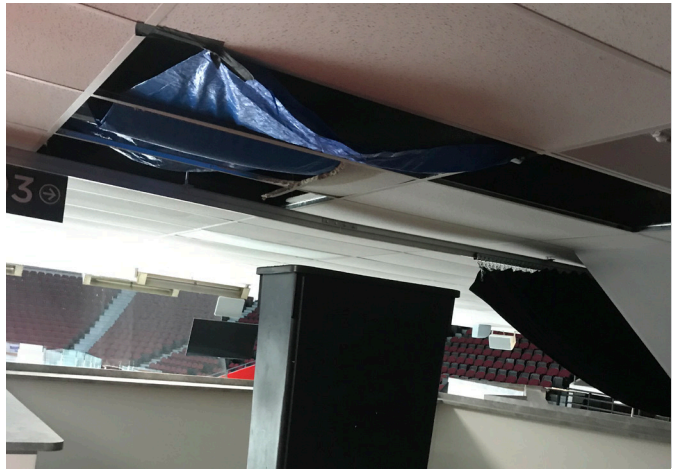
Water damaged ceiling tiles at lower concourse.

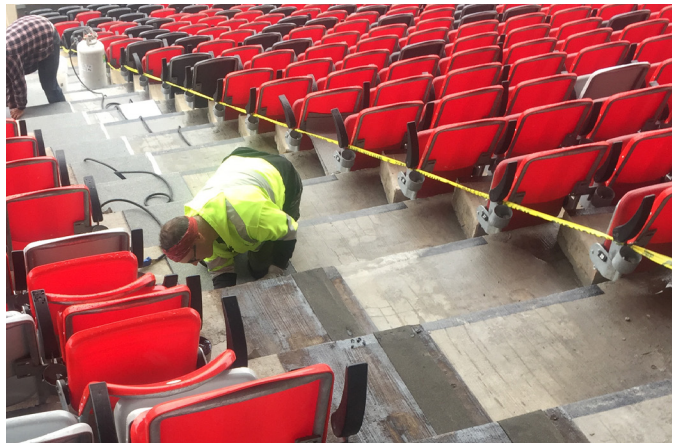
Stadia joint repairs in progress

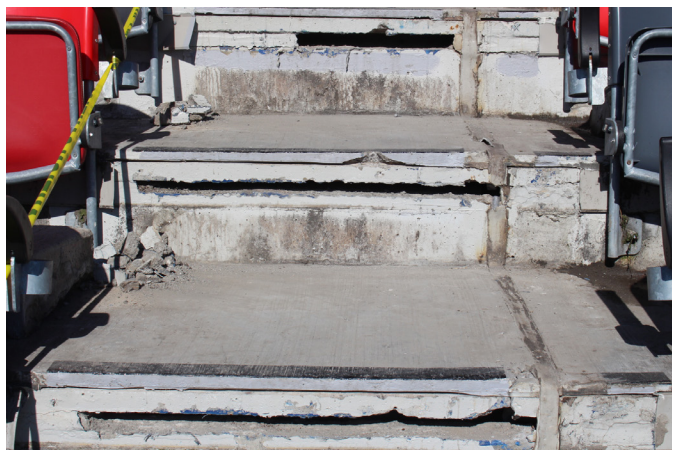
As noted in Leibe Engineering's report, the box girders are not sealed at the joints and have evidenced cracking at welded fabrication joints. Arena maintenance has also identified that there is infiltration through the precast stadia joints. While ongoing maintenance and previous capital projects have attempted to remediate this issue, there continues to be conduits for water infiltration into the building. After years of attempted repairs, it appears that it is not likely or possible to eradicate this issue permanently, causing on-going maintenance and operational costs. During the site visit there were multiple (10+) locations of water collection including suspended tarps, buckets, etc. including some areas with as many as ten buckets required to contain the leak. Arena operations has stated that they are required to replace dozens of ceiling tiles before every single event they hold within the arena. There is also evidence of mold throughout the arena both in

Deteriorating stadia/joint condition

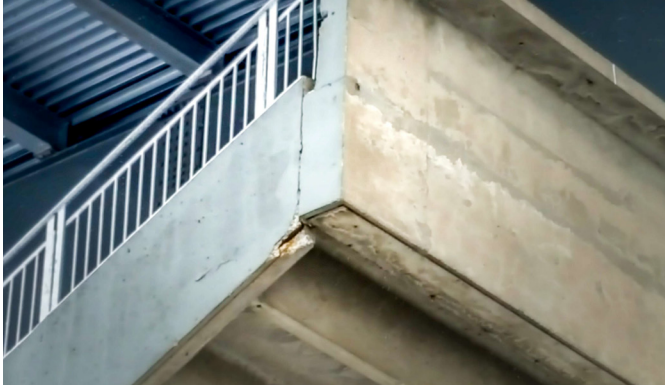
Although, this report does not aim to expand or revisit the structural assessment of the building in detail, the site observations and information from OSEG provided evidence of new cracks in concrete and corrosion of structural members. Due to the nature of the structural damage being caused by settling and movement over time, it is likely that structural maintenance will be required in the future.

Spalling concrete exposing steel reinforcing

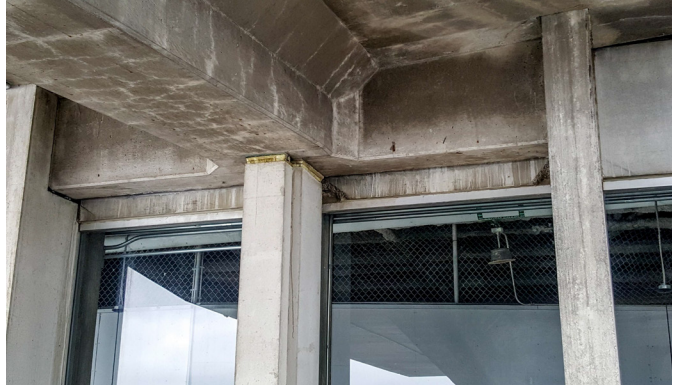
Water seepage and efflorescence

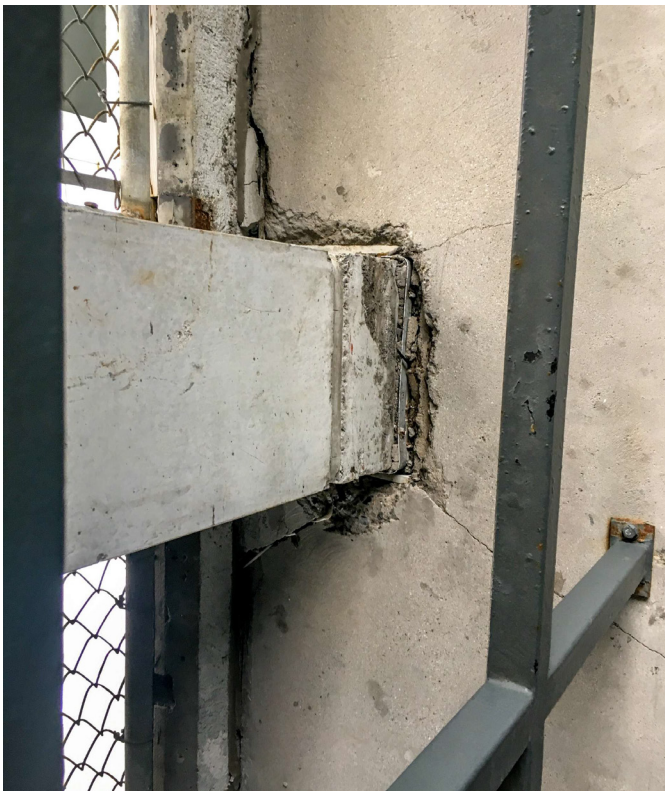
Severe concrete cracking/slab damage

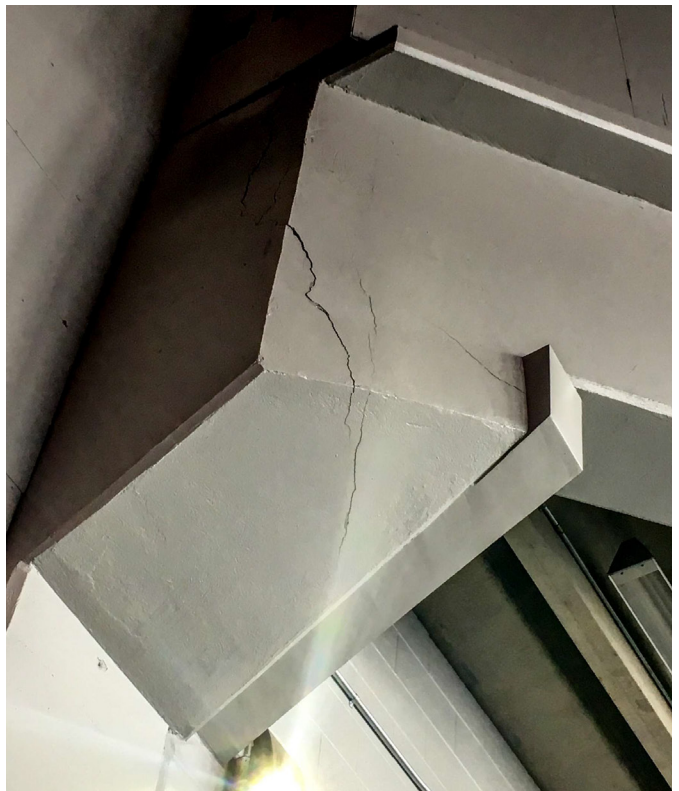
Structural concrete damage - investigation recommended

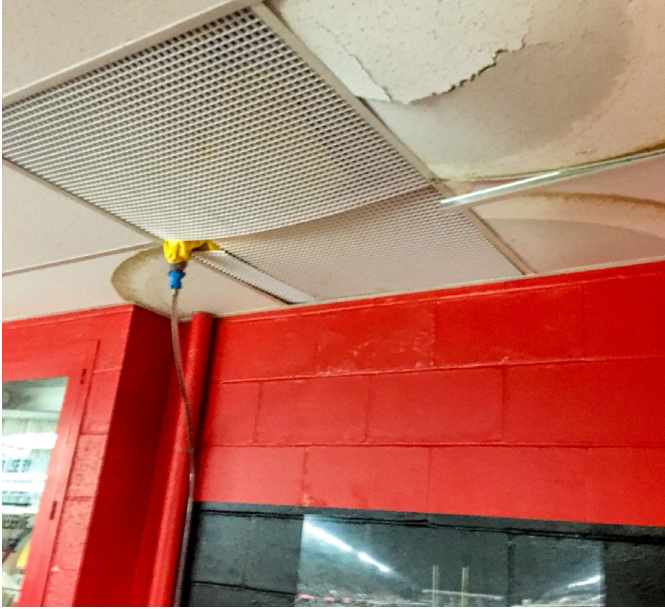
Severe, repeated water damage at lower concourse

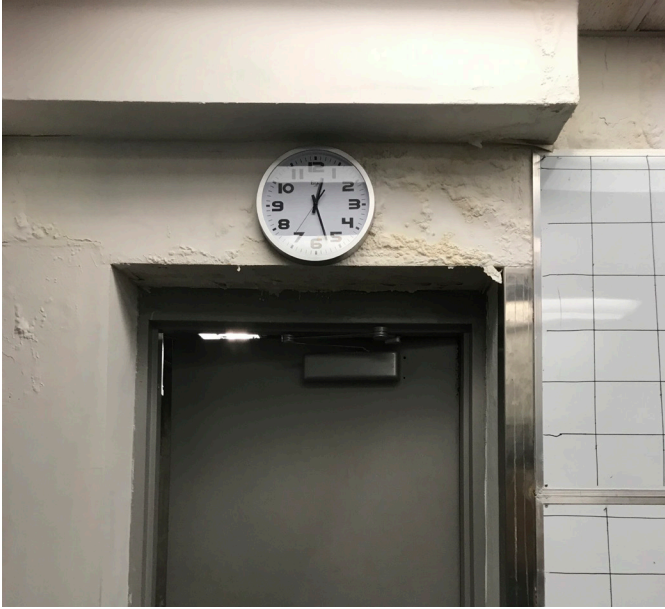
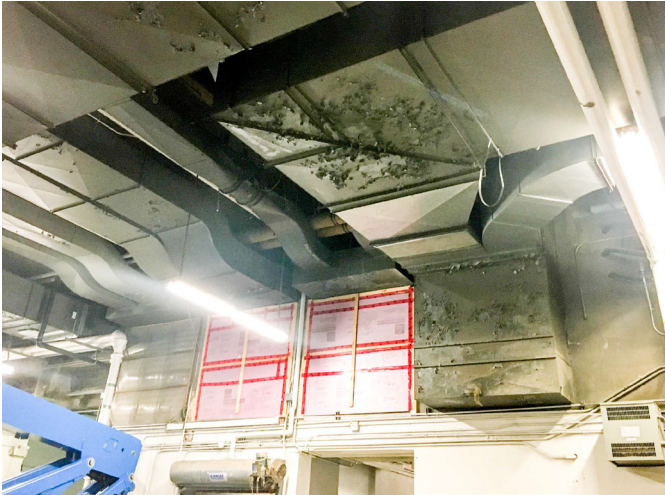
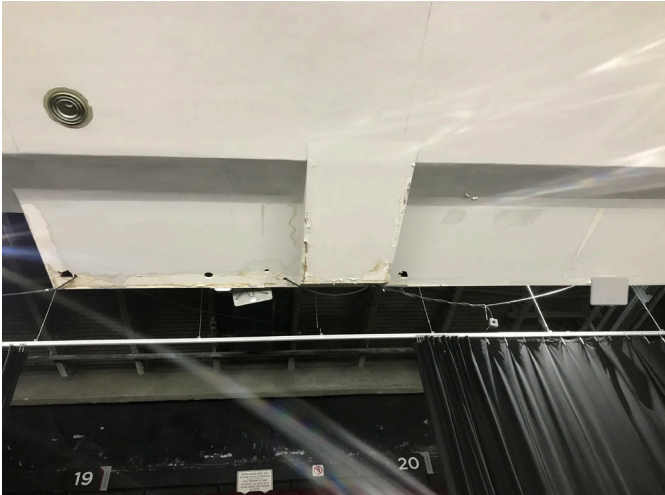
the public areas above seating and within the back of house areas in contained office spaces. Maintenance has also attempted to cover the mold issues up visually but it could possibly be causing indoor air quality issues as well.

Severe water infiltration causing mold/damage

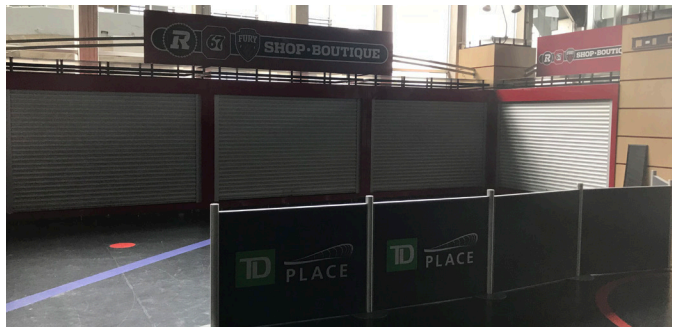
The arena has only one permanent retail for team or event merchandise sales on the concourse. As a temporary solution, OSEG utilizes two pop-up retail stores on concourse. The temporary nature of the retail requires arena staff to set up the shops for each event – requiring high labor/operations cost, inefficiencies and limits options/ revenue for merchandising. For guests entering at Gates 2 and 3, there is a small, combined team store for the 67's, REDBLACKS and Fury that is accessed off of Exhibition Way.

Lack of retail

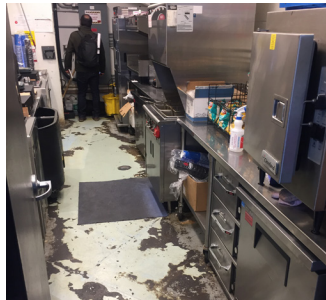
The individual concessions are very small, a majority having only two points of sale, creating inefficiencies in food service delivery and overcrowding. Operations noted that due to space and ventilation constraints the concessions have vent-less fryers which are less efficient and have limited functionality. This deficiency limits the possible offerings at each concession. Overcrowding is escalated by concourses that do not provide enough width to adequately accommodate concession queuing.

Concession conditions/  
no grease duct capability

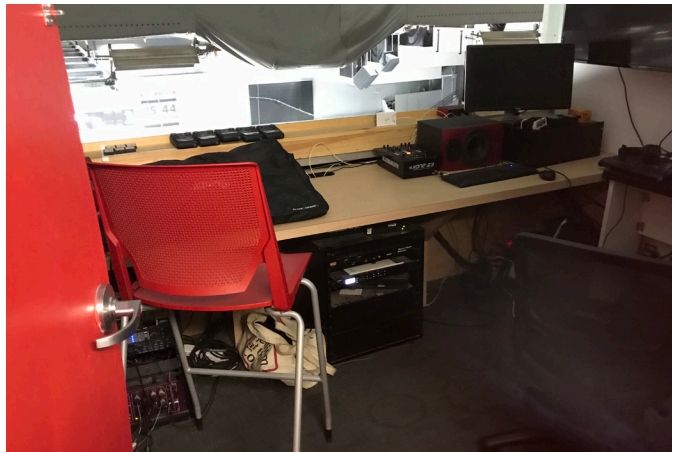
Tech space at defunct suite level

A limited number of defunct suites, discussed above, have been adapted into production spaces. The local authority having jurisdiction granted special, limited permission to utilize these suites as spaces for audio mixing and lighting operations – given that a limited number of rooms be used and there is no public access.

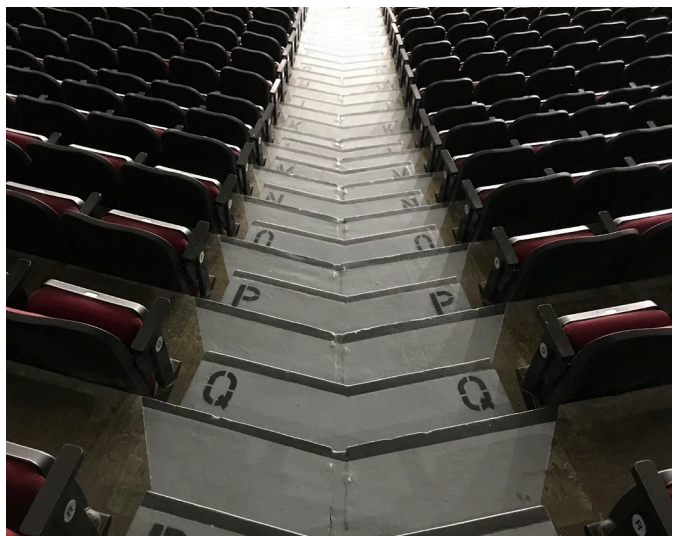
There are several building codes issues related to the seating that would require substantial modifications to the bowl to rectify. Most notably, the seating aisles are 990mm wide where 1100mm is be required by code. In addition, there are no center railings as required.

Aisle railing missing (typical)

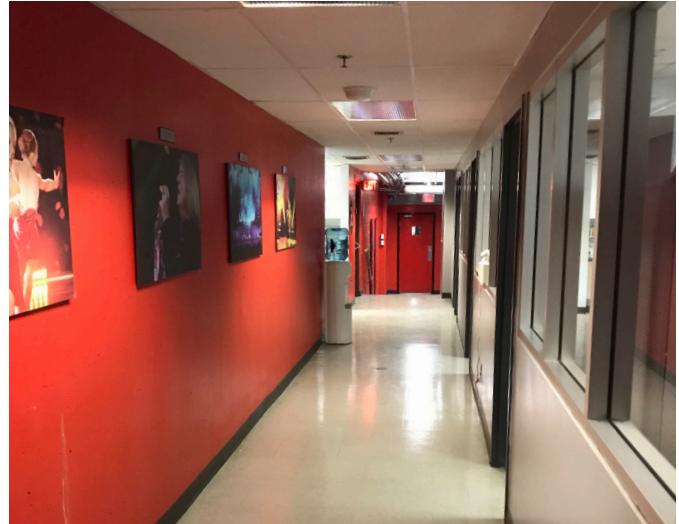
The functional issues with the placement of the elevator expands beyond its inability to serve AODA patrons. The service, public and team/ talent pathways are intermixed creating poor experience, inefficiency and maintenance issues. This creates a poor experience for VIP performers whose path to the green room might overlap with food service personal traveling to the main commissary and accessible public patrons.

Talent/Player/Service/Accessible corridor

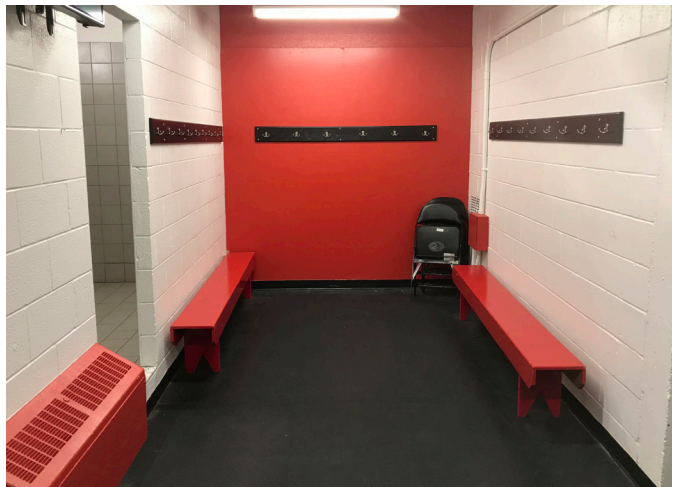
Ad hoc locker room space

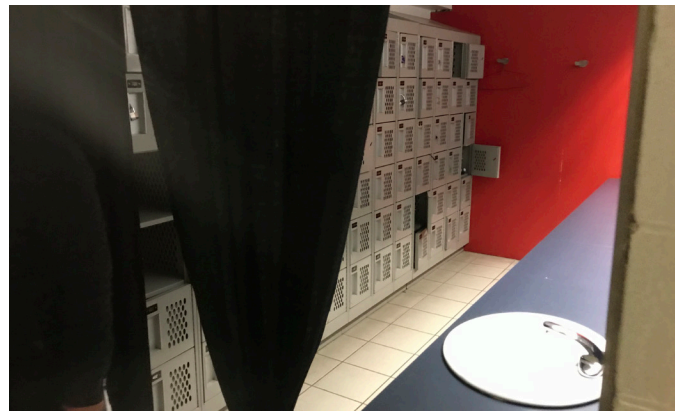
Washroom converted to locker space

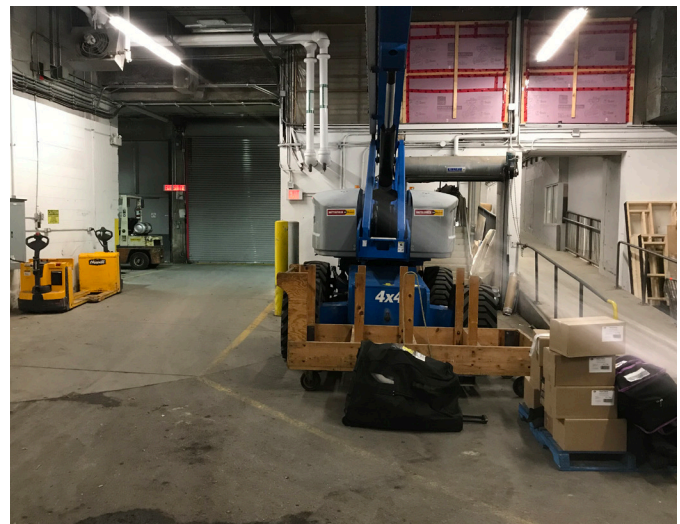
The arrangement of the loading dock creates issues for deliveries and access. A truck level loading dock is provided for trucks with lift gates but is positioned at a right angle to truck access and also does not provide a direct access to the marshalling/ storage area causing damage to building and goods. The grade level truck dock does not provide a direct route causing loading/unloading to maneuver tight turns which creates both inefficiencies and damage to building and goods. The marshalling area itself is interrupted by columns causing maneuvering difficulties and operational damage. Multiple programs overlap in the space adjacent to the loading dock resulting in a marshalling area that is difficult to navigate. At the time of the tour, a mechanical lift, Zamboni, temporary storage and staging space were all found in this area. The ice melt is also located in the middle of the marshalling area causing further difficulties for maneuvering.

Obstructed path from loading dock

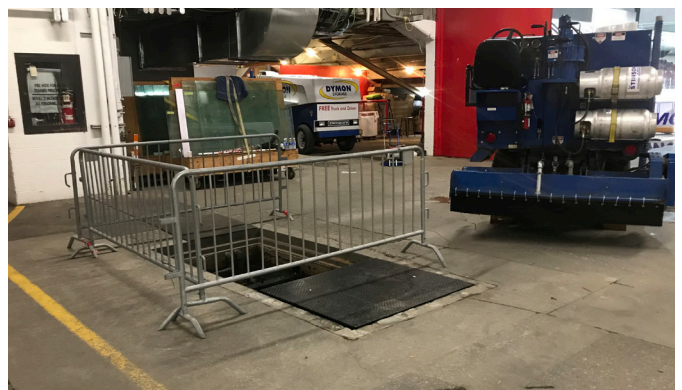
Ice melt pit obstructing circulation/marshalling space

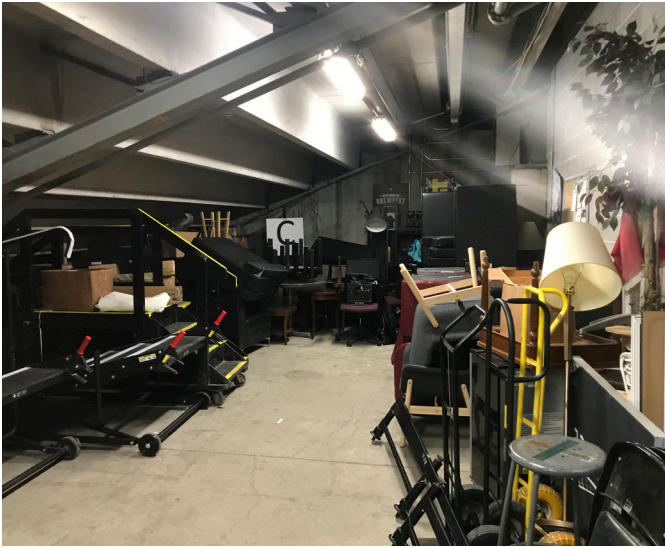
The functional operation of TD Place suffers from a lack of designated, organized and strategically located storage space. Lack of designated space has led to the makeshift creation of storage space found haphazard throughout the arena and stadium. On the exterior, unoccupiable spaces have been annexed for storage; these areas are not weather protected – uses are either limited or goods risk being damaged or stolen. The minimal designated space for storage is further tightened by office program that has overtaken storage space. For example, the food service office is housed in the dry goods storage room. In addition, operational spaces such as marshalling, loading, occupiable spaces have been seized for storage further disabling the functionality of back of house/operational efficiency.

Non-occupiable space used for storage

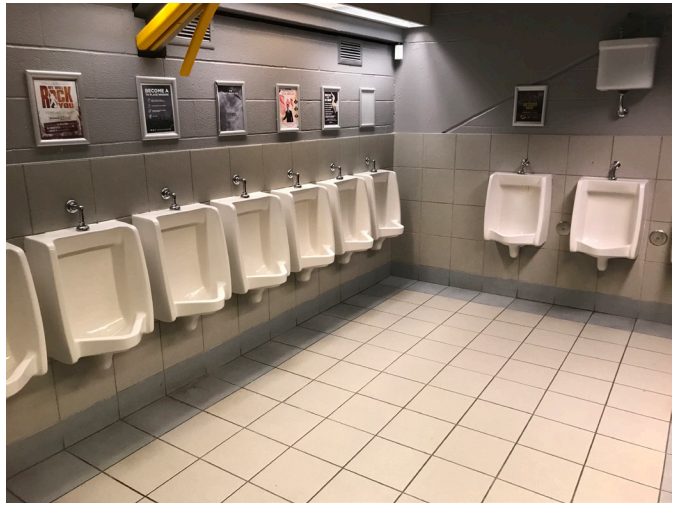
Improper spacing, lack of urinal screen, low head clearance

Further, the toilet facilities that are provided are not compliant in their current condition. Multiple toilet rooms have a urinal to toilet ratio greater than 2:1 and have a lavatory to toilet ratio less than 1:2 as required by code. No universal toilet rooms are provided for the public on the premises. While some accessible facilities are provided, some toilet rooms do not provide accessible stalls and there does not appear to be any ambulatory stalls provided. Additionally, as required by some codes, many fixtures are spaced too closely with none of the existing urinals providing privacy screens. Multiple toilet rooms that are built under the stadia also have head clearance issues at the structural members causing “head knocker” conditions that cannot be resolved without carving out unusable floor area within the already undersized toilet rooms. The arena has attempted to reduce liability by painting and/ or padding these conditions. Attempting to retrofit the existing toilet rooms into compliance would further reduce the current deficiency, with some toilet rooms losing 50% or more of their existing fixture count. The venue has attempted to remedy these deficiencies with portable toilet facilities which is not addressed within the building code.

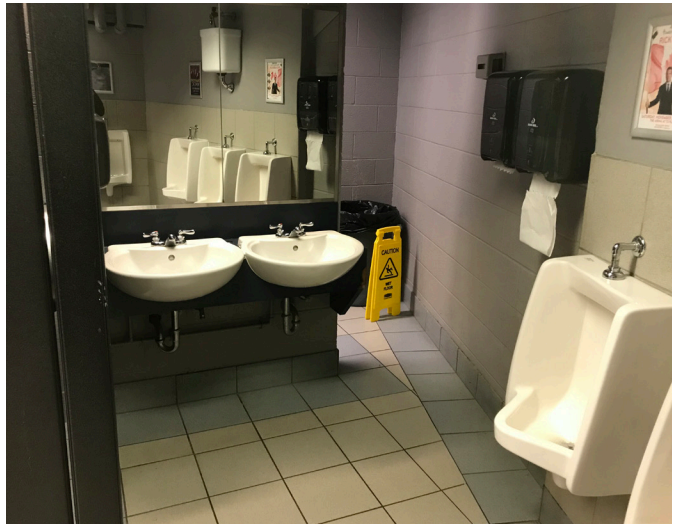
Inadequate lavatory count/clearance/accessibility

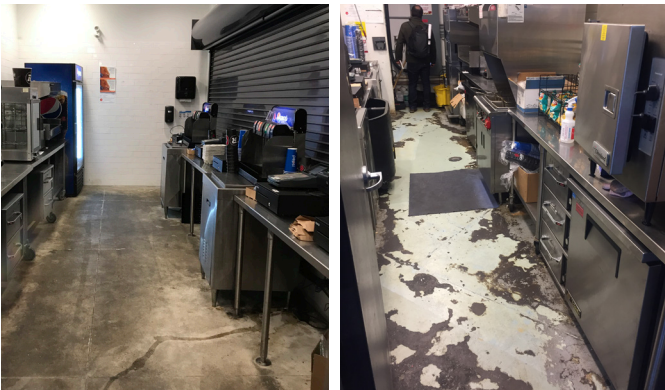
Condition of concession and lack of grease hood

There are 4 concessions on the upper stadium concourse and 2 concessions on the main stadium concourse. These concessions have similar issues as described in Section 3.4. For the North Grandstand, the lack of proper ventilation and make-up air supply has led to complaints of smelling grease from the north-side of the concessions. It was also observed that concession counter tops do not offer a section that meets AODA height requirements. Operations noted that due to space and ventilation constraints the concessions have vent-less fryers which are less efficient and have limited functionality.

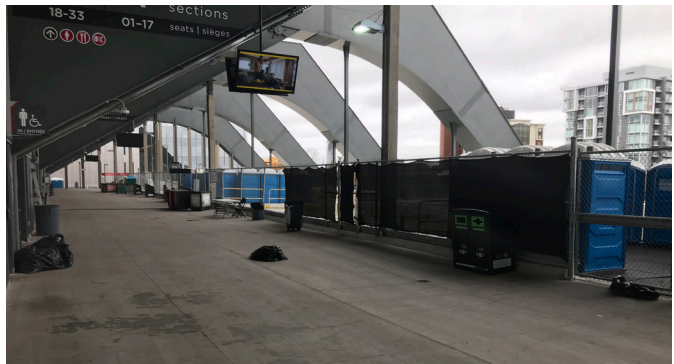
The permanent toilet room facilities of the arena and stadium are below the code required minimums for women’s washrooms and further below the recommended ratios for a competitive level of service with comparable venues.

Temporary toilet facilities permanently used

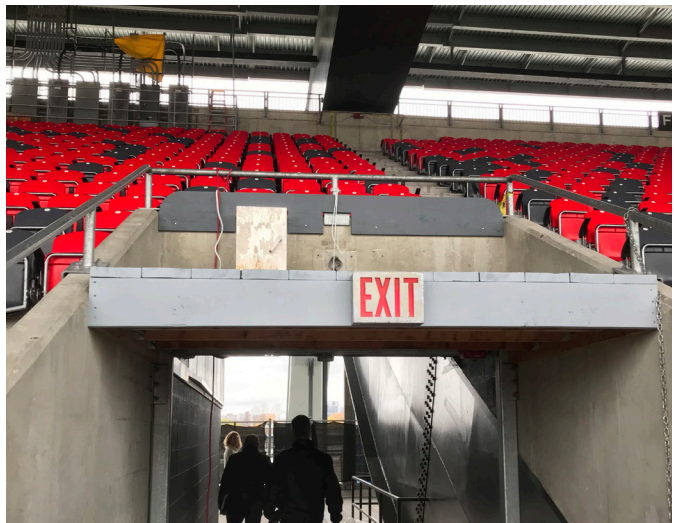
Camera locations are set up on platforms over vomitories- this causes potential sightline issues as well as issues related to accessibility and logistics.

Platform camera location (typical)
