TREE CONSERVATION REPORT

APARTMENT BUILDING DEVELOPMENT 406-408 BANK STREET CITY OF OTTAWA

December 23, 2020

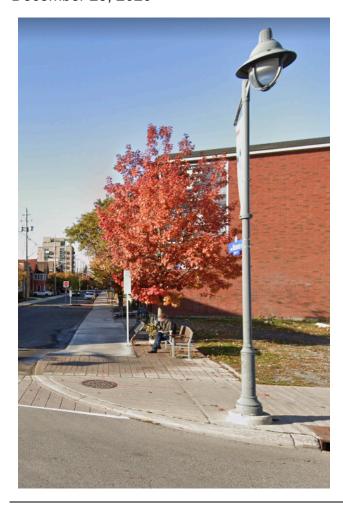
Oak on Florence showing crown extending into subject property.

Trees #3: The proposed development will impact Tree #3 's crown and possibly portions of the root system (if root system within the subject property). Pruning of the crown on the building side will be required for construction purposes as the crown extends into the proposed building envelope. The proposed building façade will prevent a normal crown development as the centre of the trunk is approximately 1 metre from the property line and proposed building façade is tight with the property line. Mitigation measures and/or possible replacement will be done in consultation and coordination with the City of Ottawa Forestry Department.

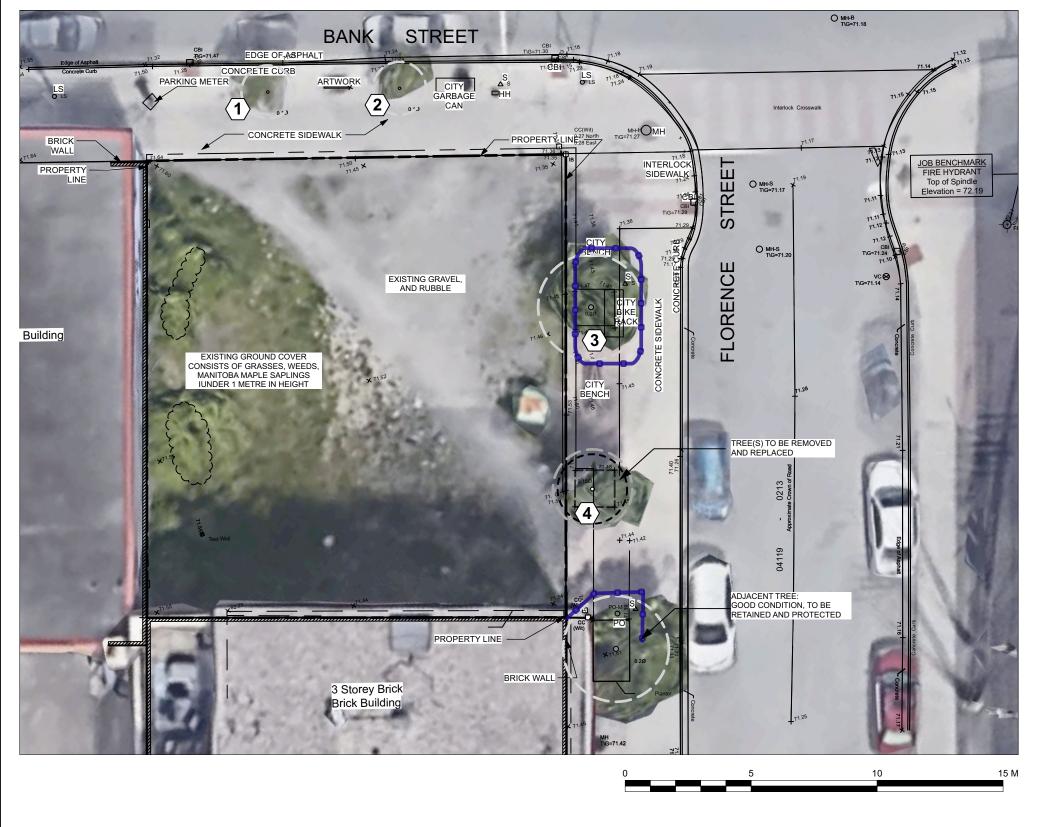
stamp			406 408 Bank Street OTTAWA, ON	drawing EXISTING CONDITION			
	Ruhland & Associates Ltd	date	21 DECEMBER 2020	drawn by TF	project no. 20-1632	dwg. no.	
	Ph 613-224-4744 Fx 613-224-1131 info@rala.ca www.rala.ca	scale		checked by MR	revision no.	IVIAP-I

REFER TO MAP 1A FOR DESCRIPTION OF EXISTING TREES

TREE #4 TO BE REPLACED IN COORDINATION WITH CITY FORESTRY DEPARTMENT AND SURFACE OPERATIONS.

REPLACEMENT TREE TO BE PLANTED IN LIKE MANNER TO EXISTING TREE.

REFER TO LANDSCAPE PLAN FOR REPLACEMETN TREE.
