Old Railway Rideau River Pedestrian Bridge Structure No. 018600 Detailed Condition Assessment and Renewal Option Analysis Report

Detailed Condition Assessment and Renewal Options Analysis Report

November 2018

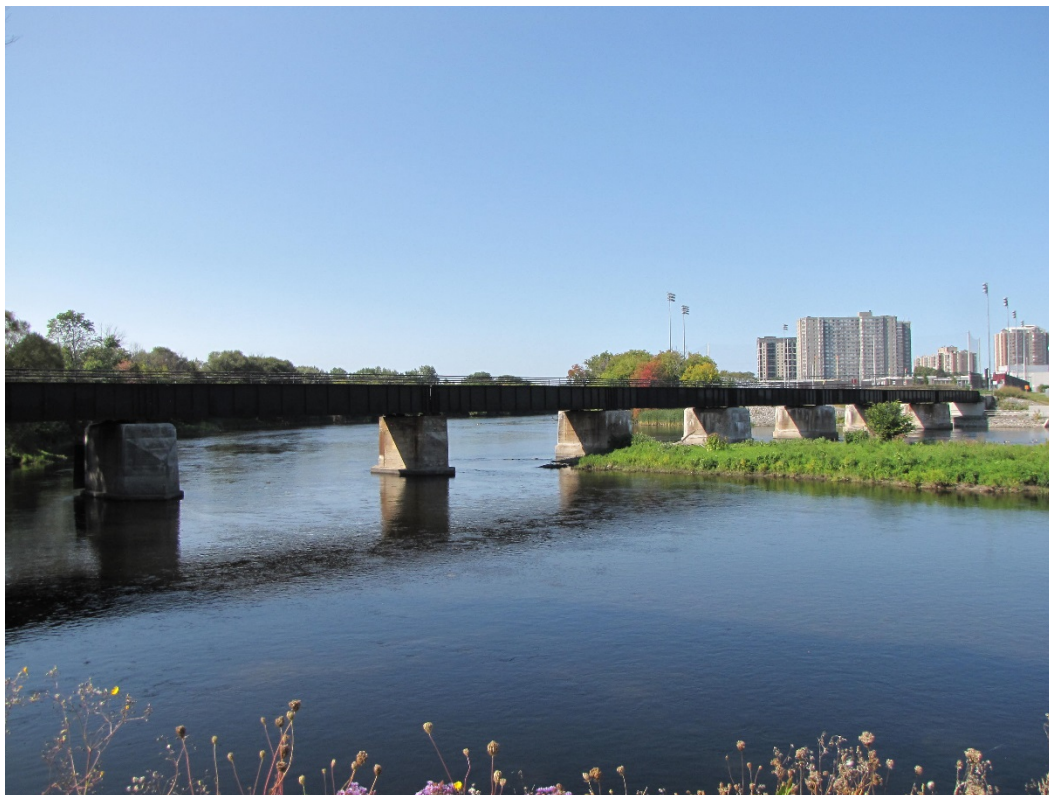
Photo 1 – North elevation of the Old Railway Rideau River Pedestrian Bridge. Note low-lying island downstream of Pier 5 and University of Ottawa (Lees Campus) located on west side of the river (background).

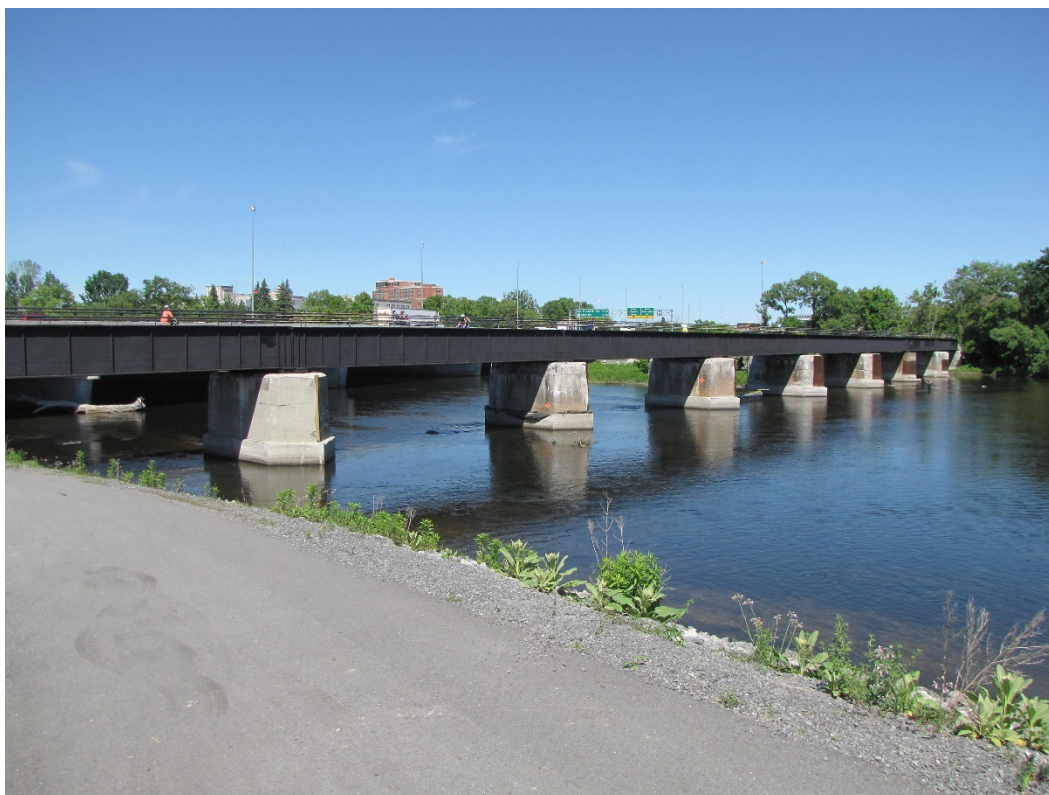
Photo 2 – South elevation. Note Rideau River Western Pathway (foreground), which passes below Span 8.

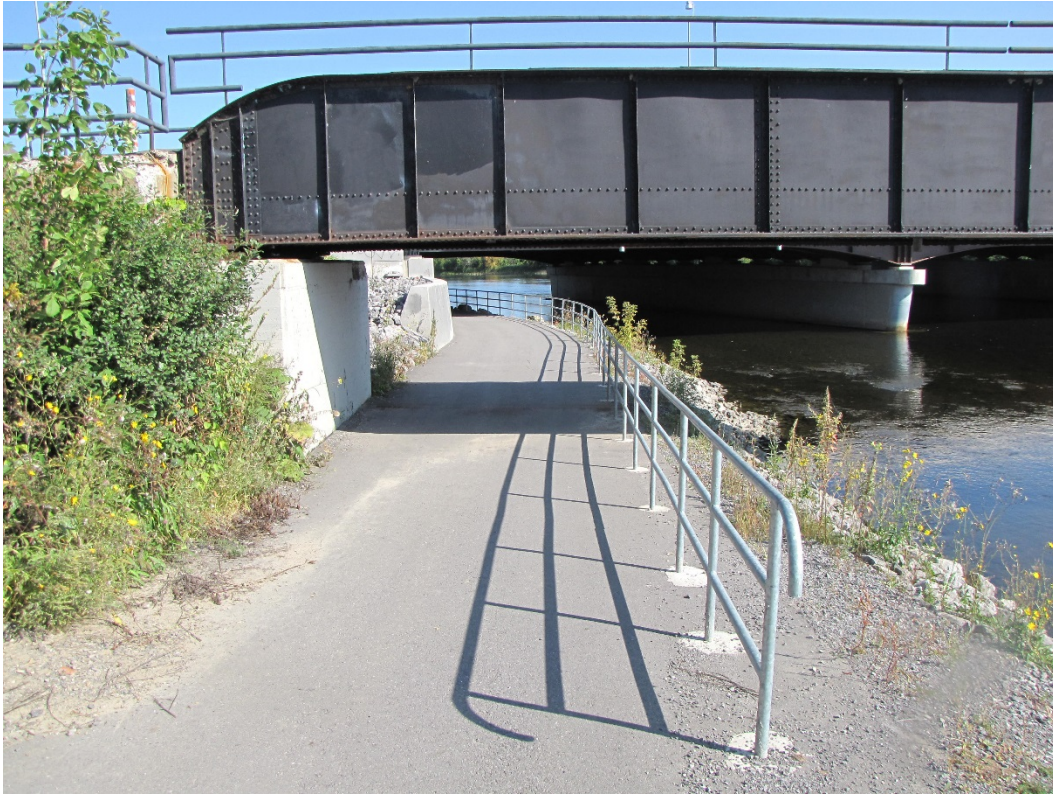
Photo 5 –South elevation. Rideau River Western Pathway passing in front of west abutment below Span 8; vertical clearance of 2.5 m. Note Highway 417 (Queensway) Hurdman Bridge pier in background.

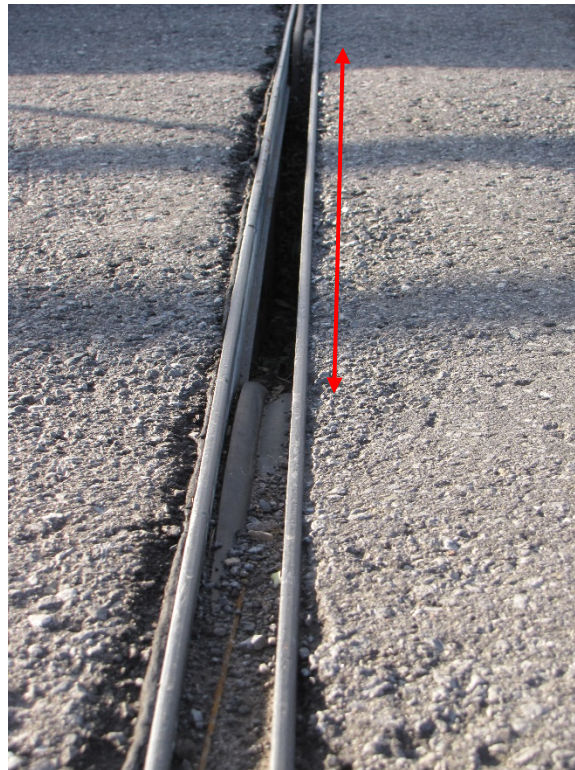
- The expansion joints are suspected to be leaking throughout due to the level of deterioration noted on the components below the joints, though observed material defects include a broken compression seal at Pier 2 and the seals at the west abutment and Pier 4 are visibly sagging beneath the deck.

Photo 18 – Failed expansion joint compression seal is sagging below at the west abutment. Also note the asphalt break-up at the expansion joint angles.

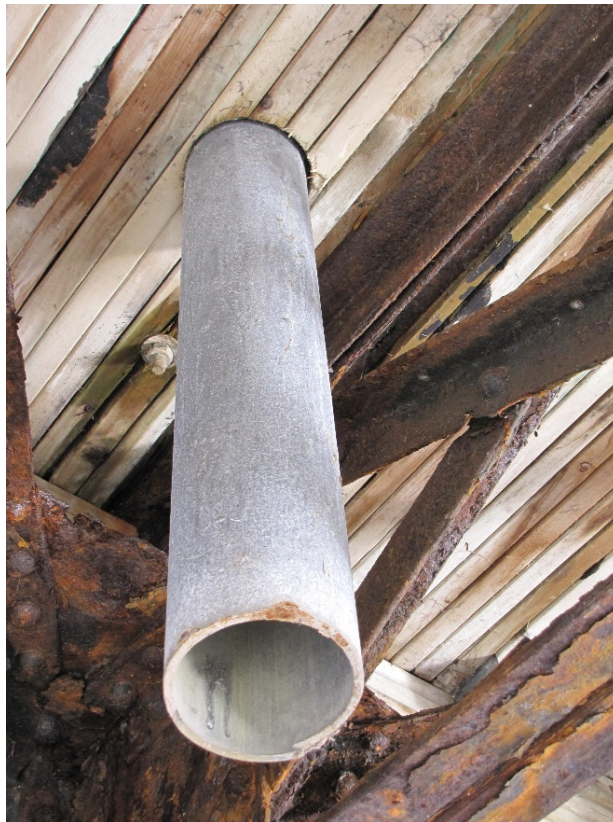
Photo 20 – Typical good condition of the deck drain downsouts with light corrosion on ends.

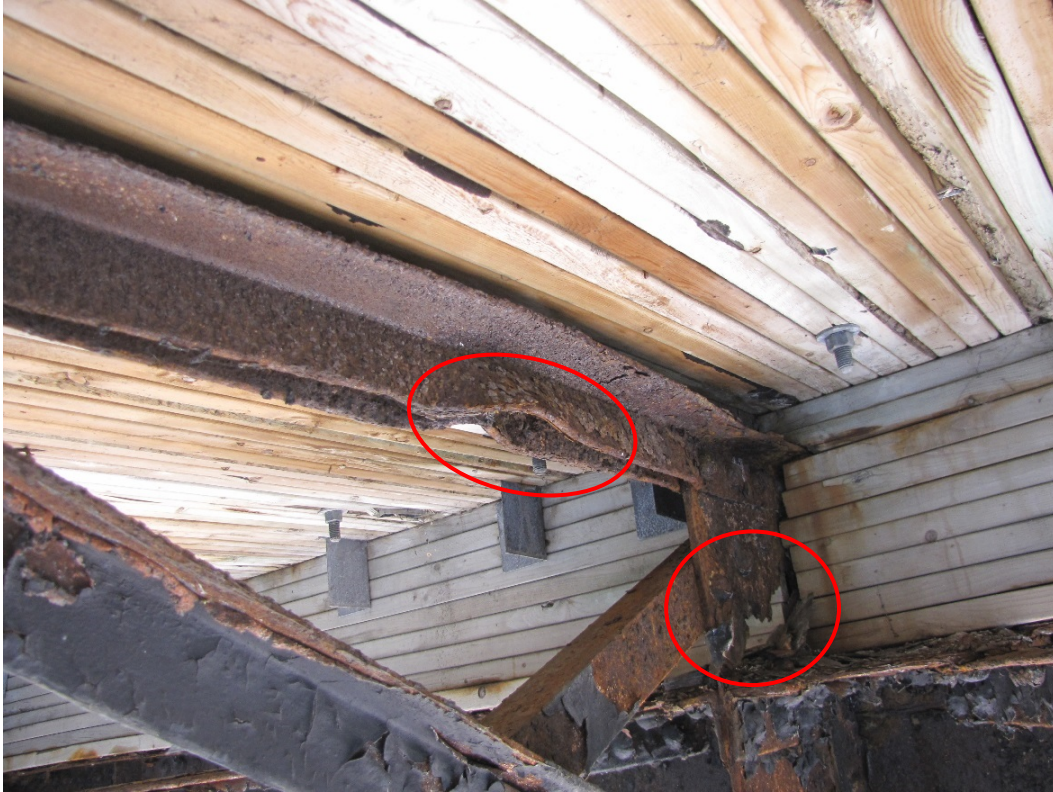
Photo 35 – Cross-frame 2 bays west of Pier 5. Perforation full width of the vertical gusset plate and severe deformation of the top brace member.

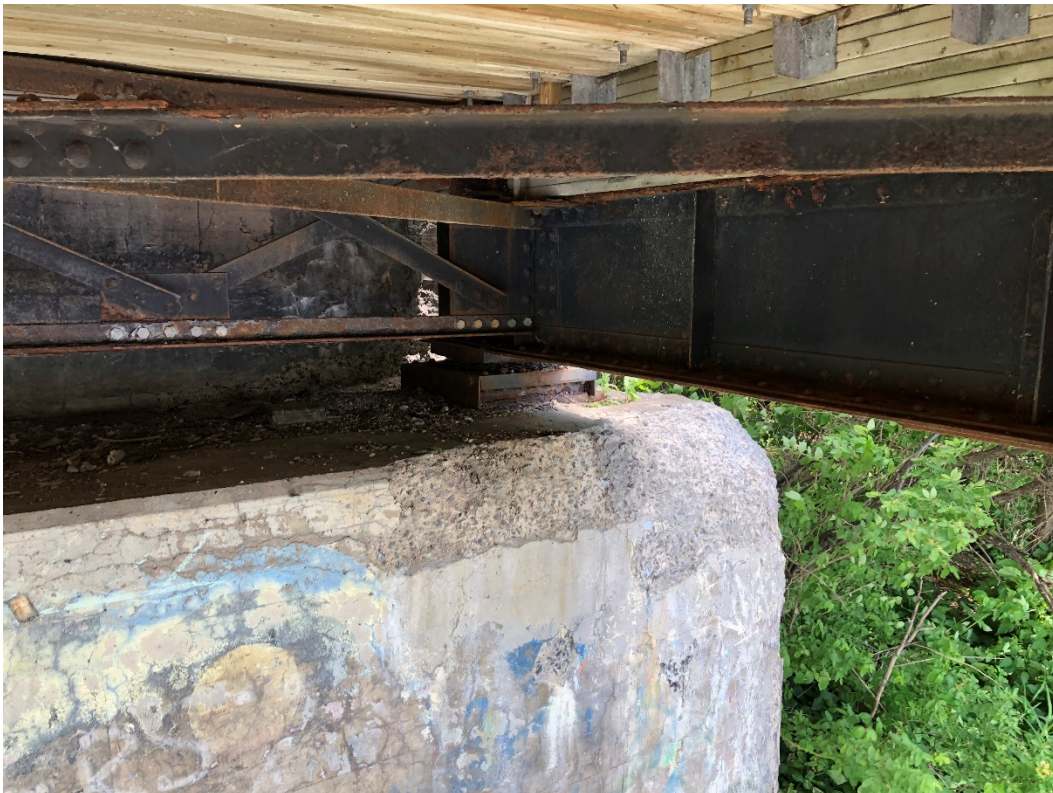
The east abutment wall, bearing seat and exposed footing are in generally poor condition (62.1% of area in poor) with numerous severe to very severe delaminations, spalls and extensive disintegration up to 150 mm deep with exposed corroded reinforcing steel (Photos 48 to 51). The west abutment wall and bearing seat are in generally good condition with localized areas in poor condition (4% of area in poor) with severe to very severe disintegration at the top of the abutment wall and bearing seat at the north end (Photo 52). Wet efflorescence stained hairline pattern cracking was noted in the bearing seat and light popouts throughout the abutment wall. There is a significant accumulation of debris on both bearing seats, including deteriorated steel and concrete (Photos 43 and 44). Also, there is non-offensive graffiti present on both abutment walls (Photos 48 and 52), though the west abutment wall has been previously painted.

Photo 50 – Very severe disintegration at the top of the east abutment wall and bearing seat at the south end.

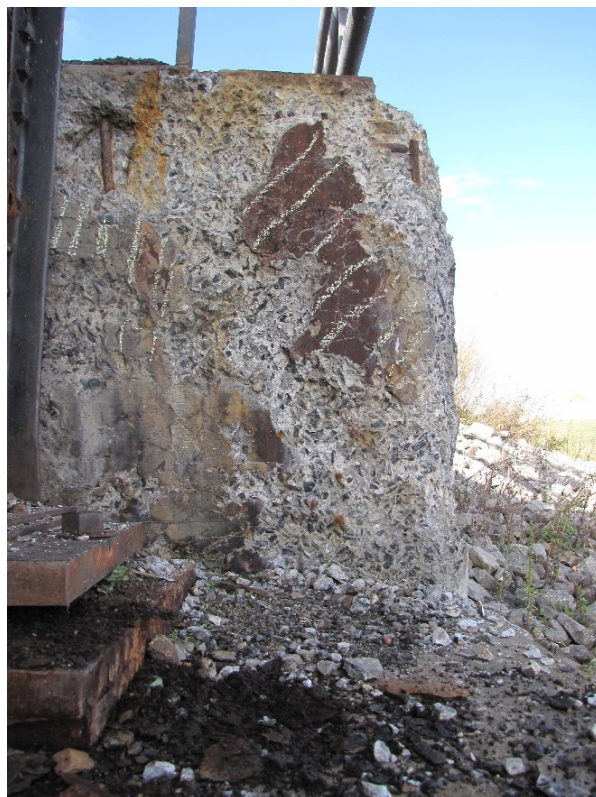
Both ballast walls are in overall fair condition with significant areas in poor condition (26.9% of area in poor) on the north and south ends of the walls due to severe to very severe spalls, delaminations and disintegration up to 150 mm deep with exposed corroded rebar (Photos 53, 54, 56 and 58). Additionally, wet and efflorescence stained hairline to narrow map cracking was noted throughout both walls (Photos 55 and 57), medium and wide vertical and horizontal cracks on the east ballast wall, and medium honeycombing and wet staining in the west ballast wall (Photo 55).

Photo 53 – Severe to very severe disintegration and delamination with exposed corroded rebar on the north end of the ballast wall.

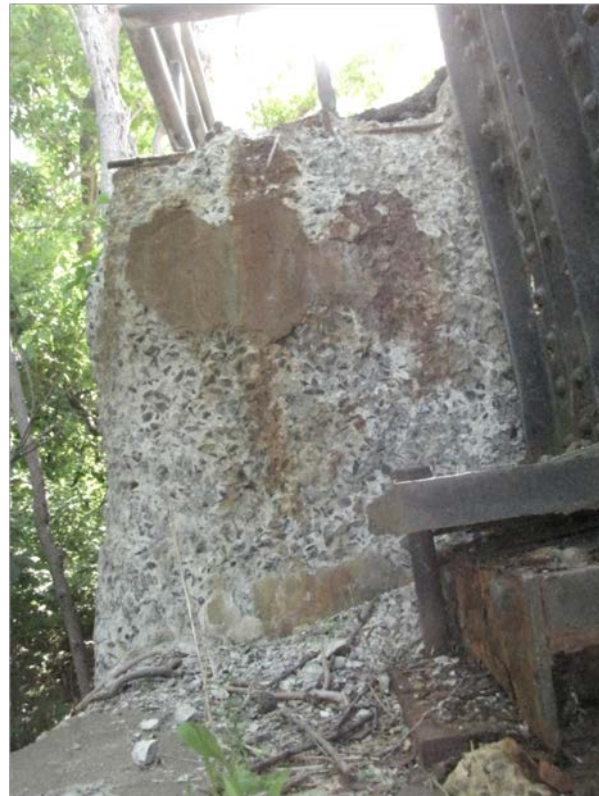
Photo 56 – Severe to very disintegration with exposed corroded rebar at the north end of the east ballast wall.

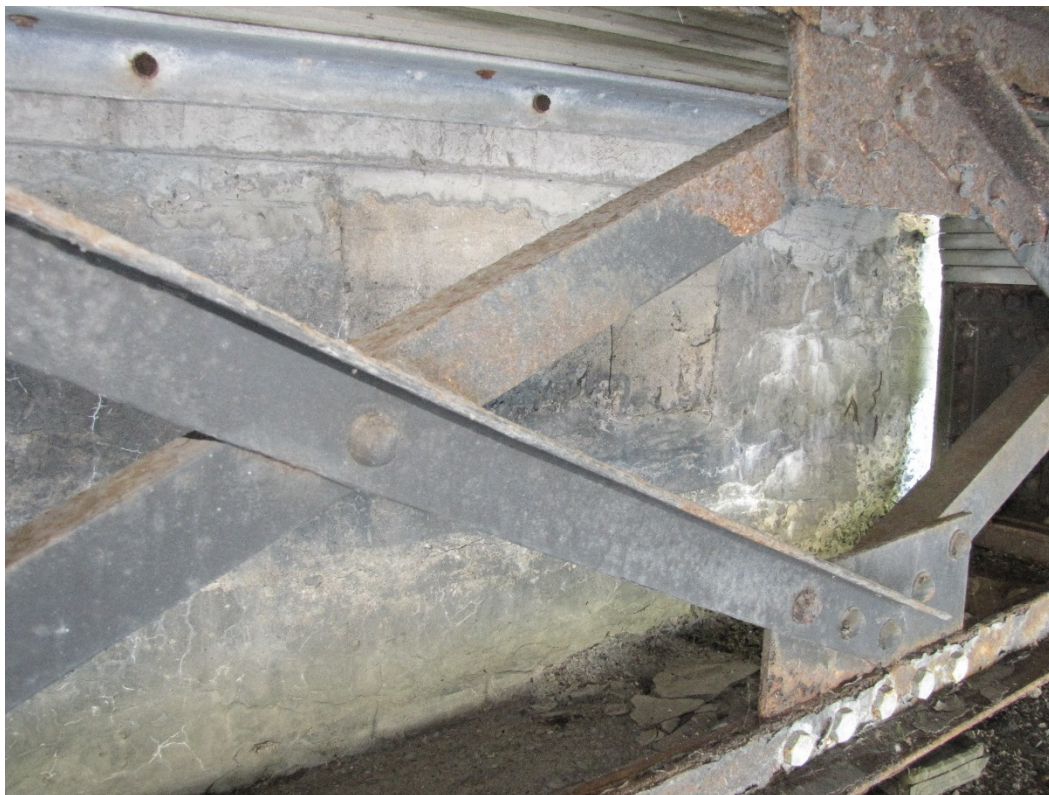
Photo 57 – Hairline to narrow wet and efflorescence stained map cracking in the east ballast wall.

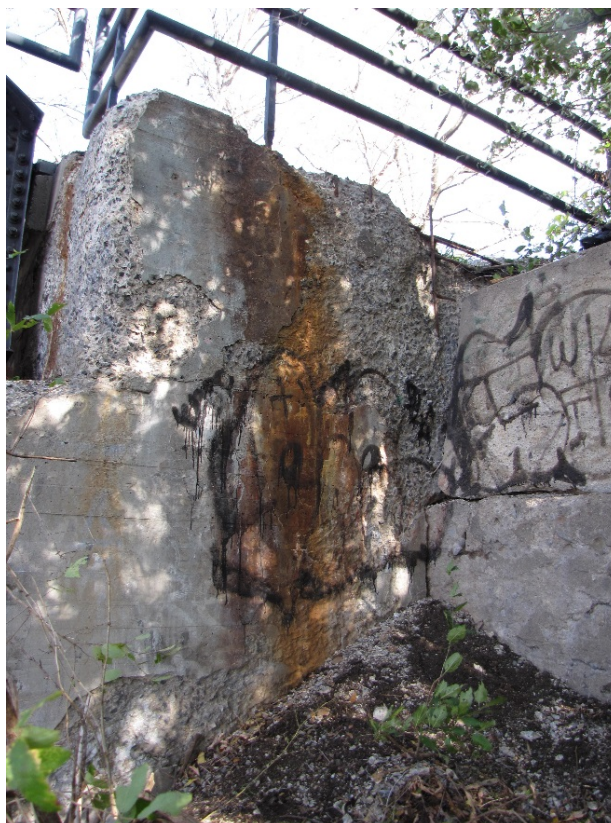
The southeast (Photo 58) and northeast (Photo 59) wingwalls are in generally poor condition, while the southwest (Photo 60) and northwest (Photo 61) wingwalls are in generally fair condition with areas in poor condition concentrated at the west ballast wall and top of wingwalls (33.7% of total area in poor). Noted defects include light to very severe disintegration up to 150 mm deep, spalls and delaminations with exposed corroded rebar in all wingwalls, wet and efflorescence stained hairline to narrow map cracking in all wingwalls, medium to wide horizontal crack on the southwest wingwall, and a localized area of medium scaling and medium honeycombing along a horizontal construction joint on the northwest wingwall. There is also non-offensive graffiti on the southeast, northeast and northwest wingwalls.

Photo 58 – Extensive areas of medium to very severe disintegration with exposed corroded rebar, delaminations, and hairline to narrow wet and efflorescence stained map cracking on the southeast wingwall.

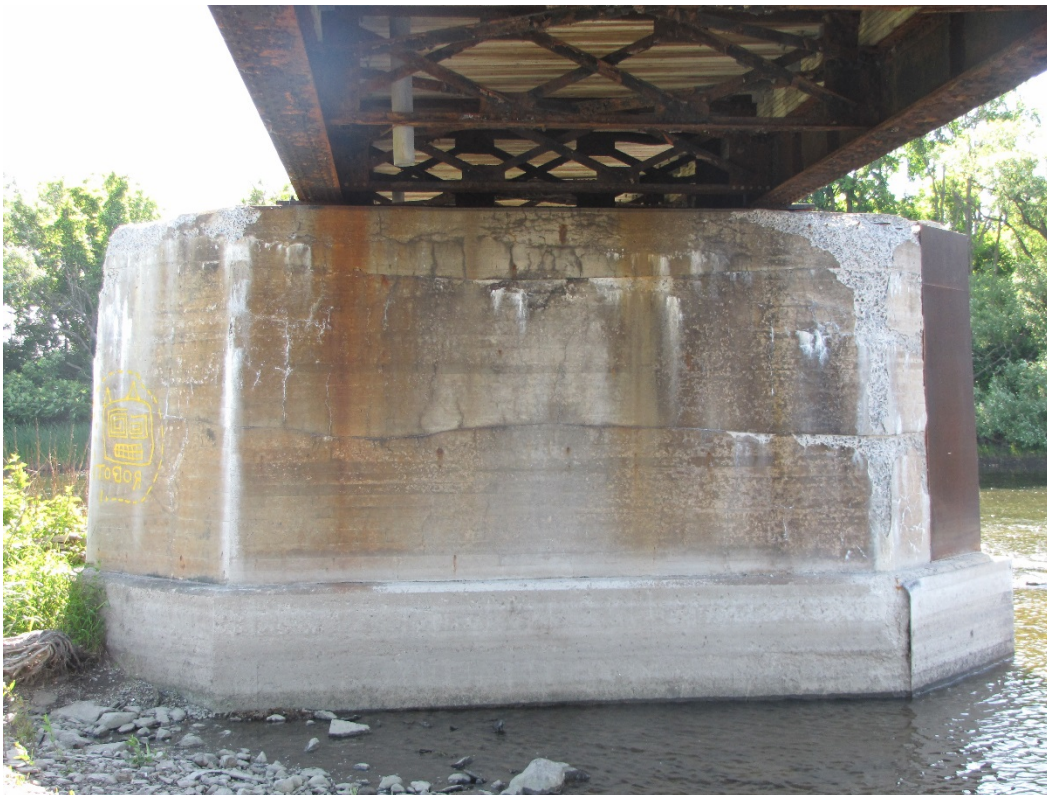
Photo 64 – Pier 3, west elevation. Severe to very severe disintegration with exposed corroded rebar at the bearing seat, isolated cracks and map cracking with wet or efflorescence staining, and wide horizontal construction joints.

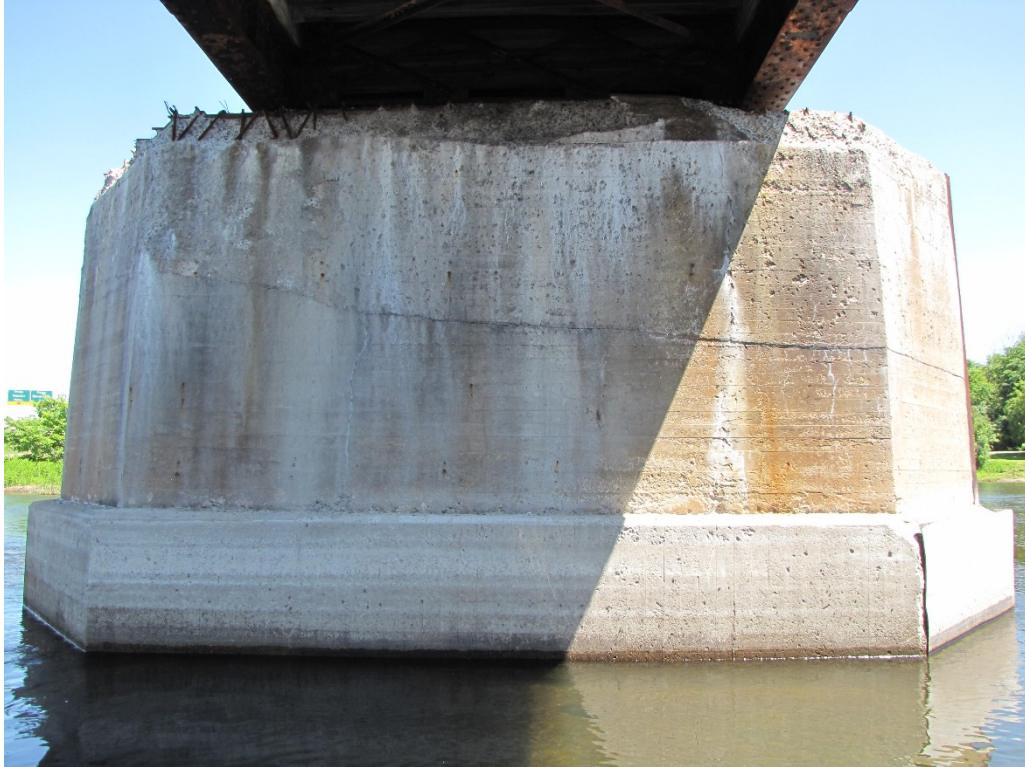
Photo 67 – Pier 5, west elevation. Extensive very severe disintegration with exposed corroded rebar at the bearing seat and wide horizontal construction joint.

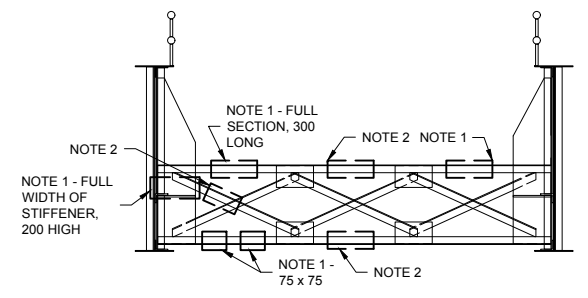
CROSS-FRAME 1-4
1:75

NOTE:
 CROSS-FRAME ELEMENTS BELOW THE TIMBER DECK ARE IN POOR CONDITION ON ACCOUNT OF SEVERE TO VERY SEVERE CORROSION THROUGHOUT.

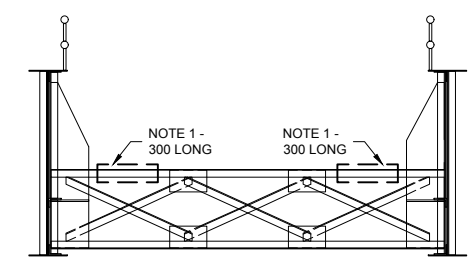
CROSS-FRAME 3-1
1:75

NOTE:
 CROSS-FRAME ELEMENTS BELOW THE TIMBER DECK ARE IN POOR CONDITION ON ACCOUNT OF SEVERE TO VERY SEVERE CORROSION THROUGHOUT.

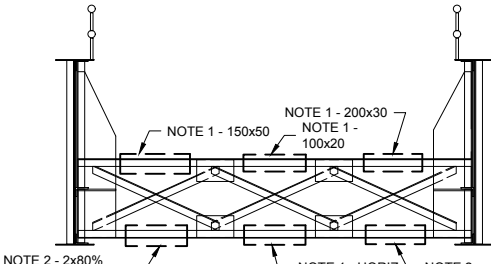
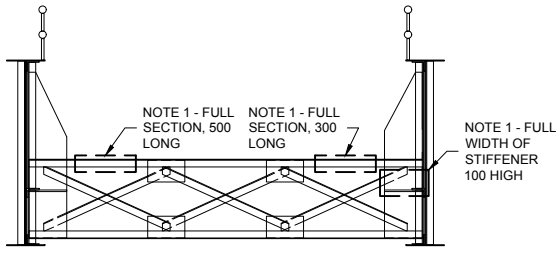
NOTE: CROSS-FRAME ELEMENTS BELOW THE TIMBER DECK ARE IN POOR CONDITION ON ACCOUNT OF SEVERE TO VERY SEVERE CORROSION THROUGHOUT.

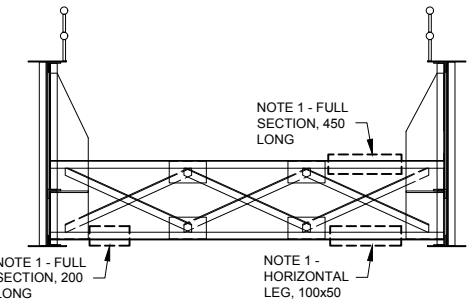
CROSS-FRAME 8-2
1:75

NOTE:
 CROSS-FRAME ELEMENTS BELOW THE TIMBER DECK ARE IN POOR CONDITION ON ACCOUNT OF SEVERE TO VERY SEVERE CORROSION THROUGHOUT.

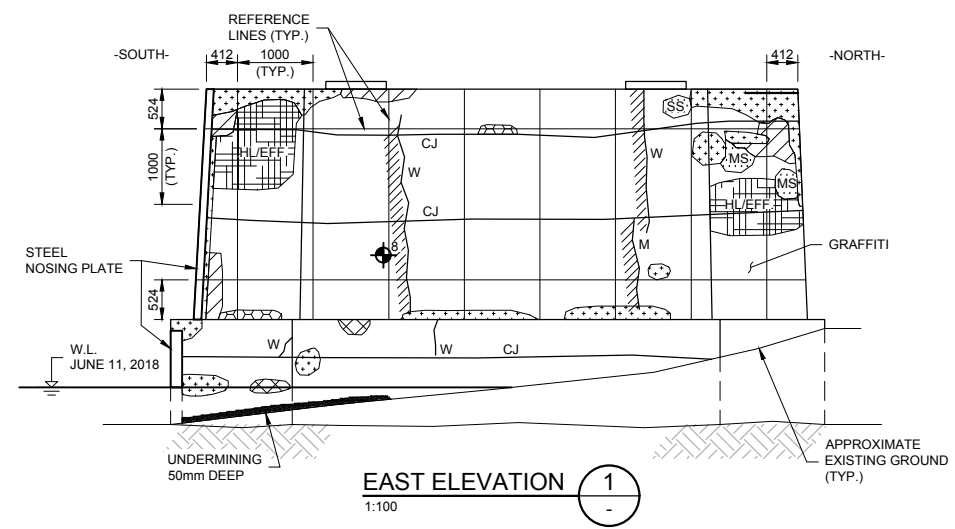
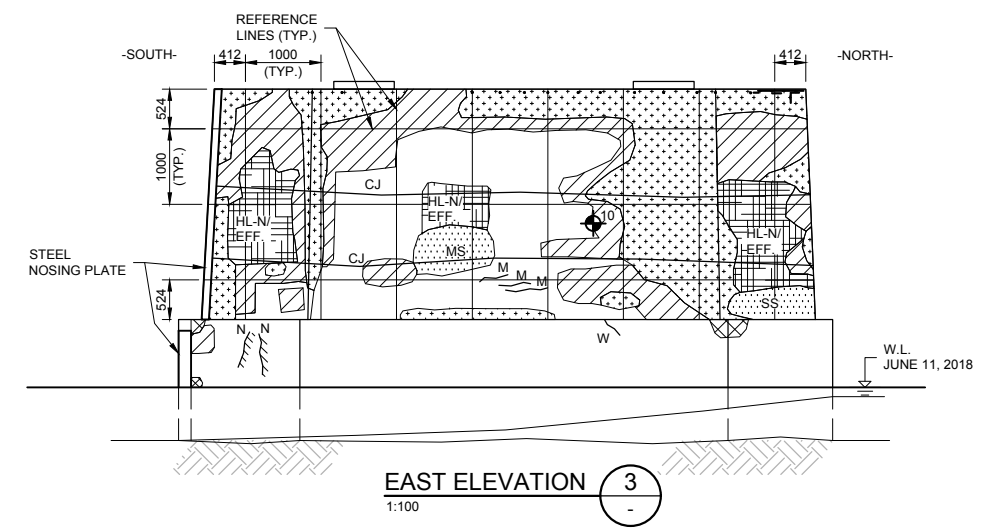
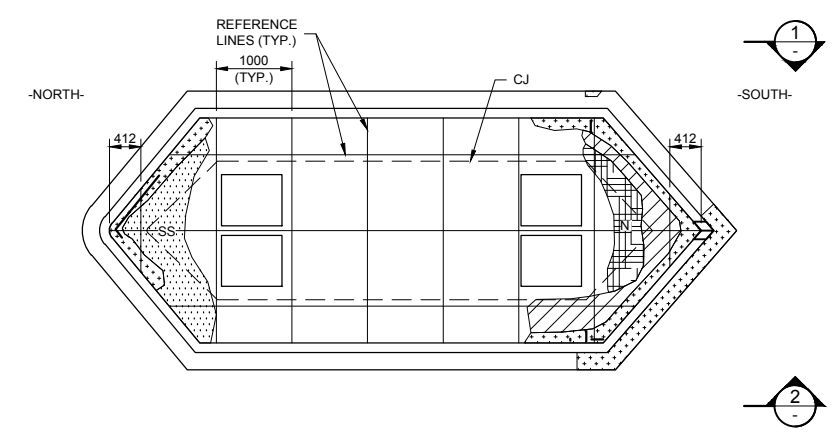
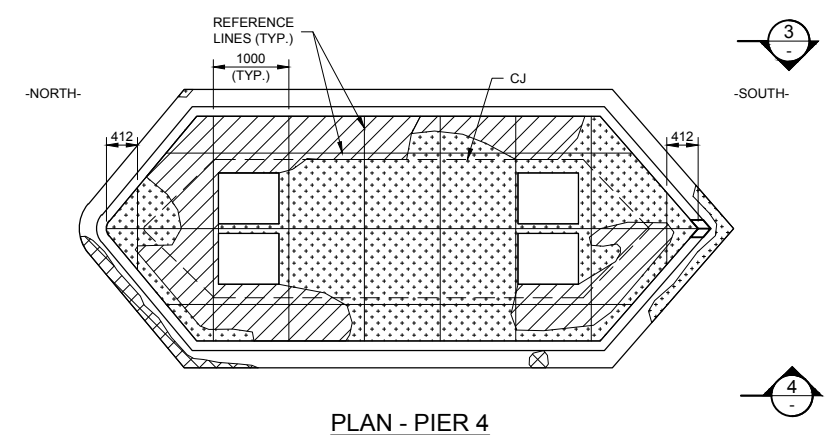
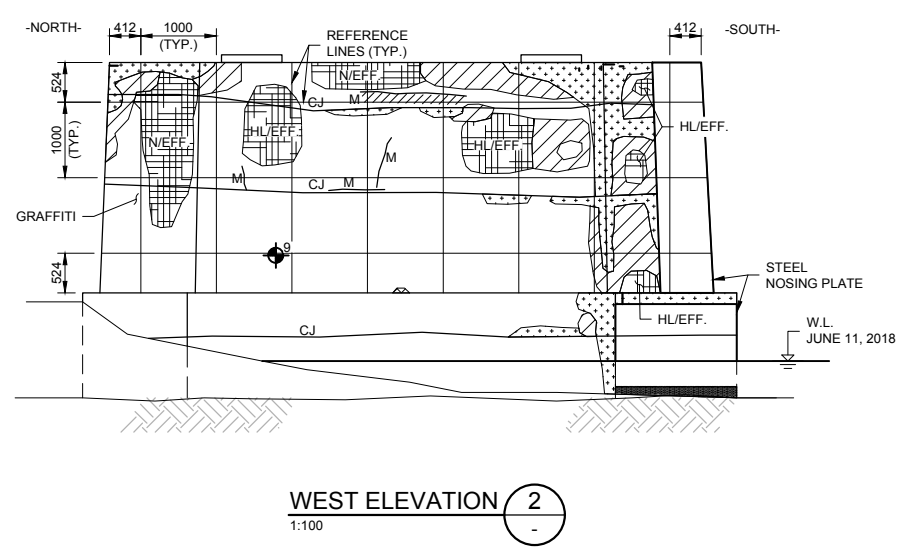
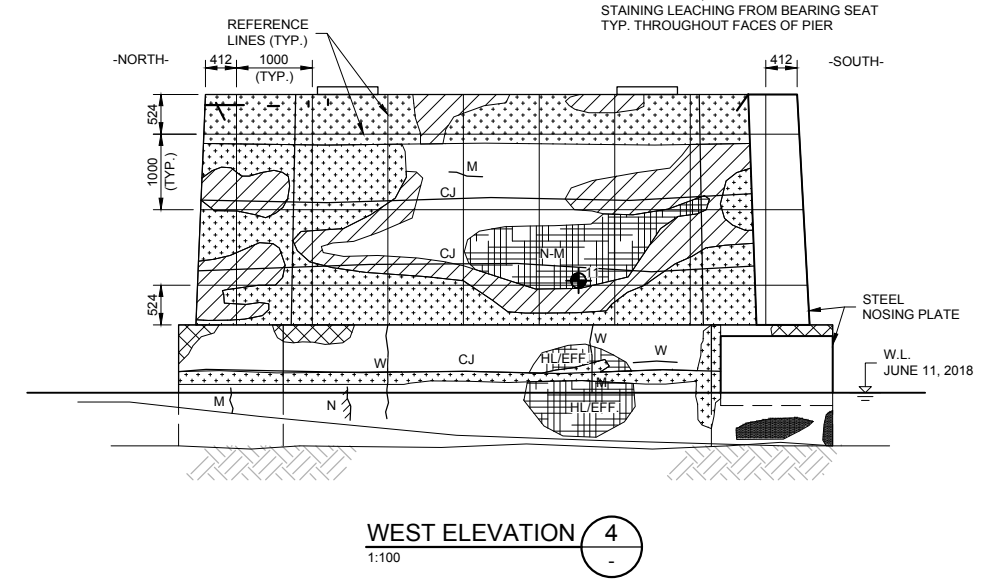
PIERS 3 & 4 DETERIORATION

NOTE: LOCALIZED HL-N PATTERN CRACKING, LIGHT SCALING, AND EFFLORESCENCE STAINING LEACHING FROM BEARING SEAT TYP. THROUGHOUT FACES OF PIER

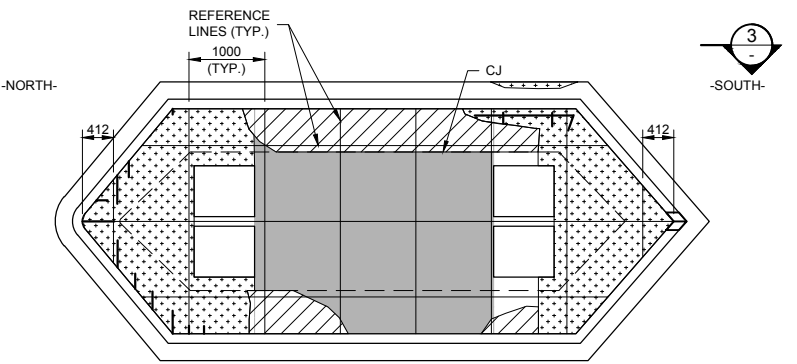
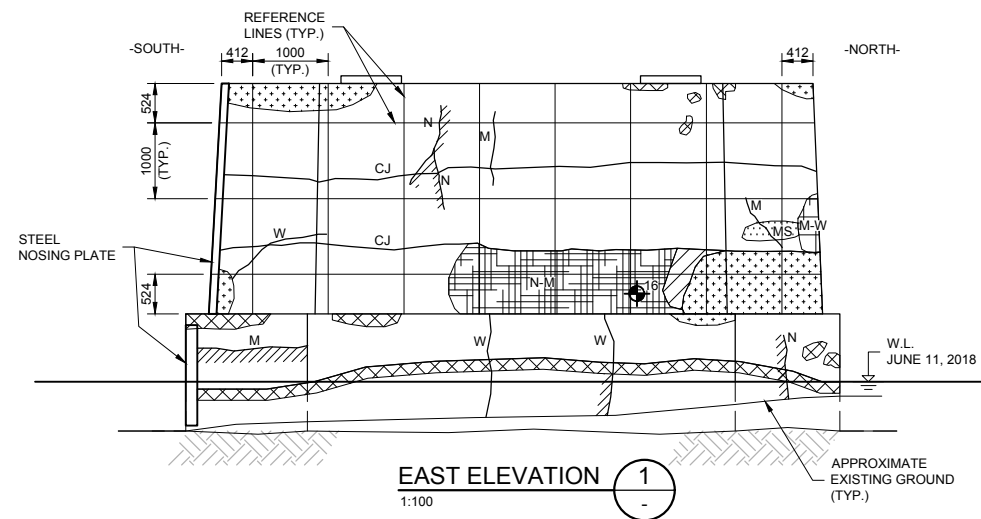
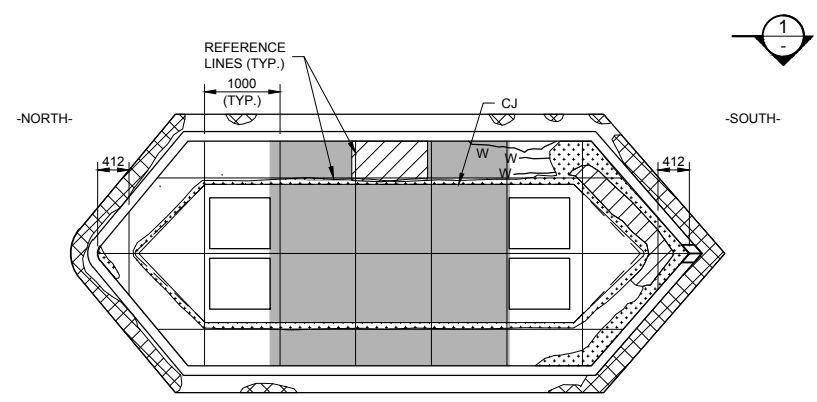
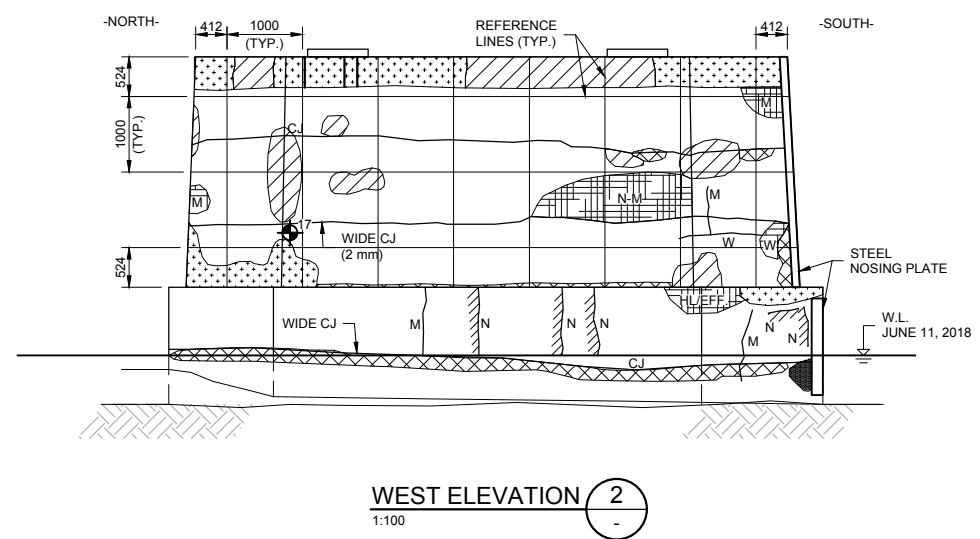
NOTE: LOCALIZED HL-N PATTERN CRACKING, LIGHT SCALING, AND EFFLORESCENCE STAINING LEACHING FROM BEARING SEAT TYP. THROUGHOUT FACES OF PIER

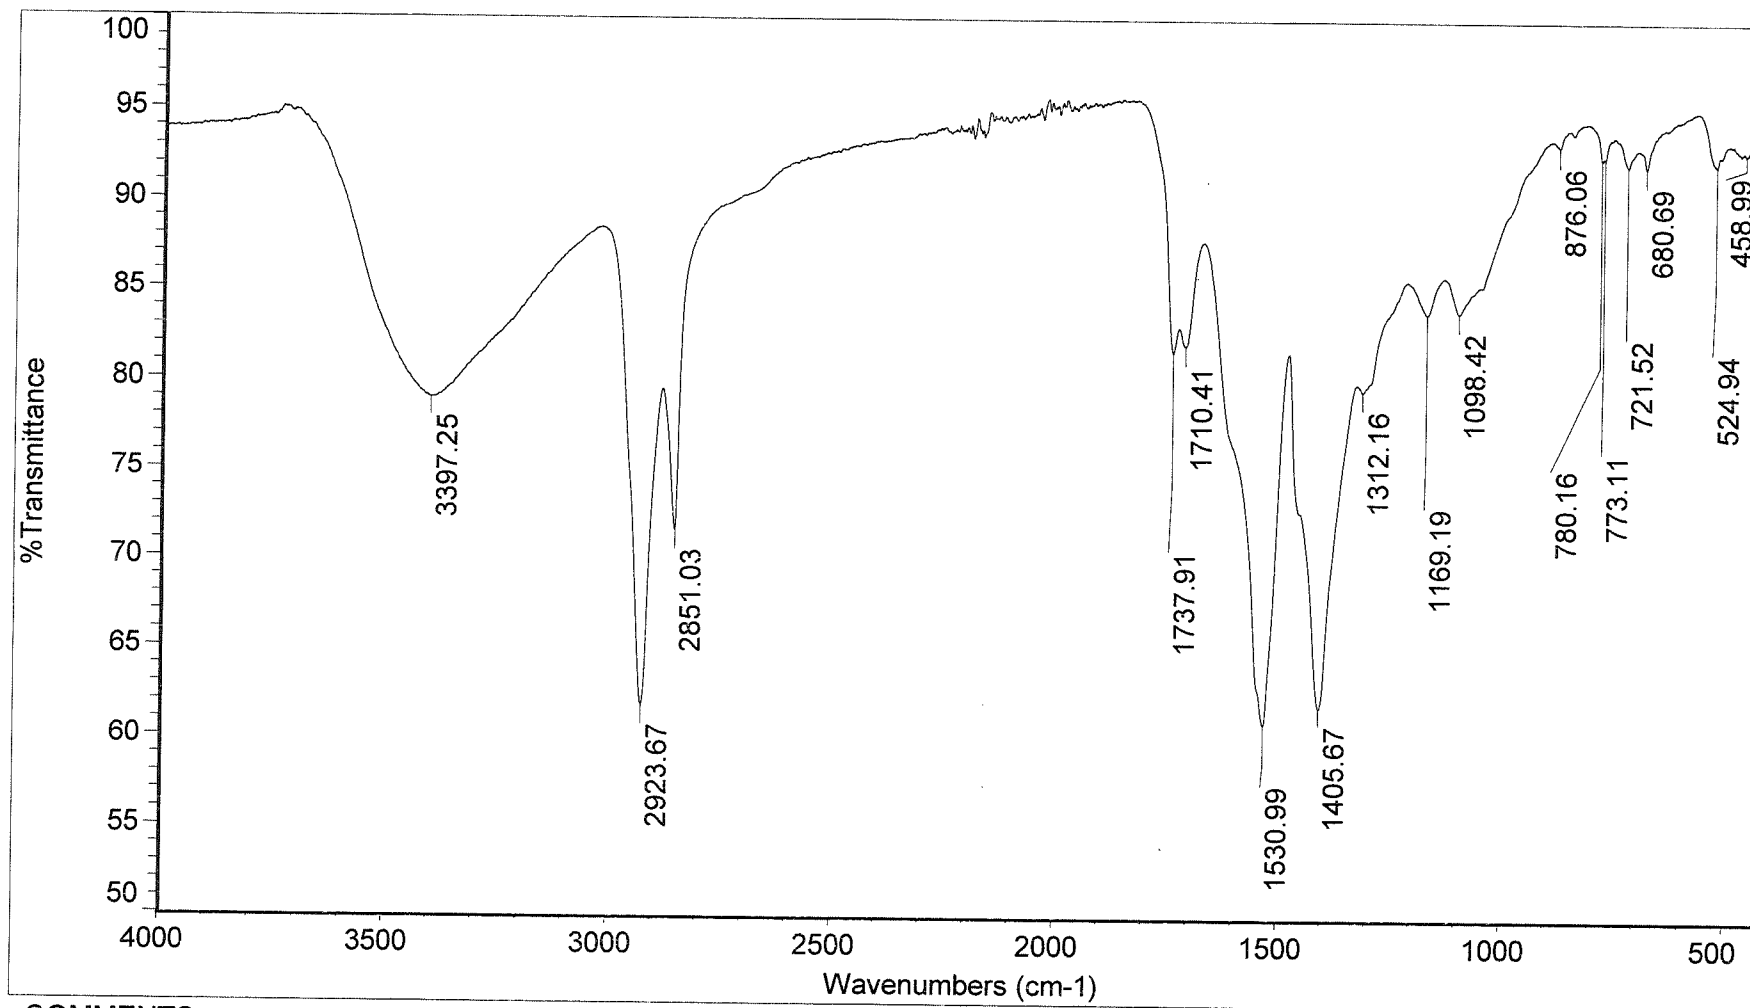
18-74457-236968
Old Railway Pedestrian Bridge over
Rideau River - Span #7 Cross Frame
orange layer (top)

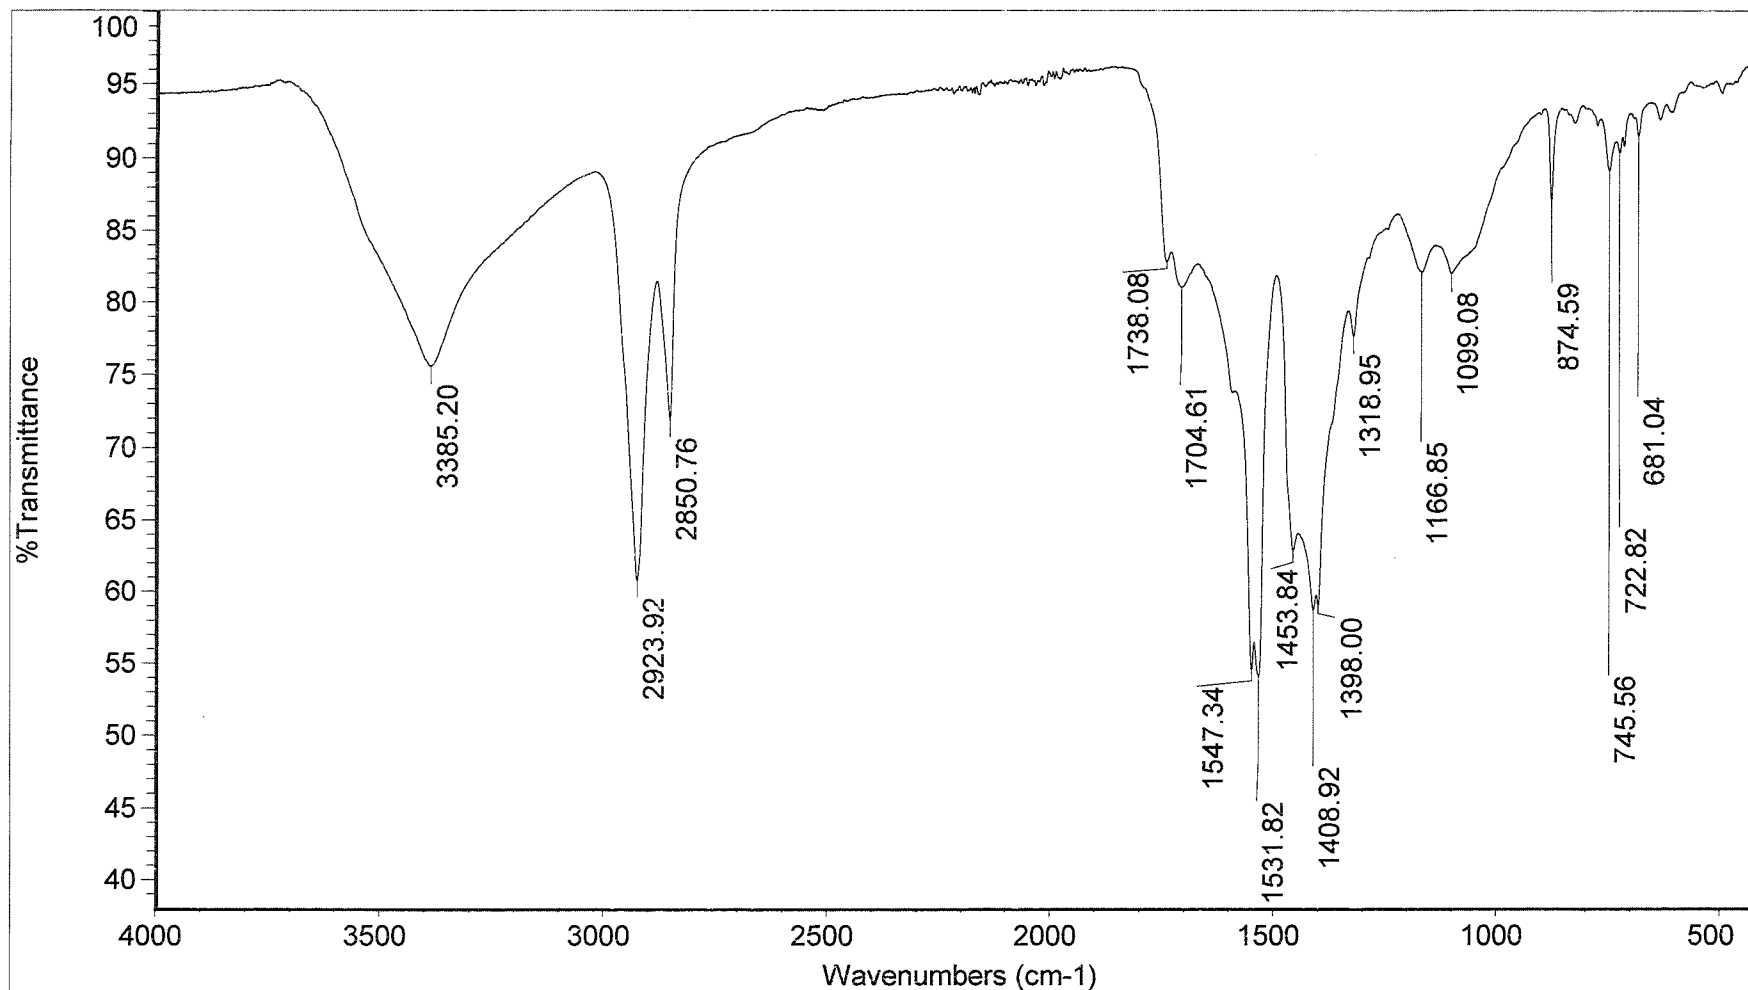
18-74457-236968
Old Railway Pedestrian Bridge over
Rideau River - Span #7 Cross Frame
white layer (middle)

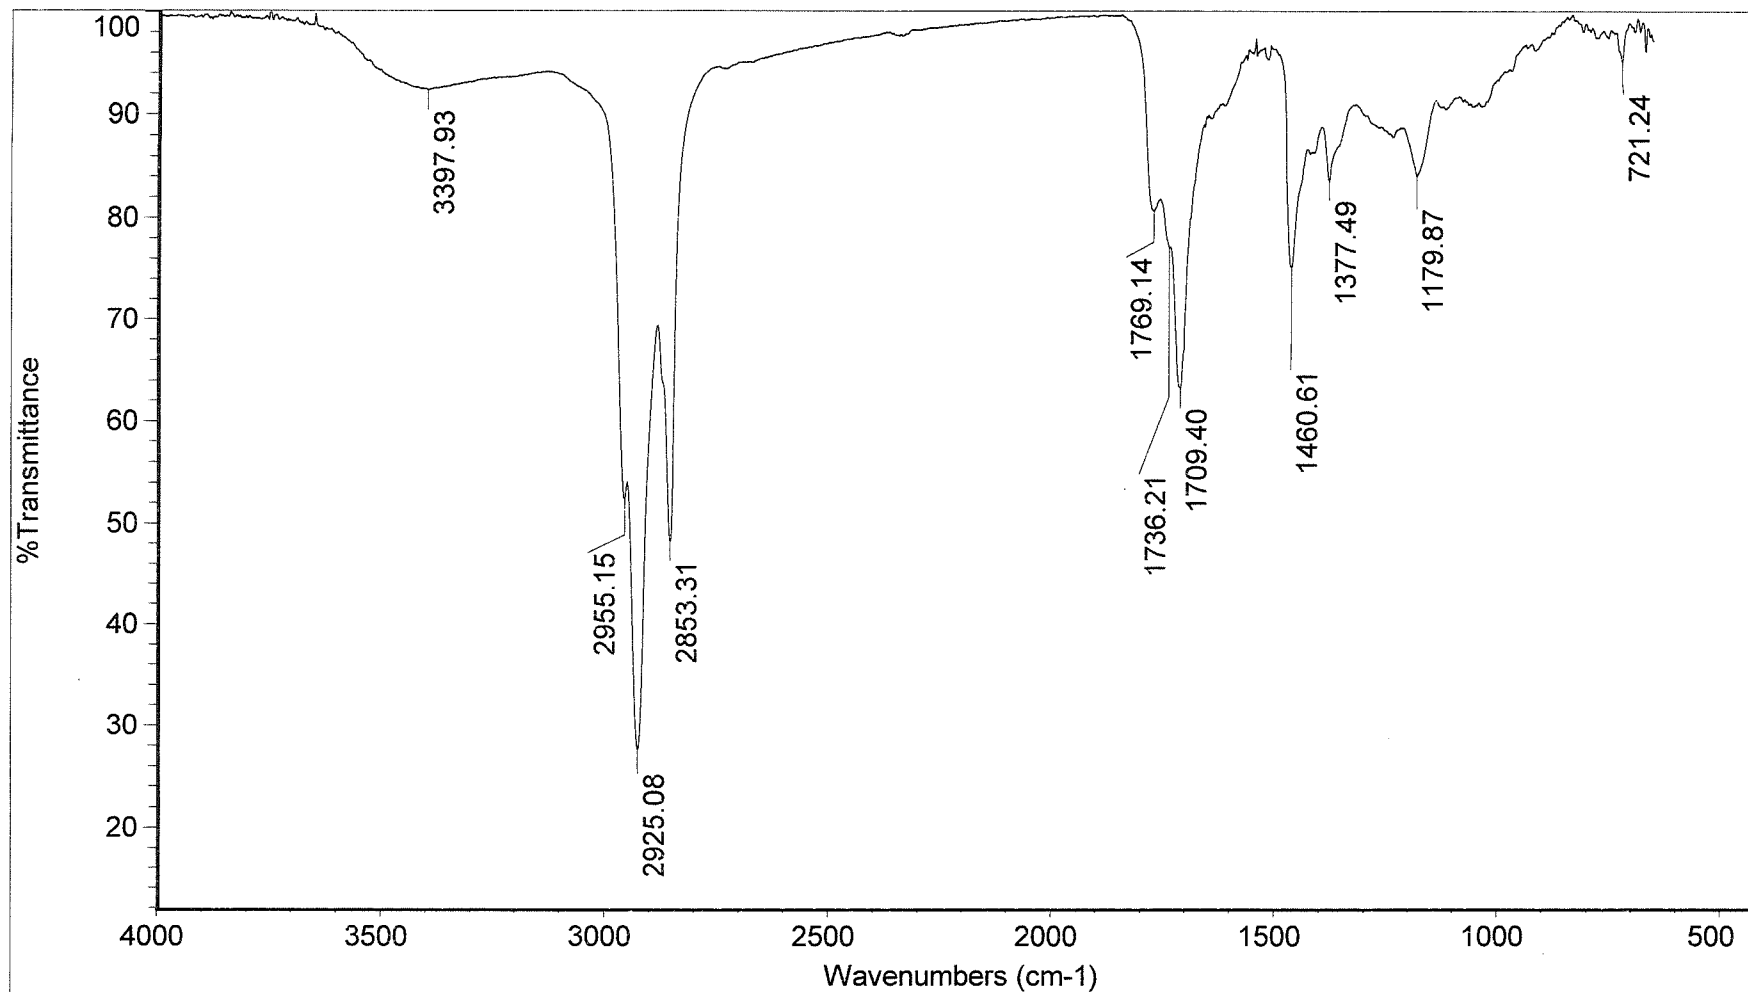
18-74457-236968
orange layer (top) + white layer (middle)
PYROLYZATE

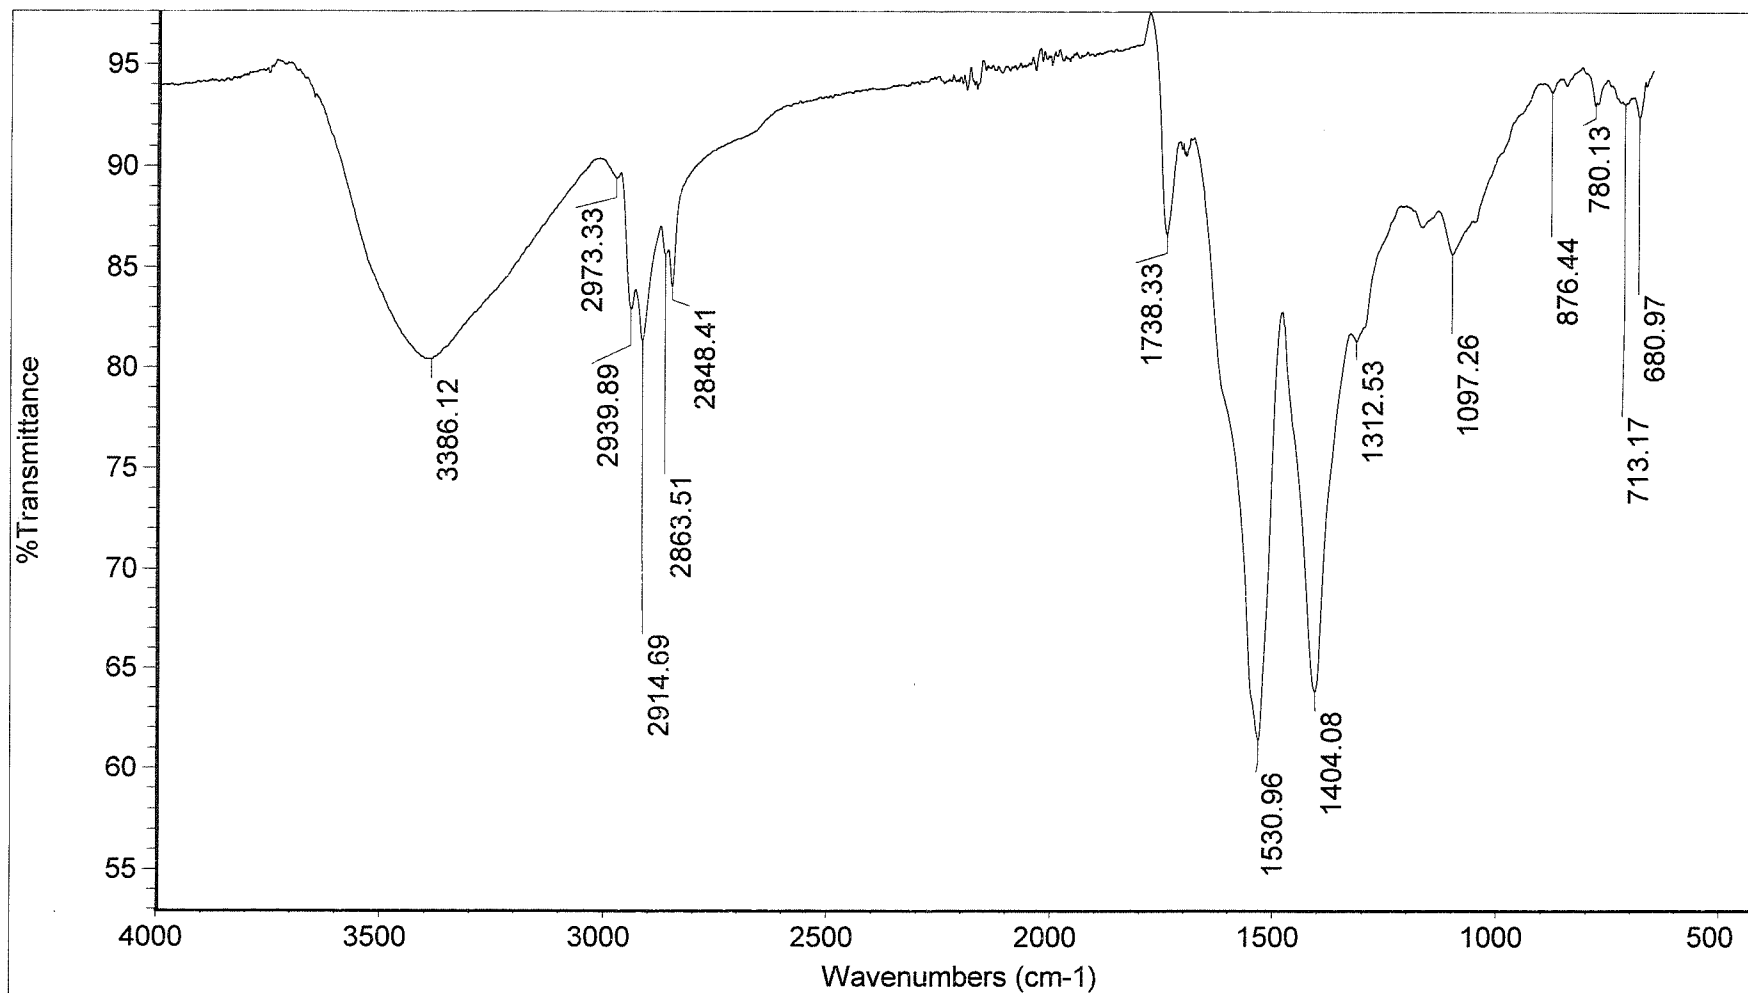
18-74457-236968
subtraction result 187445701A - 187445701G
orange (top) - orange/white pyrolyzate
