Old Railway Rideau River Pedestrian Bridge Structure No. 018600 Detailed Condition Assessment and Renewal Option Analysis Report

Detailed Condition Assessment and Renewal Options Analysis Report

November 2018

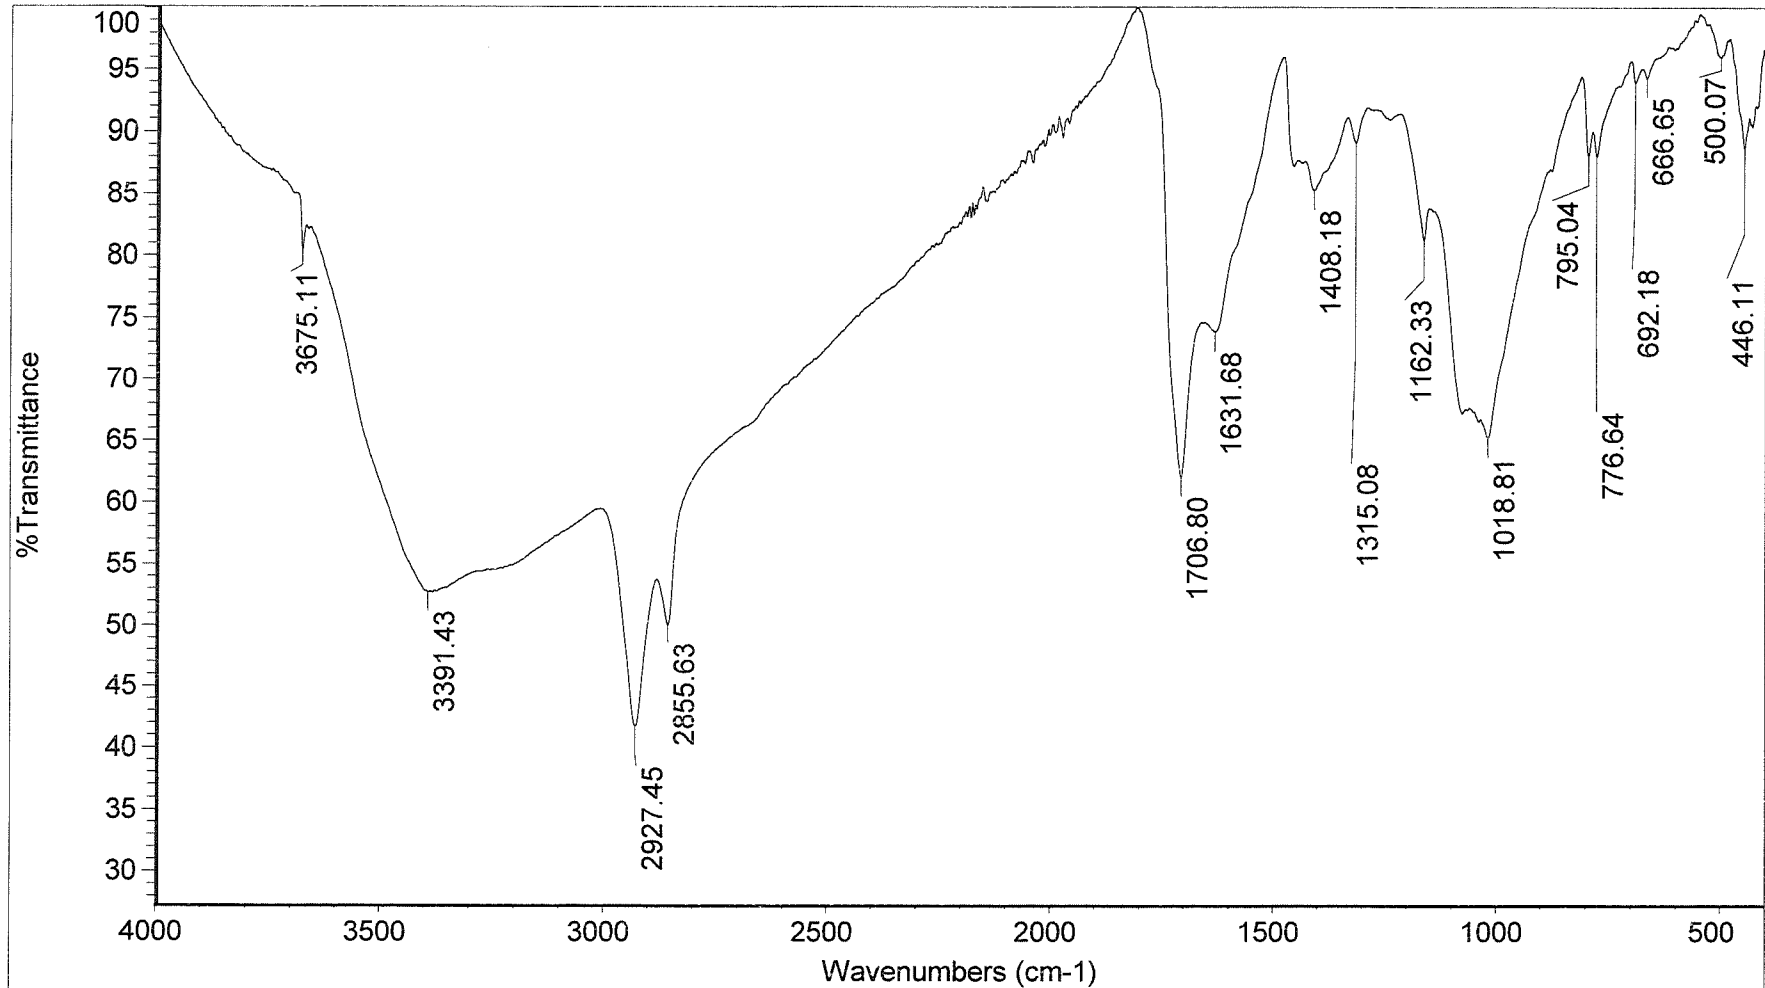
18-74457-236968
Old Railway Pedestrian Bridge over
Rideau River - Span #7 Cross Frame
black/dark grey layer (middle)

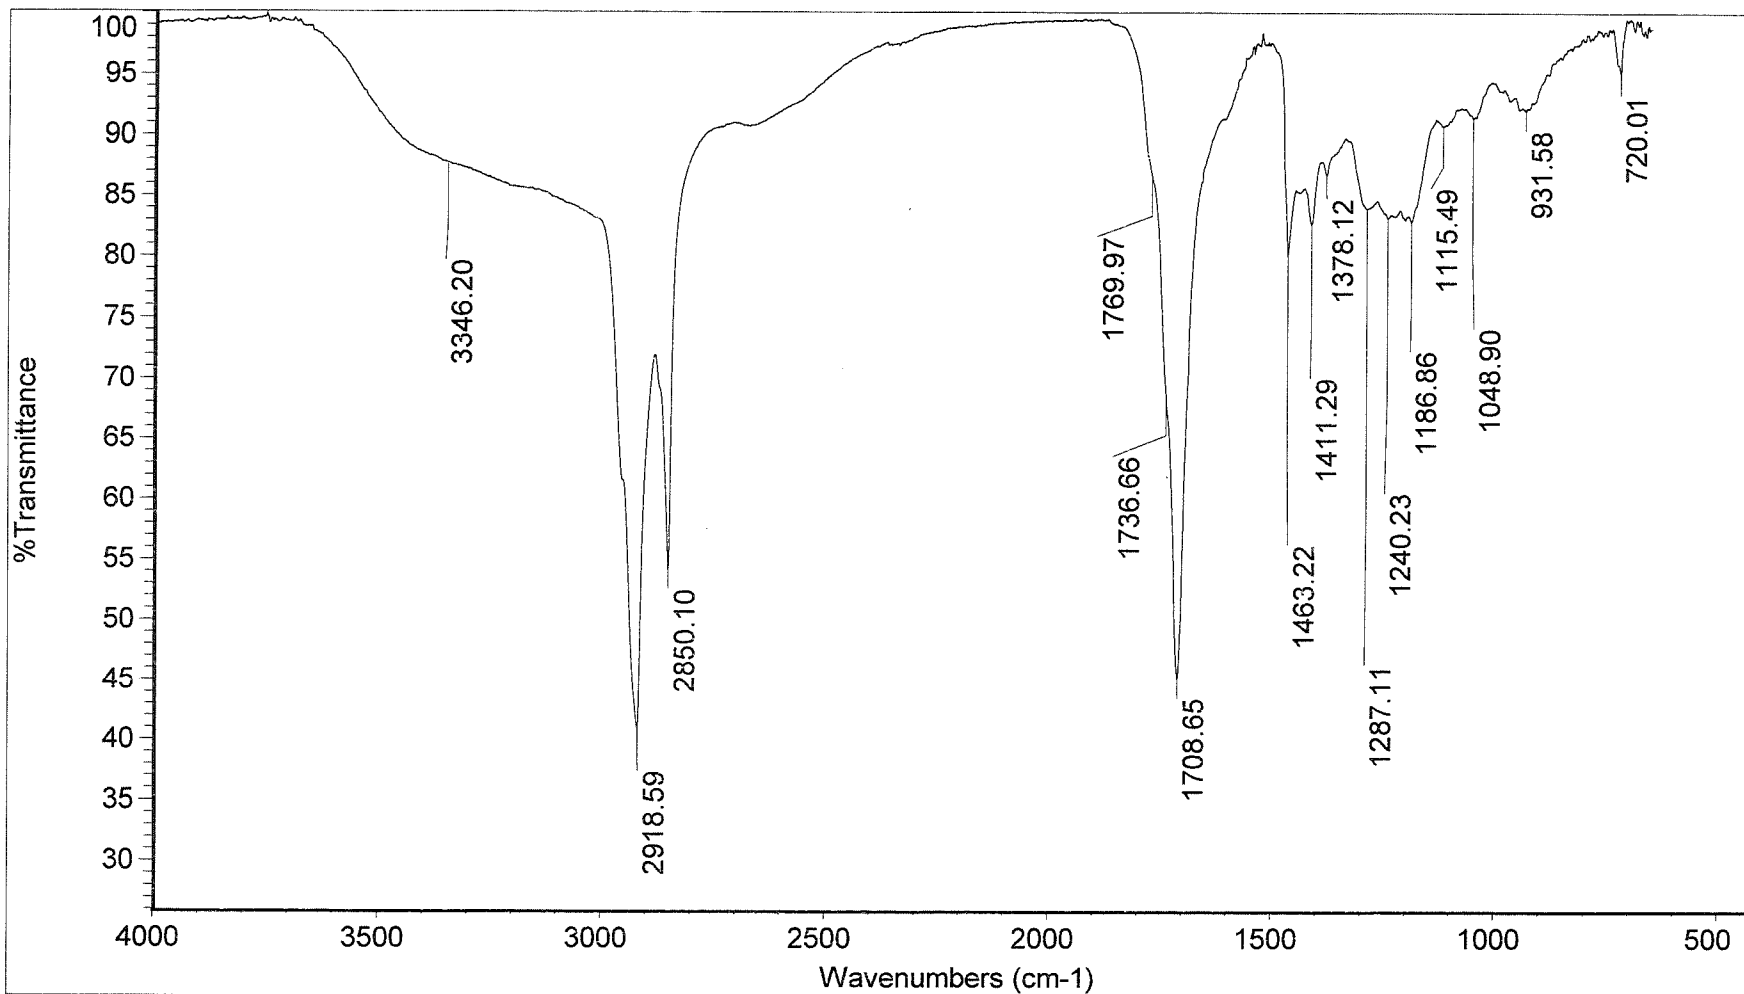
18-74457-236968
black/dark grey (middle) layer
PYROLYZATE

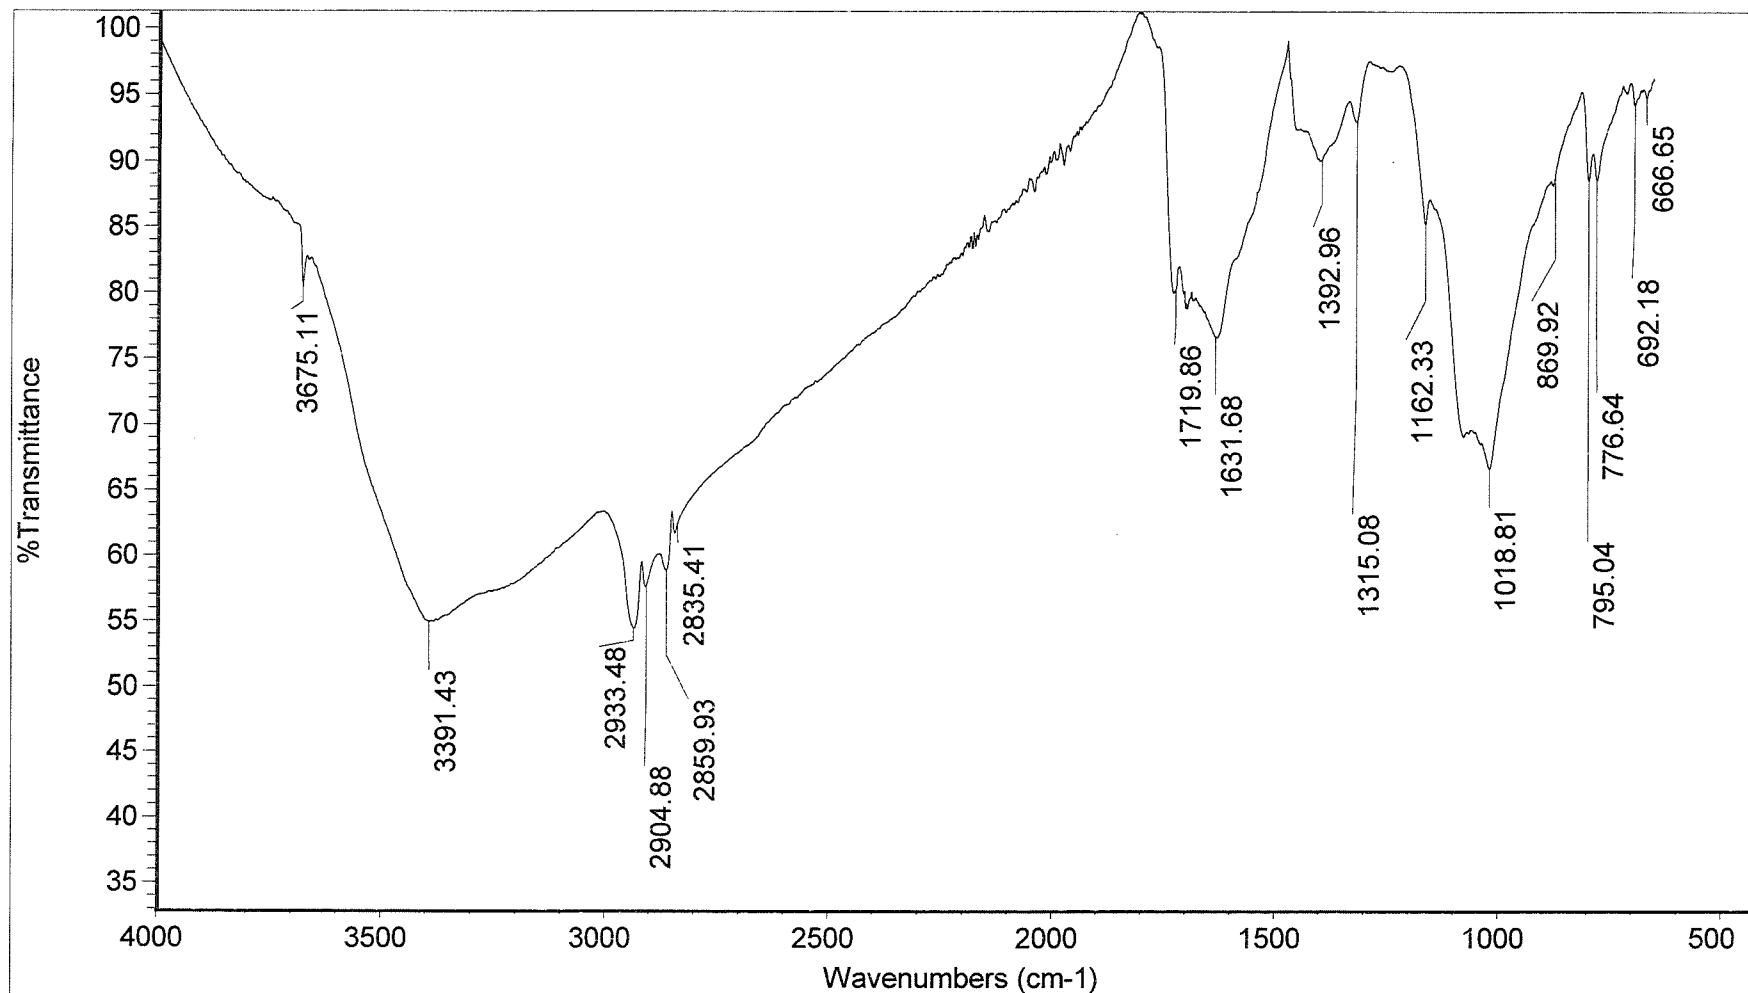
18-74457-236968
subtraction result 187445701D - 187445701F
dark grey (middle) - dark grey (middle) pyrolyzate

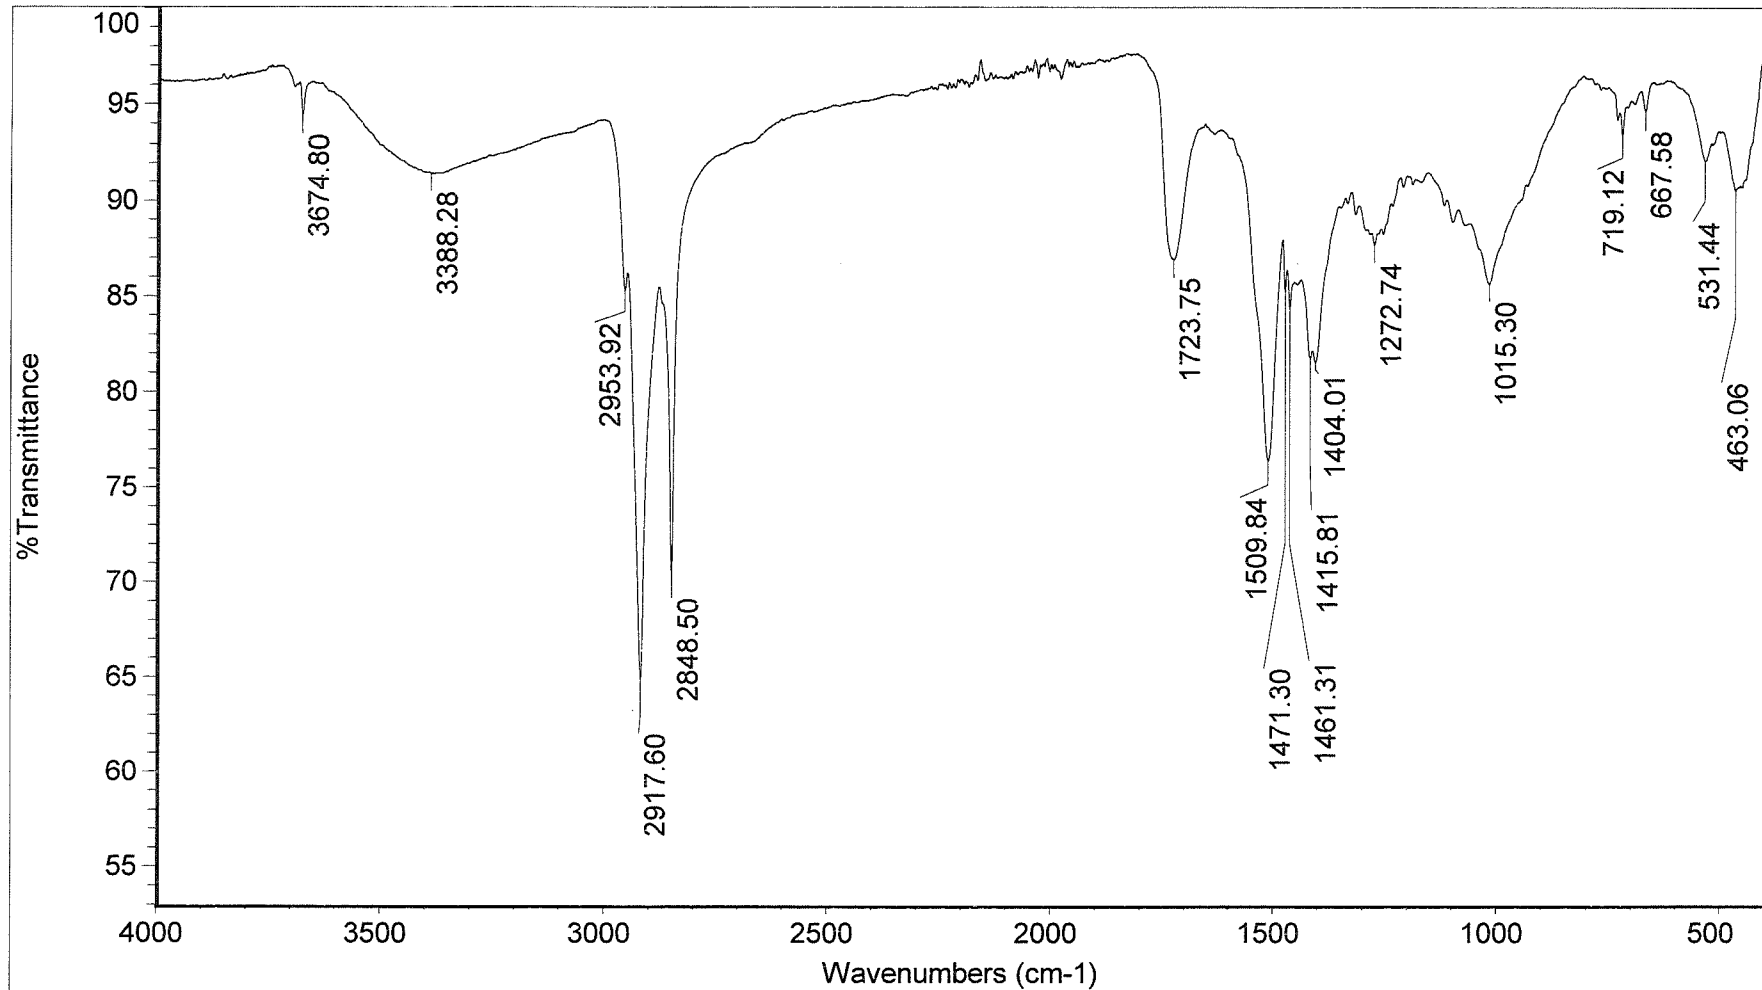
18-74457-236968
Old Railway Pedestrian Bridge over
Rideau River - Span #7 Cross Frame
orange layer (middle)

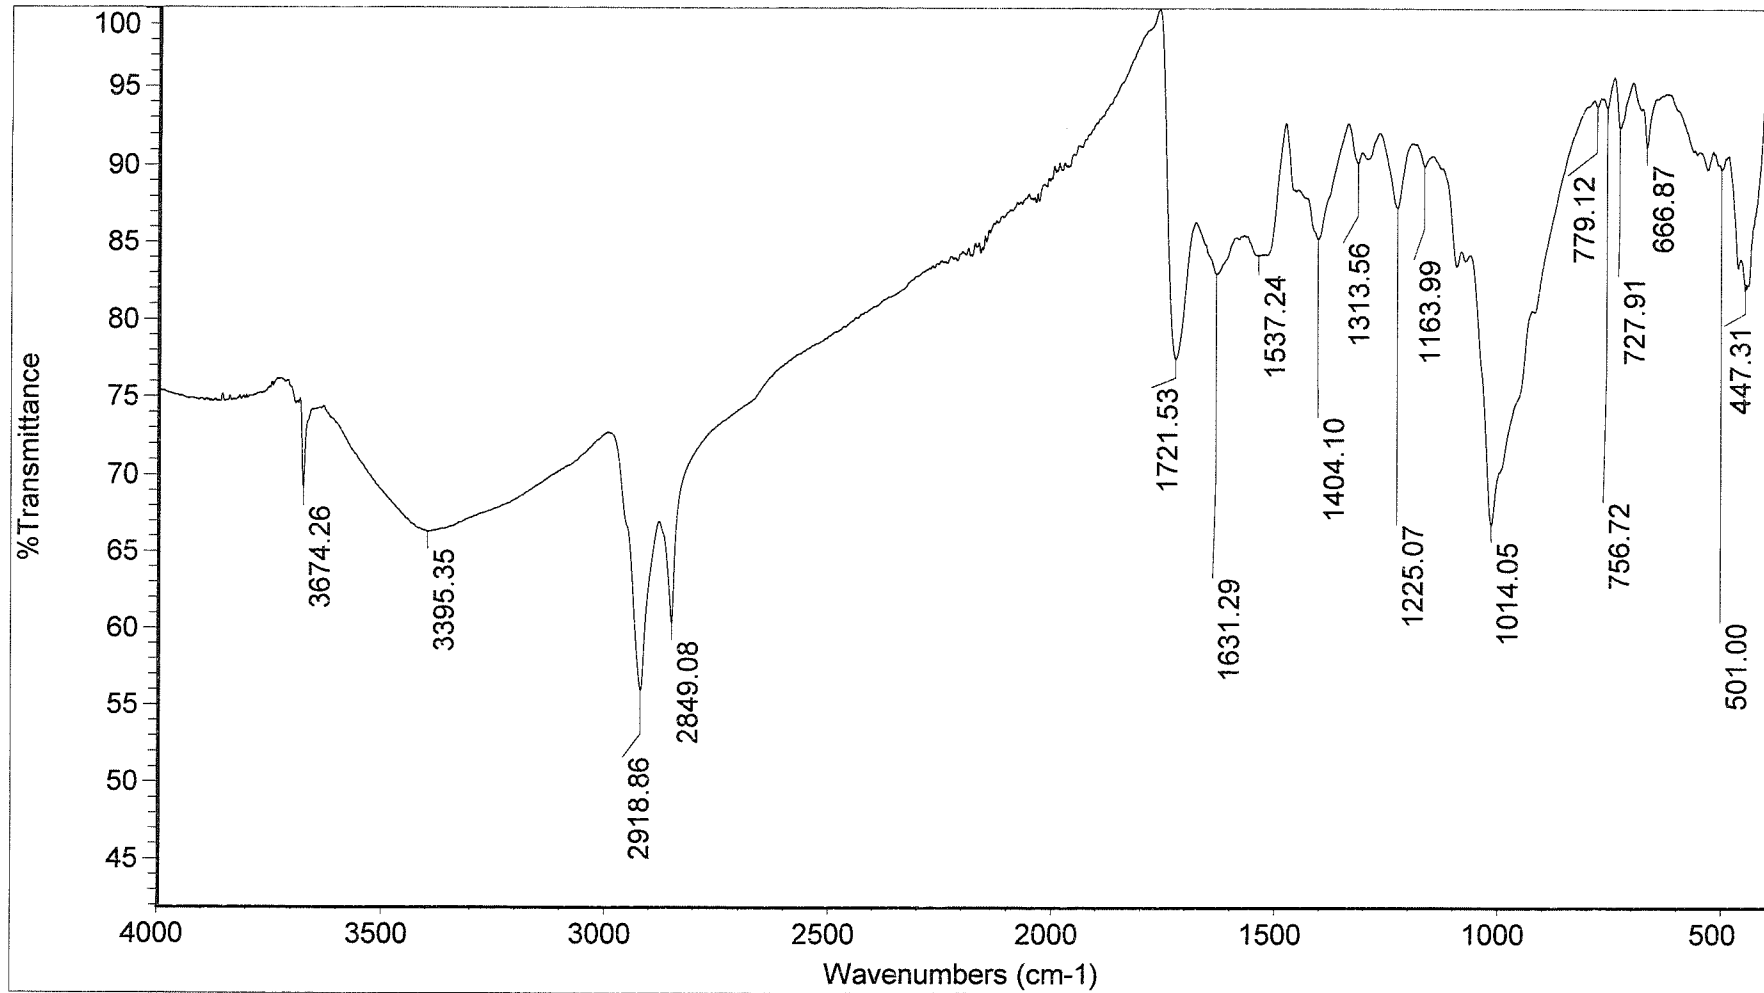
18-74457-236968
Old Railway Pedestrian Bridge over
Rideau River - Span #7 Cross Frame
black/dark grey layer (back/bottom)
