Old Railway Rideau River Pedestrian Bridge Structure No. 018600 Detailed Condition Assessment and Renewal Option Analysis Report

Contract No.
ISD17-7087
Work Order Package
No. 11316522

Detailed Condition Assessment and Renewal Options Analysis Report

November 2018

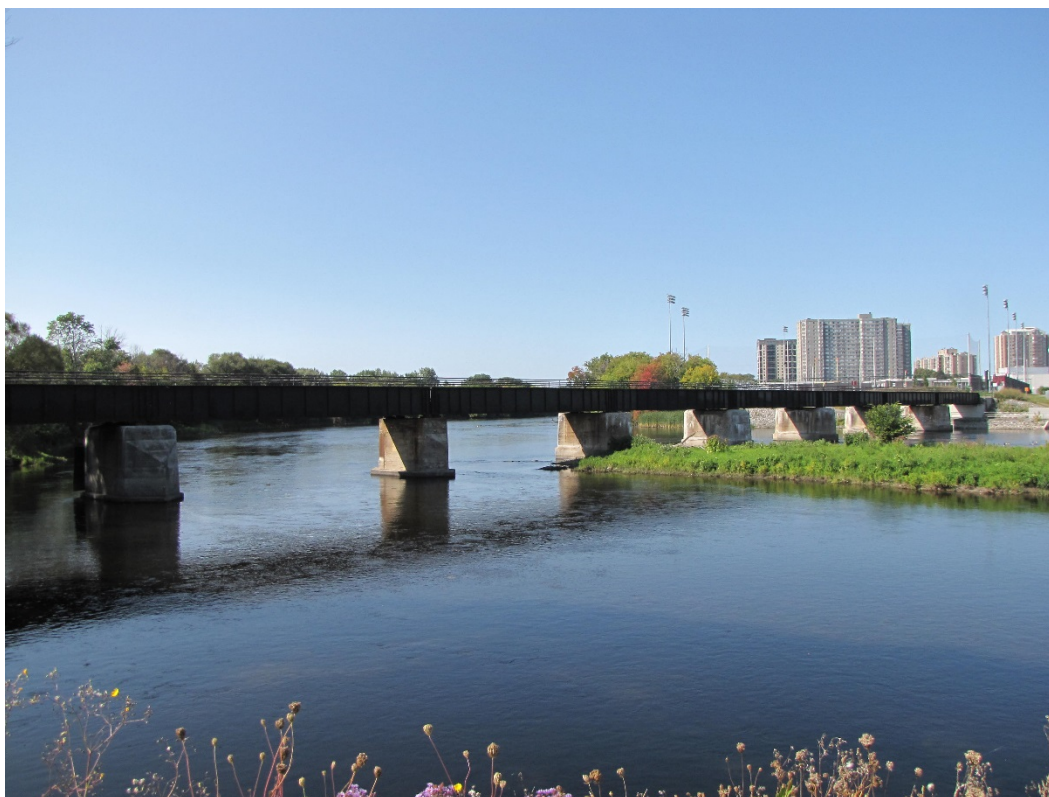
Photo 1 – North elevation of the Old Railway Rideau River Pedestrian Bridge. Note low-lying island downstream of Pier 5 and University of Ottawa (Lees Campus) located on west side of the river (background).

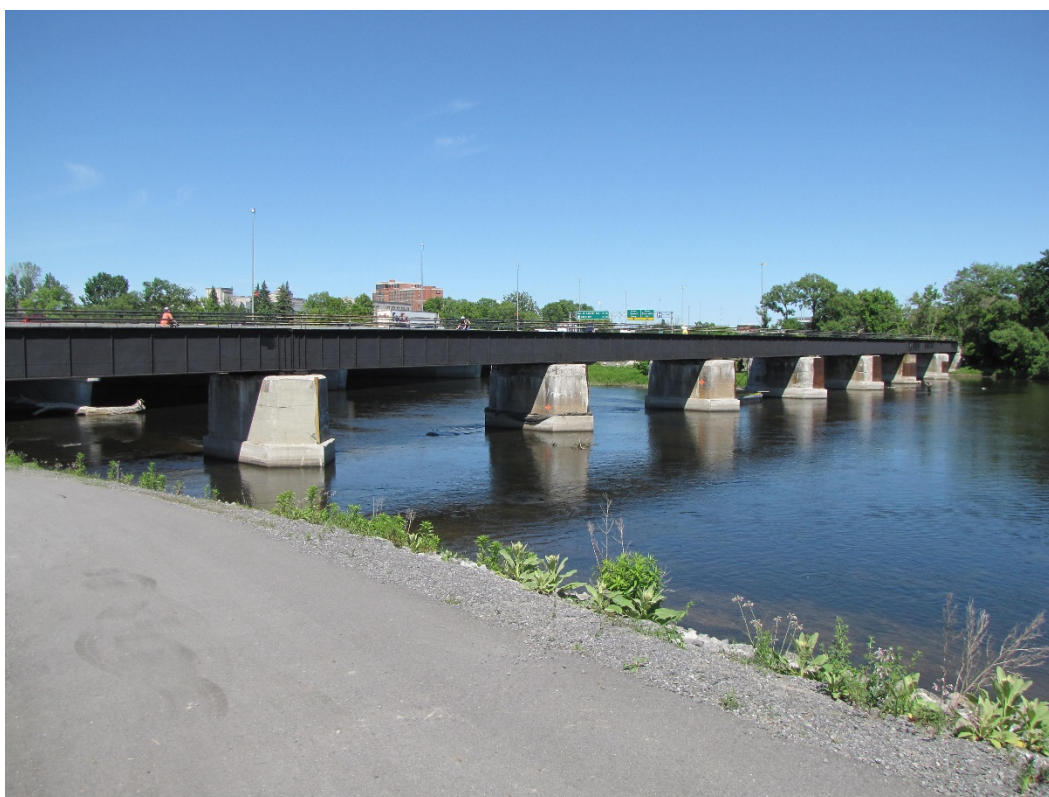
Photo 2 – South elevation. Note Rideau River Western Pathway (foreground), which passes below Span 8.

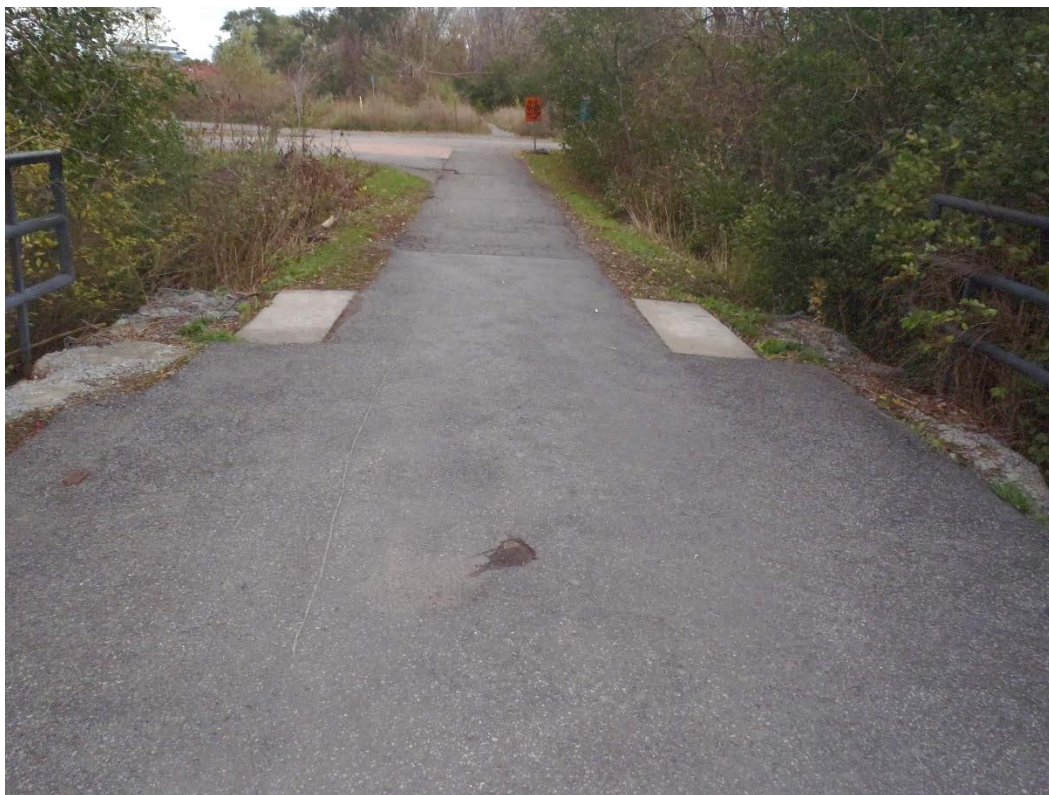
Photo 9 -Light to medium ravelling typical throughout the east approach wearing surface.

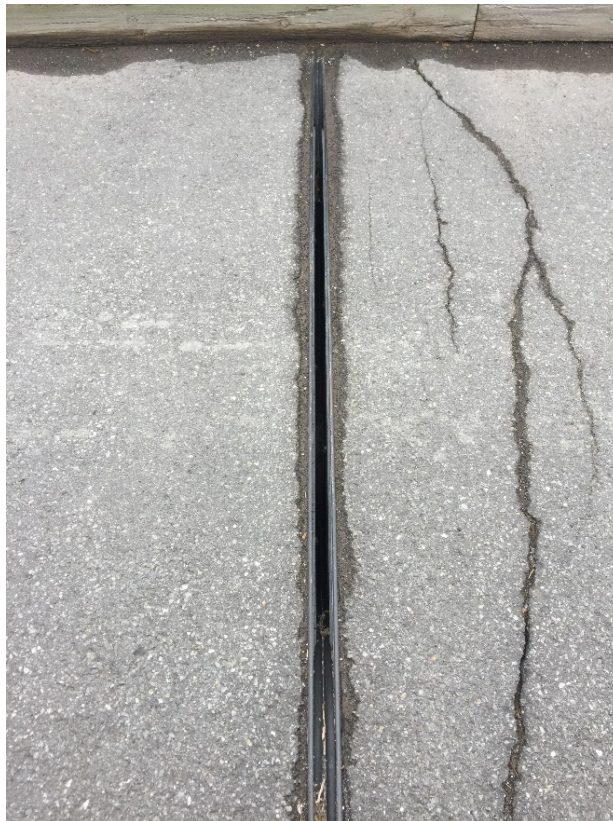
- The expansion joints are suspected to be leaking throughout due to the level of deterioration noted on the components below the joints, though observed material defects include a broken compression seal at Pier 2 and the seals at the west abutment and Pier 4 are visibly sagging beneath the deck.

Photo 16 – Failed section expansion joint compression seal sagging below deck at Pier 4.

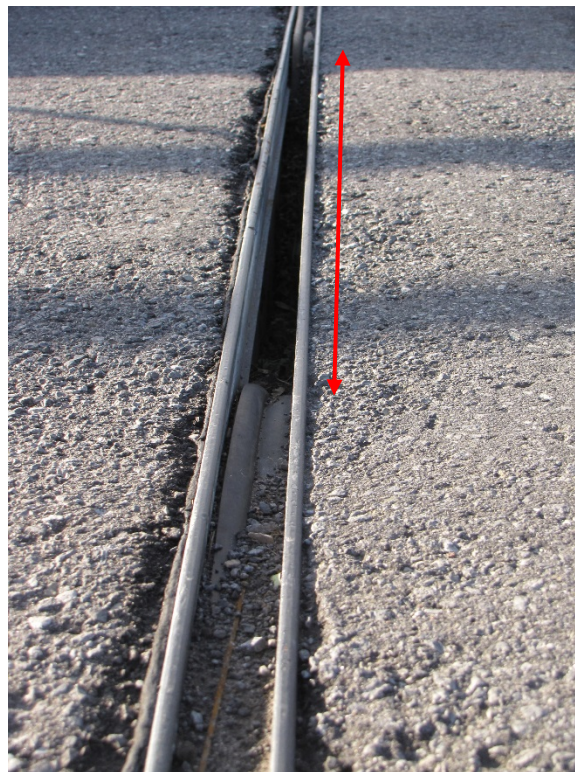
Photo 18 – Failed expansion joint compression seal is sagging below at the west abutment. Also note the asphalt break-up at the expansion joint angles.

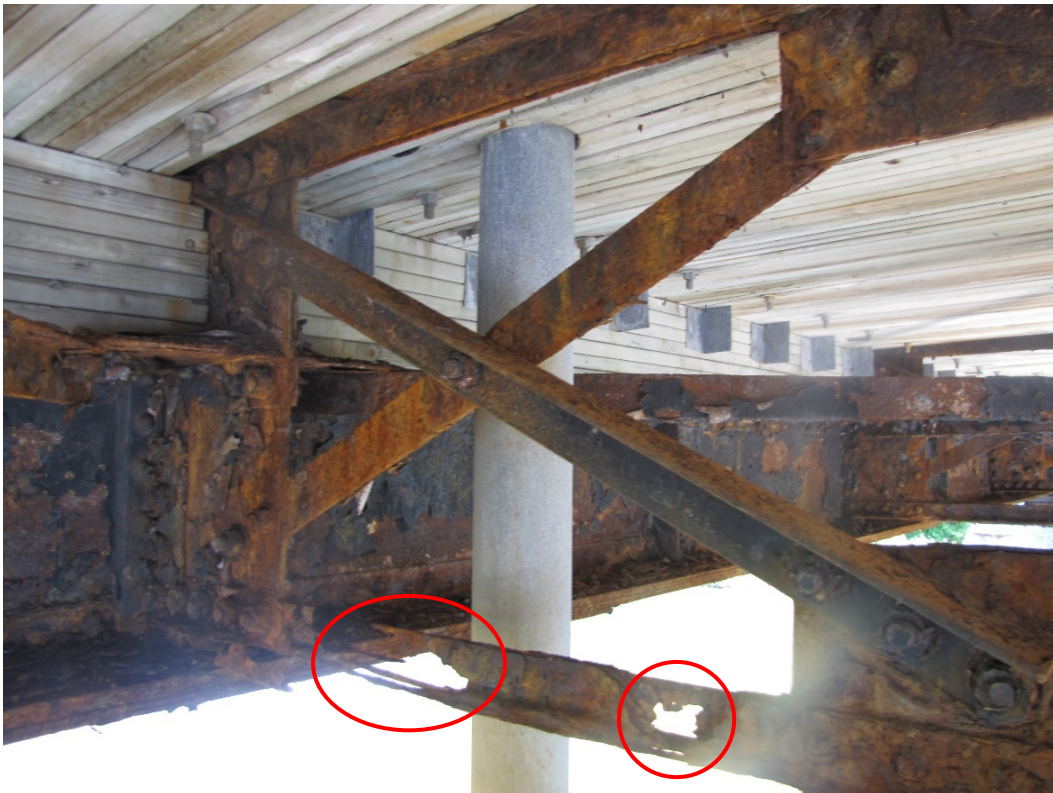
Photo 32 - Cross-frame 3 bays east of Pier 2 has 100% section loss in the bottom brace.

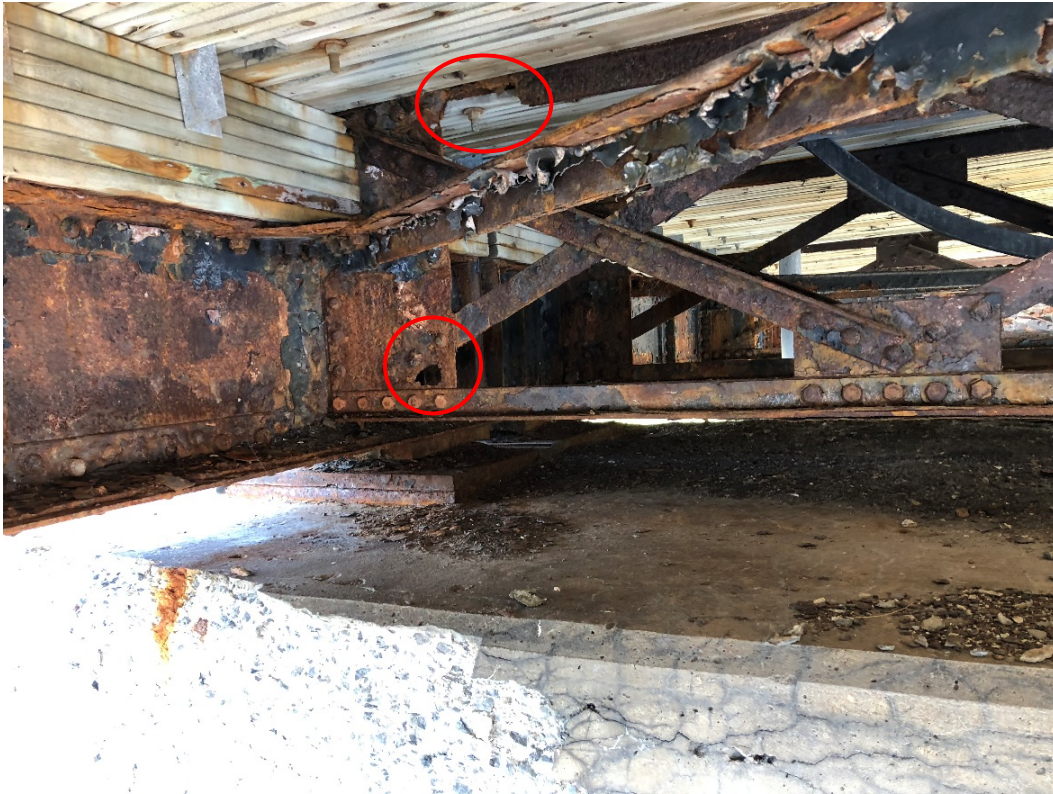
Photo 33 – Cross-frame at Pier 4 complete section loss on the top brace and perforation in the vertical gusset plate.

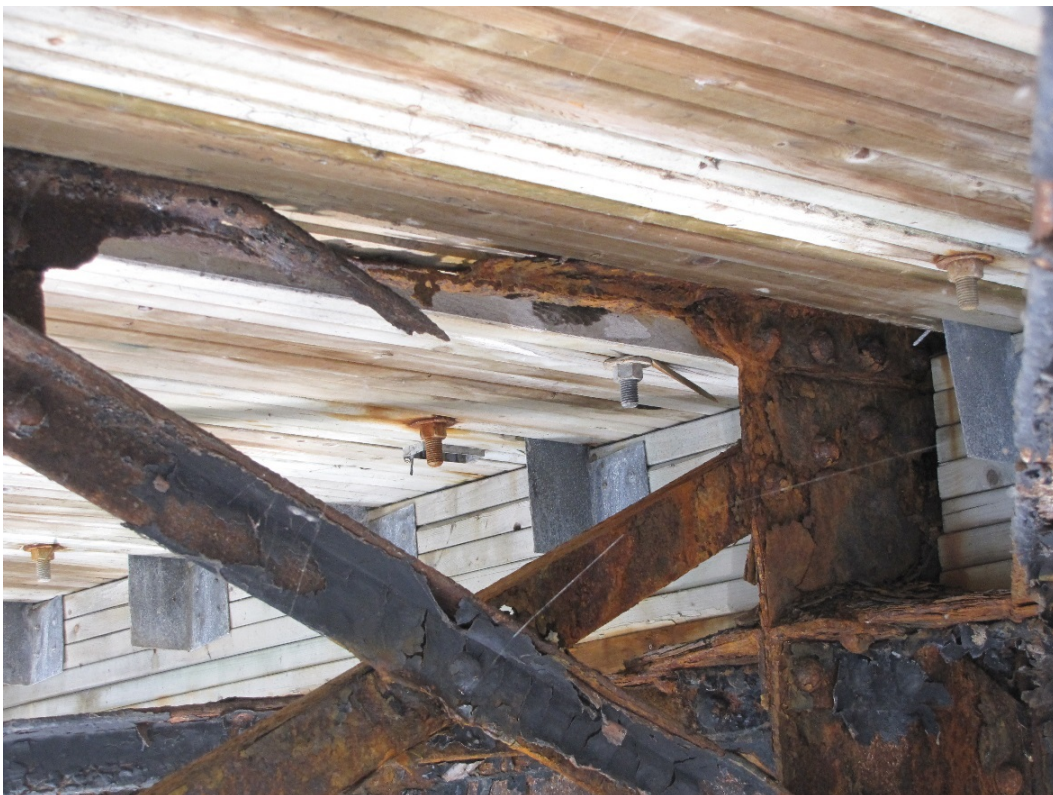
Photo 34 – Cross-frame in the bay just east of Pier 6 has 100% section loss in the top brace.

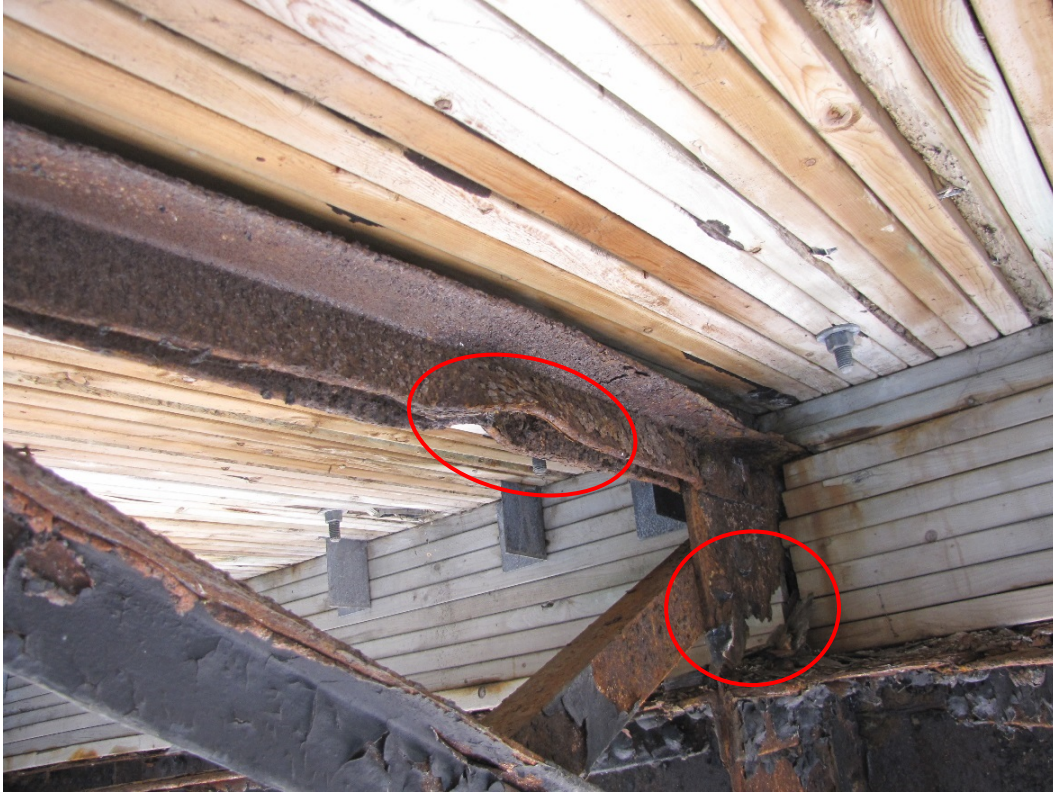
Photo 35 – Cross-frame 2 bays west of Pier 5. Perforation full width of the vertical gusset plate and severe deformation of the top brace member.

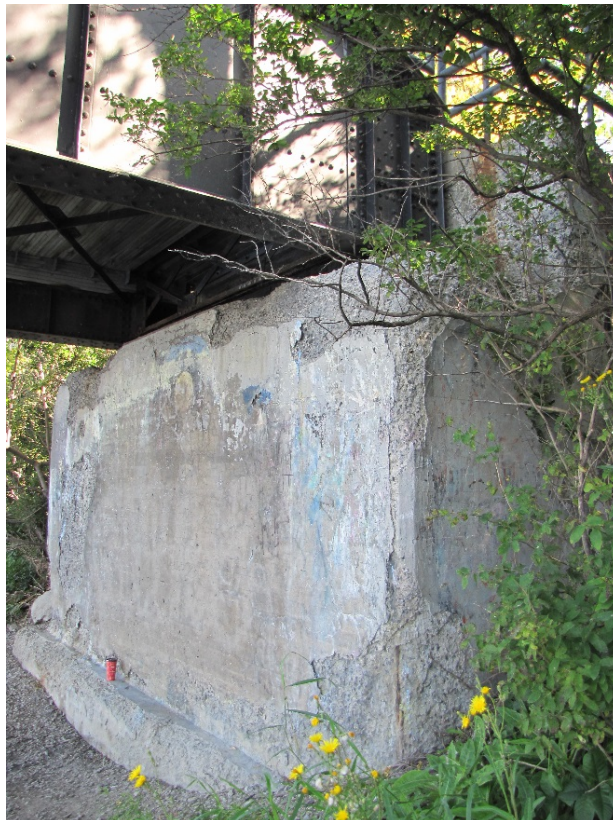
The east abutment wall, bearing seat and exposed footing are in generally poor condition (62.1% of area in poor) with numerous severe to very severe delaminations, spalls and extensive disintegration up to 150 mm deep with exposed corroded reinforcing steel (Photos 48 to 51). The west abutment wall and bearing seat are in generally good condition with localized areas in poor condition (4% of area in poor) with severe to very severe disintegration at the top of the abutment wall and bearing seat at the north end (Photo 52). Wet efflorescence stained hairline pattern cracking was noted in the bearing seat and light popouts throughout the abutment wall. There is a significant accumulation of debris on both bearing seats, including deteriorated steel and concrete (Photos 43 and 44). Also, there is non-offensive graffiti present on both abutment walls (Photos 48 and 52), though the west abutment wall has been previously painted.

Photo 48 – East abutment. very severe disintegration throughout with spalls, delaminations and exposed corroded rebar on the abutment wall and footing.

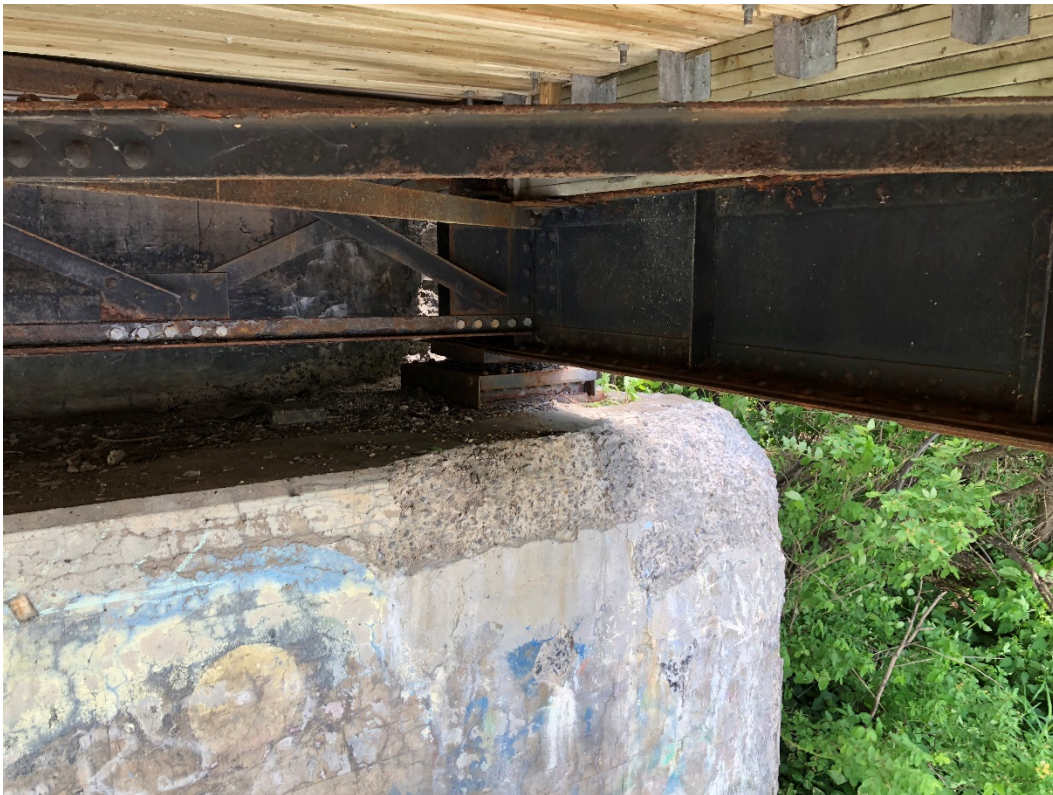
Photo 50 – Very severe disintegration at the top of the east abutment wall and bearing seat at the south end.

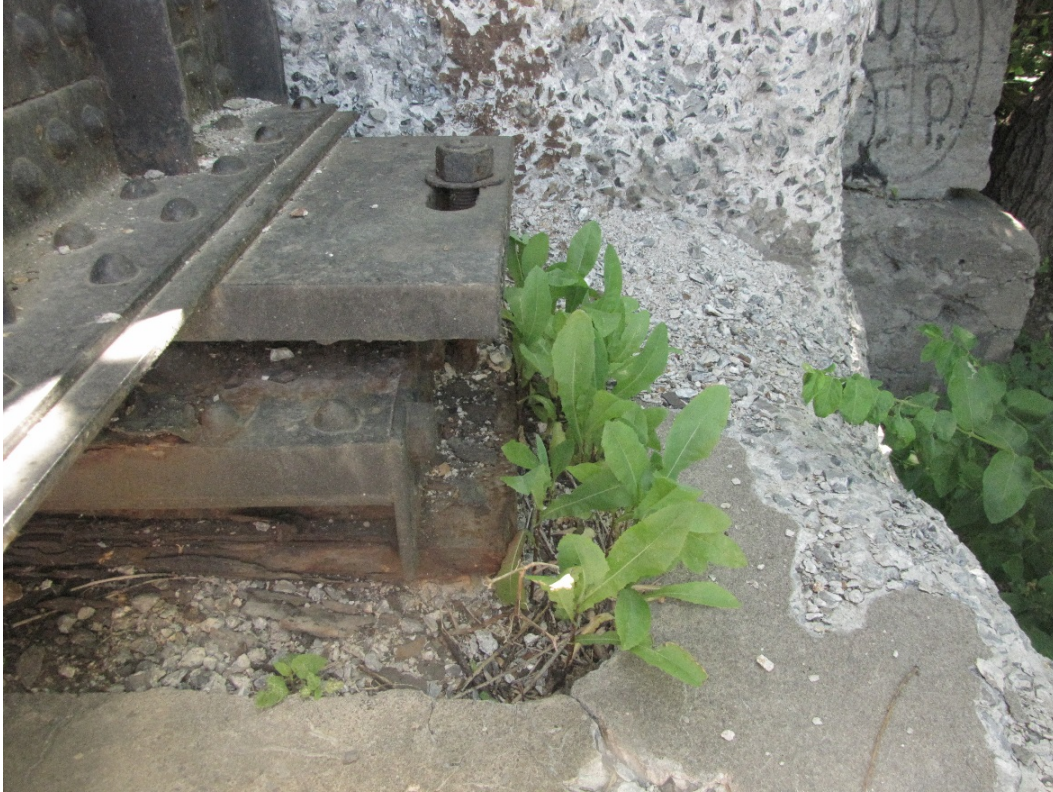
Photo 51 – Very severe disintegration on the ballast wall and adjacent to the south expansion bearing at the east abutment. Note vegetation growth in bearing seat.

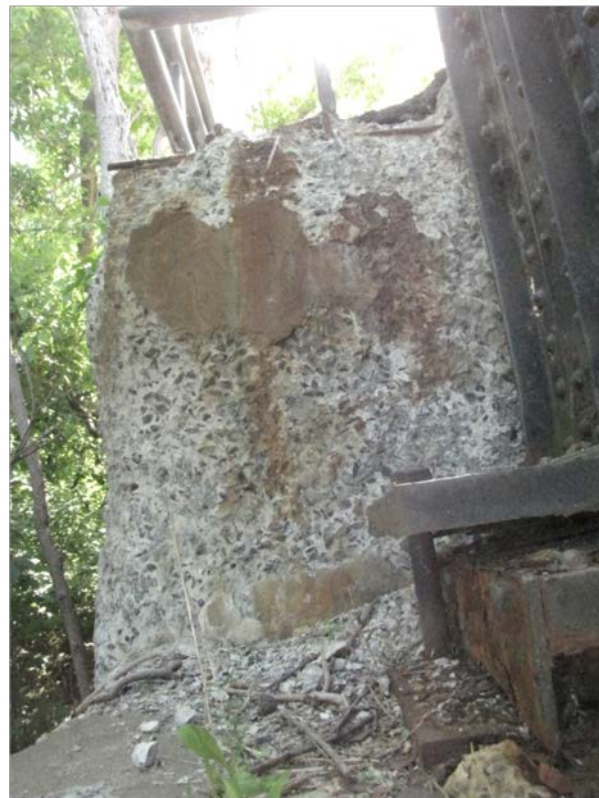
Photo 56 – Severe to very disintegration with exposed corroded rebar at the north end of the east ballast wall.

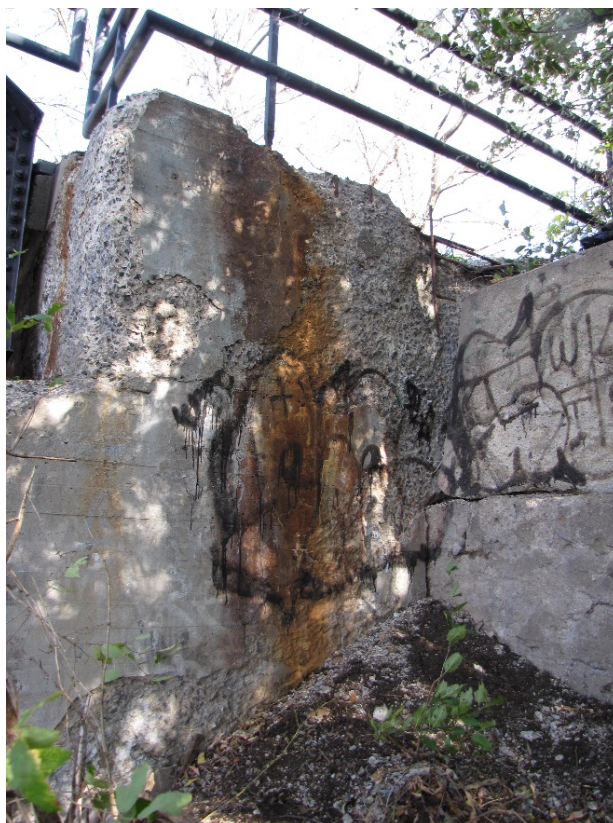
Photo 58 – Extensive areas of medium to very severe disintegration with exposed corroded rebar, delaminations, and hairline to narrow wet and efflorescence stained map cracking on the southeast wingwall.

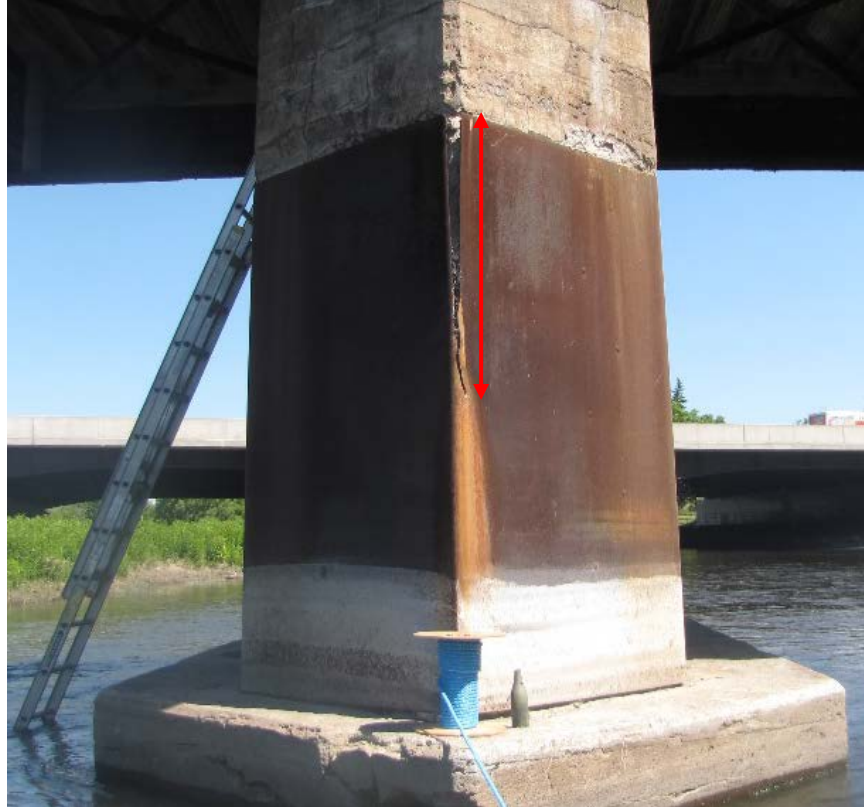
Photo 63 – Pier 2 steel nosing plate is cracked and separated, extending from the top to midway down the center of the plate. Note lack of a steel nosing angle or plate on the upstream nosing of the footing with a very severe spall.

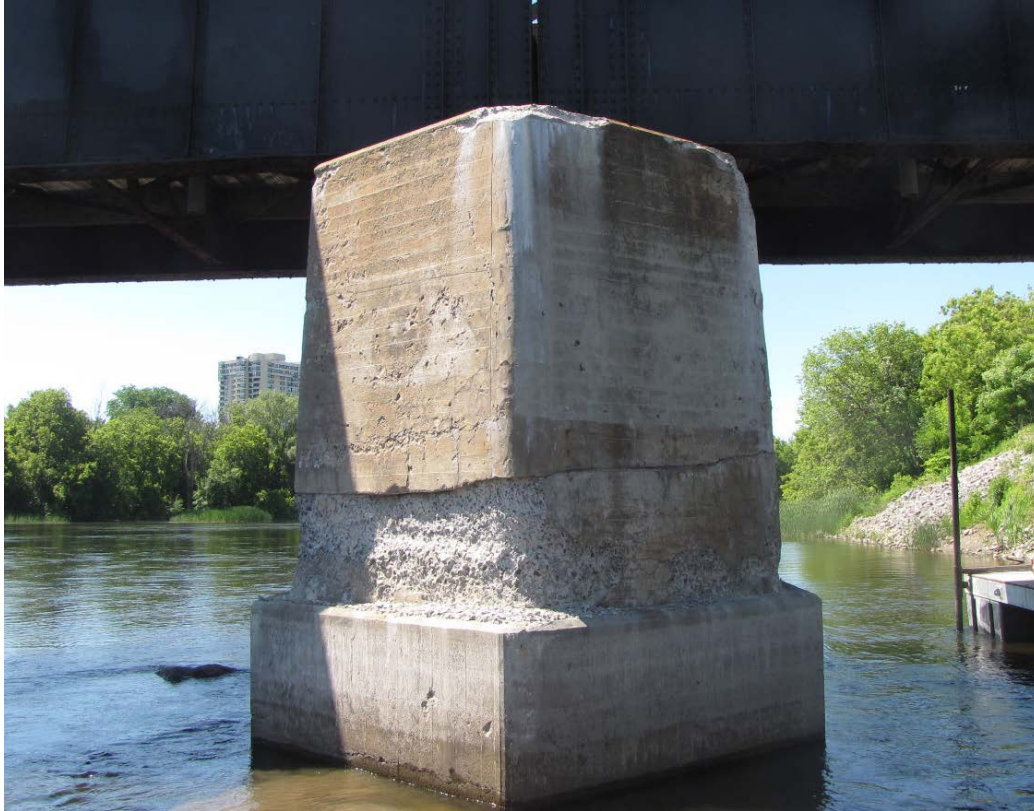
Photo 71 – Pier 7, north elevation. Severe to very severe disintegration below the horizontal construction joint and at the bearing seat.

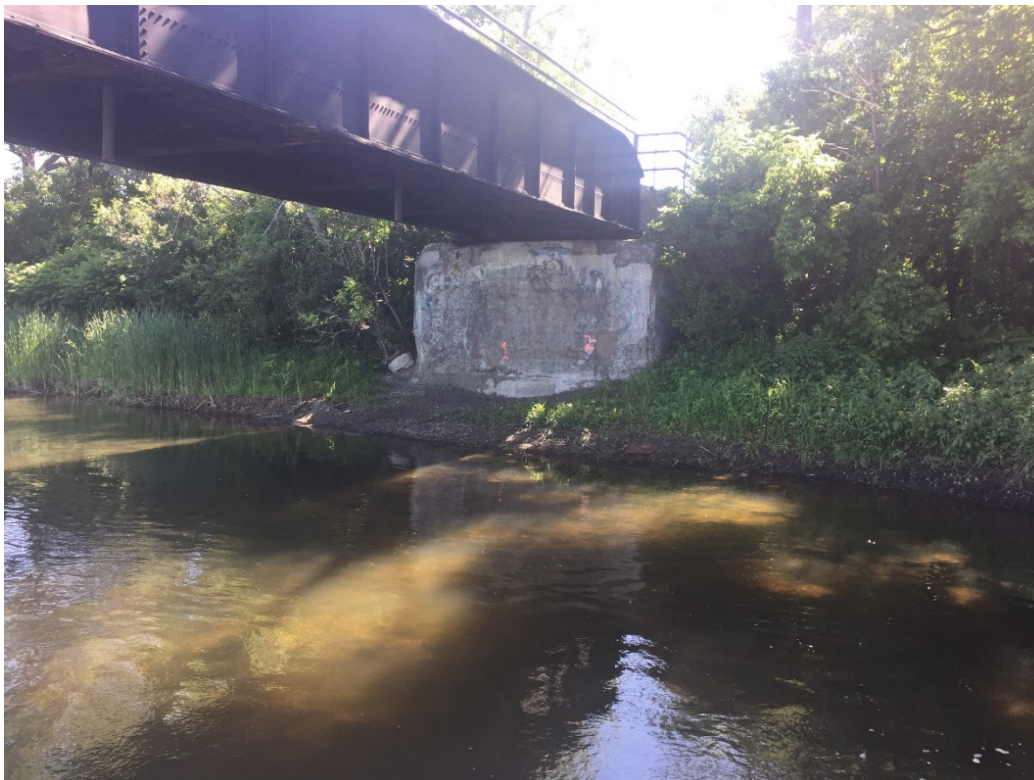
The embankments are in generally good condition, except for the embankment in front of the east abutment, which is in fair condition due to erosion of embankment material greater than 10%, likely due to high flows (Photo 72). The side slope embankments at the southwest and northwest are moderately sloped, but southwest embankment has well vegetated with light erosion due to a foot path (Photo 73), while the northwest embankment is covered in rip-rap (Photo 74). The embankment in front of the west abutment and Rideau River Western Pathway is covered with rip-rap. The side slope embankments at the southeast and northeast are steeply sloped and well vegetated no significant erosion (Photo 72).

Photo 72 – Embankment in front of the east abutment in fair condition due to erosion of embankment material. Southeast and northeast embankments well vegetated, but steep.

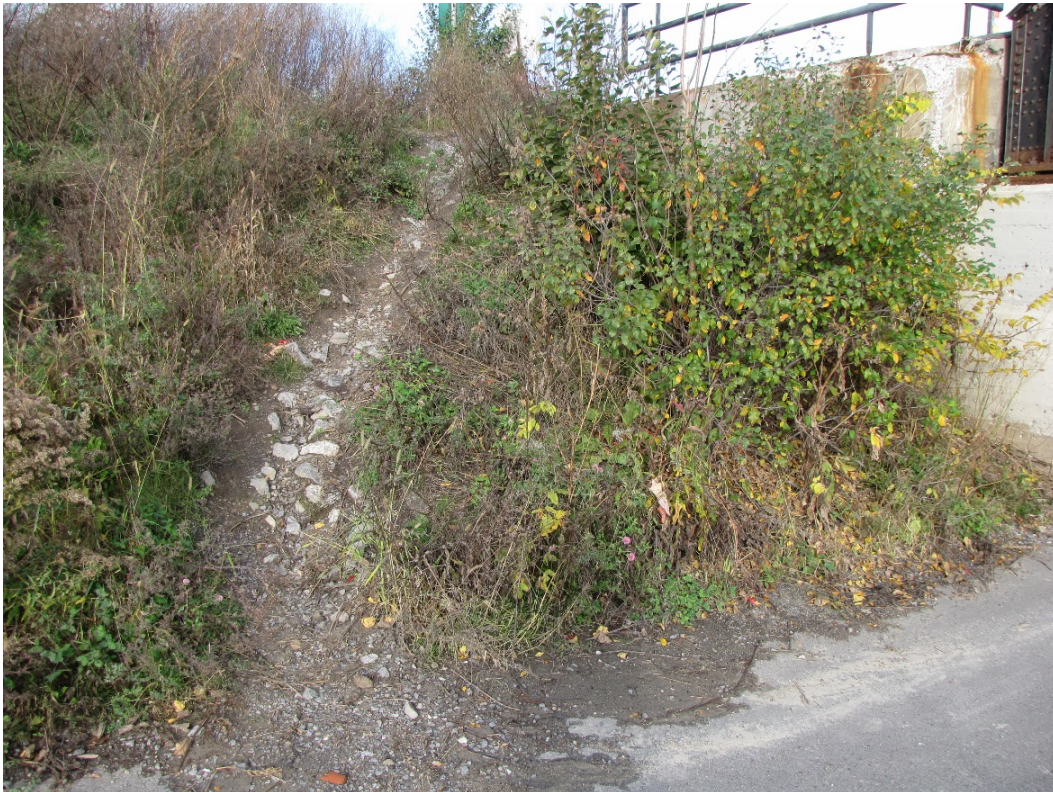
Photo 73 – Southwest embankment is well vegetated with light erosion due to a foot path leading down from the top of the embankment to the multi-use pathway below.

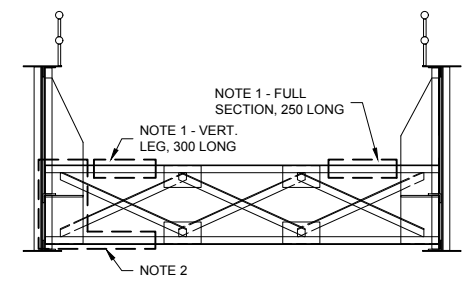
CROSS-FRAME 1-7
1:75

NOTE:
 CROSS-FRAME ELEMENTS BELOW THE TIMBER DECK ARE IN POOR CONDITION ON ACCOUNT OF SEVERE TO VERY SEVERE CORROSION THROUGHOUT.

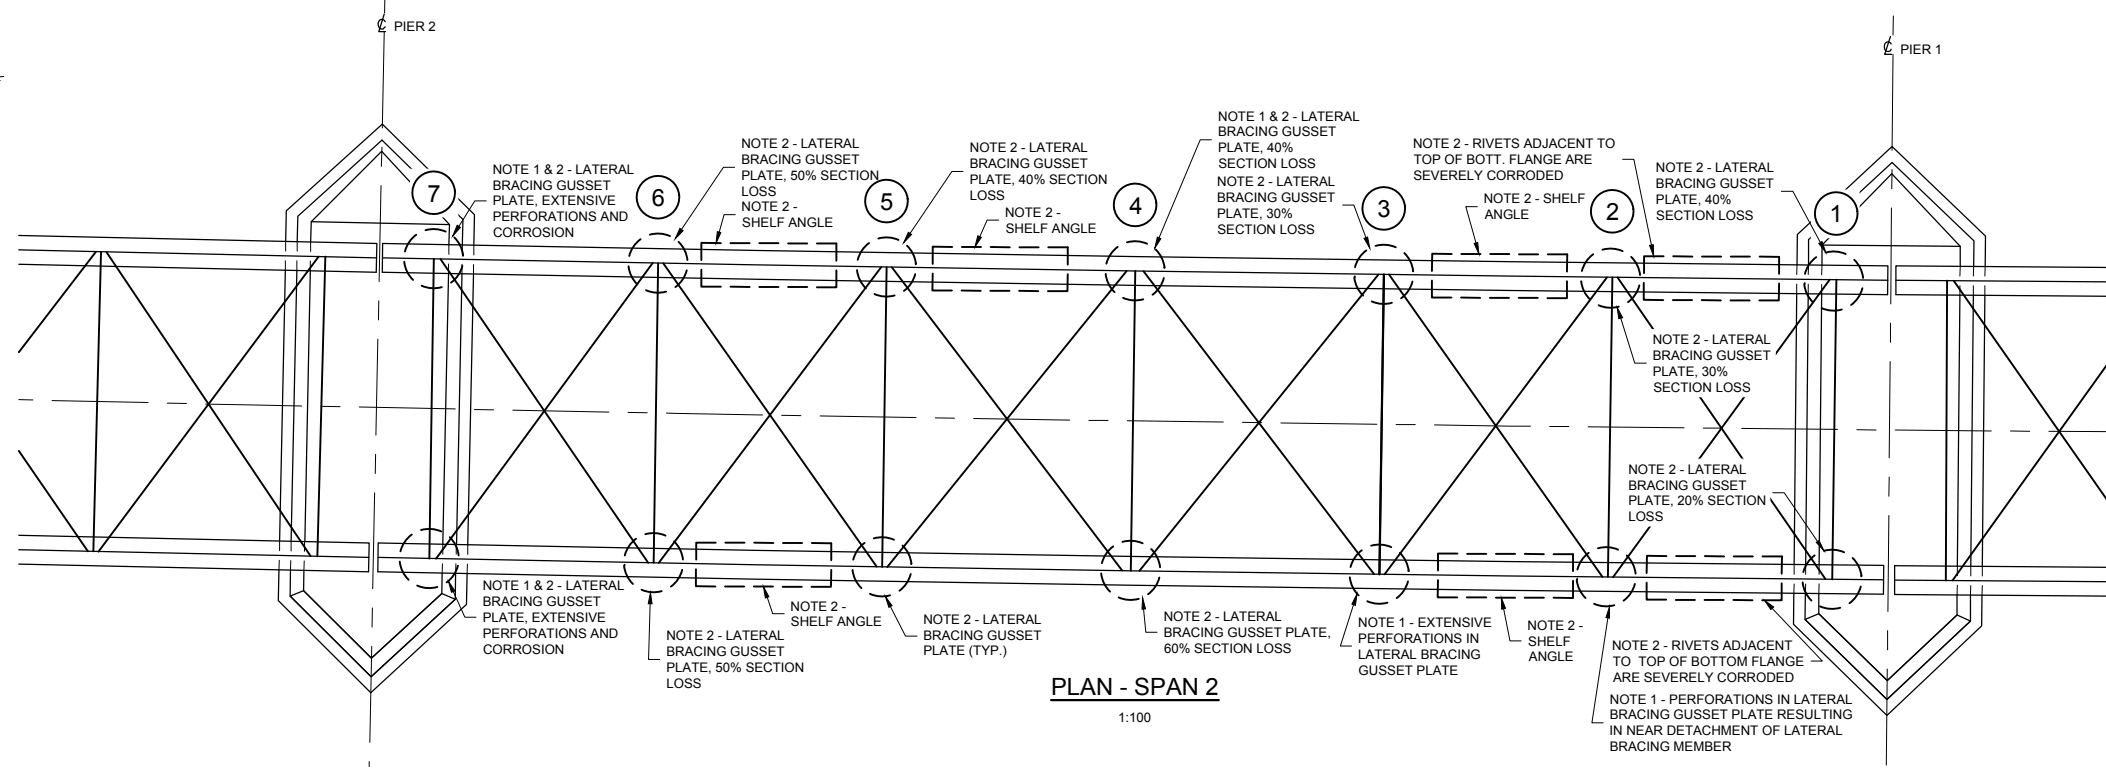
SPAN 2 DETERIORATION

NOTE: CROSS-FRAME ELEMENTS BELOW THE TIMBER DECK ARE IN POOR CONDITION ON ACCOUNT OF SEVERE TO VERY SEVERE CORROSION THROUGHOUT.

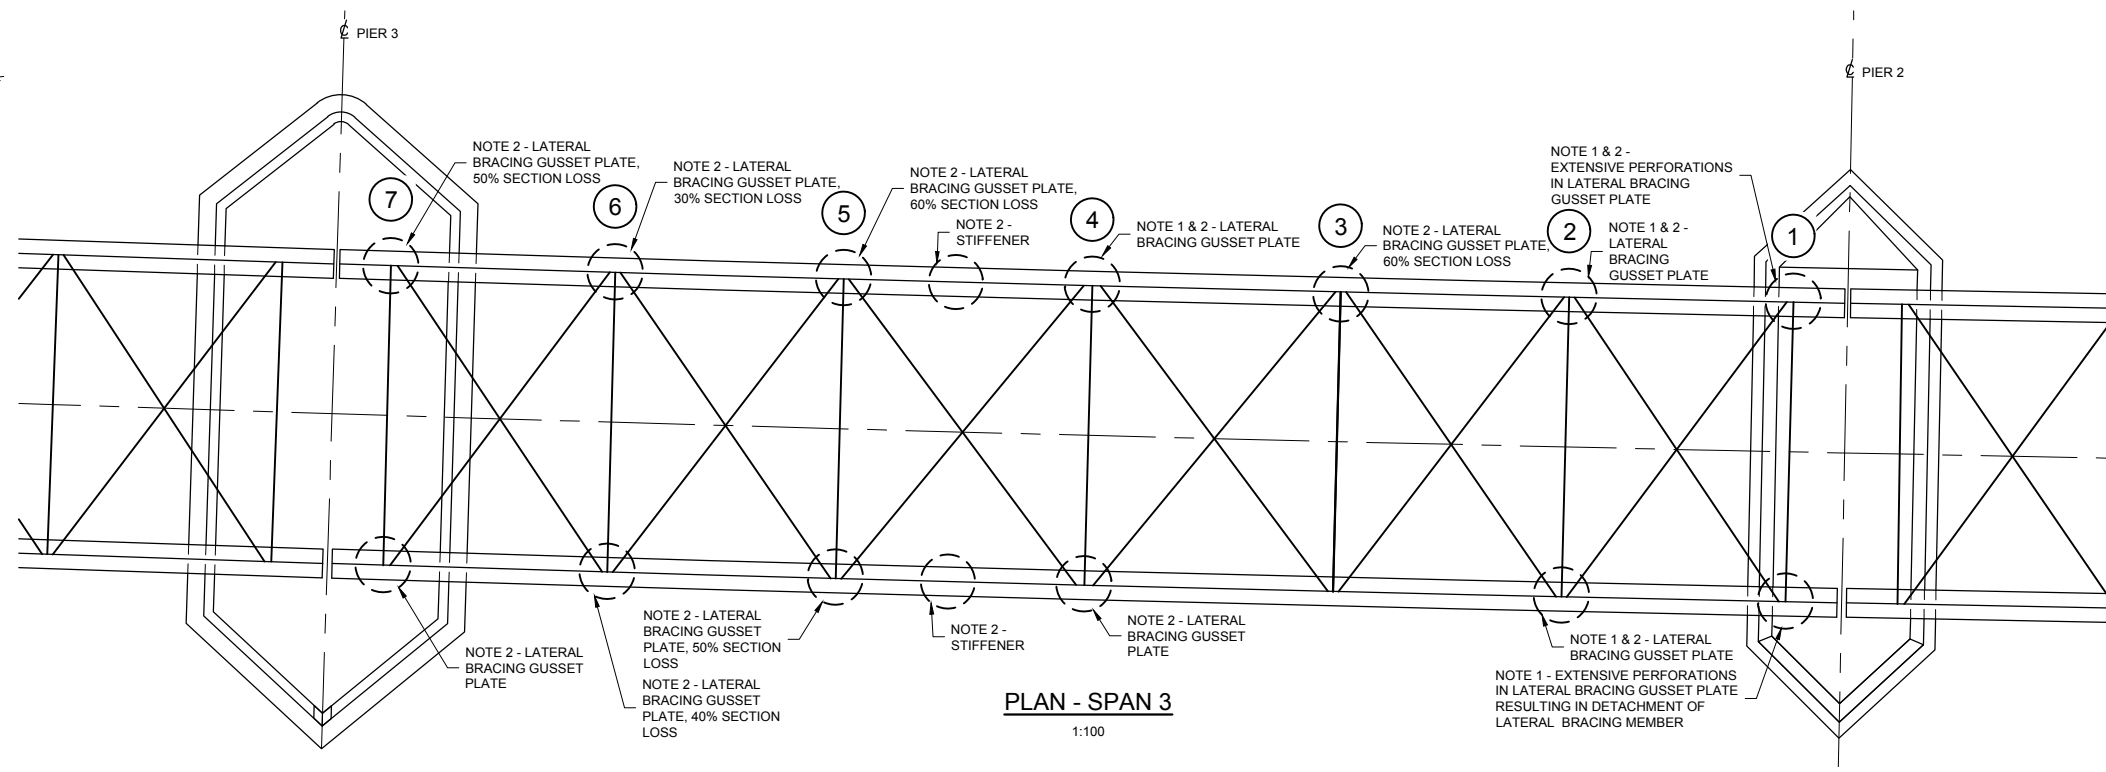
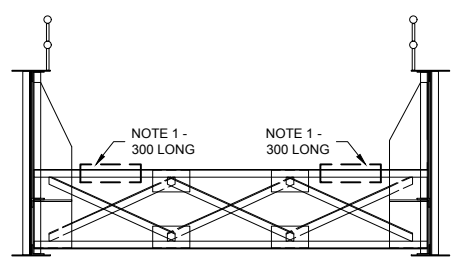
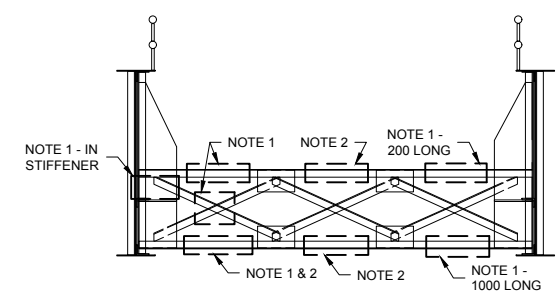
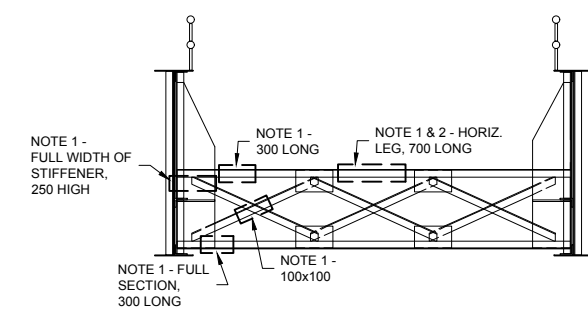
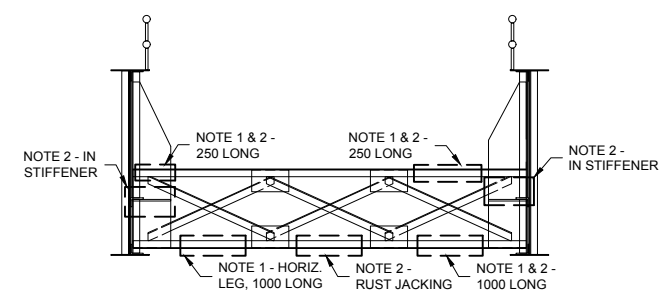
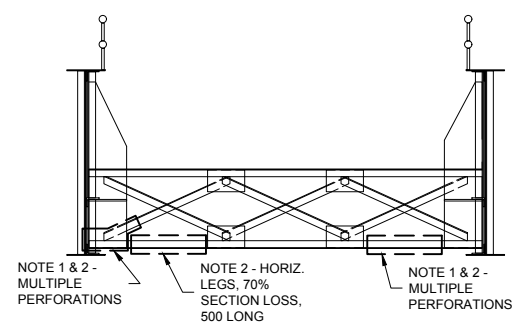
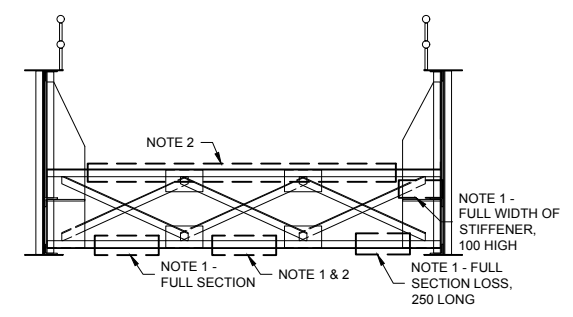
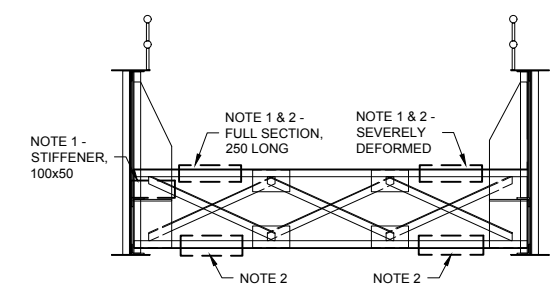
SPAN 3 DETERIORATION

NOTE:
 CROSS-FRAME ELEMENTS BELOW THE TIMBER DECK ARE IN POOR CONDITION ON ACCOUNT OF SEVERE TO VERY SEVERE CORROSION THROUGHOUT.

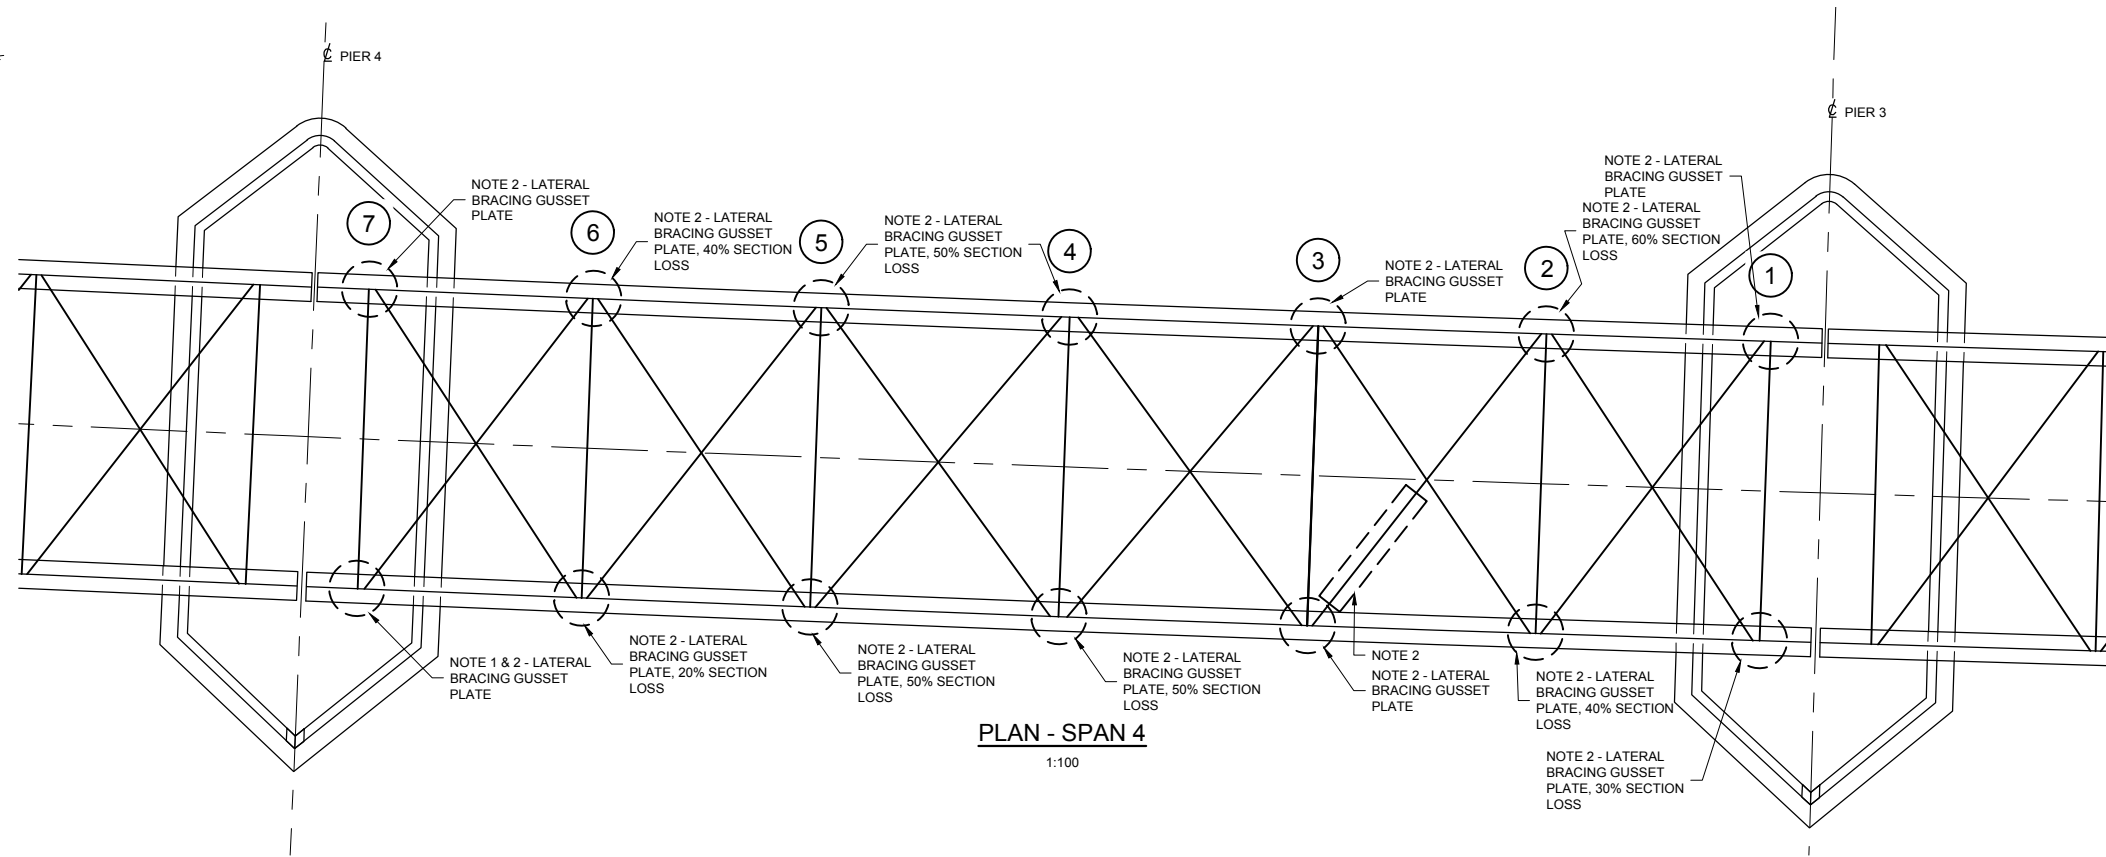
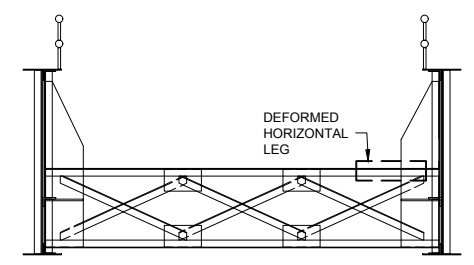
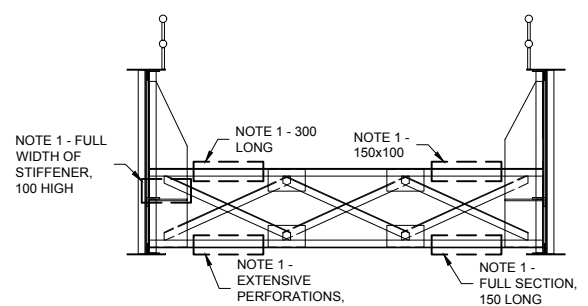
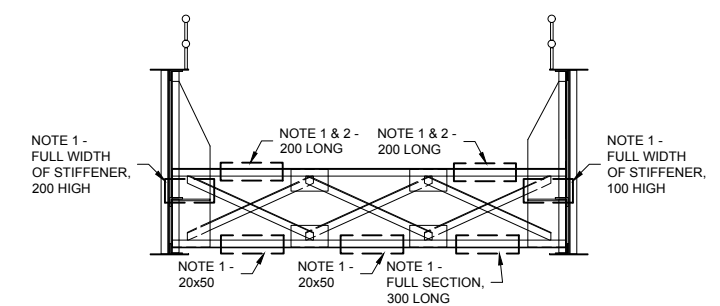
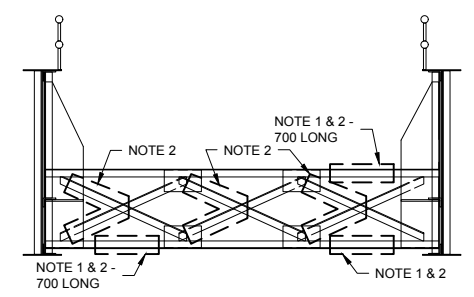
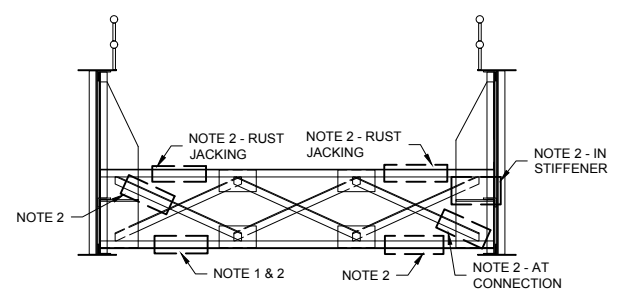
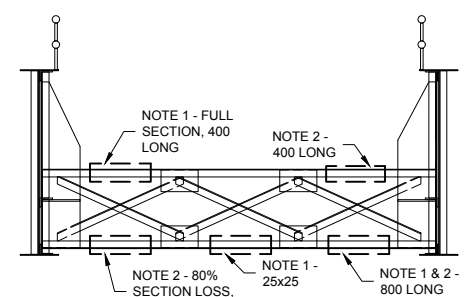
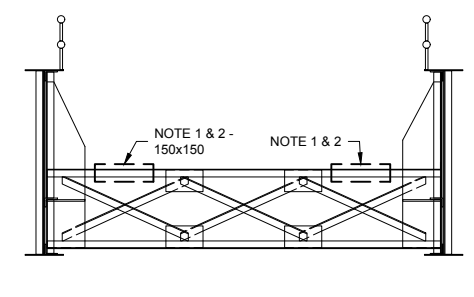
SPAN 4 DETERIORATION

NOTE:
 CROSS-FRAME ELEMENTS BELOW THE TIMBER DECK ARE IN POOR CONDITION ON ACCOUNT OF SEVERE TO VERY SEVERE CORROSION THROUGHOUT.
