Old Railway Rideau River Pedestrian Bridge Structure No. 018600 Detailed Condition Assessment and Renewal Option Analysis Report

Contract No.
ISD17-7087
Work Order Package
No. 11316522

Detailed Condition Assessment and Renewal Options Analysis Report

November 2018

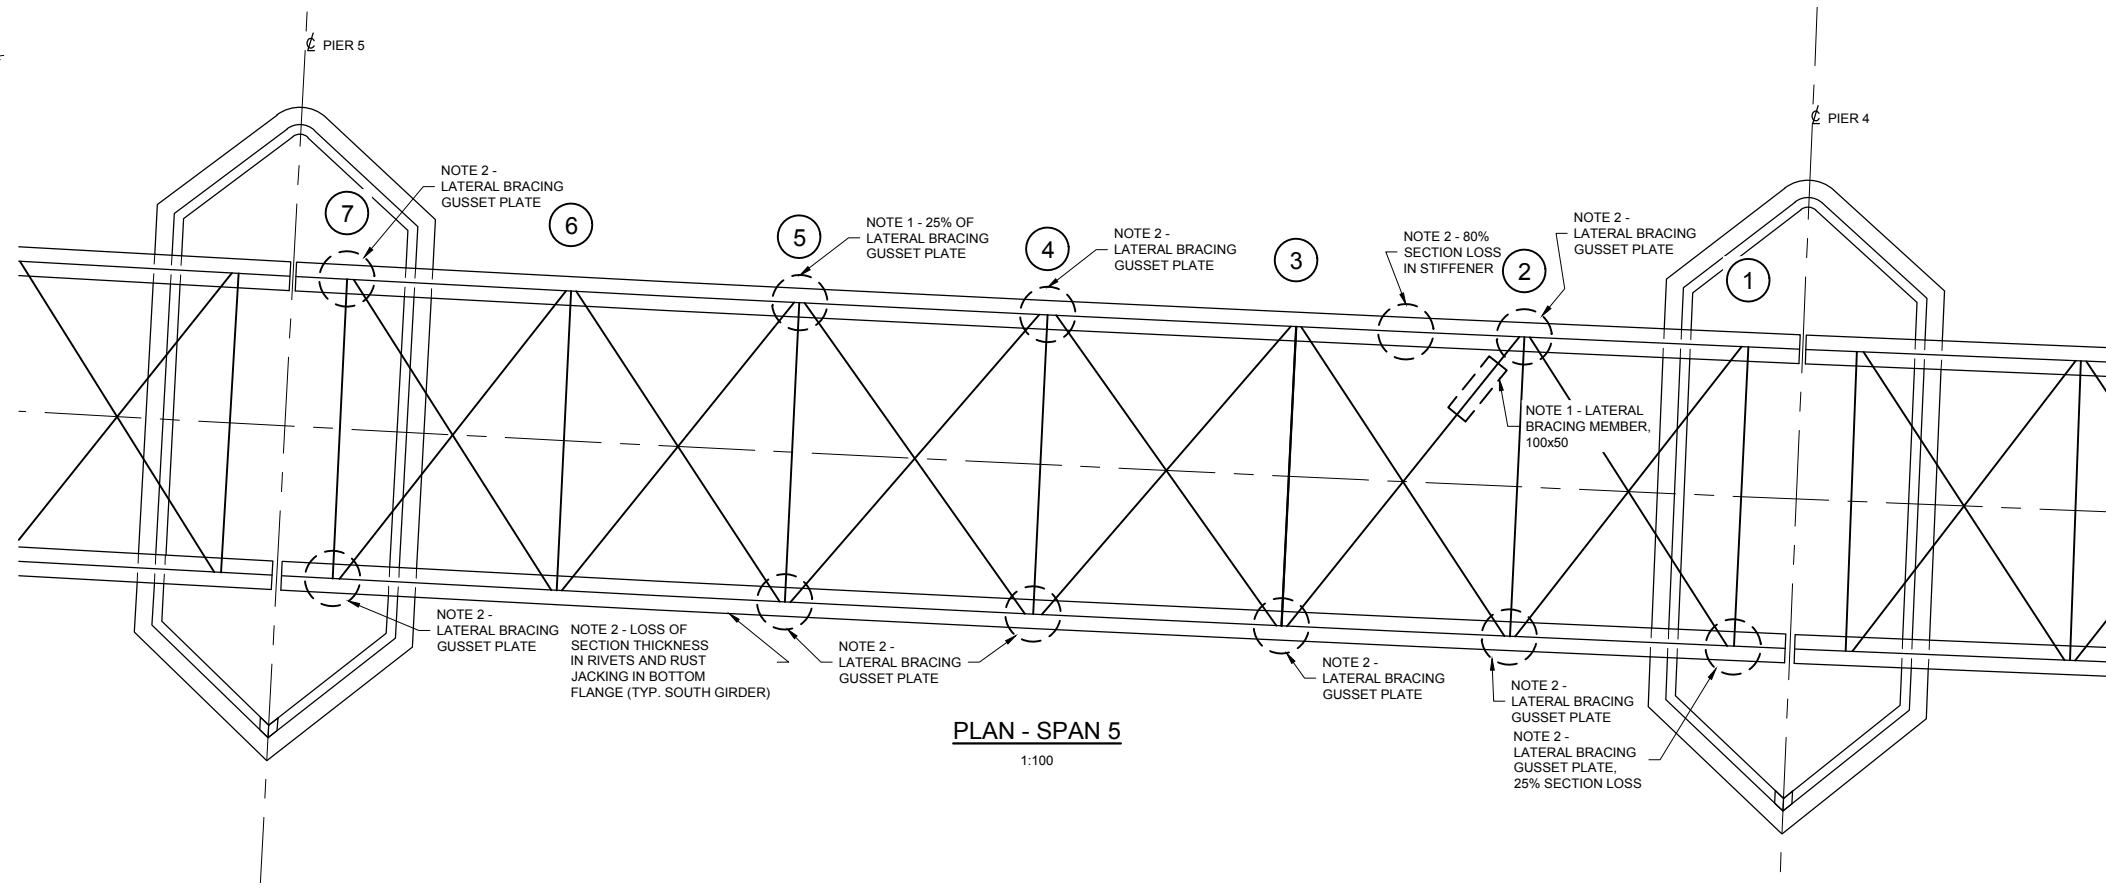
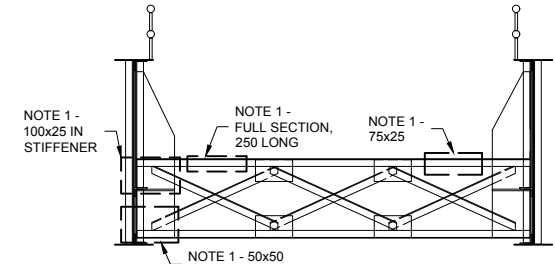
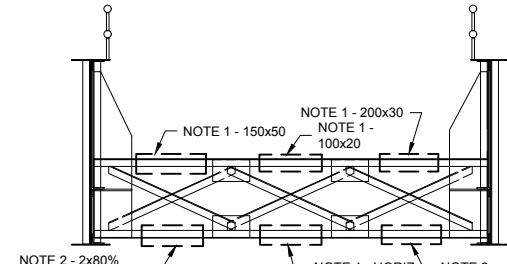
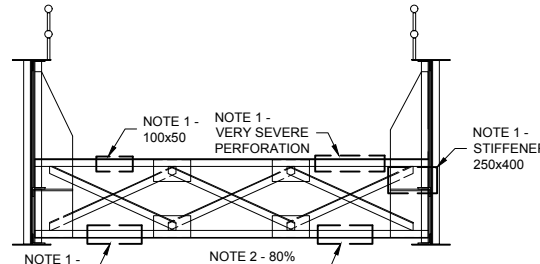
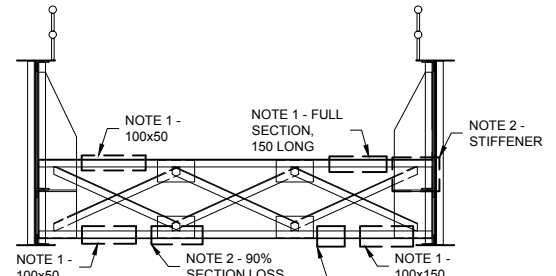
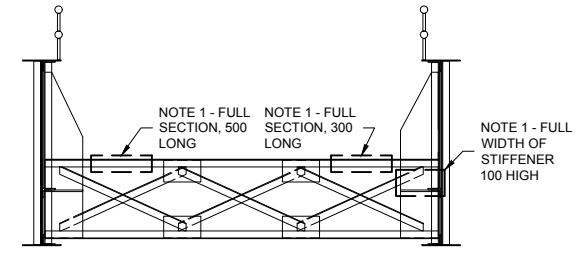
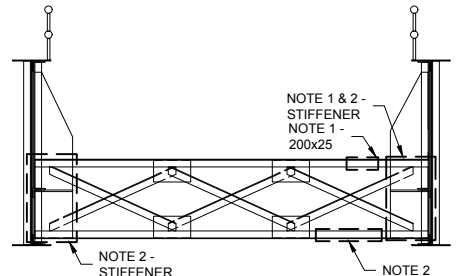
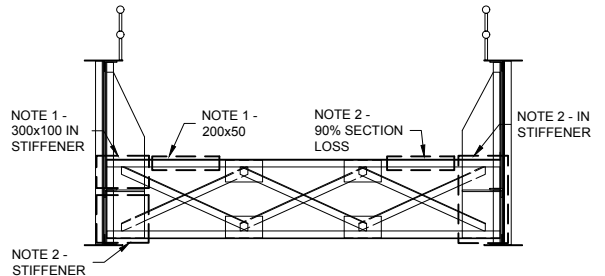
SPAN 5 DETERIORATION

NOTE:
 CROSS-FRAME ELEMENTS BELOW THE TIMBER DECK ARE IN POOR CONDITION ON ACCOUNT OF SEVERE TO VERY SEVERE CORROSION THROUGHOUT.

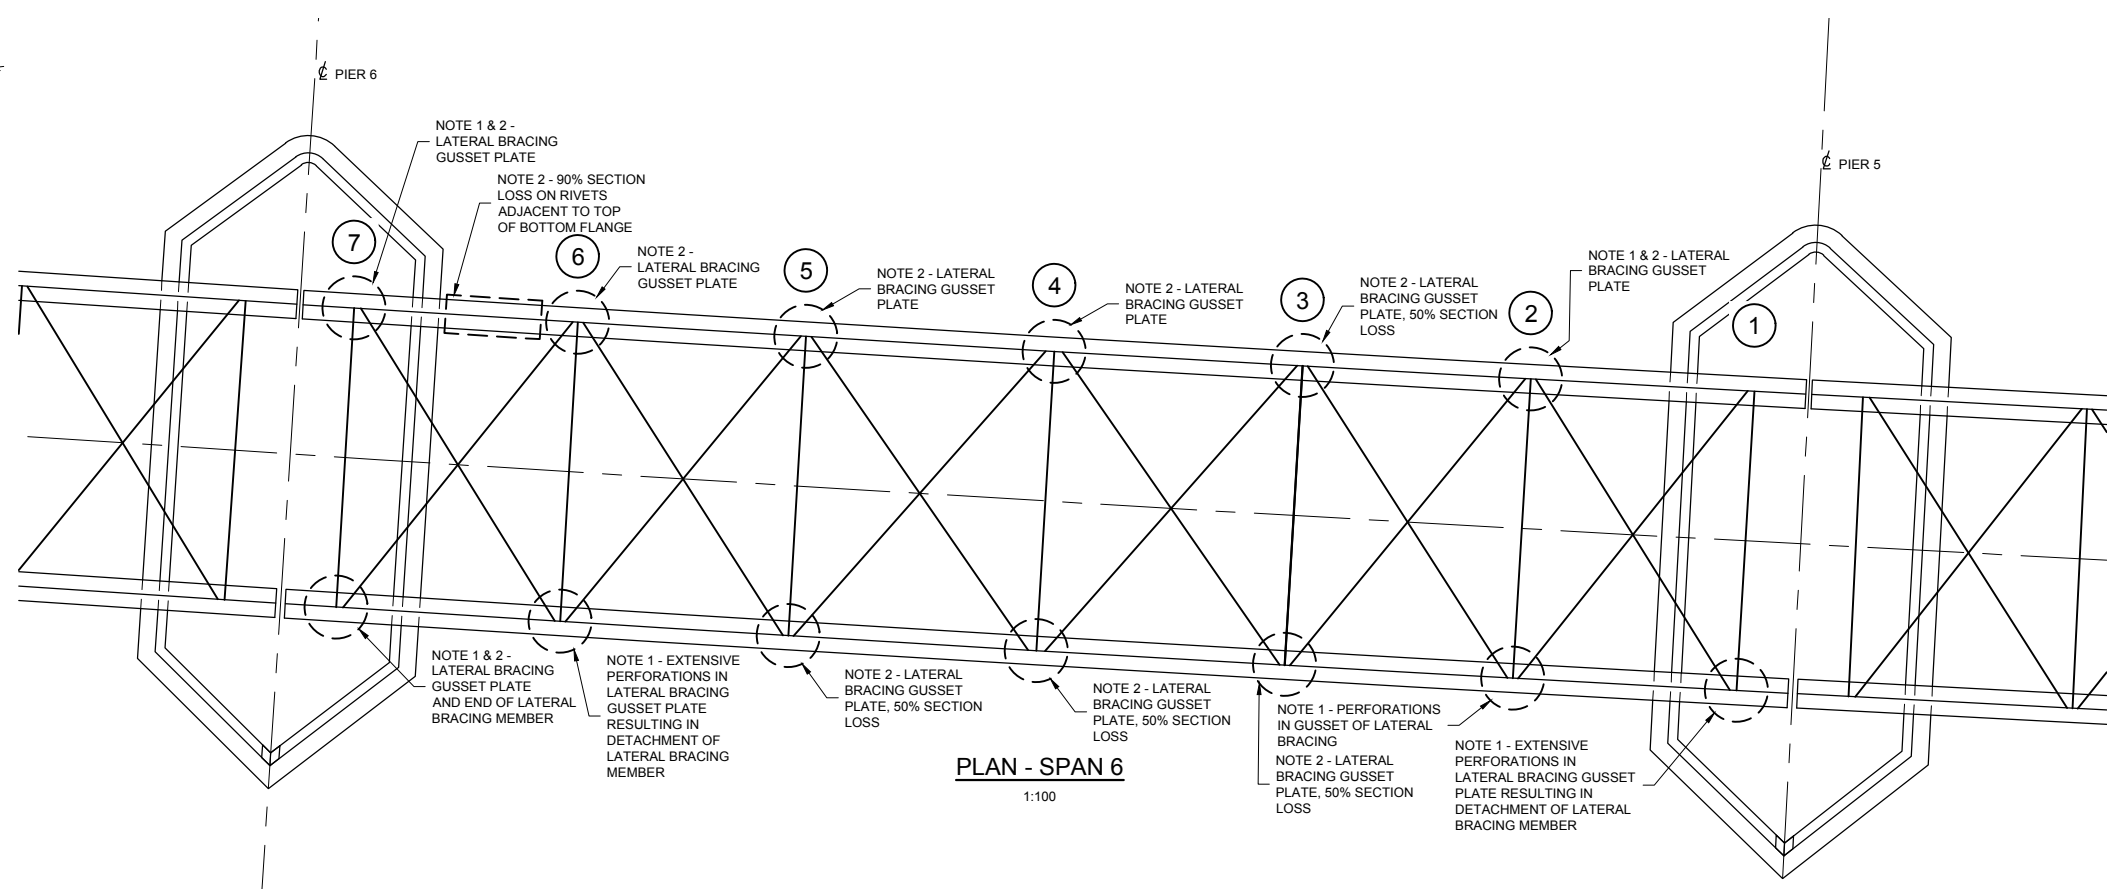
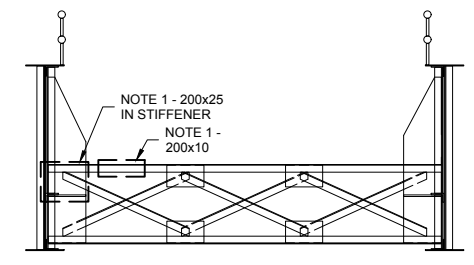
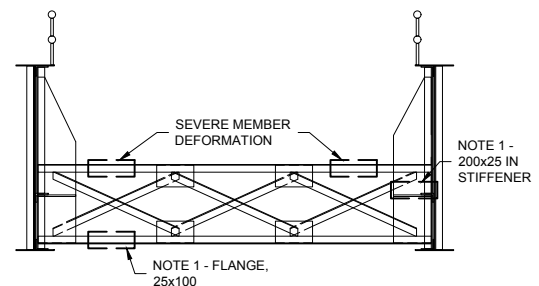
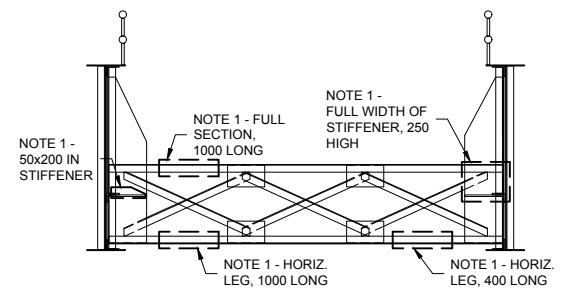
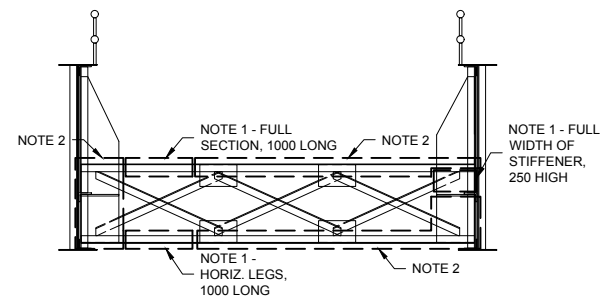
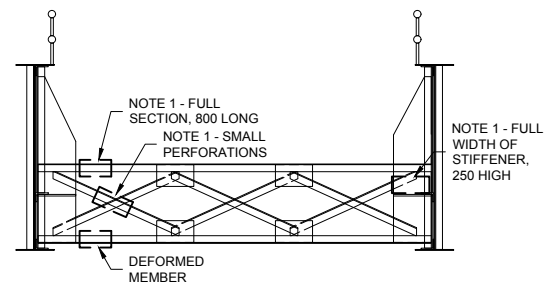
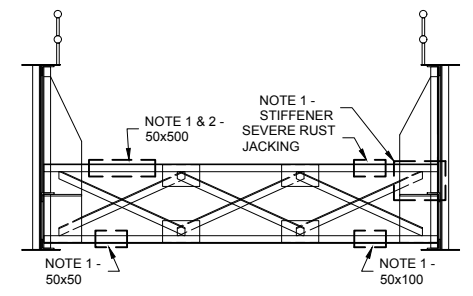
SPAN 6 DETERIORATION

NOTE:
CROSS-FRAME ELEMENTS BELOW THE TIMBER DECK ARE IN POOR CONDITION ON ACCOUNT OF SEVERE TO VERY SEVERE CORROSION THROUGHOUT.

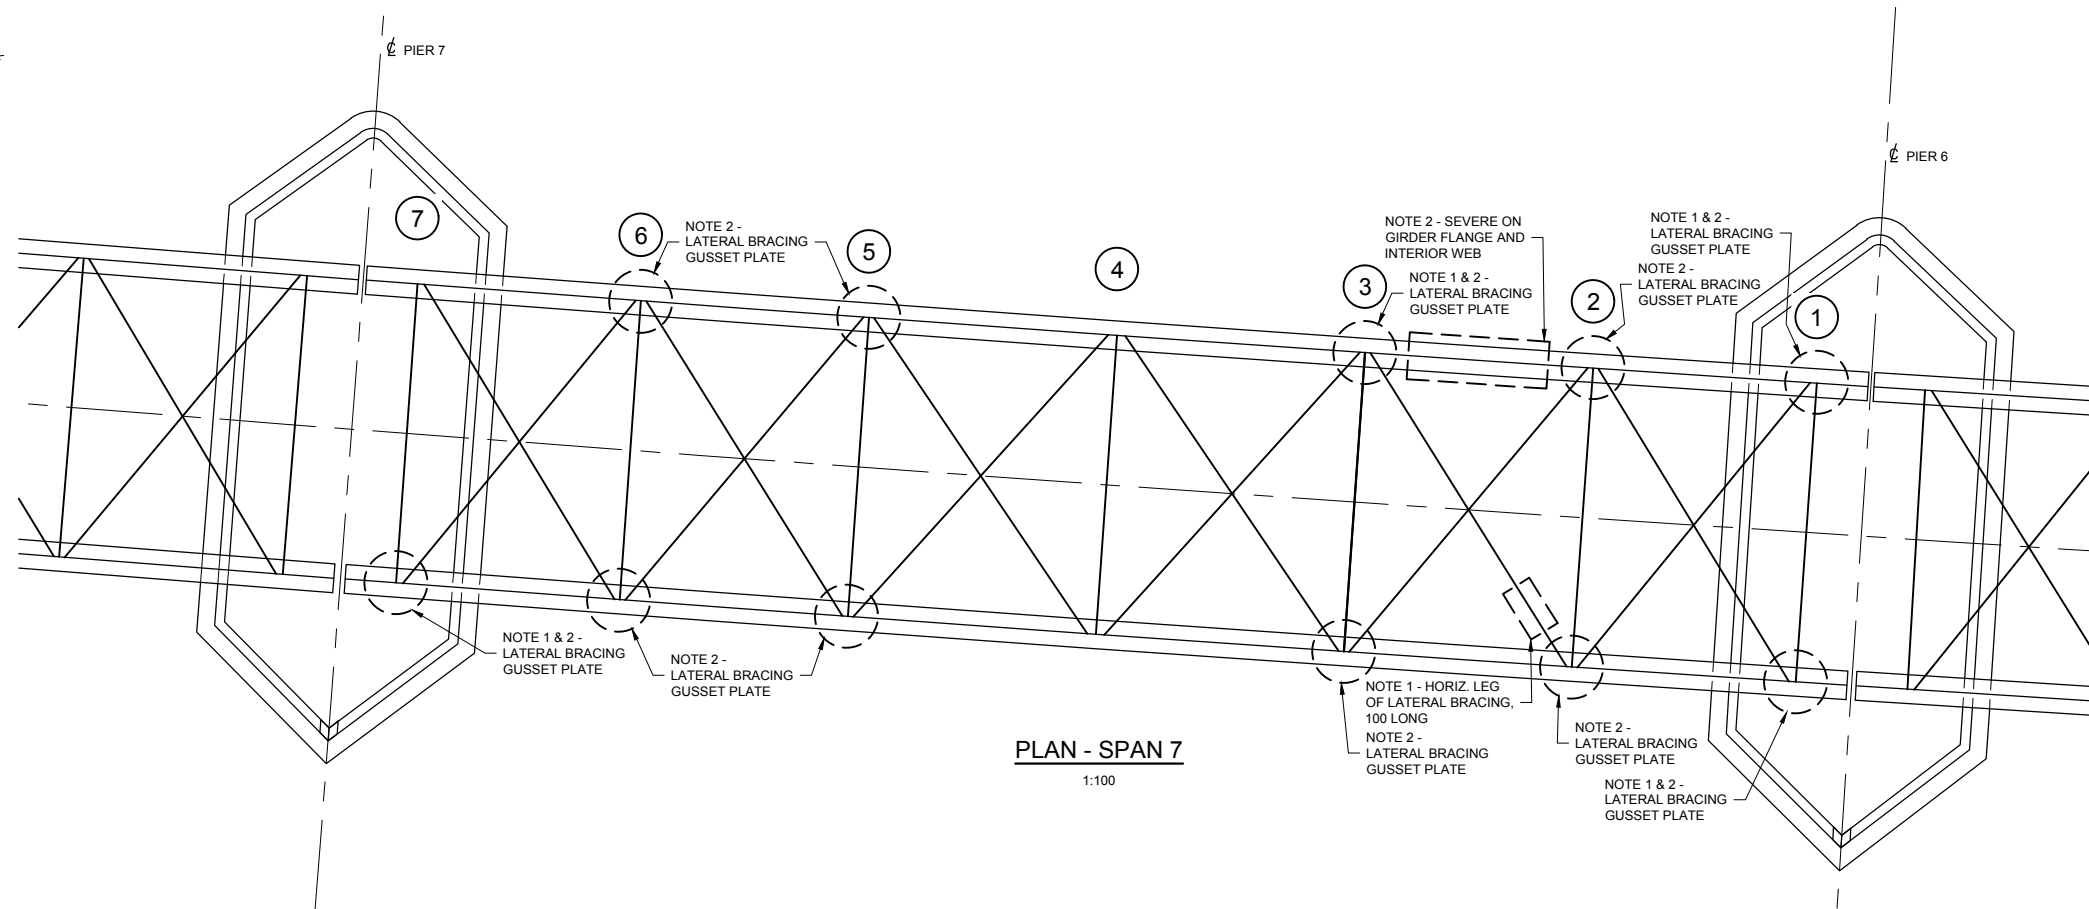
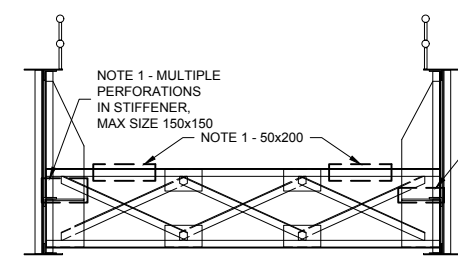
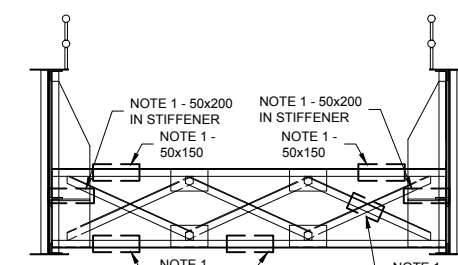
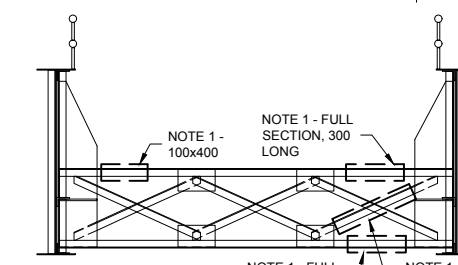
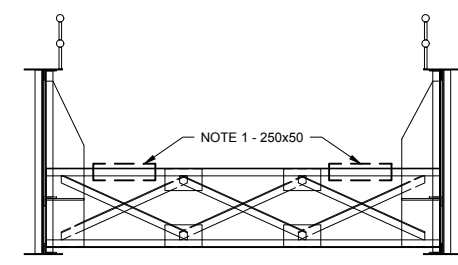
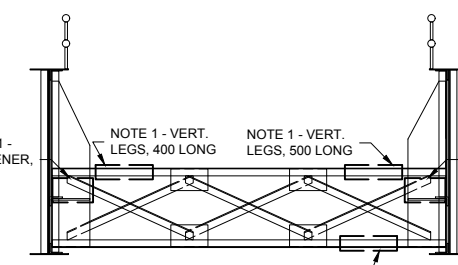
SPAN 7 DETERIORATION

NOTE:
 CROSS-FRAME ELEMENTS BELOW THE TIMBER DECK ARE IN POOR CONDITION ON ACCOUNT OF SEVERE TO VERY SEVERE CORROSION THROUGHOUT.

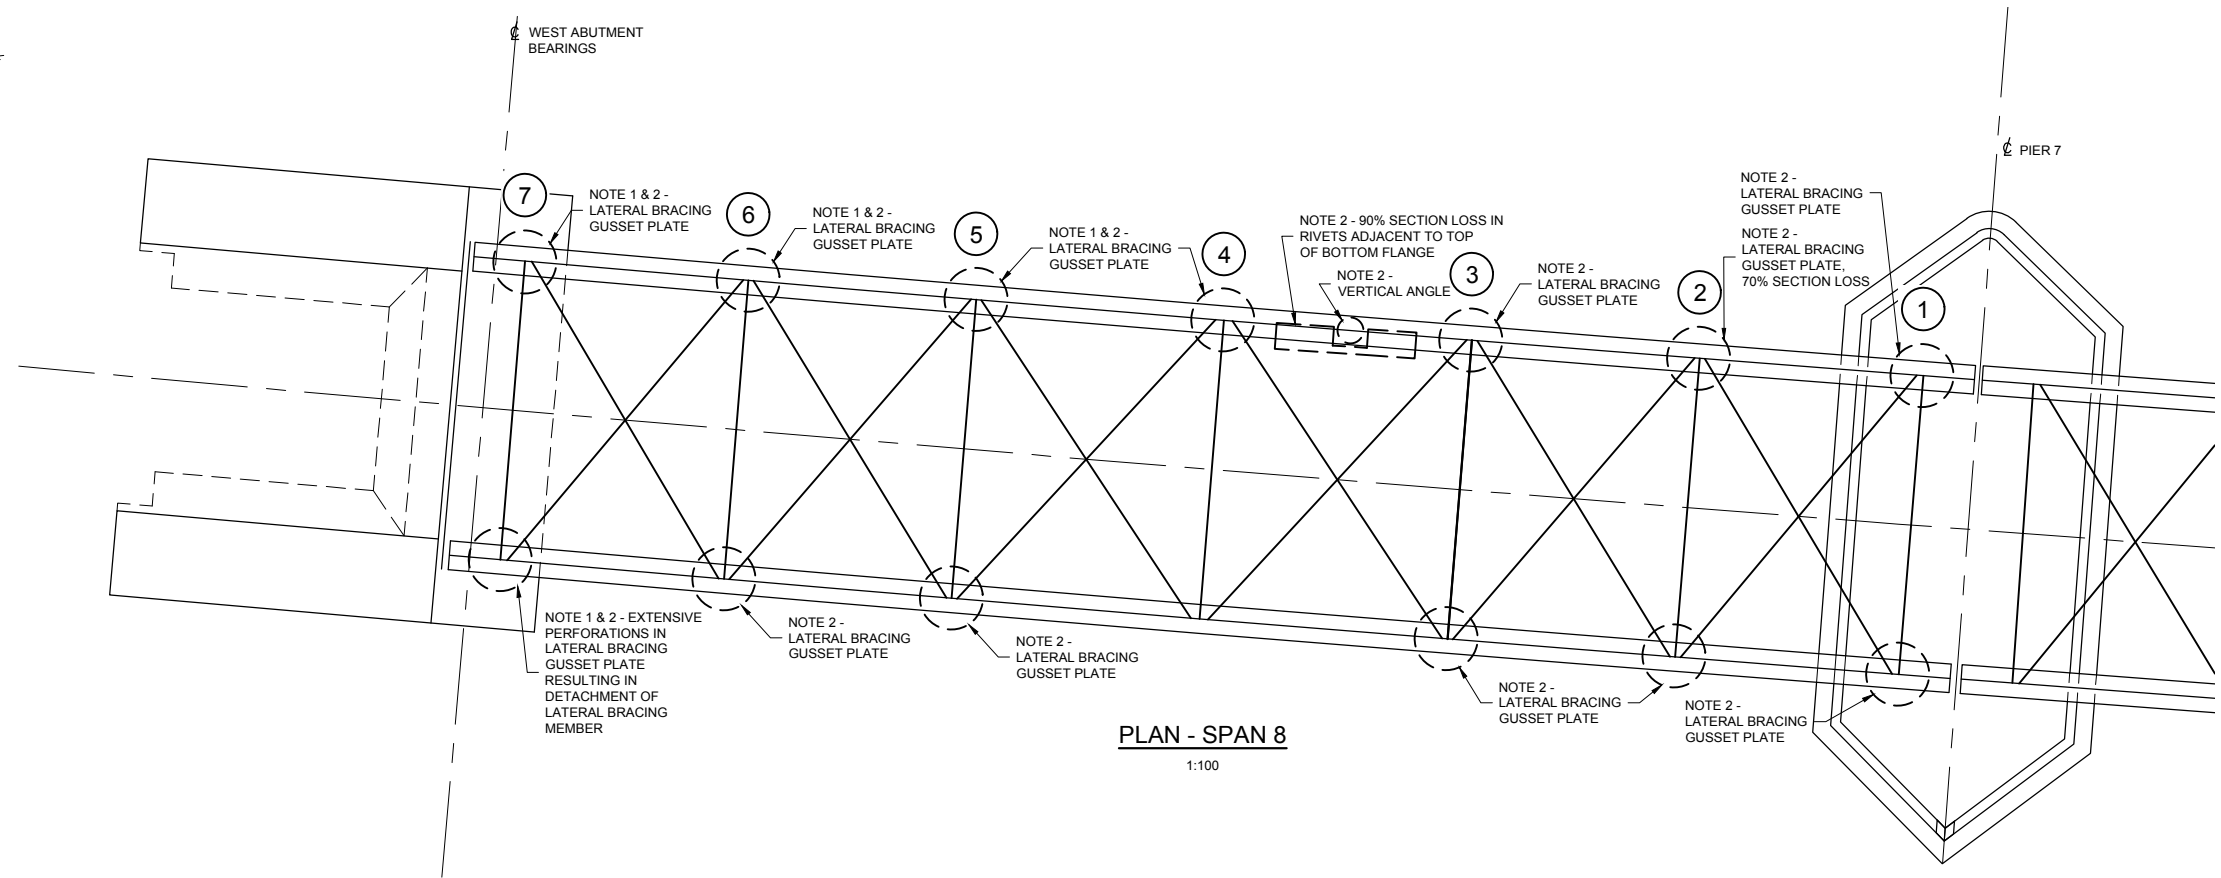
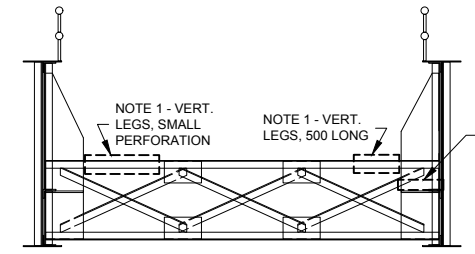
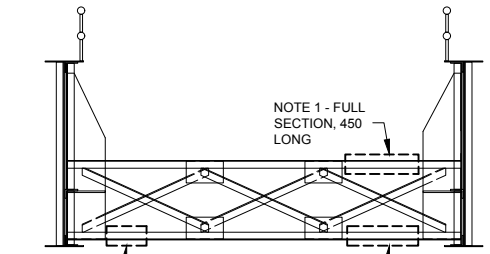
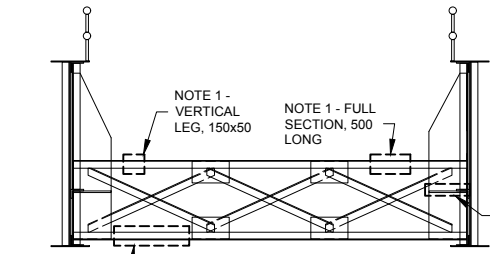
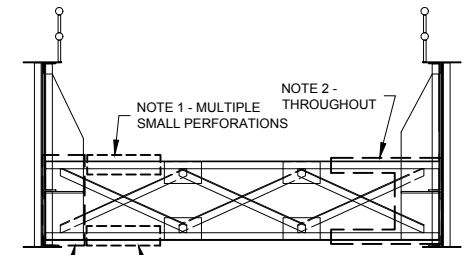
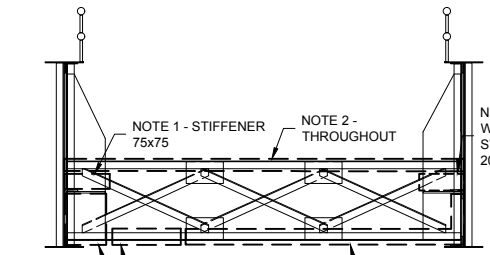
SPAN 8 DETERIORATION

NOTE:
 CROSS-FRAME ELEMENTS BELOW THE TIMBER DECK ARE IN POOR CONDITION ON ACCOUNT OF SEVERE TO VERY SEVERE CORROSION THROUGHOUT.

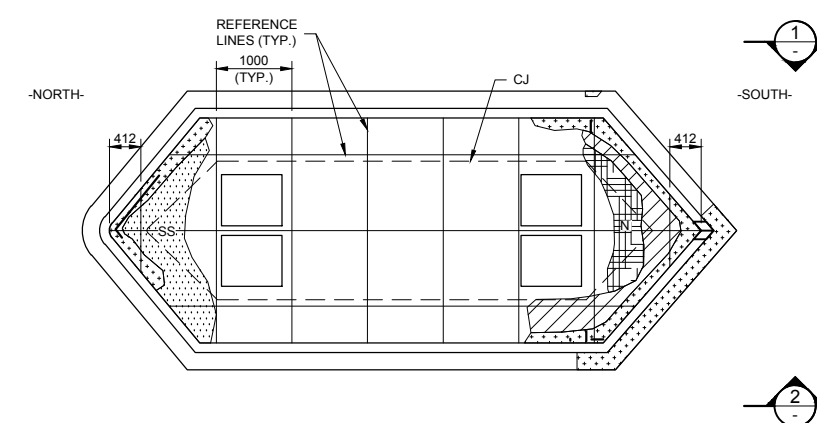
PLAN - PIER 3
1:100

NOTE: LOCALIZED HL-N PATTERN CRACKING, LIGHT SCALING, AND EFFLORESCENCE STAINING LEACHING FROM BEARING SEAT TYP. THROUGHOUT FACES OF PIER

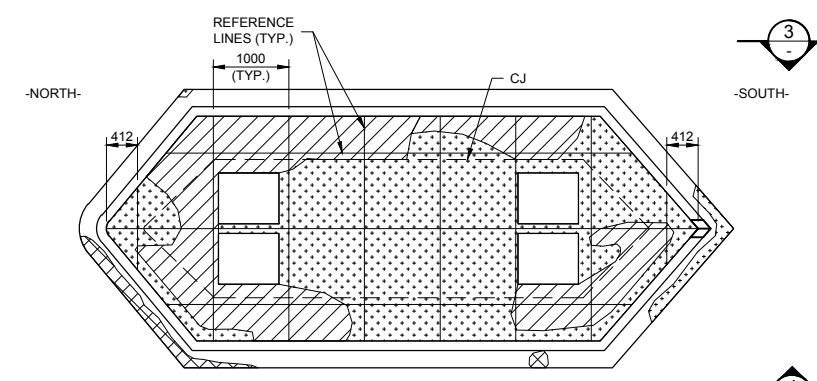
PLAN - PIER 4
1:100

NOTE: LOCALIZED HL-N PATTERN CRACKING, LIGHT SCALING, AND EFFLORESCENCE STAINING LEACHING FROM BEARING SEAT TYP. THROUGHOUT FACES OF PIER

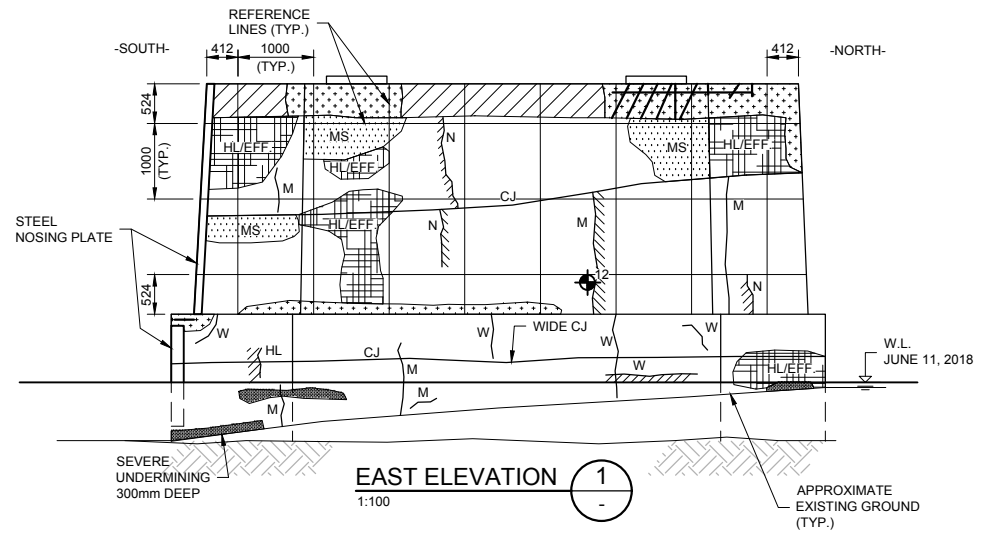
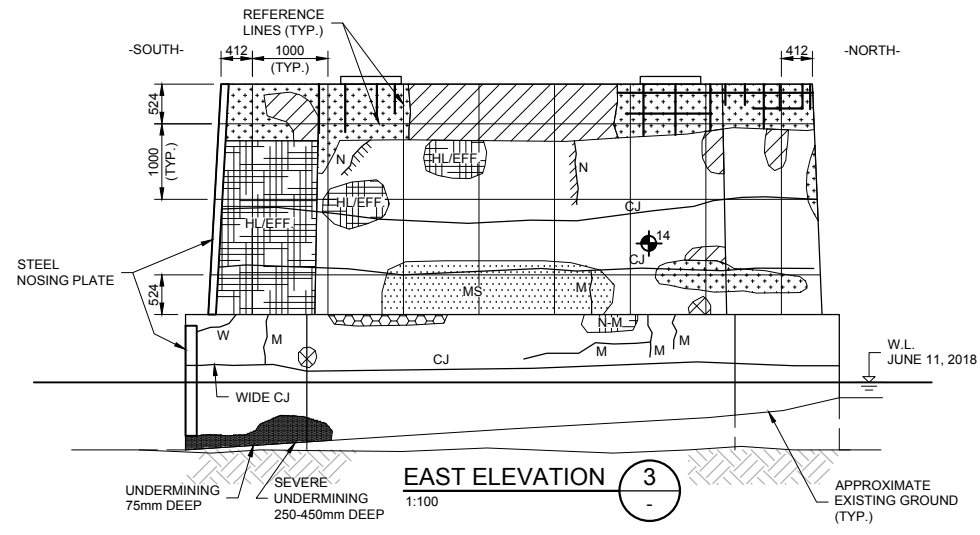
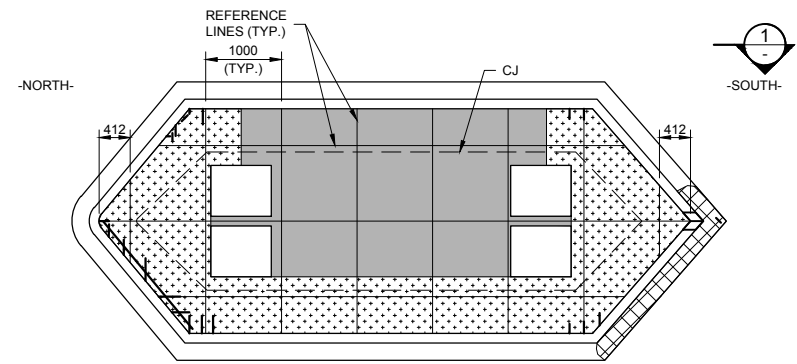
NOTE: LOCALIZED HL-N PATTERN CRACKING, LIGHT SCALING, AND EFFLORESCENCE STAINING LEACHING FROM BEARING SEAT TYP. THROUGHOUT FACES OF PIER

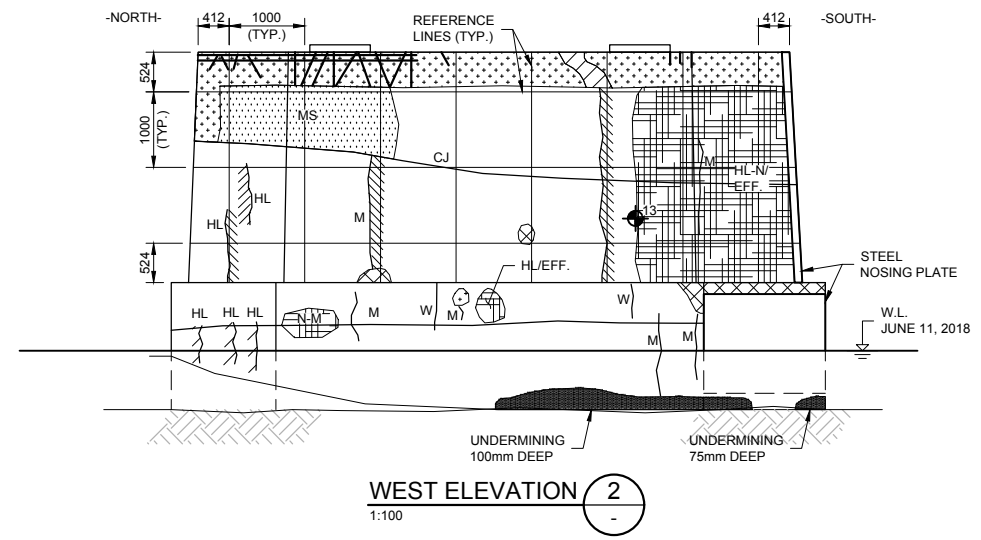
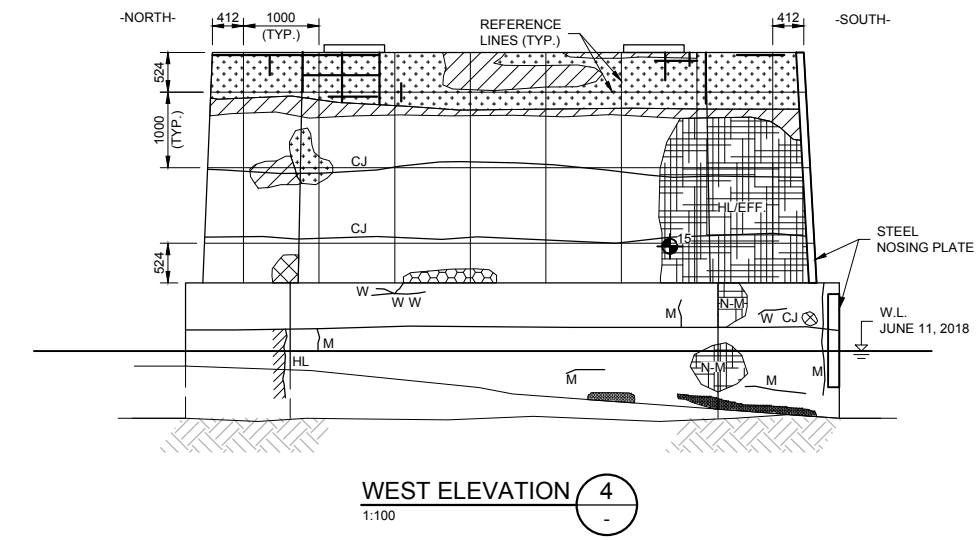
NOTE: LOCALIZED HL-N PATTERN CRACKING, LIGHT SCALING, AND EFFLORESCENCE STAINING LEACHING FROM BEARING SEAT TYP. THROUGHOUT FACES OF PIER

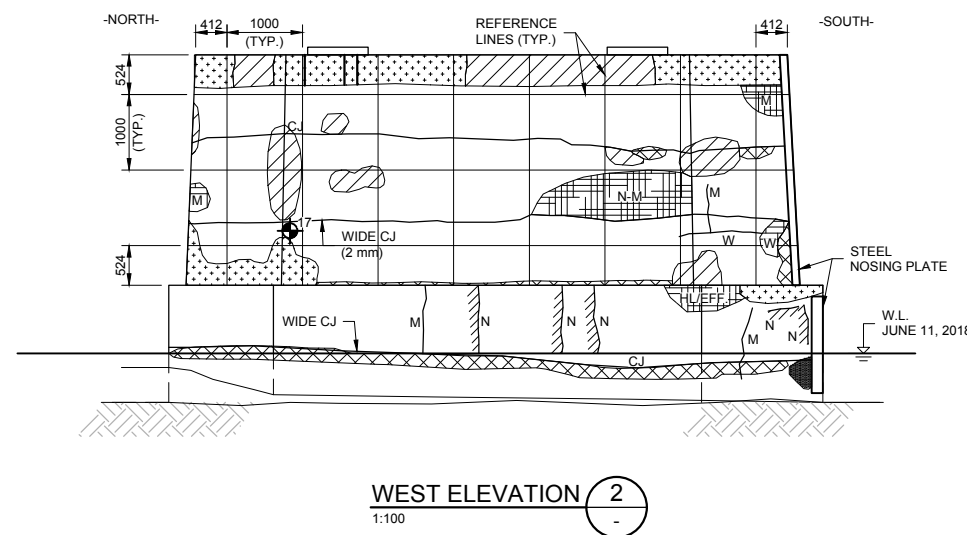
NOTE: LOCALIZED HL-N PATTERN CRACKING, LIGHT SCALING, AND EFFLORESCENCE STAINING LEACHING FROM BEARING SEAT TYP. THROUGHOUT FACES OF PIER

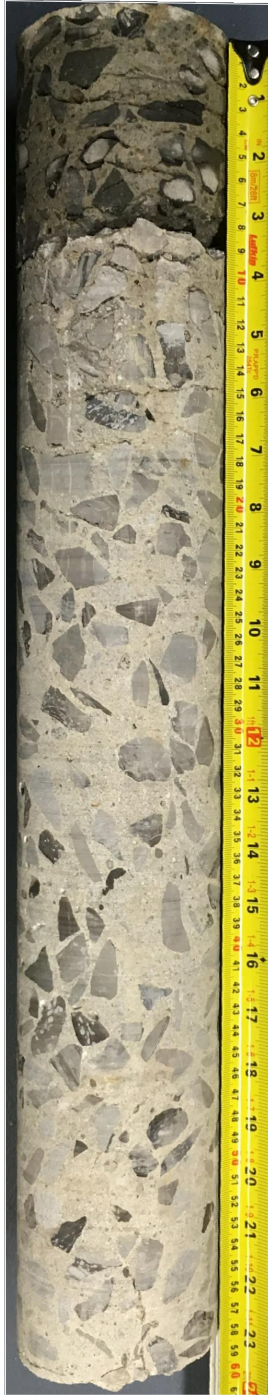
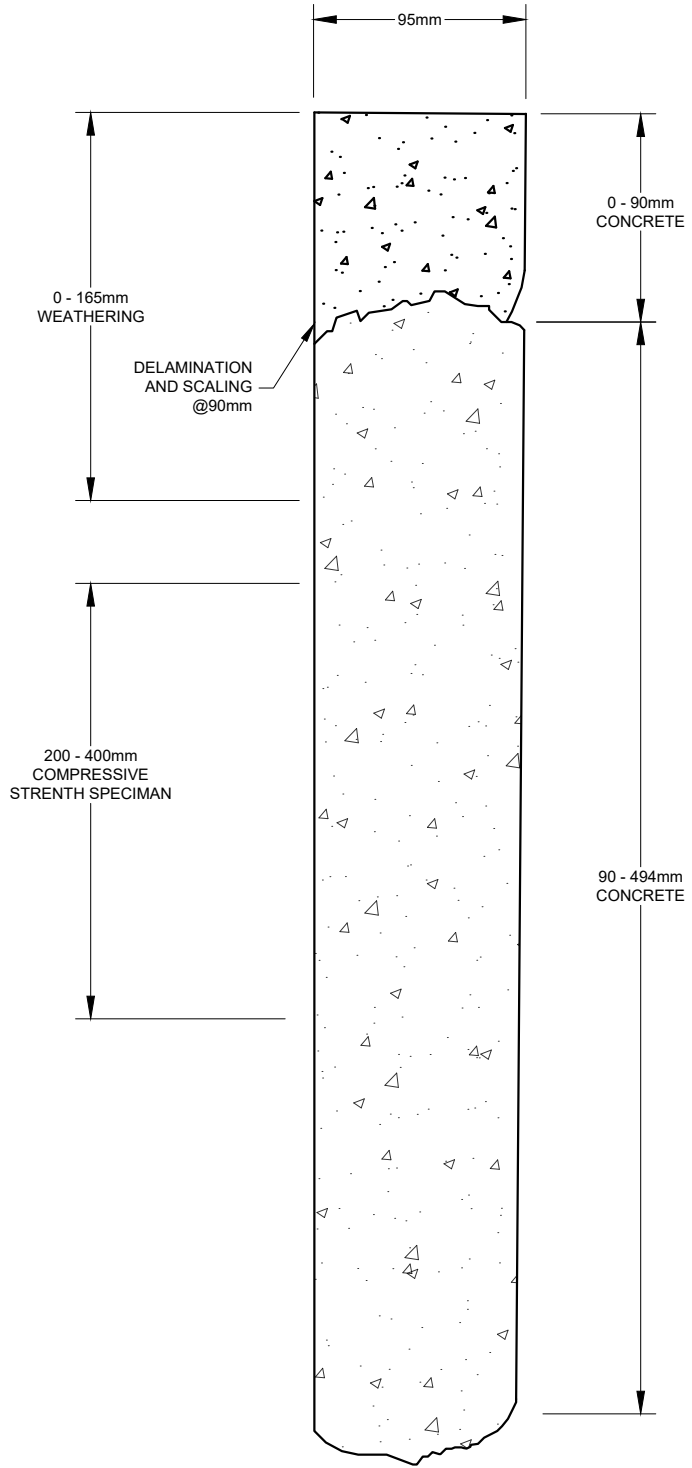
FIGURE 1

CORE 1

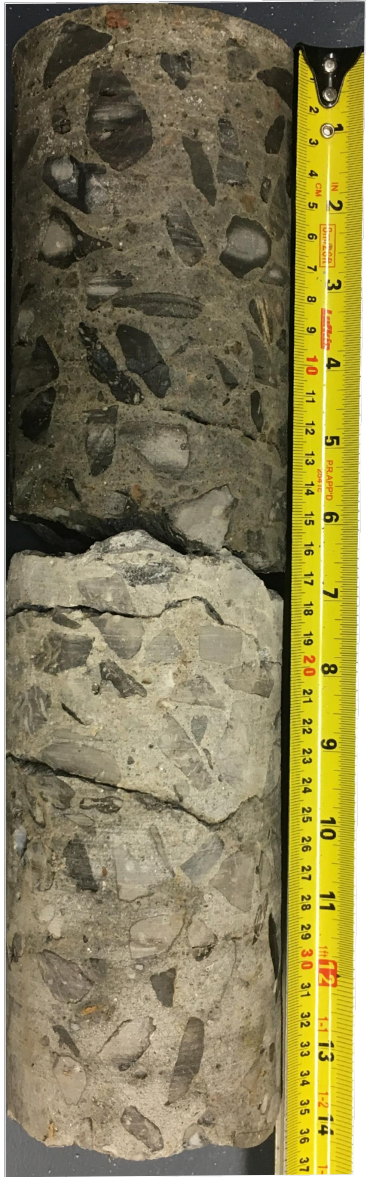
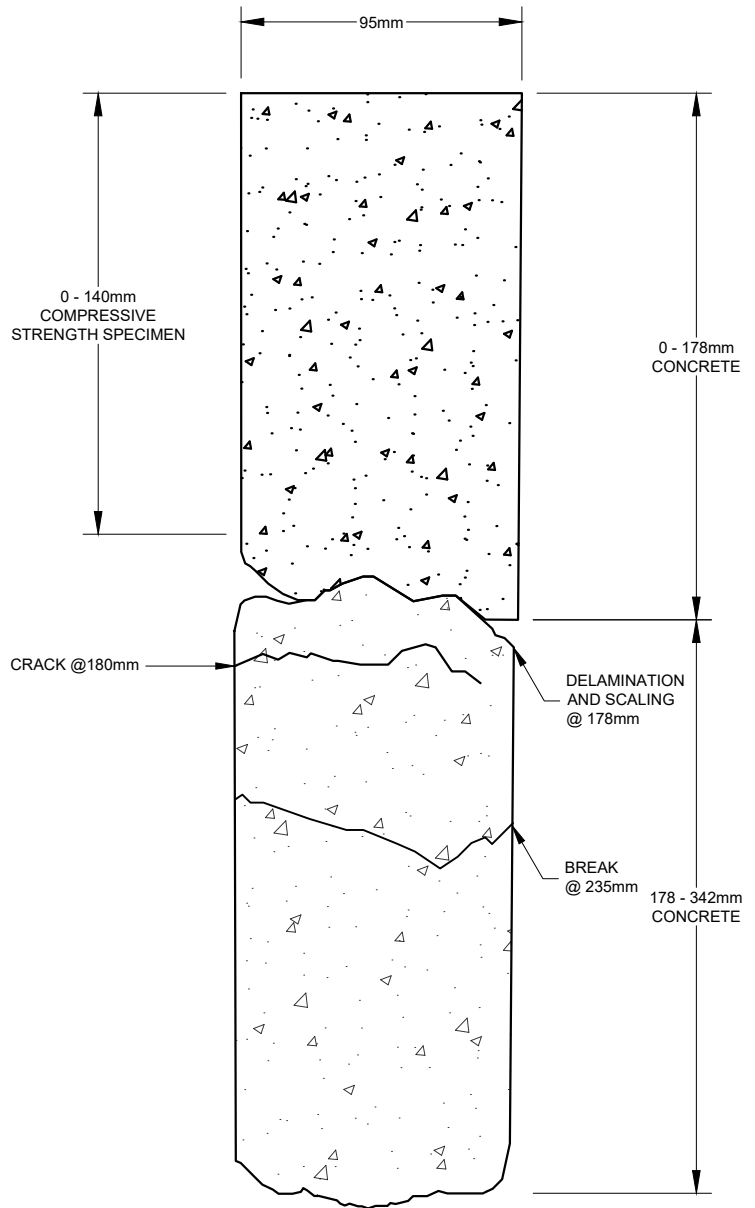
FIGURE 2

CORE 2

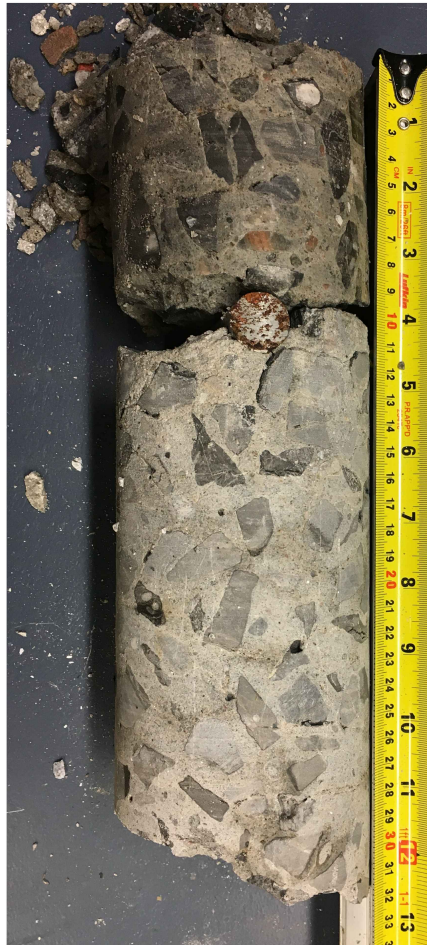
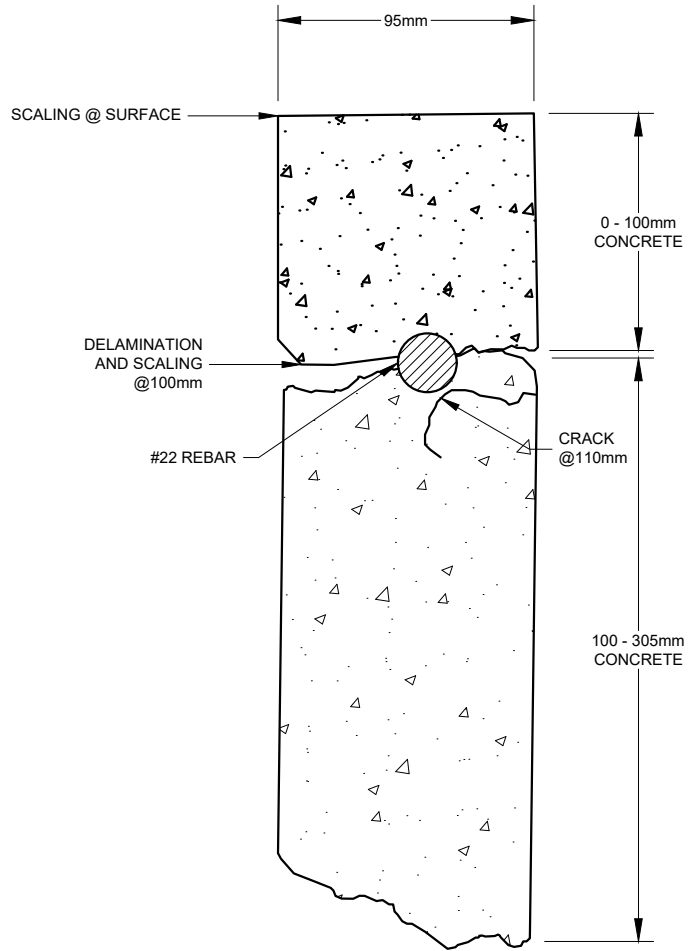
FIGURE 3

CORE 3

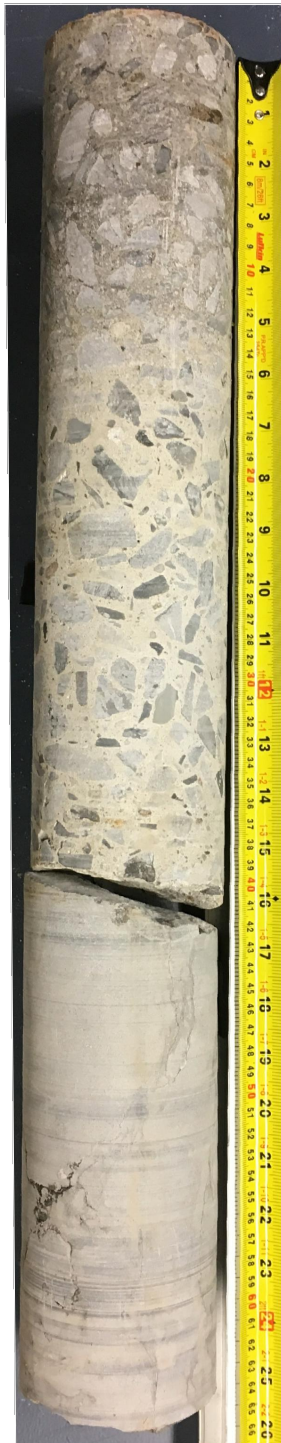
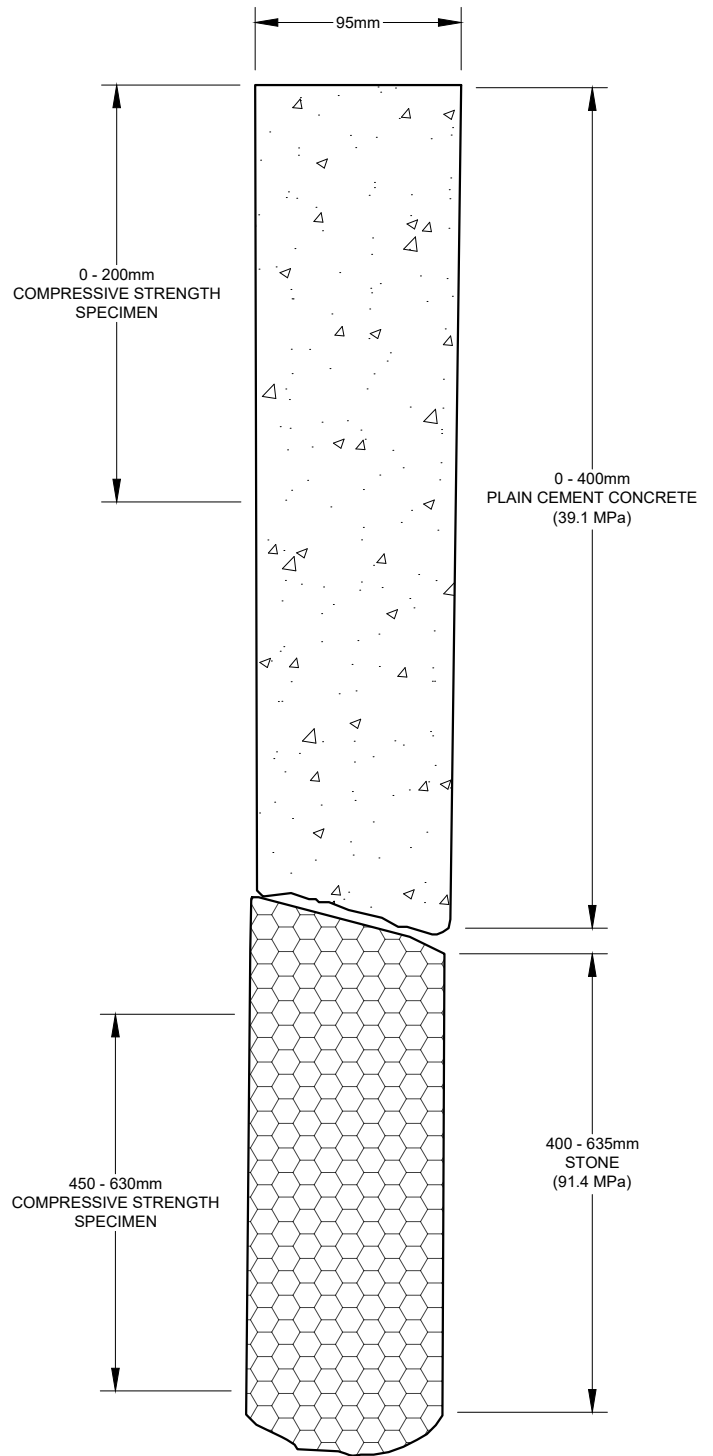
FIGURE 5

CORE 5

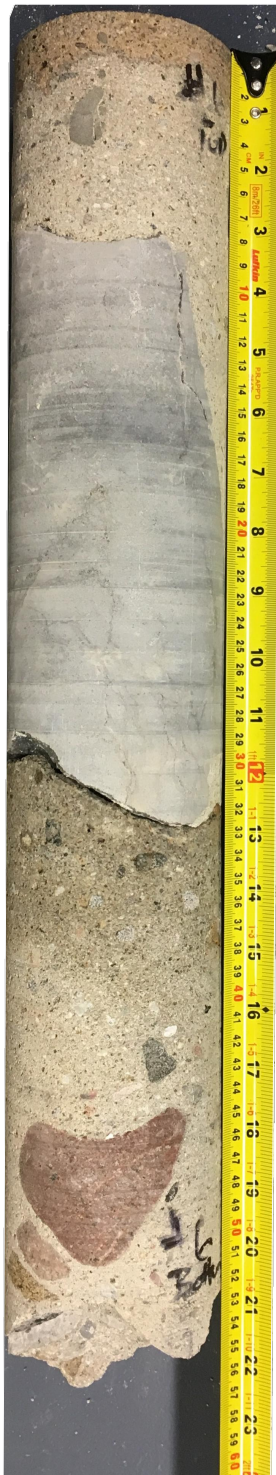
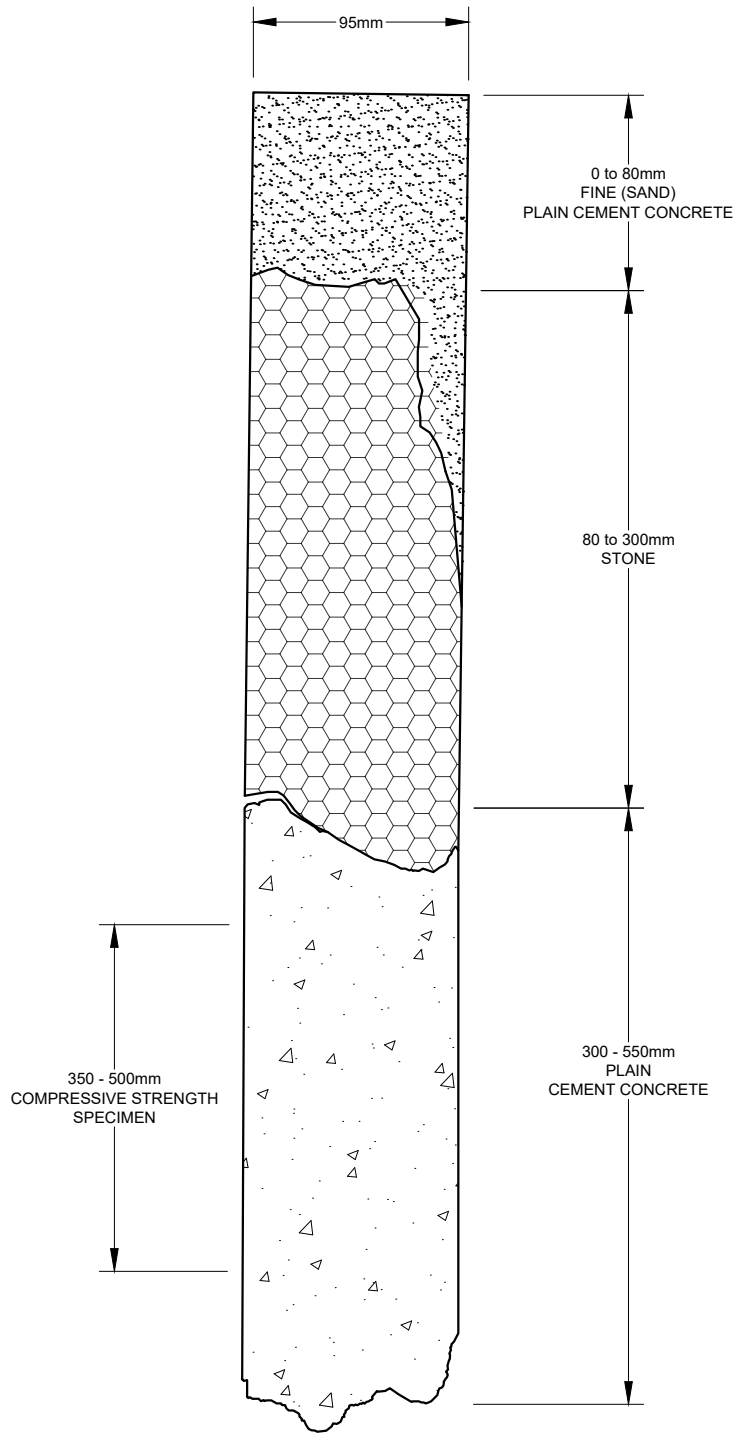
FIGURE 6

CORE 6

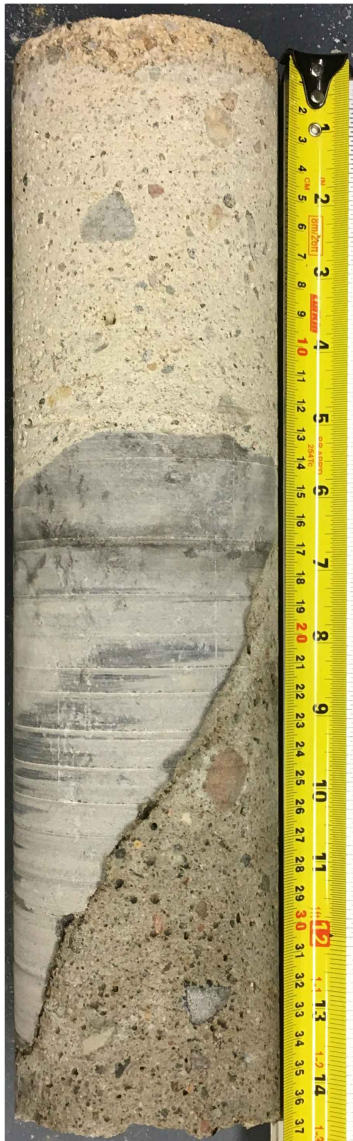
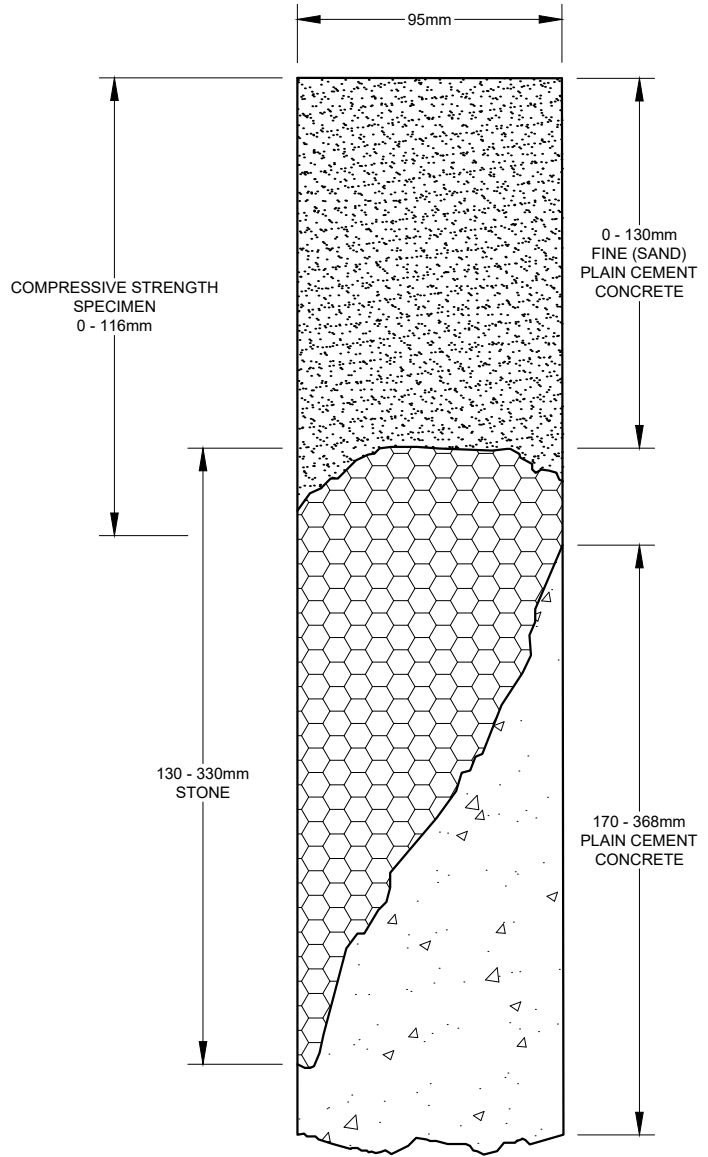
FIGURE 7

CORE 7
