Old Railway Rideau River Pedestrian Bridge Structure No. 018600 Detailed Condition Assessment and Renewal Option Analysis Report

Contract No.
ISD17-7087
Work Order Package
No. 11316522

Detailed Condition Assessment and Renewal Options Analysis Report

November 2018

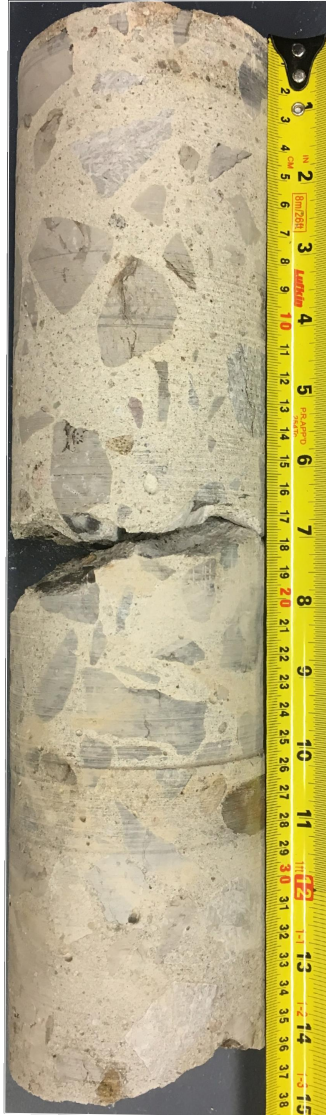
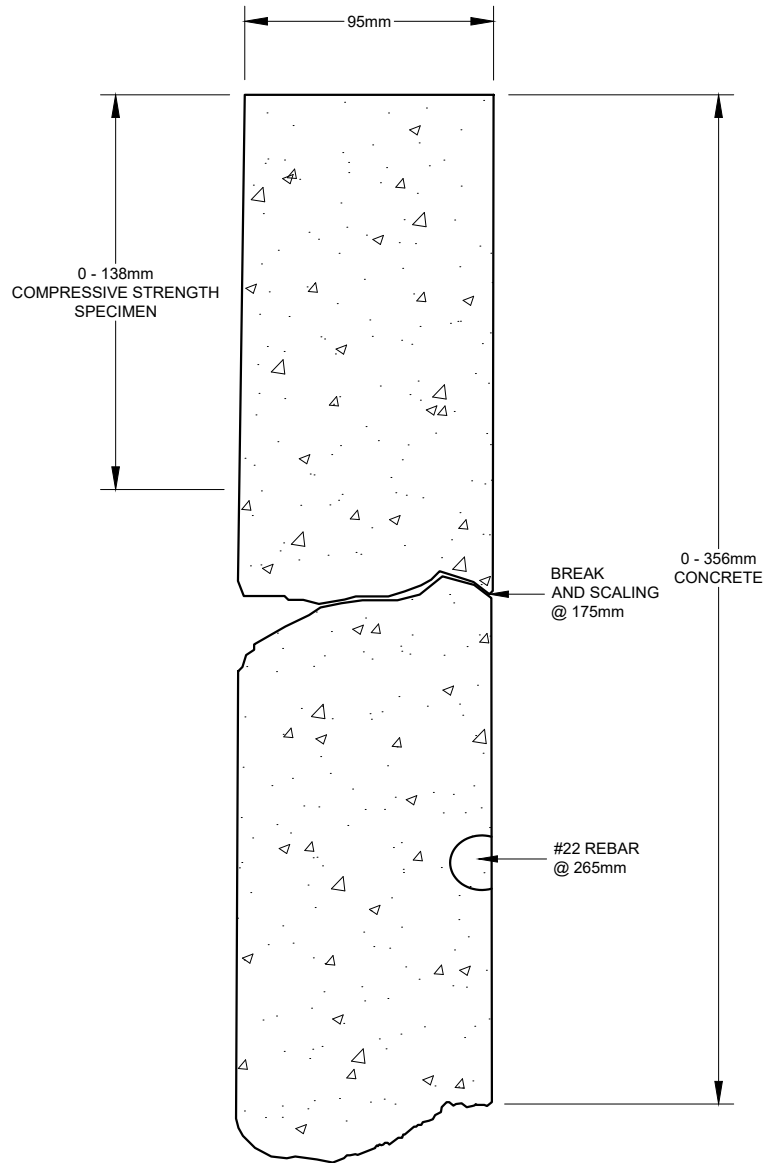
FIGURE 8

CORE 8

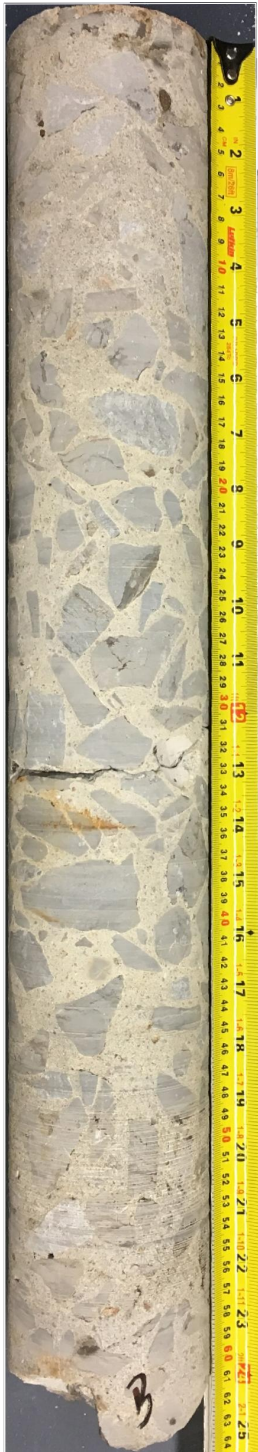
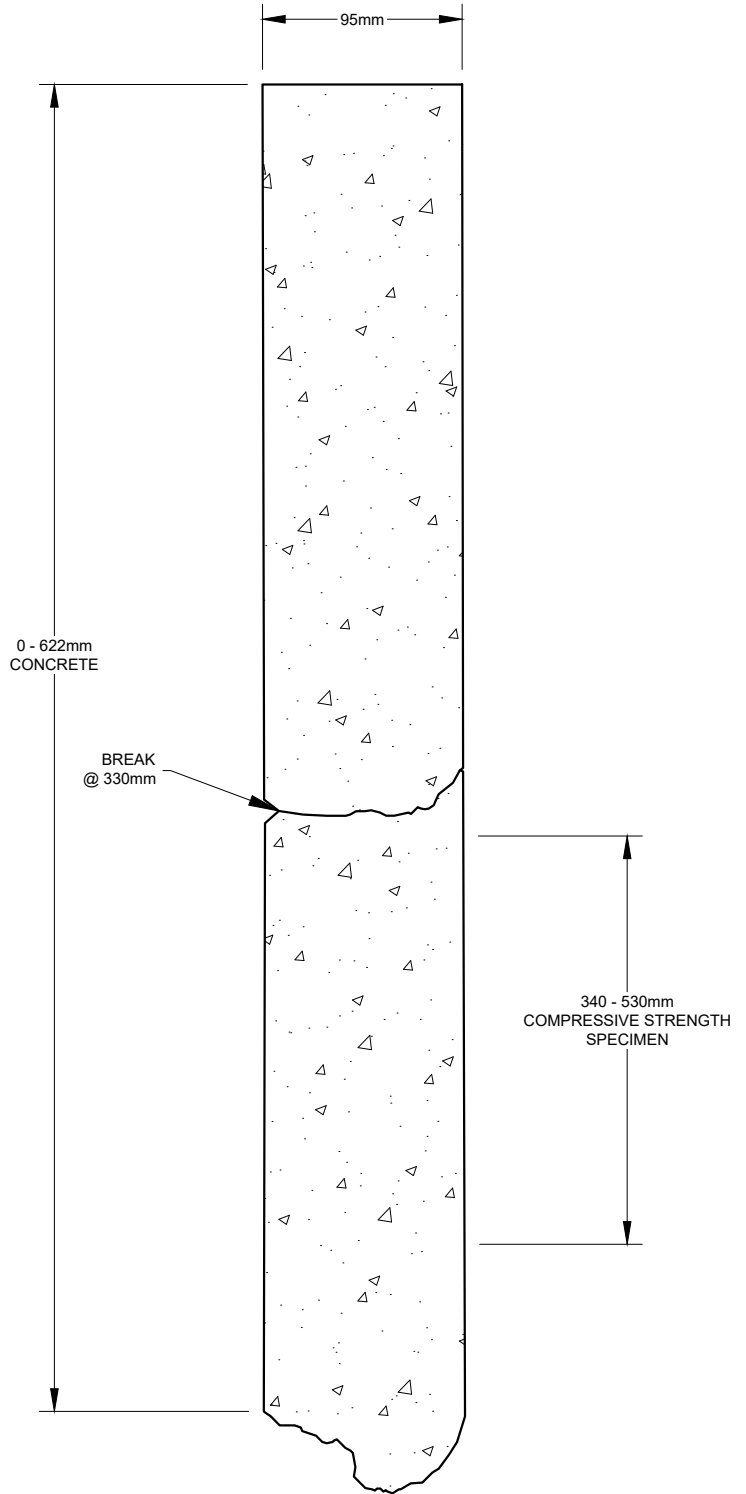
FIGURE 9

CORE 9

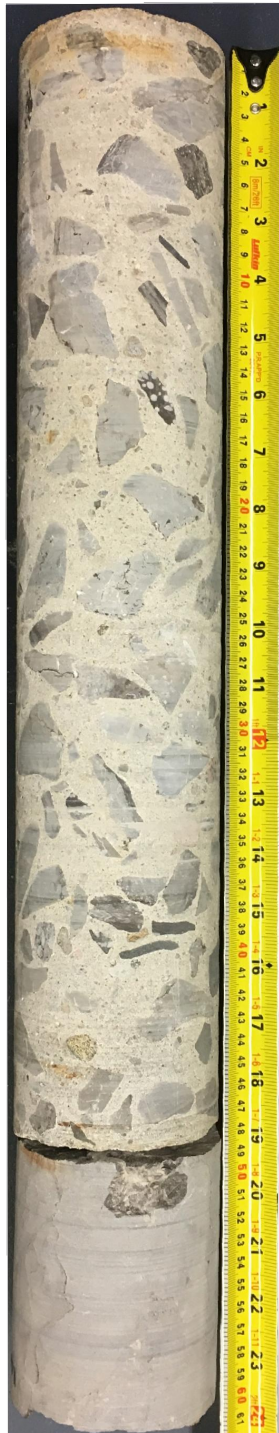
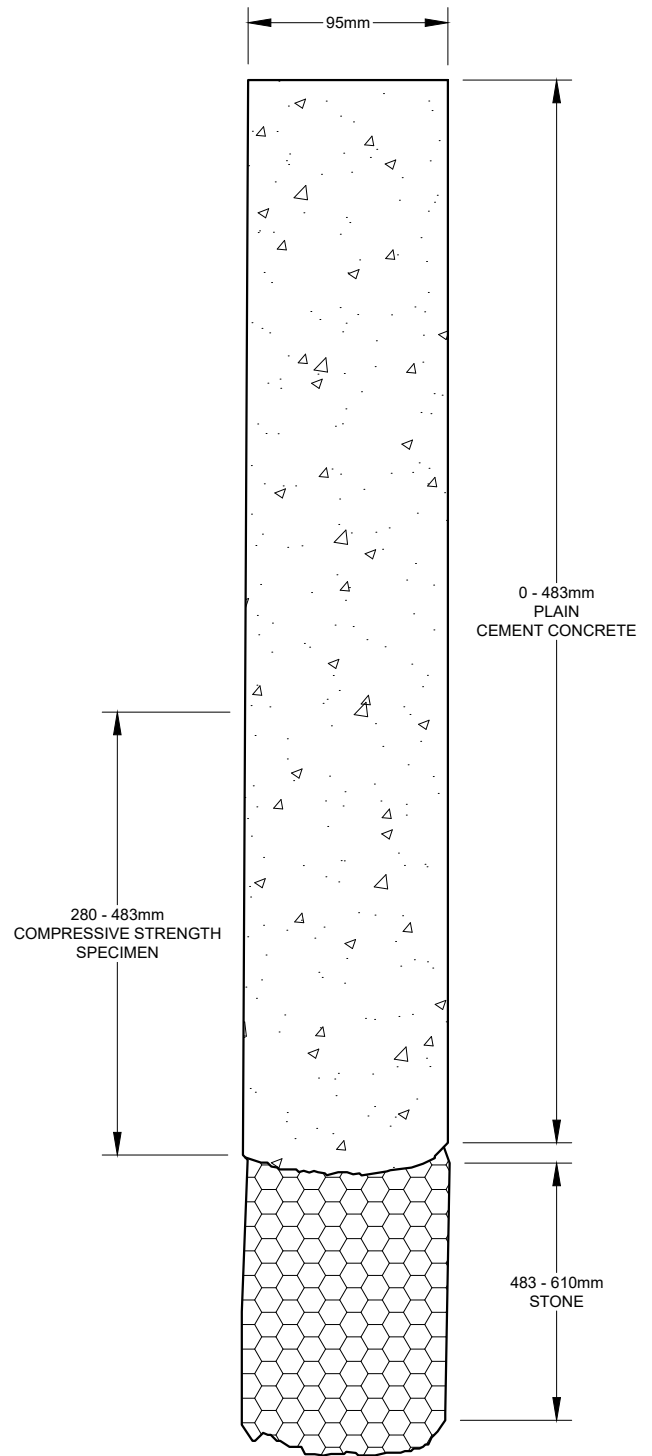
FIGURE 10

CORE 10

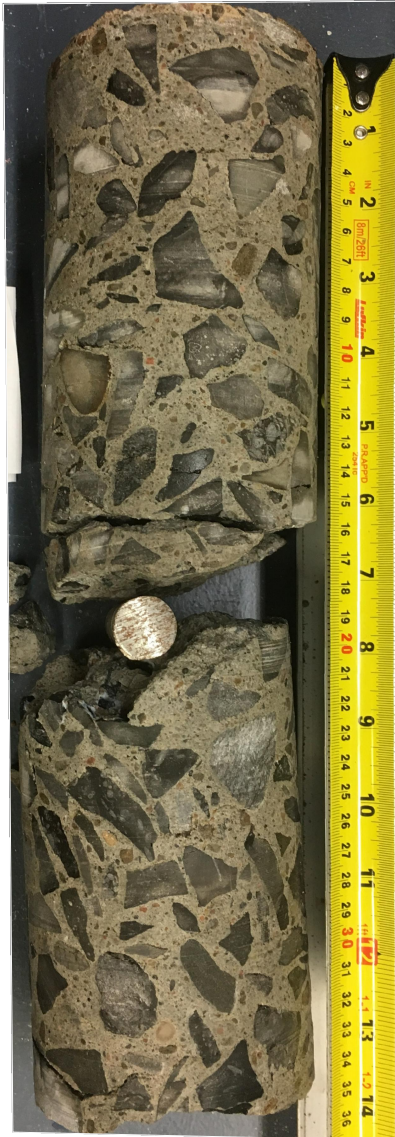
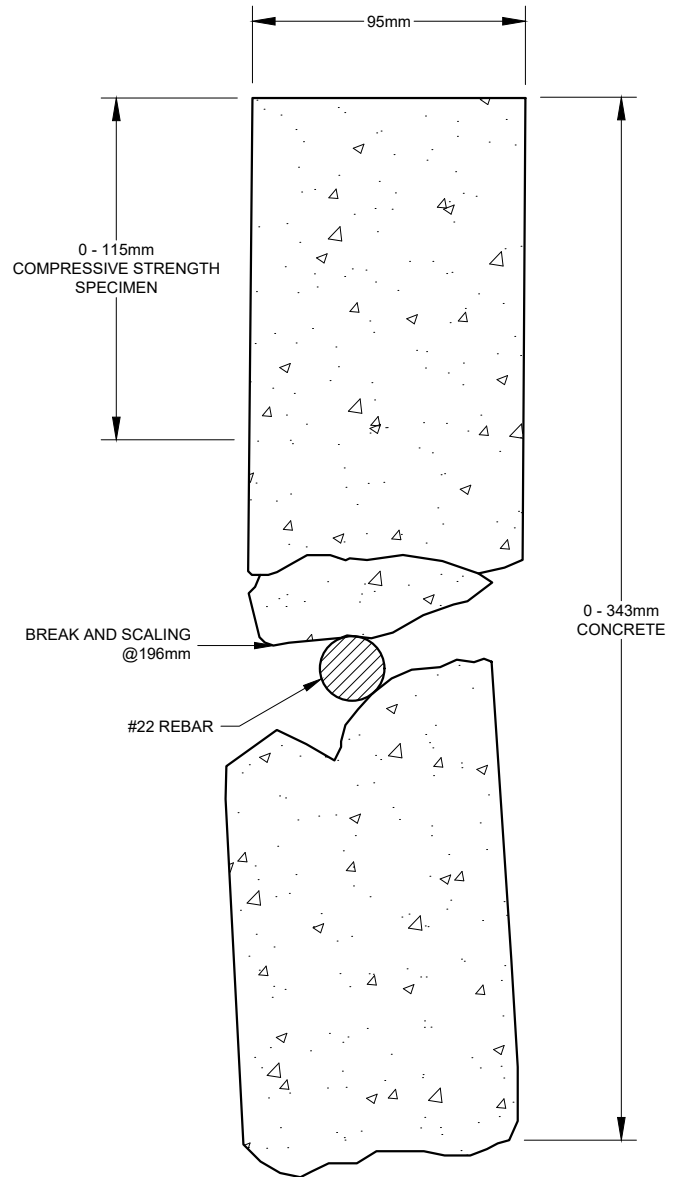
FIGURE 11

CORE 11

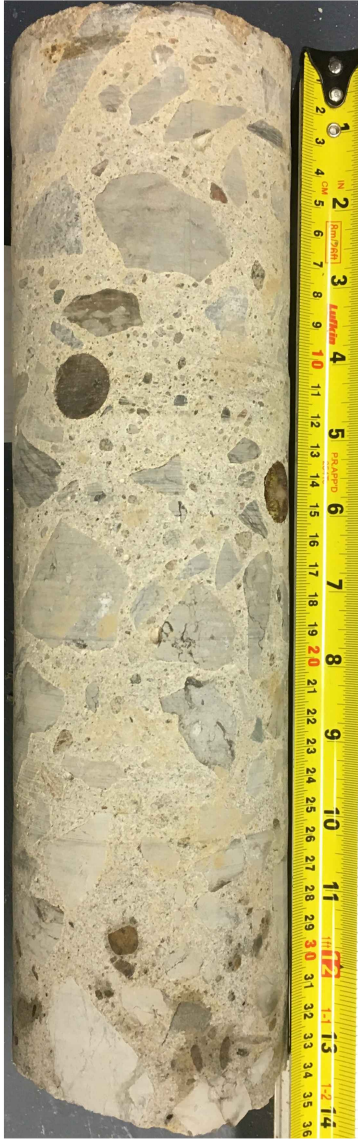
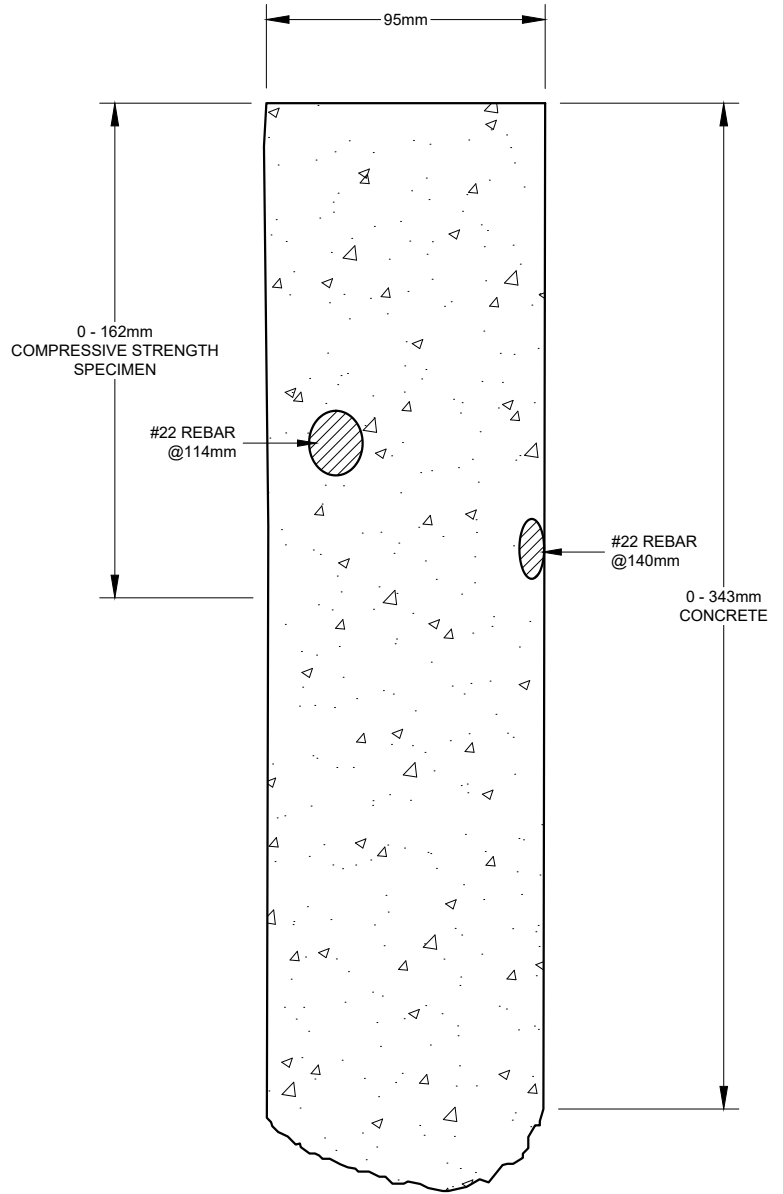
FIGURE 12

CORE 12

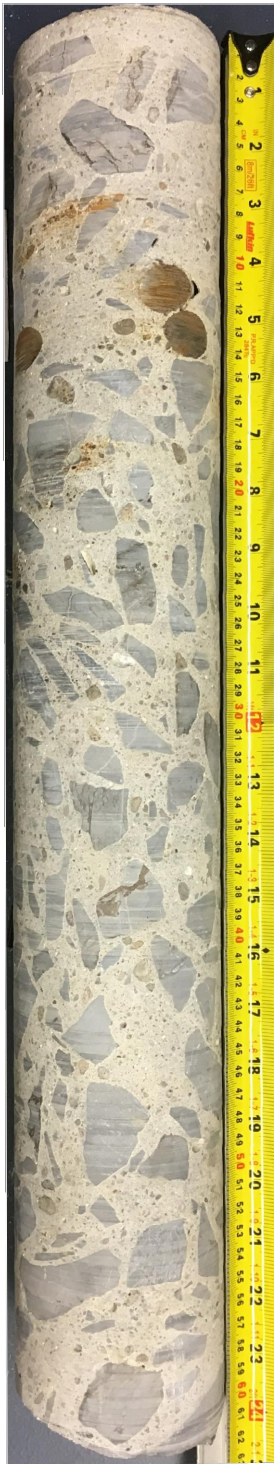
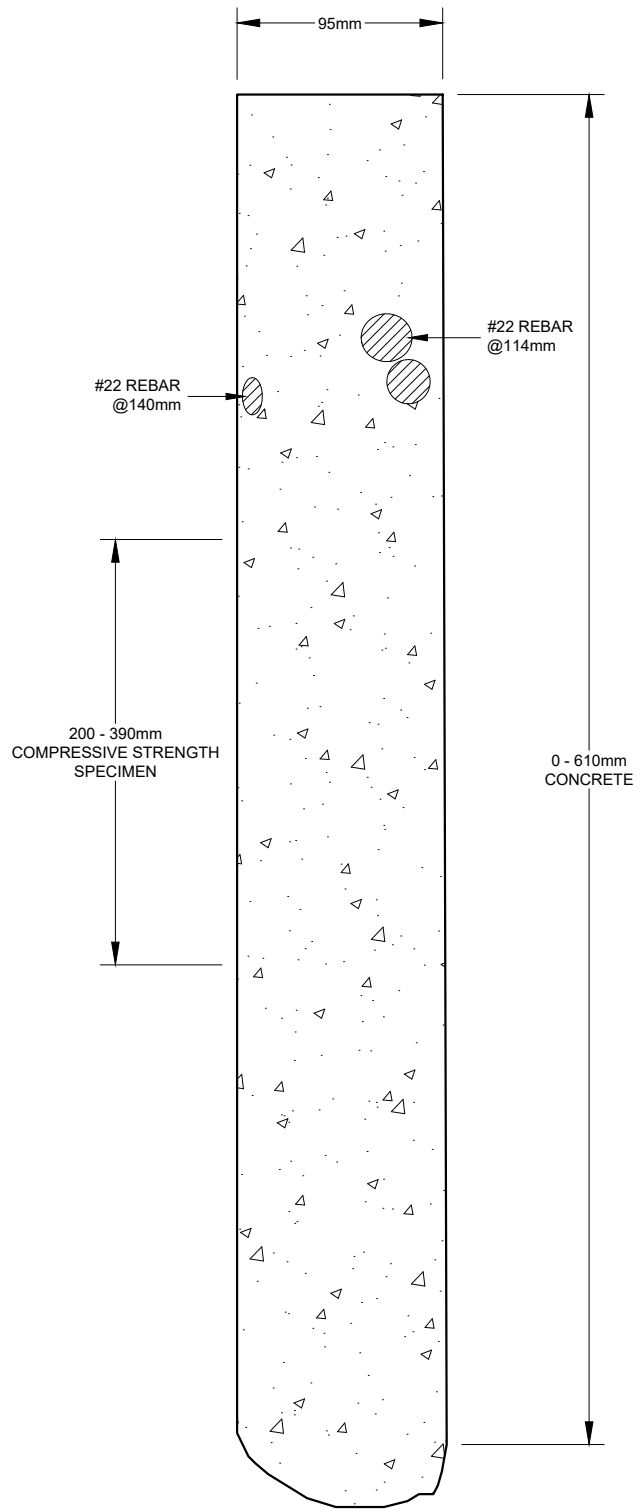
FIGURE 13

CORE 13

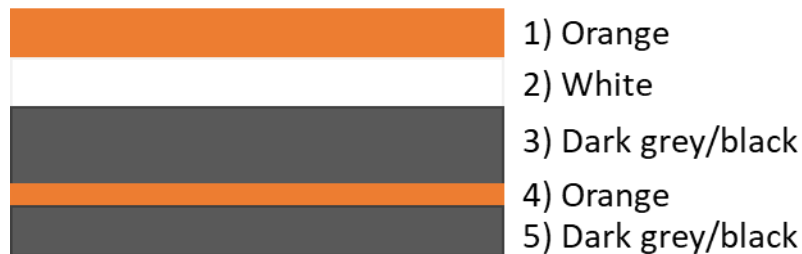
Figure 1: Cross sectional overview of the five layers of the paint chip.

Spectrum #1 (Figure 1, layer 1) represents the outer orange layer. Overall the spectrum shows intense absorbance bands indicating the presence of a polyester based hydrocarbon, as shown by the presence of carbonyl groups (e.g. esters, carboxylic acids) and hydroxyl groups. There are also intense absorbance bands attributed to inorganic components, such as silicates (e.g. sand, quartz) and carbonates (e.g. calcium carbonate).
